Report No. VTRC 06-R22	Report Date March 2006	No. Pages 17	Type Report: Final Period Covered:	Project No.: 78783
				Contract No.
Title: Evaluation of Precast Patches on U.S. 60 Near the New Kent and James City County Line				Key Words: Precast concrete patch, concrete pavement repair
Authors: Shabbir Hossain, Ph.D., P.E., Celik Ozyildirim, Ph.D., P.E. and Thomas R. Tate, P.E.				
Performing Organization Name and Address: Virginia Transportation Research Council 530 Edgemont Road Charlottesville, VA 22903				
Sponsoring Agencies' Name and Address Virginia Department of Transportation 1401 E. Broad Street Richmond, VA 23219				
Supplementary Notes				
<p>Abstract</p> <p>This project evaluated the use of precast concrete patches for repairing jointed concrete pavement. Six patches were placed: three had dowels cast into them during fabrication, and three had dowels inserted in place (dowel bar retrofit). Fabrication and placement were documented. The load transfer efficiency at the joints and the ride quality were determined approximately 2 weeks after construction.</p> <p>After 1.5 years, the general condition of the patches was determined by a visual survey for cracks and spalls. I

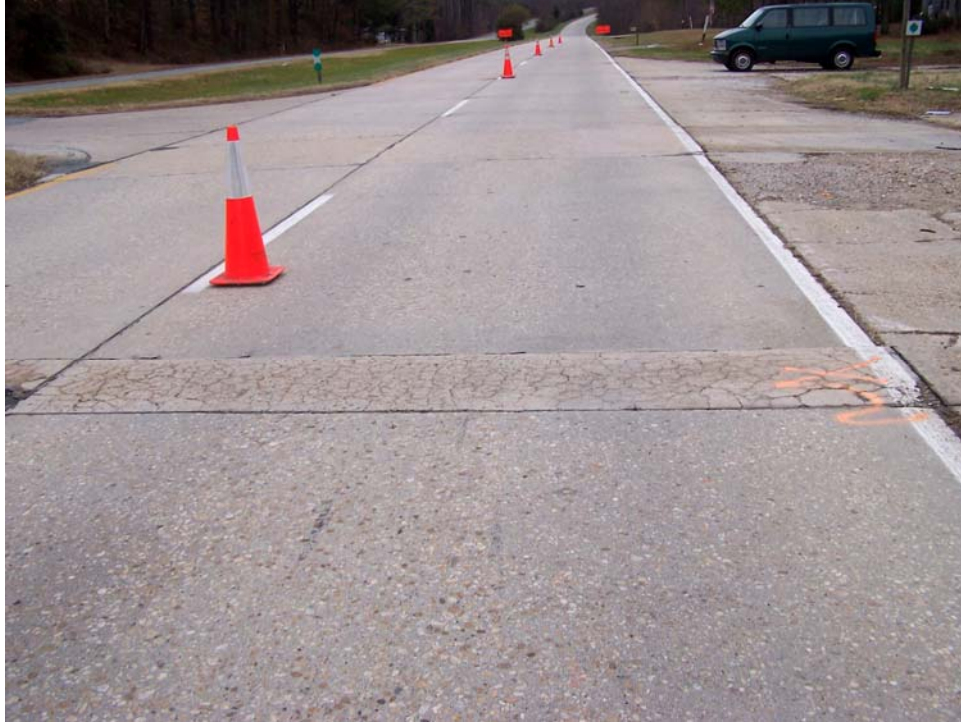
Figure 1. Pavement Condition Before Precast Patching Installation

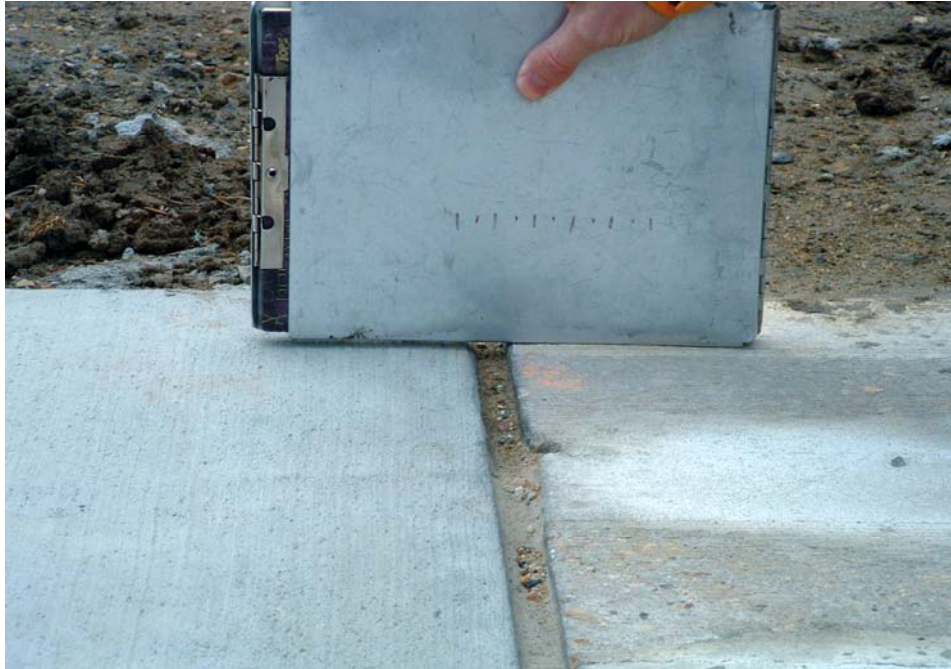
The difficulty in placing the precast patches involved connecting the new patch to the existing concrete. The joints were sealed with silicone over the backer rod. Figure 6 shows the cutting of dowel slots for dowel retrofit. For the slabs with preinstalled dowels, the receiving end in the existing slab was slotted before the placement of the precast slab. After placement, some areas were not level. The elevation difference between the patch and existing pavement is shown in Figure 7.

Figure 7. Checking Elevation Difference After Placement of Precast Slab

Concrete slabs with satisfactory strengths were cast. The cylinder strengths at 27 days were 4,720 psi and 4,706 psi. Although flowable fill was used to level the slabs, the patches had a differential height difference up to one-fourth inch in limited areas, necessitating greater

2. *The Virginia Transportation Research Council and VDOT's Materials Division should evaluate leveling options including flowable fill and diamond grinding to achieve acceptable IRI values.*

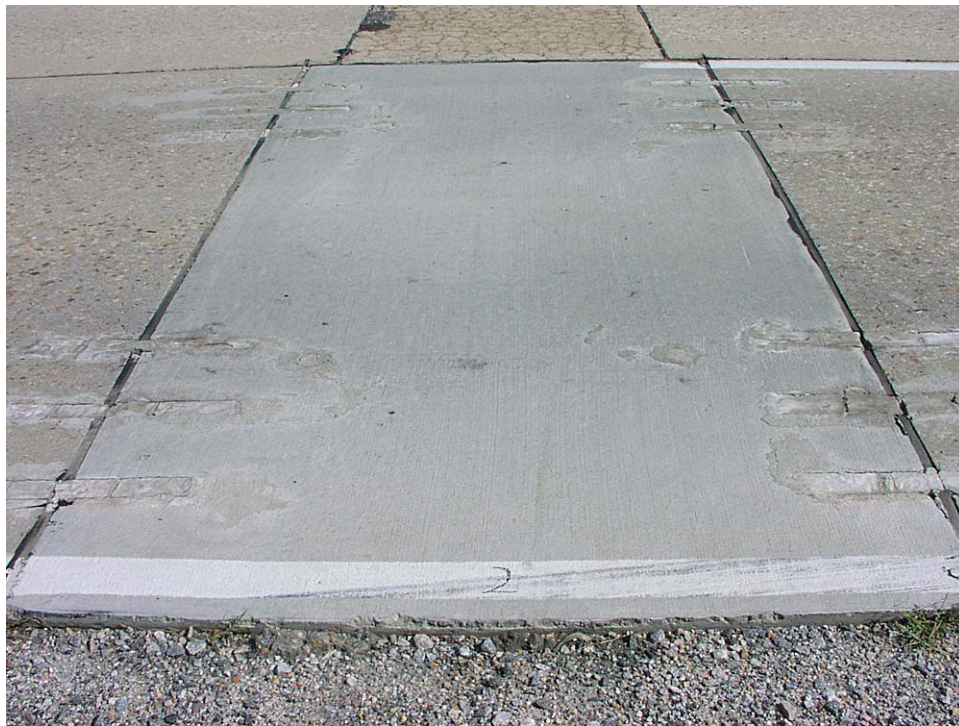
In the September 2005 survey, the contractor indicated that during installation of the slabs with pre-fabricated dowels difficulties were encountered in aligning and centering the dowels. There is also some evidence of misalignment as indicated by cracks initiating at the corners of the dowel slots. The construction practices for securing dowel bars with grout and forming joints in the dowel retrofit area were less than desirable. Specifically, in the first two patches, the grouted area was continuous between the new slab and the old pavement. The joint was not cut at that location, as shown in Figure 8. Thus, the joints at the slots were filled with grout instead of silicone. Three of the dowels in Slab 1 and all 12 in Slab 2 were reset or reinstalled within 2 months of initial construction. In addition, the slots were not well cleaned before dowels and grout were placed during initial construction.

Figure 8. Discontinuous Joint at Dowel Retrofit

4. *VDOT should ensure that the contractor cuts or forms the grouted area for a continuous joint and places the joint material at the proper depth.*
5. *The Virginia Transportation Research Council and VDOT's Materials Division should evaluate the cost-effectiveness of precast slabs since the construction and placement cost may be higher than the cast-in place patches. However, the lane closure times and user delays might be reduced, leading to savings that could offset the cost of construction.*

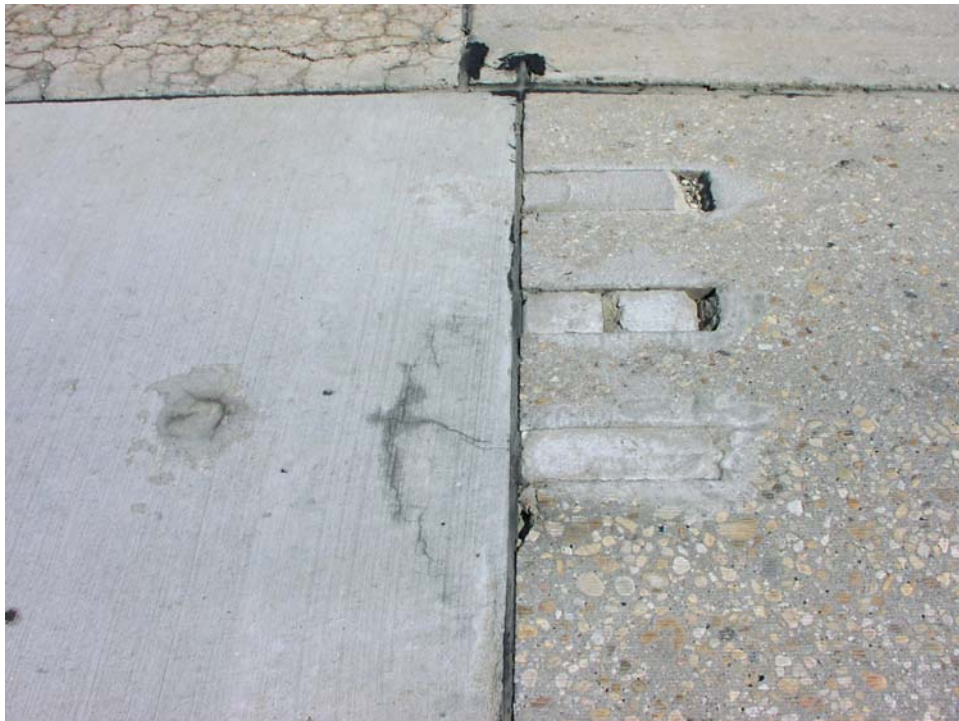
Table 4 provides the number of cracked or spalled grout areas. In all three slabs cast with dowels, cracks were observed propagating into the patch because of the presence of dowel, as shown in Figure 9. In all the patches, there were grouted areas with cracks. All except one of the slabs also had spalled joint areas; in one area, the dowel was visible, as shown in Figure 10. In two of the patches cast with dowels, cracks were also noticed propagating between the wheel

Figure 9. Cracks Propagating into Patch Cast With Dowel

3. *Asset Management Division should try using both the dowel retrofit and dowel cast in slab. However, better construction practices in aligning and better consolidating around the dowel should be accomplished. The movement of the dowels vertically reduces the load transfer efficiency.*

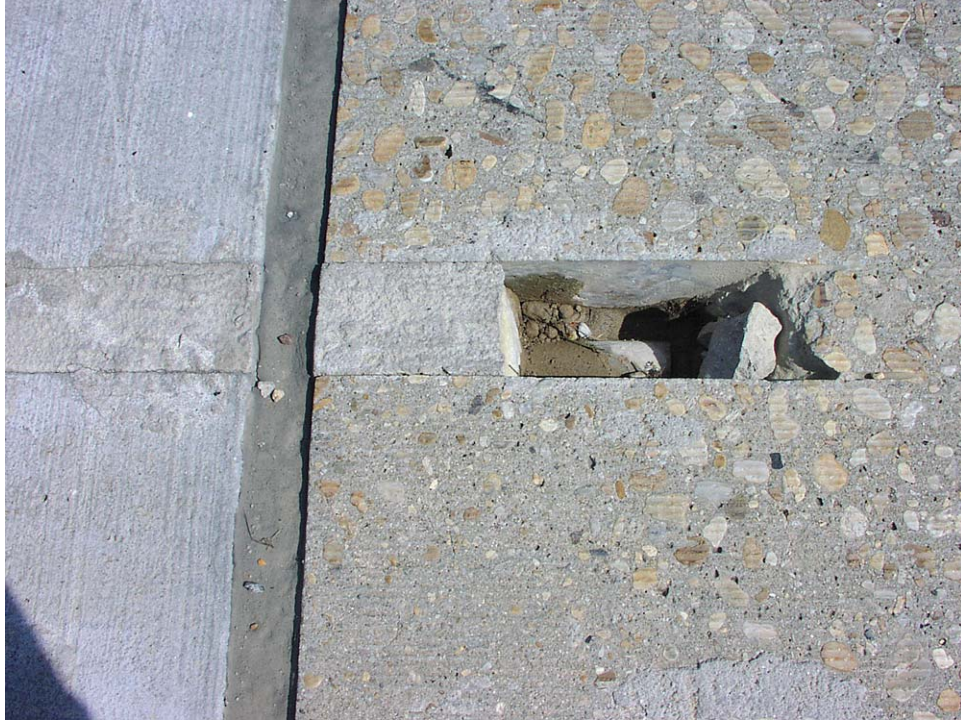
Figure 10. Exposed Dowel

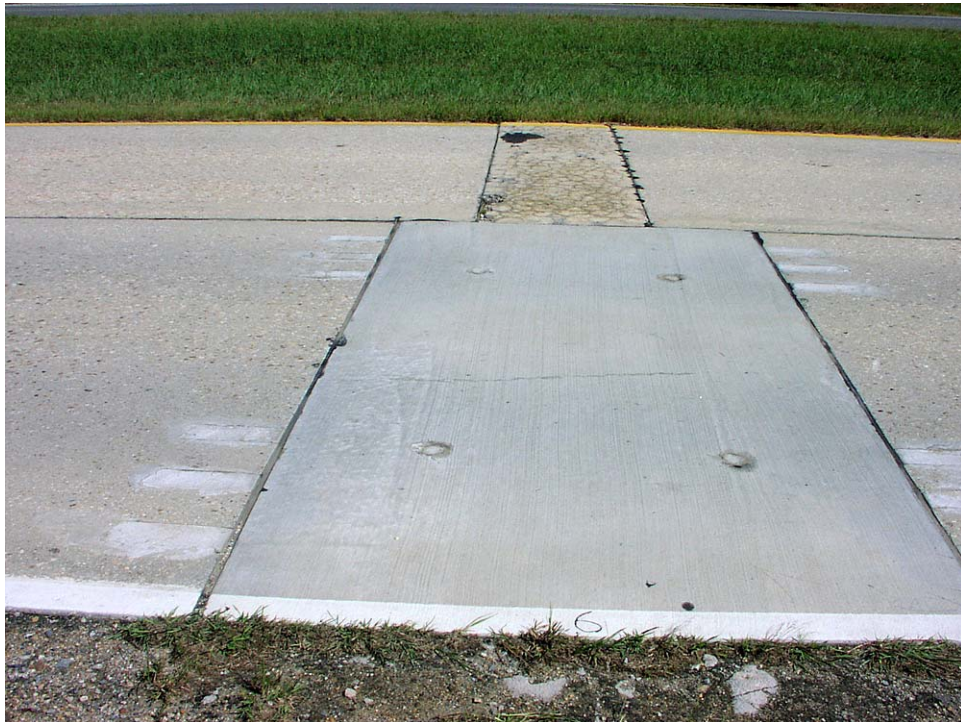
paths in a region without dowels, as shown in Figure 11. In limited areas, the silicone joint material was missing or its surface was depressed up to an inch below the top of the slab as shown in Figure 12. This also indicates the need for better construction practices.

Figure 11. Crack Propagating Between Wheel Paths in Patch with Cast-In Dowel

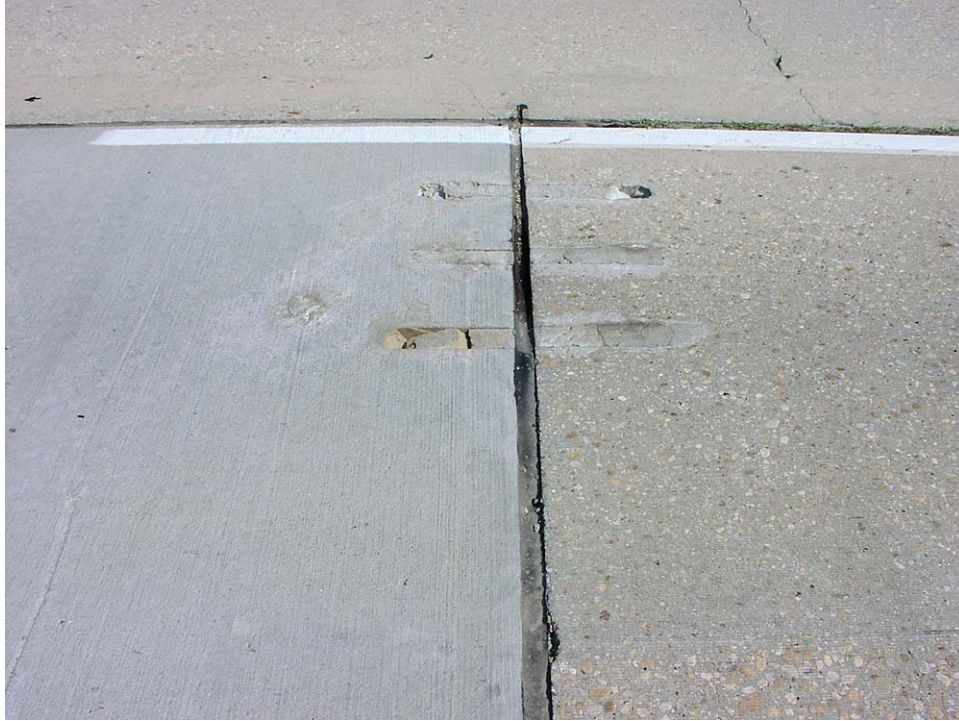
Figure 12. Missing Silicone Joint Sealer
