Repairs With Self-Consolidating Concrete and Galvanic Anodes to Extend Bridge Life

H. CELIK OZYILDIRIM, Ph.D., P.E.
Principal Research Scientist

STEPHEN R. SHARP, Ph.D., P.E.
Senior Research Scientist

Final Report VTRC 18-R9

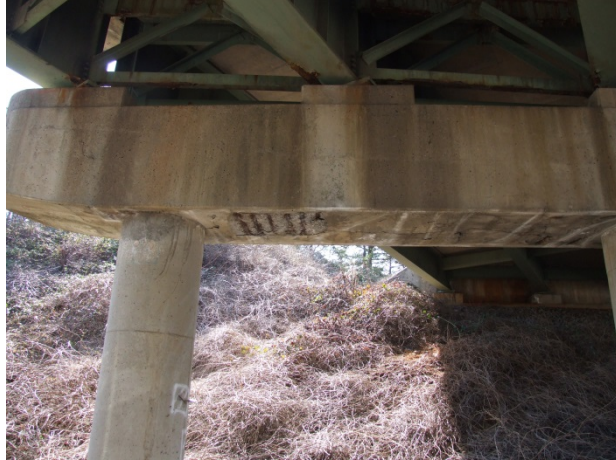
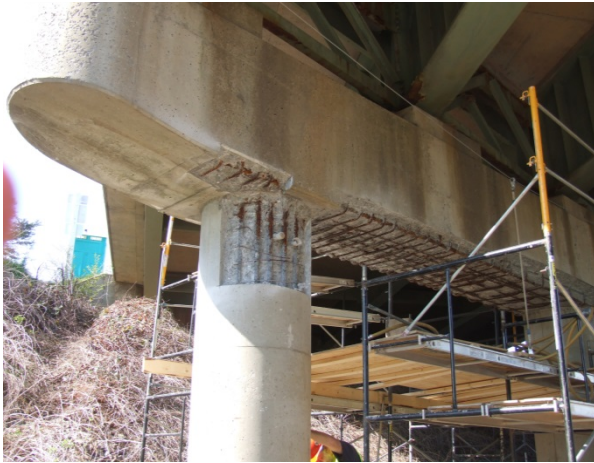
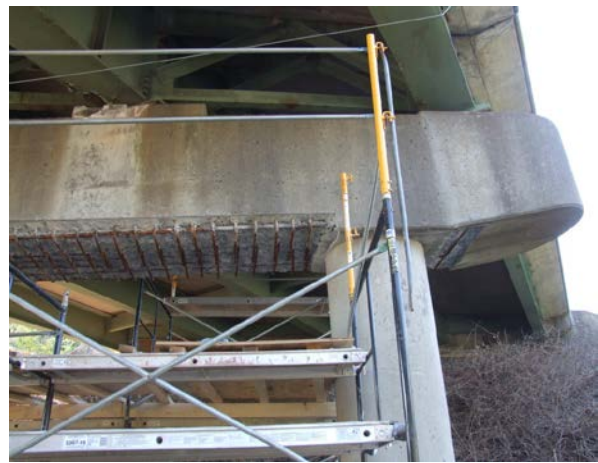
Figure 3. Cap for Route 712 Bridge: (a) after sounding for delamination but before concrete removal; (b) north side; (c) south side after concrete removal in preparation for anode placement and SCC repair

It was decided that the cap and columns in Pier 1 at the north end with the most damaged area would be selected for testing and observation on the Route 712 Bridge. The deteriorated concrete was removed with jack hammers. The 49-ft-long cap had three columns. The limits of removal of the chloride-contaminated concrete were determined by sounding that indicated delaminations. Figure 3 provides an example of the conditions, showing the bottom side of the northern portion of the pier cap before and after concrete removal. After removal of concrete, anodes with and without embedment mortar were placed in selected patch areas, as shown in Figure 4.

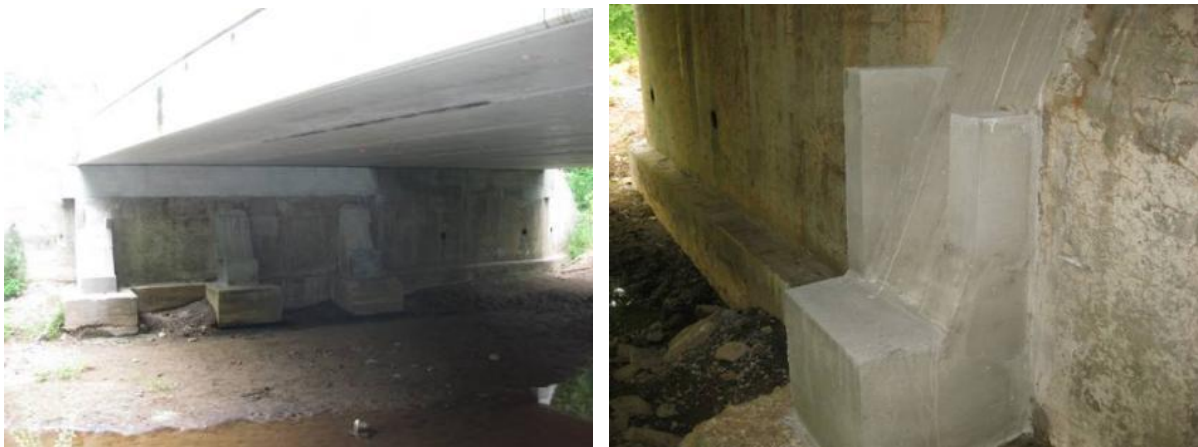
Figure 9. SCC Repaired Backwall (*left*) and Buttress (*right*) for Route 699 Bridge

The SCC for the Route 699 Bridge was tested at the jobsite and had a high slump flow (30 in) without any segregation. The 28-day strength was 7,610 psi. The repaired backwall showed a very smooth finish, as shown in Figure 9. The buttresses had sharp corners. Since this bridge repair did not include anodes, corrosion measurements were not made.

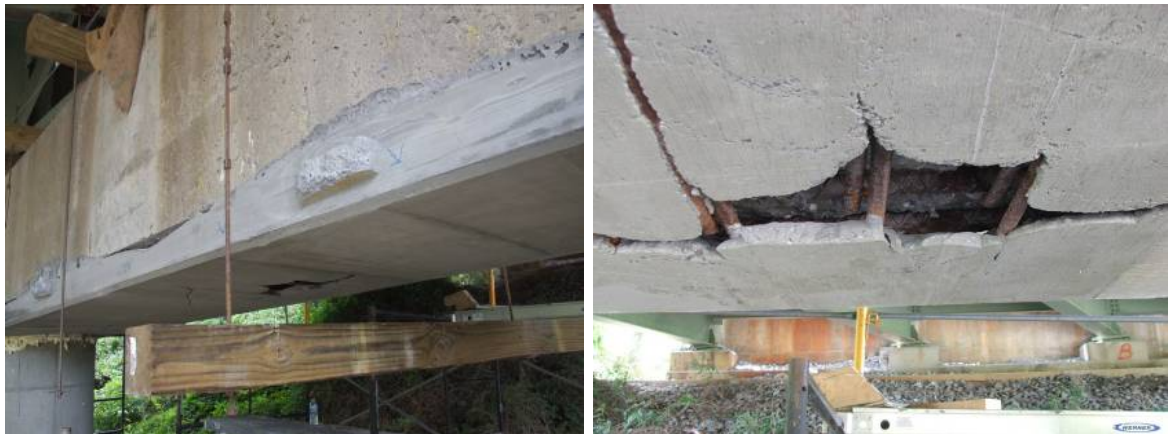
Figure 10. Ports Lower Than High Points (left) and Void at Bottom With Shy Cover (right) for Route 712 Bridge

On July 29, 2010, the concrete repair was inspected and large voids were observed on the top and bottom of the repair area placed on July 21, 2010. The ports to place the concrete were built too low, causing voids on the top, as shown in Figure 10. At the bottom, the reinforcement was close to the surface with shy cover between the bottom of the form and the steel, which would hinder the flow of SCC. In addition, pouring with small buckets did not provide enough pressure to assist with flow, causing a large void at the bottom, as shown in Figure 10.

Concrete was removed from the area with the large voids. After removal of the old SCC repair, new anodes were placed on August 18, 2010. This was done in a manner similar to that of the initial placement. The new formwork provided a continuous open chute at the high end of the repair area on both sides, and a larger clearance between the bottom form and the steel was created by lowering the formwork from the initial level, as shown in Figure 11.

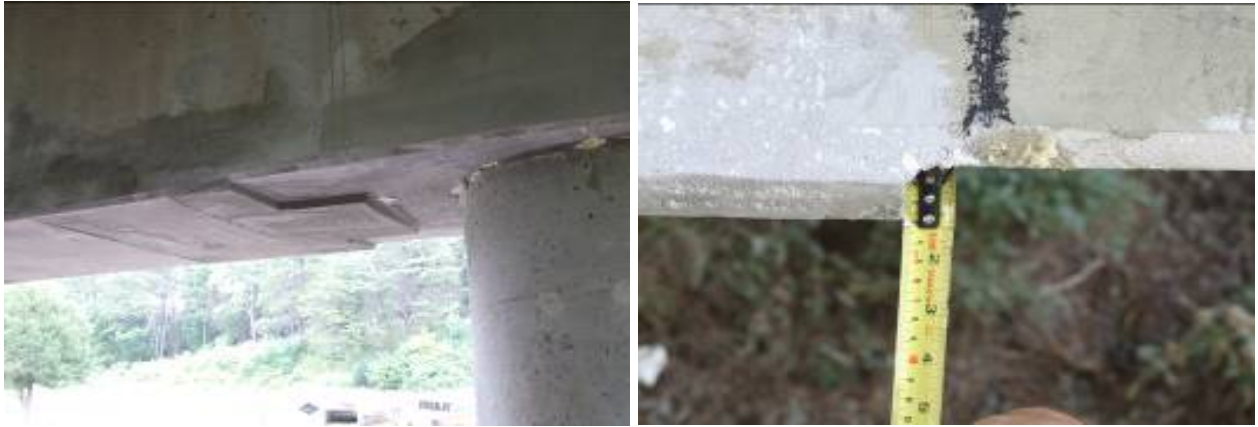
Figure 11. More Cover Depth in Repair Area of Route 712 Bridge Provided by Lowering of Formwork: Overview (*left*) and Measured Difference of Protrusion (*right*)

Although increasing the cover depth was necessary, extending the new surface to the column or to an edge would have provided a more aesthetically pleasing view. The first batch of 2 ft³ of concrete delivered had a very high air content (15%) and was rejected. The second batch had a high flow rate (30 in) and an acceptable air content (7%) and thus was used. With the truck positioned under the bridge, SCC was placed in a container and lifted near the repair area. SCC was filled into the small buckets by dipping and then poured into the opening. The placement was completed in about 30 min. The slump flow at the completion of the project was 26.8 in. The forms were removed on Monday, August 23, 2010, and the inspection revealed sound concrete with no delaminated areas. As shown in Figure 12, except for the drop shown in Figure 11, the repaired pier cap and column looked satisfactory and matched the geometry well.

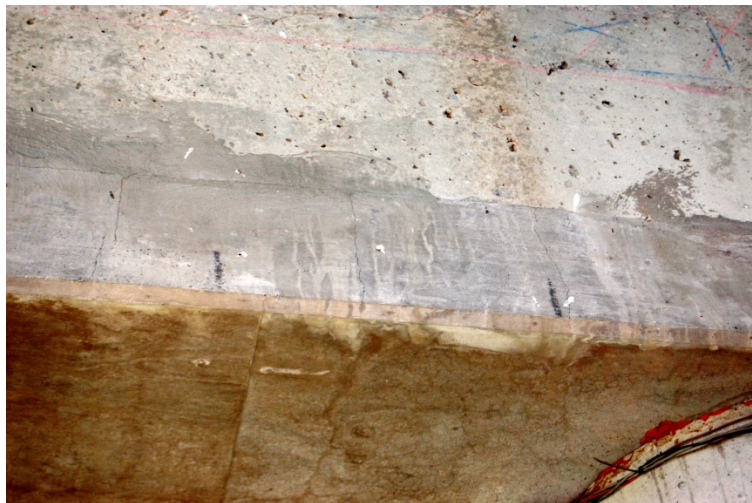
Figure 14. Tight Shrinkage Cracks in Repair Area of Route 712 Bridge in 2017

Even though the shrinkage values were high, there were no wide cracks in the repaired areas after the completion of the repairs because of the heavy reinforcement and limited size of the repair area. In a field survey on March 8, 2017, about 7 years after placement, cracks were observed, as shown in Figure 14. The cracks were tight and their spacing ranged from 1 to 4 ft.

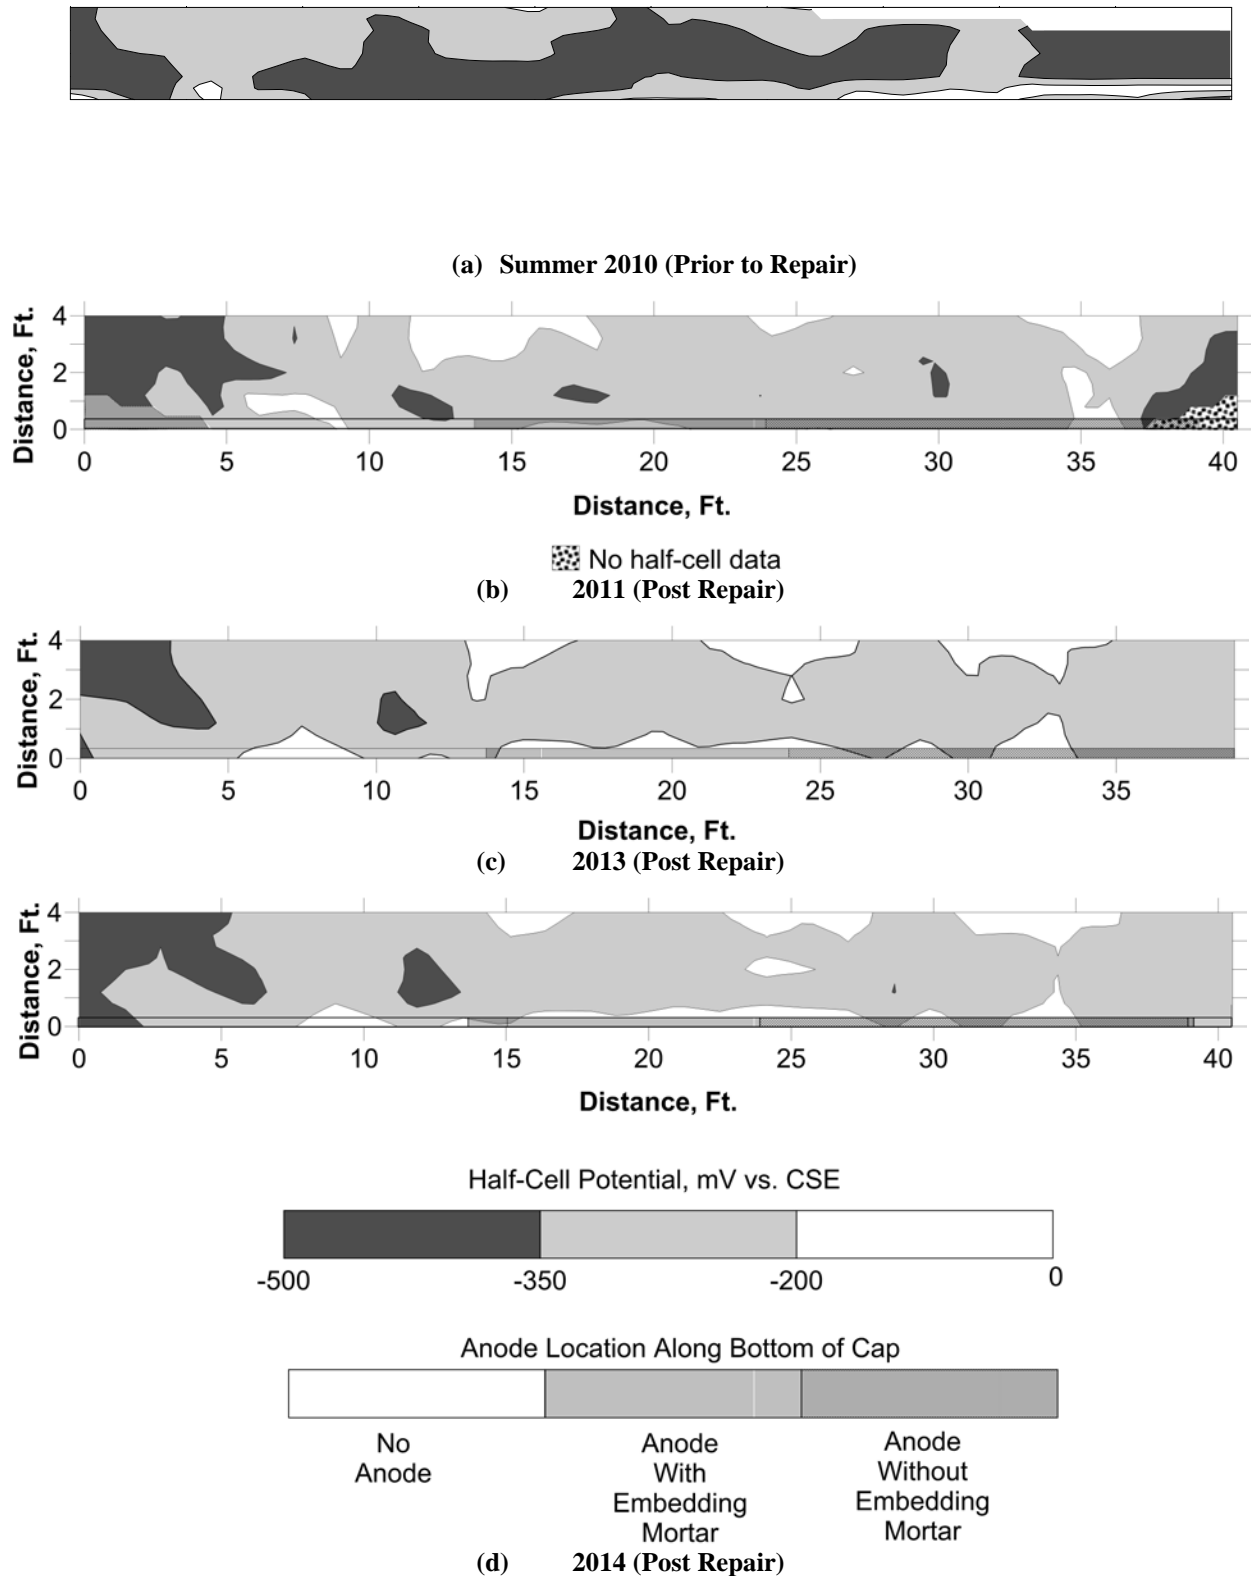
To monitor the probability of corrosion in the original concrete, half-cell data were gathered during July and August over several years. These data were converted into potential maps and are shown in Figure 16. Although anodes were placed in selected regions along the bottom of the cap, the upper region, which exhibited corrosion risk based on half-cell measurements, did not receive any anodes. In Figure 16, it is clear that there is a high probability of corrosion in several regions where concrete was not removed. These regions are also outside the area of influence of the anodes that were placed along the bottom of the cap.

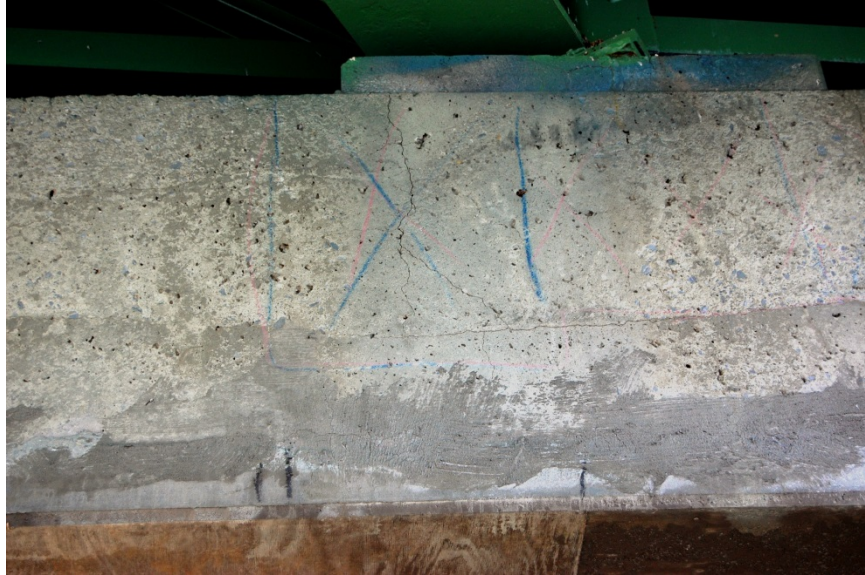
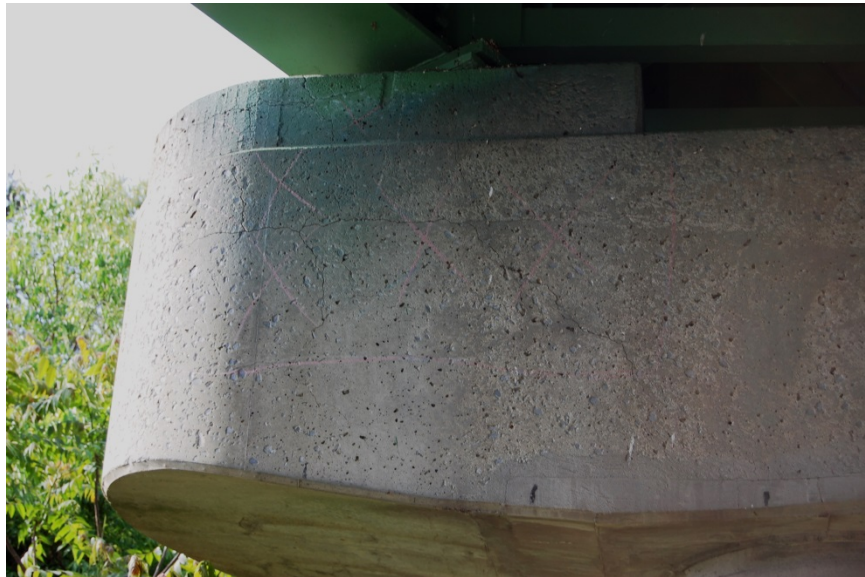
Figure 17. Cracks Evident in Upper Region of Pier Cap of Route 712 Bridge on Locations Separated From Embedment Anodes. Image of cracking in interior region is shown in (a), and cracks in end cap are shown in (b).

Cracks were observed in the upper region of the pier cap, which was especially noticeable below the bridge seat, as shown in Figure 17a. Cracking was also obvious along the end of the northern cap, as shown in Figure 17b. More negative half-cell potential readings were seen in regions with cracking, which is consistent with the higher probability of corrosion activity that is expected according to ASTM C876.

This raises questions about the cost-effectiveness of always using galvanic anodes in repairs when adjacent chloride-contaminated concrete is not removed. From what was observed at Altavista, if the area with chloride-contaminated concrete is limited, as in the case of the end of a pier cap, galvanic anodes could be beneficial. However, if the chloride-contaminated concrete area is located too far away from the patch repair area, galvanic anodes will most likely not mitigate corrosion in the contaminated area. This will result in the need for future repairs in those remote chloride-contaminated areas. Moreover, in some cases, galvanic CP will not suffice, so other repair techniques, such as impressed current CP or even removal of a greater volume of chloride-contaminated concrete, should be considered.

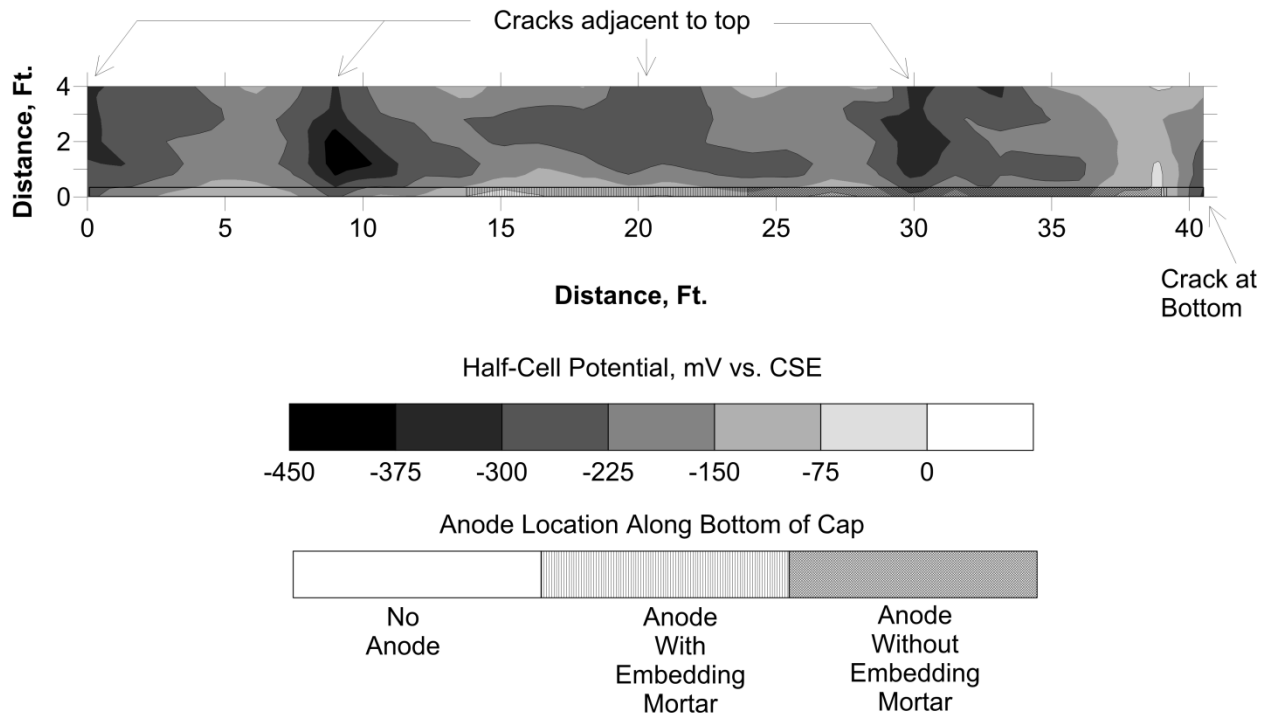
Figure 18. Recent Half-Cell Potential Map Showing Crack Location in Unrepaired Area Along Vertical Face of Pier Cap of Route 712 Bridge. Anode locations are described earlier, with the coordinate 0,0 in these figures indicating the northern bottom end of the cap.

To visualize better the correlation between the half-cell potential readings and the crack locations, the half-cell potential map contour intervals based on data gathered on May 5, 2017, were adjusted and the crack locations in the original concrete were overlaid to create Figure 18. Although the lower portion of the structure where the repair was made several years ago is doing well and showing only smaller periodic cracks with no indication of corrosion, the older chloride-contaminated concrete that was not removed has continued to corrode and is now exhibiting damage.

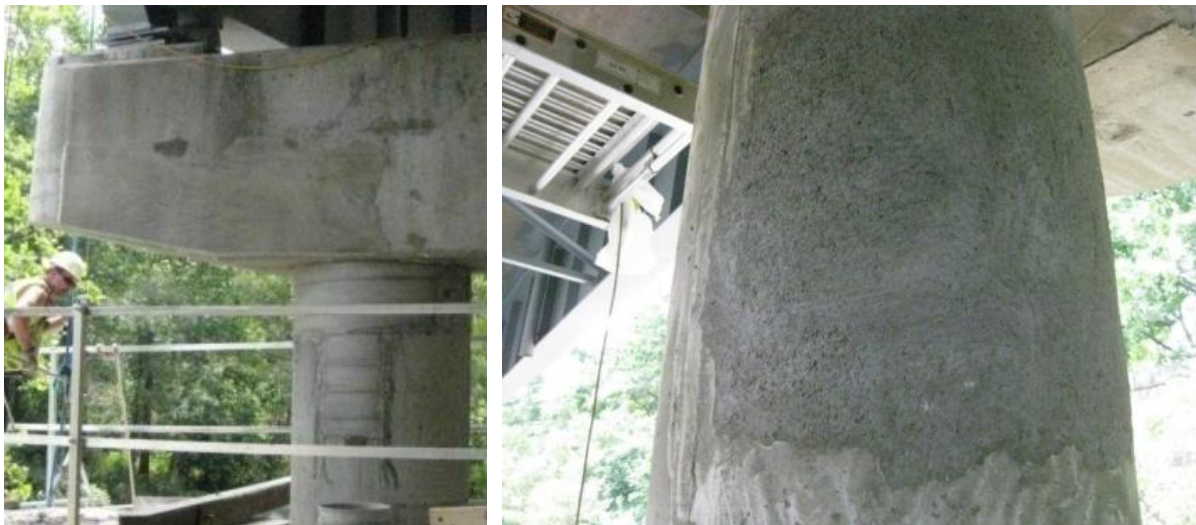
Figure 19. SCC With Smooth Surface (left) and Shotcrete Rough Surface (right) of Route 712 Bridge

The SCC repair was made to a pier cap and column. Three other pier caps were repaired at the same time using shotcrete. The repair with SCC resulted in a much smoother finish and was less noticeable aesthetically. Figure 19 shows the surface of the SCC and the shotcrete.
