Durability and Inspection of Hybrid Composite Beams

Final Report VTRC 20-R7

FINAL REPORT

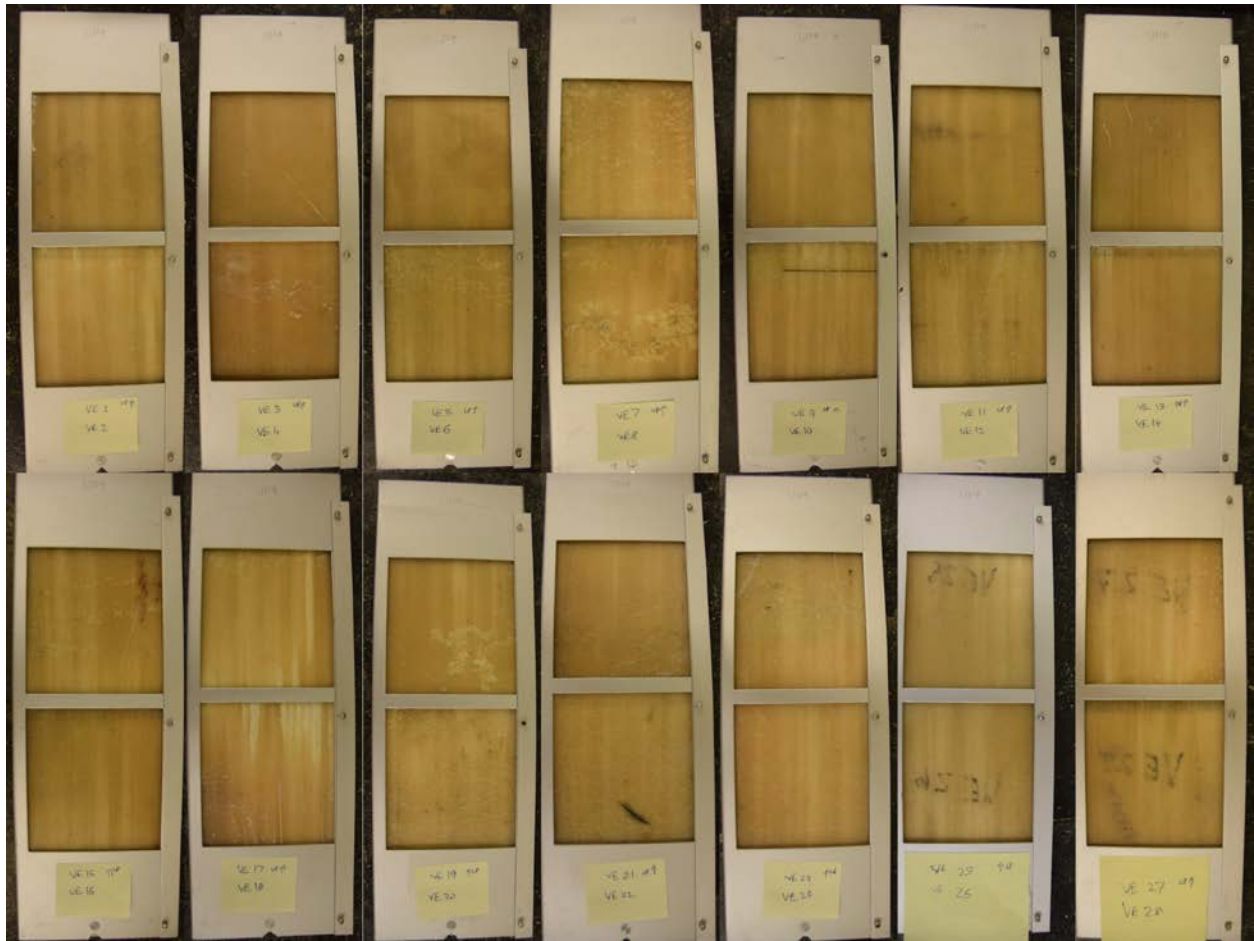
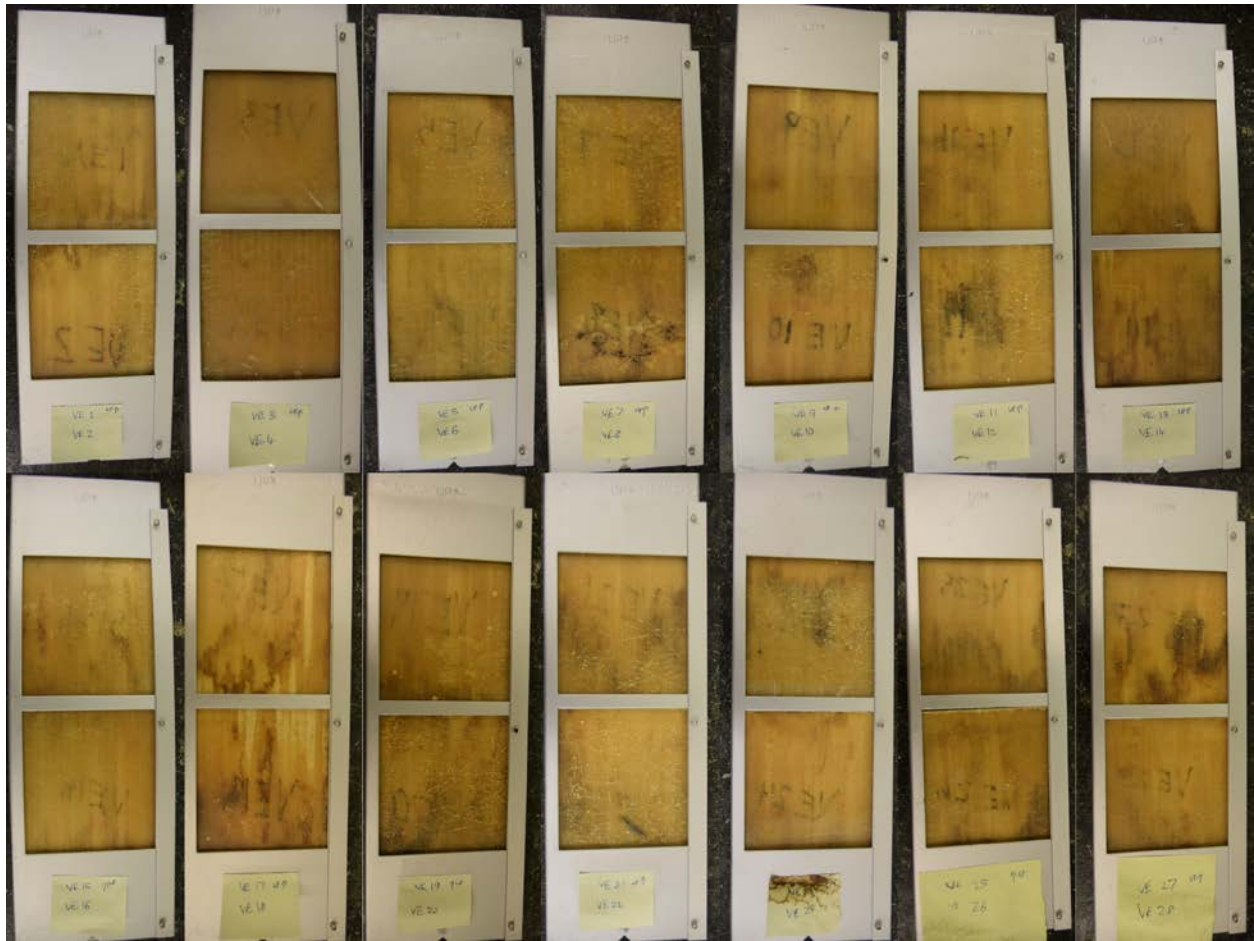
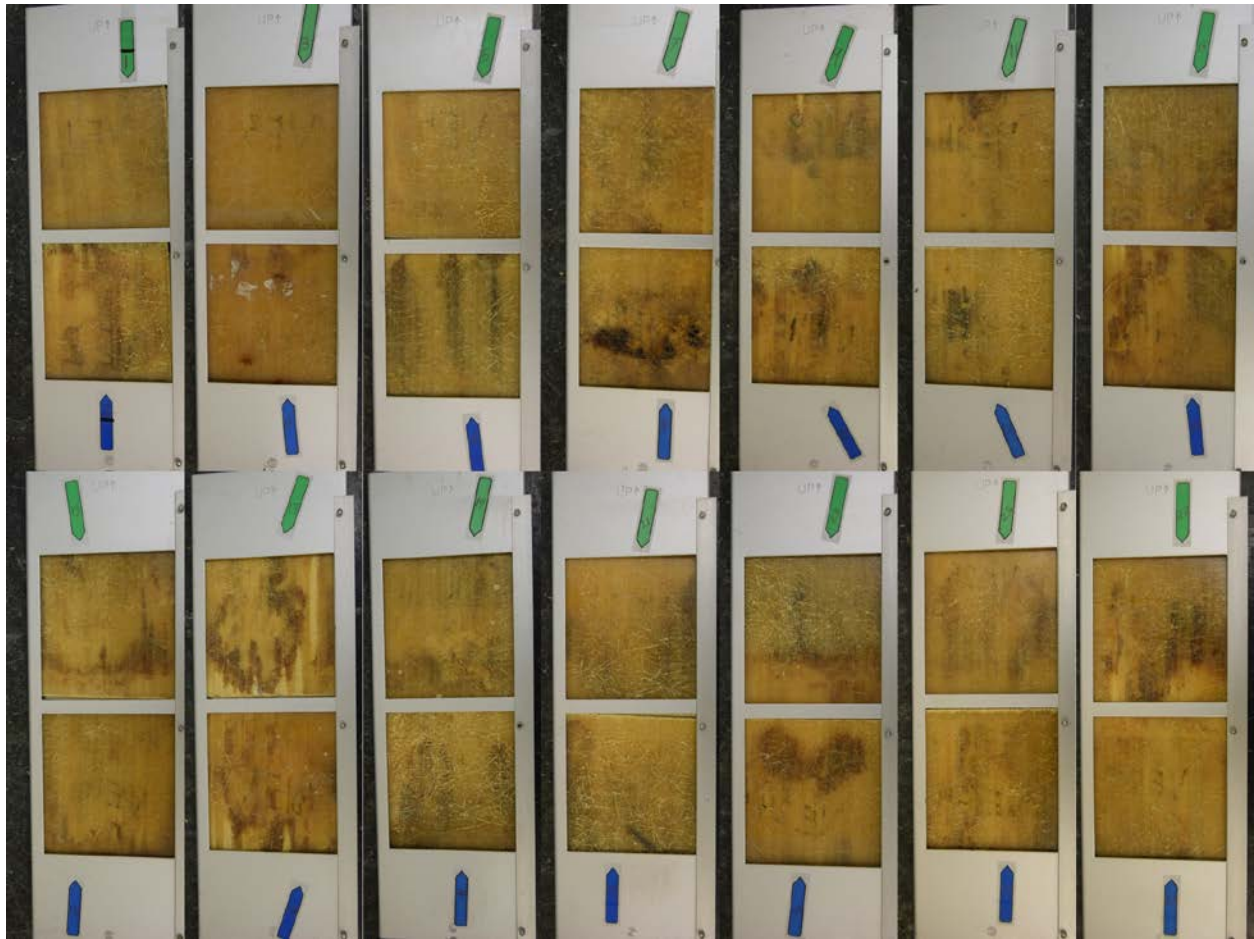
Figures 10 through 12 show the laboratory specimens at 0 hr, 920 hr, and 2,000 hr of UV aging, respectively. Visually, the specimens appear to become darker. However, no damages such as pitting, cracking, or crumbling were observed except on Specimen 8, which developed a burn on the surface at 920 hr (Figure 11). This black spot can be observed to grow bigger at the end of 2,000 hr of UV aging (Figure 12). This might have been because of the presence of a thin delamination from the load testing at Virginia Tech. Based on this, there was a suspicion that the accelerated exposure might be too aggressive in the later stages of the degradation and might not represent the actual conditions of the field structures, so the aging was stopped at this stage.

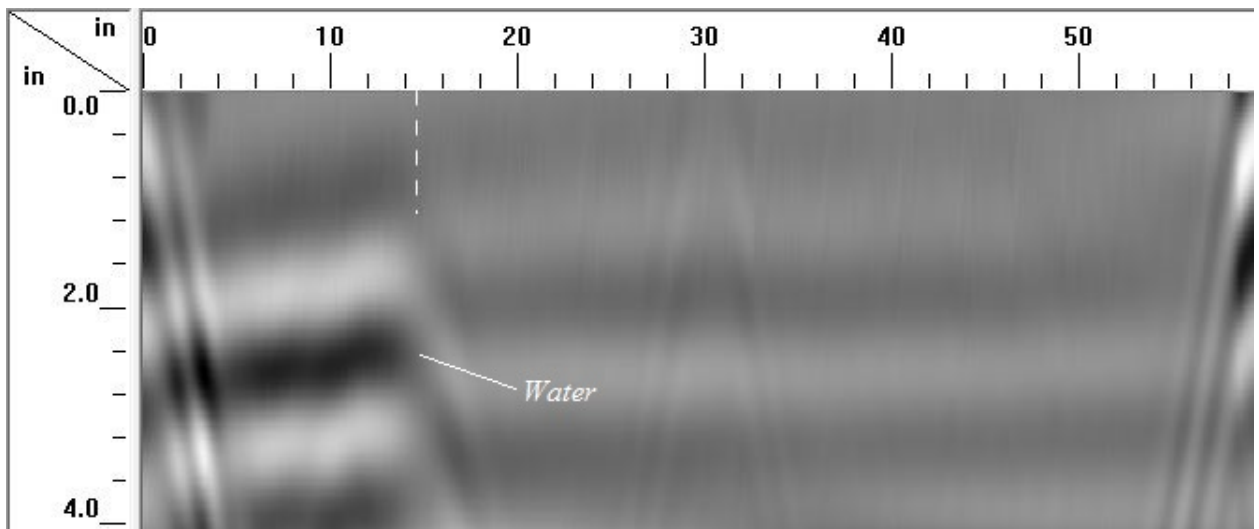
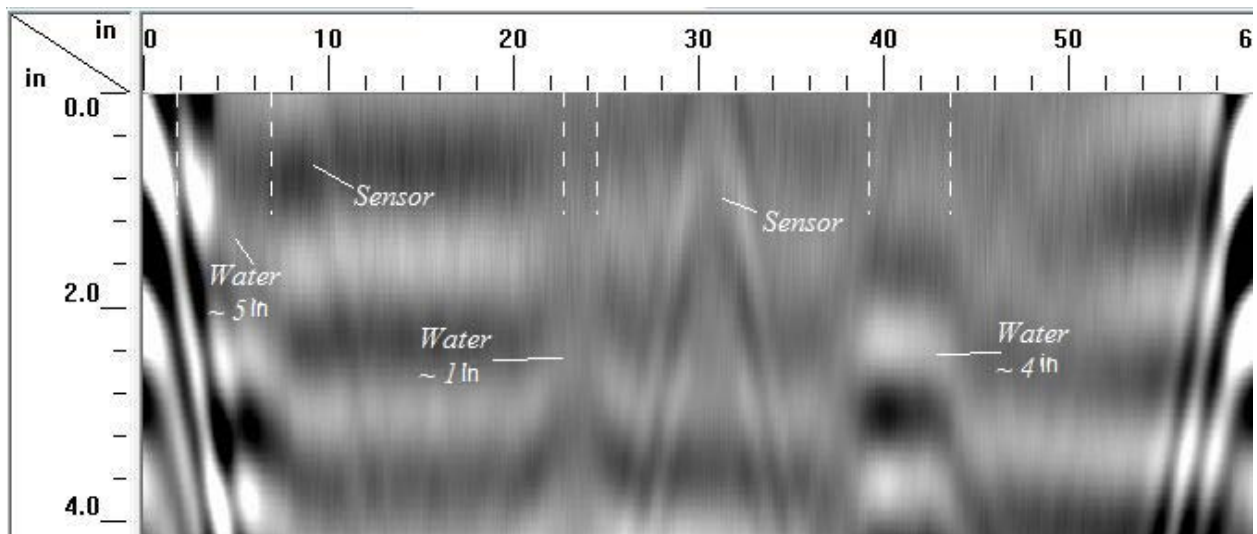
To test the sensitivity of GPR in detecting moisture, three circles of moisture of different sizes were dabbed using a brush at three locations along the same longitudinal section: 5-in, 1-in, and 4-in diameter from the left. Figure 27 shows the results from this scan. The locations of the water locations, even the one as small as 1 in, are clearly visible except that the first location from the left (5 in) was partly hidden by the edge effect.

This laboratory experimentation proves GPR’s capability to detect even a trivial moisture presence inside the HCB.

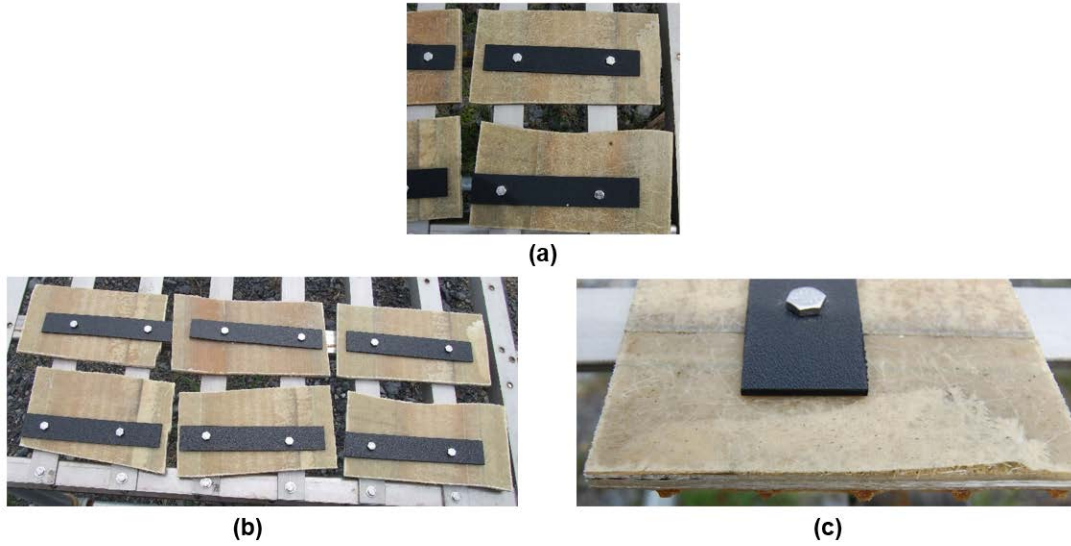
Delamination of the glass layer was observed along a cut edge (Figure 33) in one sample, which was probably attributable to moisture penetrating the sample and expanding and contracting during seasonal cycles of freezing and thawing. Most of the specimens, however, visually seemed to have performed well and did not show signs of substantial degradation. This response was especially surprising for the foam specimens (Figure 35) since this component of the composite beam was somewhat protected from the weather because it was placed inside the fiberglass shell that makes up the beam.

Figure 33. Comparisons of Fiberglass Specimens: (a) initially; (b) several specimens after 1 year and 8 months; (c) close-up of delaminated edge after 1 year and 8 months

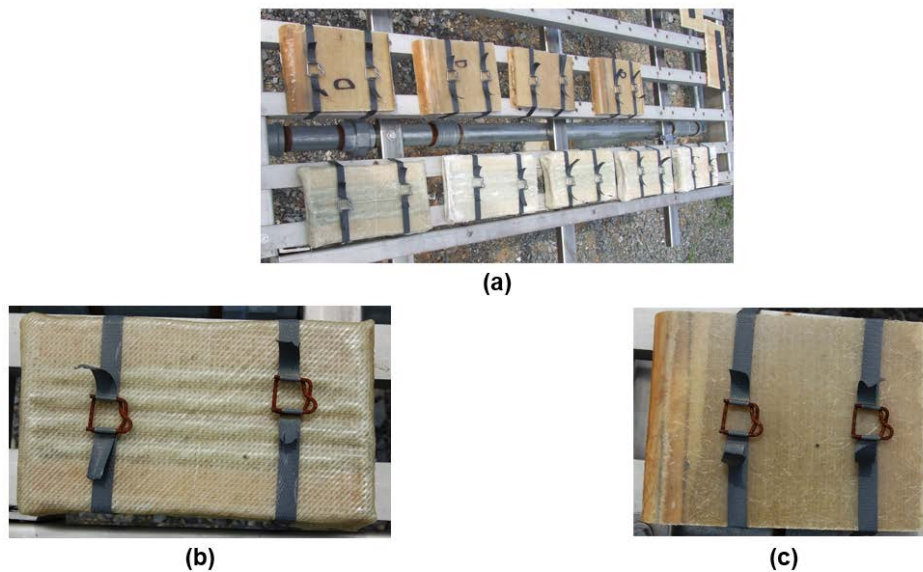
Figure 34. (a) Fiberglass with the exposed steel specimens, on upper sample line in each photograph, and fiberglass with the protected steel specimens shown along the lower sample line in each photograph with no exposure; (b) close-up of a typical protected steel sample after 1 year and 8 months; (c) close-up showing a typical exposed steel sample after 1 year and 8 months

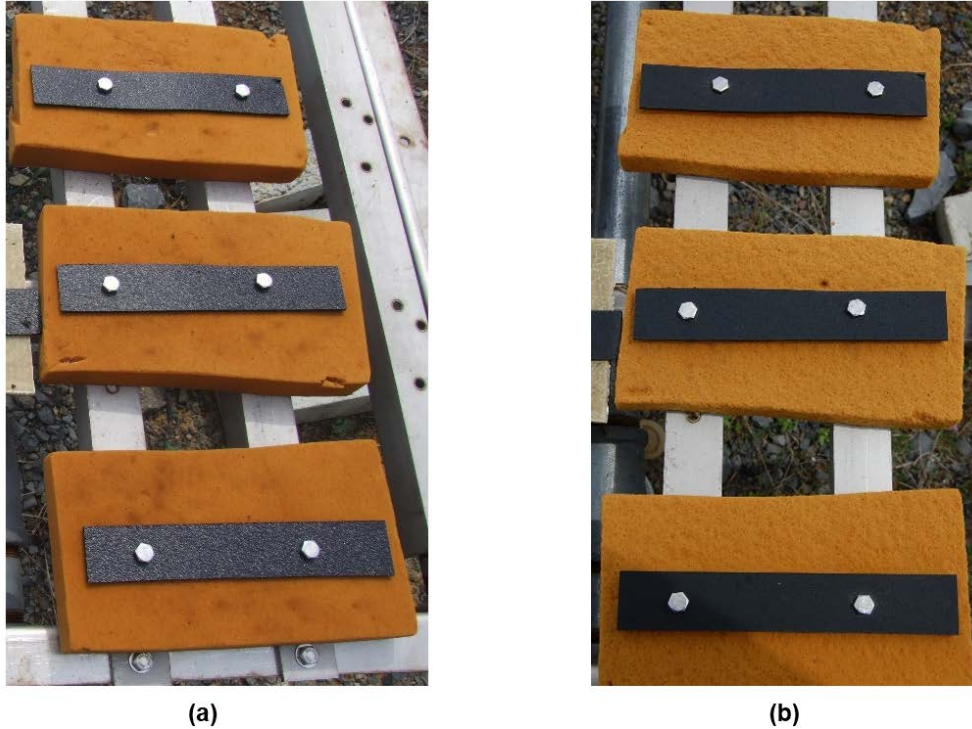
Figure 35. Comparisons of Foam Specimens: (a) initially; (b) after 1 year and 8 months

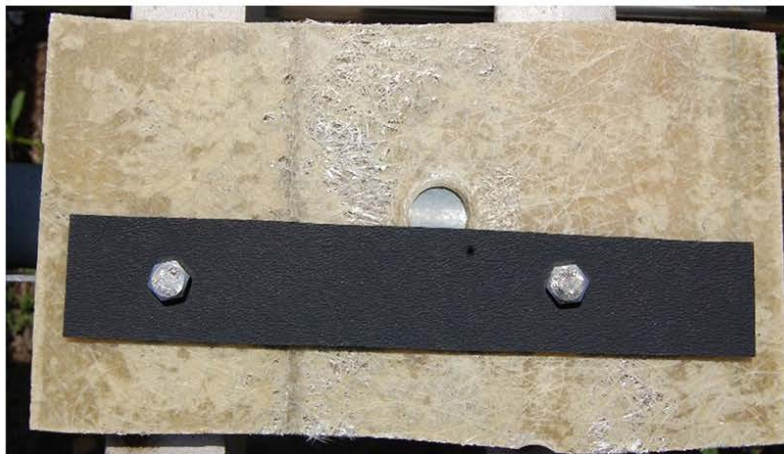
Delaminations and damage to the exterior surface of the fiberglass layer were observed (Figure 36) in several specimens. Other test specimens that exhibited damage also included the foam, which clearly exhibited more damage, as seen in Figure 38. This was interesting since the weather data for this site were less extreme as compared to the Harrisonburg site with the exception of the UV index data. Therefore, it appears that although the composite beam components showed only minor deterioration, UV exposure most likely contributed the most to damaging the exposed components.

Figure 36. Comparisons of Fiberglass Specimens: (a) initially; (b) after 1 year and 8 months, exhibiting delamination and exposure of the fibers; (c) in an area that initially had some fibers showing; (d) observed to have grown larger after 1 year and 8 months

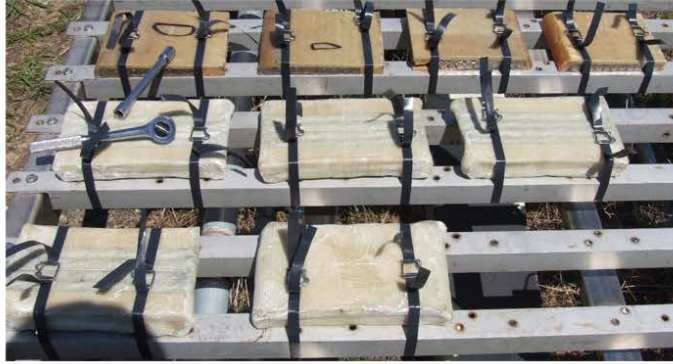
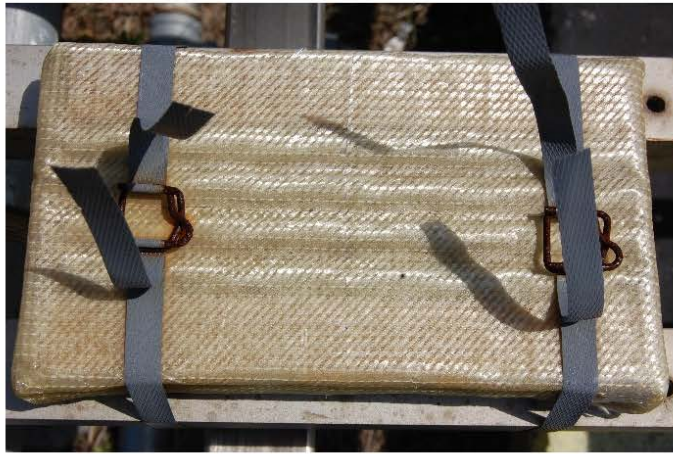
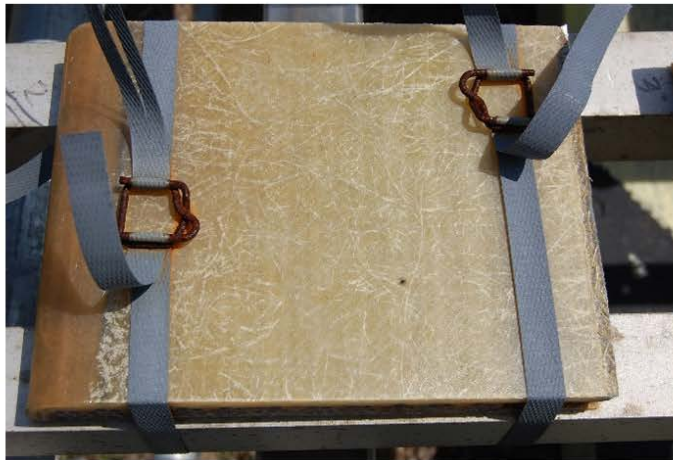
Figure 37. (a) Fiberglass with the exposed steel specimens, on upper sample line in each photograph, and fiberglass with the protected steel specimens shown along the lower sample line in each photograph initially; (b) close-up showing a typical protected steel sample after 1 year and 8 months; (c) close-up showing a typical exposed steel sample after 1 year and 8 months

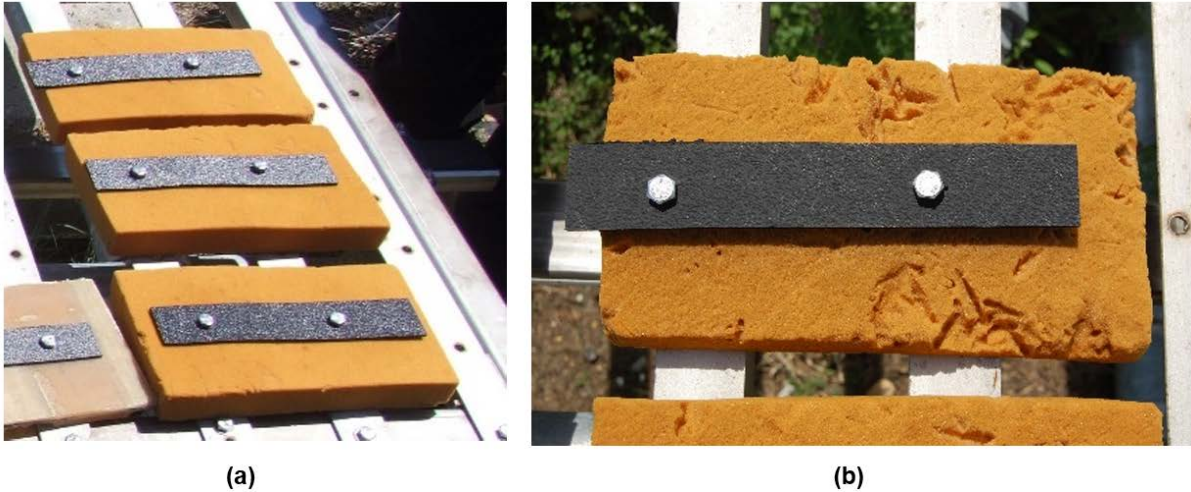
Figure 38. Comparisons of Foam Specimens: (a) initially; (b) after 1 year and 8 months showing how foam has degraded and exhibits loss of material, especially along the edge because of exposure
