Documentation and Evaluation of ASTM A709 Grade 50CR Steel Bridges on Virginia's Eastern Shore

Final Report VTRC 24-R2

Virginia Transportation Research Council
(A partnership of the Virginia Department of Transportation
and the University of Virginia since 1948)

November 2023
VTRC 24-R2

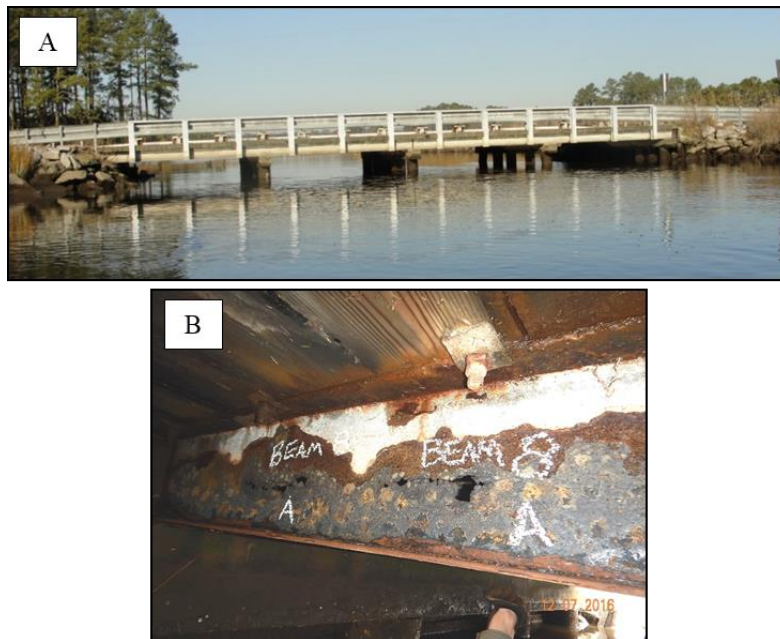
By 1999, the bridge inspection report indicated that the coating had “popped off at several randomly located areas with rust occurring at same” locations. By 2018, VDOT’s Hampton Roads District had installed three sister beams in Span 1, and timber blocks had been installed at the abutments on several beams due to the extensive corrosion damage; at this point, a replacement structure was needed. Figure 2 shows photographs of the 1993 Holdens Creek Bridge’s low water clearance and section loss due to corrosion as of 2016.

Figure 2. Photographs of the 1993 Holdens Creek Bridge in 2016: (A) low water clearance; (B) section loss as of 2016.

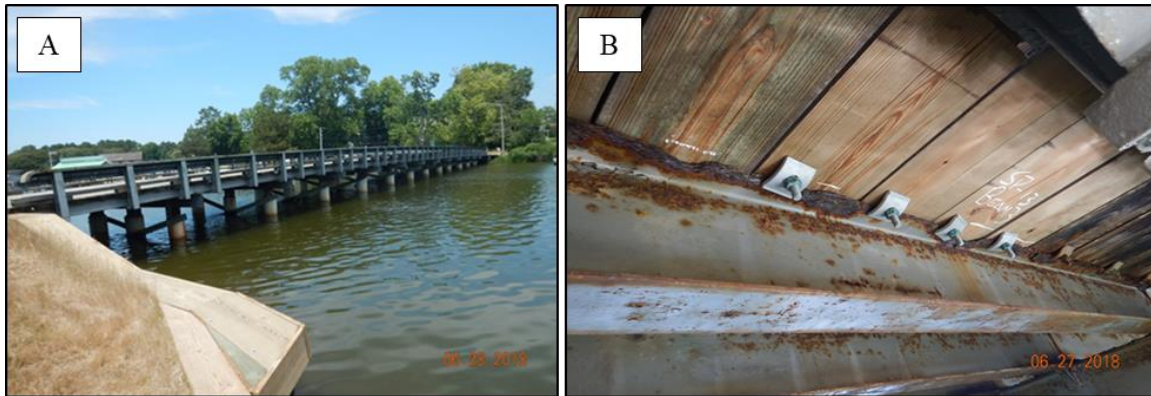
Like the 1993 Holdens Creek Bridge, the Onancock Bridge was a coated beam bridge. It was built in 1977 with a timber deck and asphalt wearing surface. It also had a low water clearance to the brackish water below, but its clearance was much greater than for the 1993 Holdens Creek Bridge. By 2018, the bridge had minor coating failures throughout but also had a few locations where section loss had occurred and affected the structural capacity of the bridge. The Hampton Roads District decided that bolted repairs were warranted at these locations of increased section loss. Figure 3 shows photographs of the Onancock Bridge’s low water clearance and corrosion damage as of 2018.

Figure 3. Photographs of the Onancock Bridge: (A) low water clearance; (B) corrosion damage as of 2018.

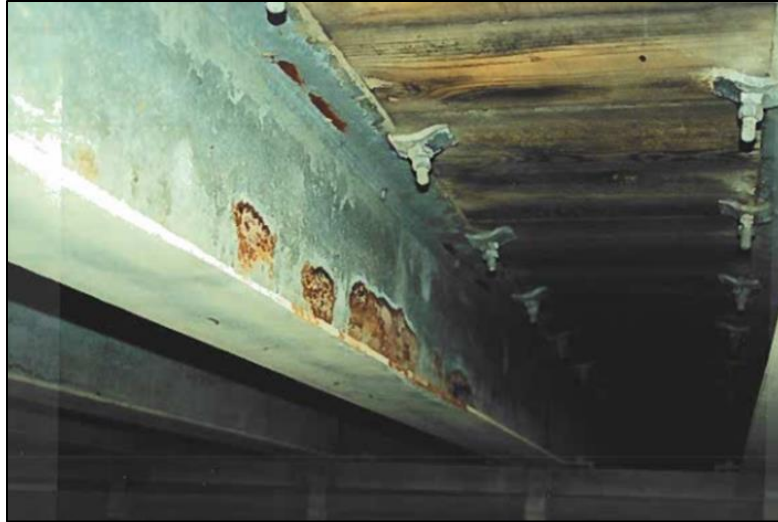
Upon completion of construction of the bridge in 1993, the coating system on the beams was rated “Good” in the 1993 inspection report. Six years later, in 1999, the coating rating was downgraded to “Fair,” and the inspection report noted that the coating had “popped off at several randomly located areas with rust occurring at same” locations. Figure 5 shows a photograph of the condition of the coating system on the girders in 1999. This indicates that portions of the coating began to reach the end of their service life in 1999 since some areas of the steel beams were no longer protected from the corrosive environment. Other portions of the coating still provided corrosion protection but continued to degrade slowly.

Figure 5. Photograph Showing Coating Breakdown for the 1993 Holdens Creek Bridge in 1999, Indicating Loss of Complete Coating Protection After 6 Years

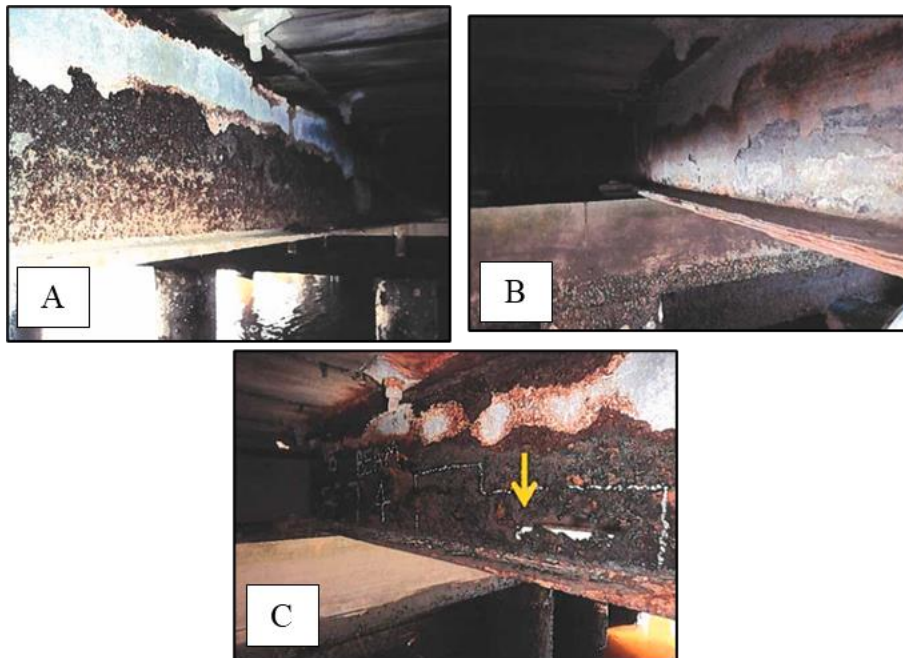
By 2005, the coating was rated “Poor,” and the inspection report indicated there was no significant section loss to the beams. The 2011 inspection report noted that the superstructure condition was rated “6” but also indicated the presence of pitted and stratified rust on beams, shown in Figure 6a. No significant section loss to the beams was reported at that time. The 2014 inspection report indicated a measurable section loss of up to 1/16 in on the steel beams. An example photograph from this inspection report showing this condition is shown in Figure 6b. One year later, the 2015 inspection report noted perforations in beam webs, shown in Figure 6c. Thus, the underlying steel had reached the end of its service life in 2015.

Figure 6. Photographs Showing the 1993 Holdens Creek Bridge: (A) pitted and stratified rust on steel beams in 2011; (B) up to 1/16-in section loss on beams in 2014; (C) perforations in beam webs first reported in 2015.

Based on the notes and photographs from the inspection reports over the life of the 1993 Holdens Creek Bridge, portions of the coating reached the end of their service life in 1999, after approximately 6 years. This resulted in these steel areas being directly exposed to the corrosive environment at Holdens Creek. By 2015, the inspection report noted the original ¼-in-thick web had perforations, 16 years after the coating had reached the end of its service life. Thus, the underlying steel of the beams was able to provide a service life of approximately 16 years.

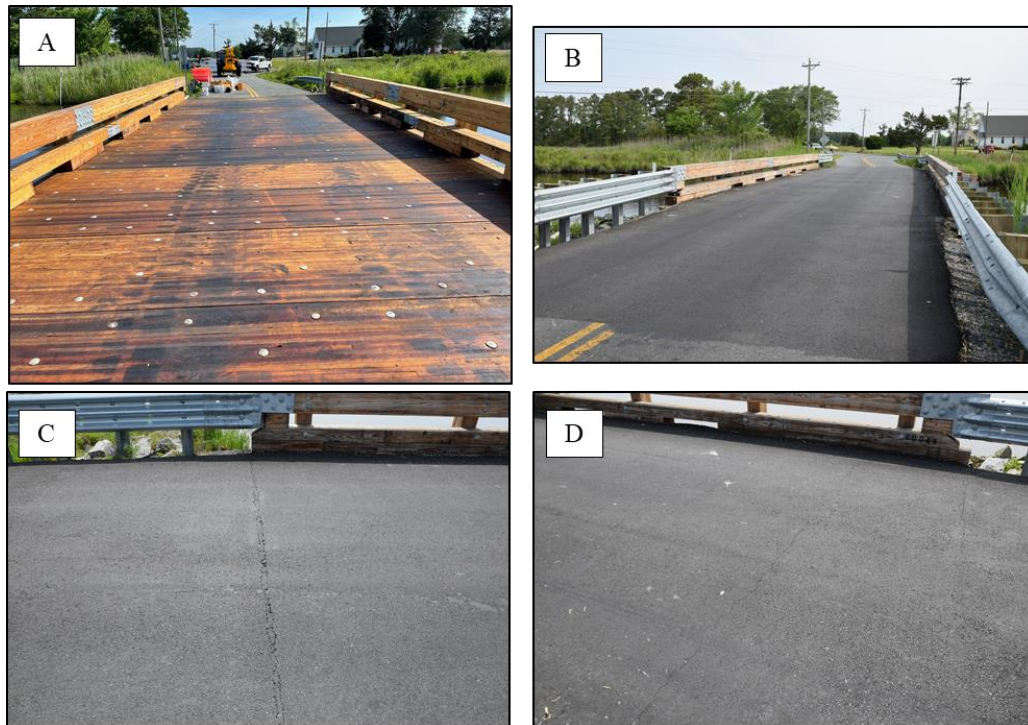
Figure 17. Photographs of the 2022 Holdens Creek Bridge Deck: (A) before asphalt overlay; (B) after asphalt overlay; (c) view of asphalt reflective cracking at north abutment; (D) view of asphalt reflective cracking at south abutment.

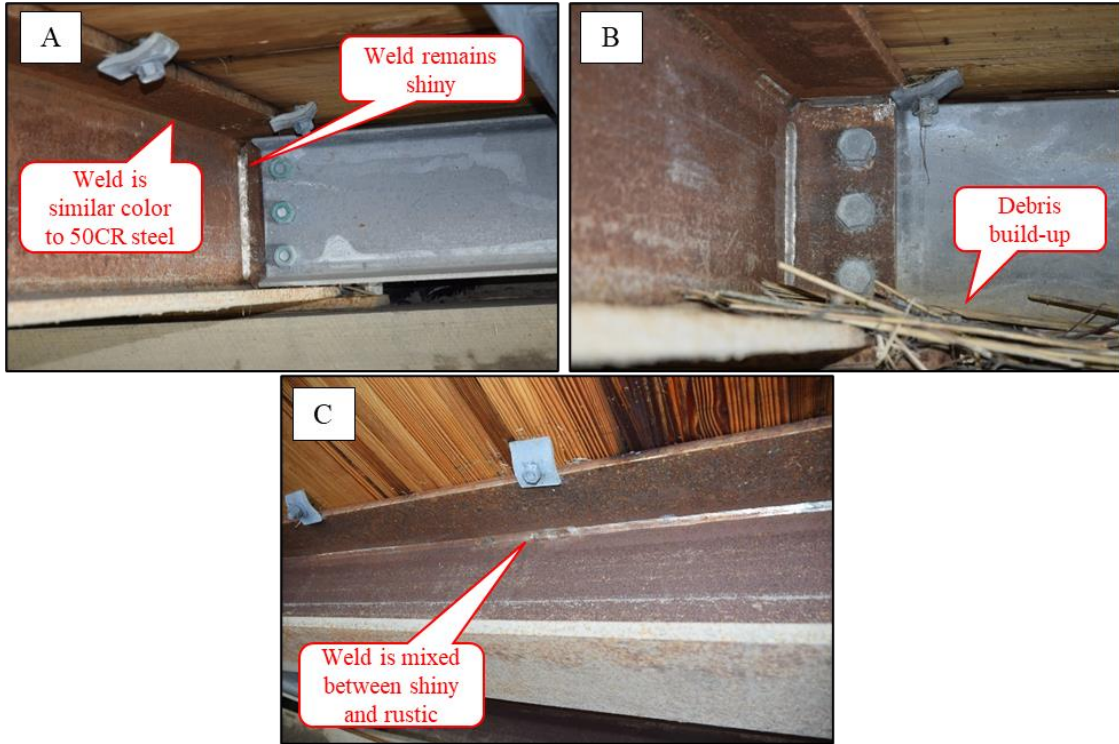
Figure 21. Photographs Showing Differences in Weld Coloration: (A) at diaphragm connection; (B) at diaphragm connection with debris build-up; (C) along length of girder.

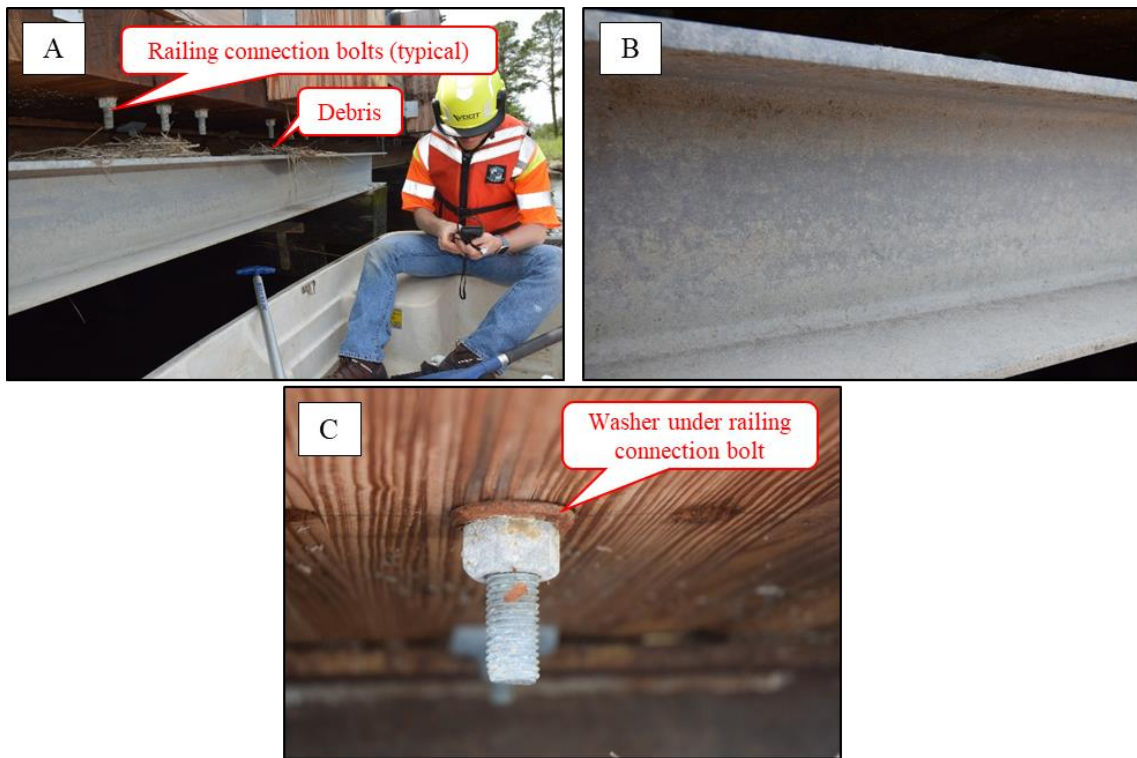
Figure 22 shows photographs taken around the galvanized nonstructural beam, which is located on the Chesapeake Bay side of the bridge. Figure 22a shows the close elevation between the nonstructural beam and the boat sitting on the water below the bridge. Figure 22a also shows additional debris buildup on top of the nonstructural beam, and the close-up photograph in Figure 22b shows a light accumulation of debris on the galvanized nonstructural beam. Figure 22a also shows some vertical railing connection bolts above the galvanized nonstructural beam.

Figure 22. Photographs of Galvanized Nonstructural Beam on Chesapeake Bay Side of the 2022 Holdens Creek Bridge: (A) general view; (B) close-up of beam; (C) close-up of railing connection bolt above beam.

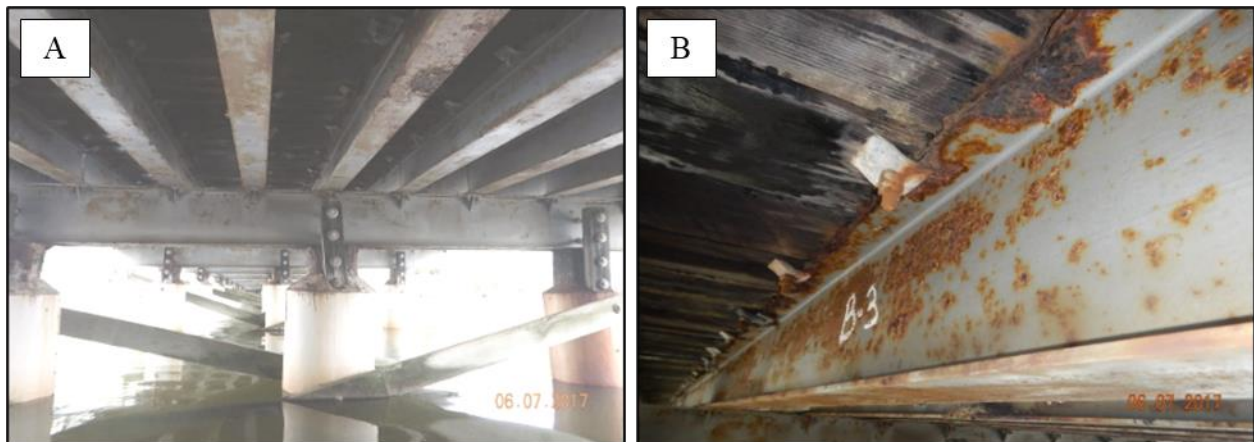
The 2017 inspection report recommended that multiple deficient beams receive special attention and be made a priority over routine and preventative maintenance work. It also recommended that a contract be scheduled to clean and paint all structural steel, 6,576 ft², which included the steel beams and steel caps.

Figure 26. Photographs Showing Coating on Beams of the Onancock Bridge in 2017: (A) loss of coating and surface rusting along beams; (B) section loss on top flange of beams.

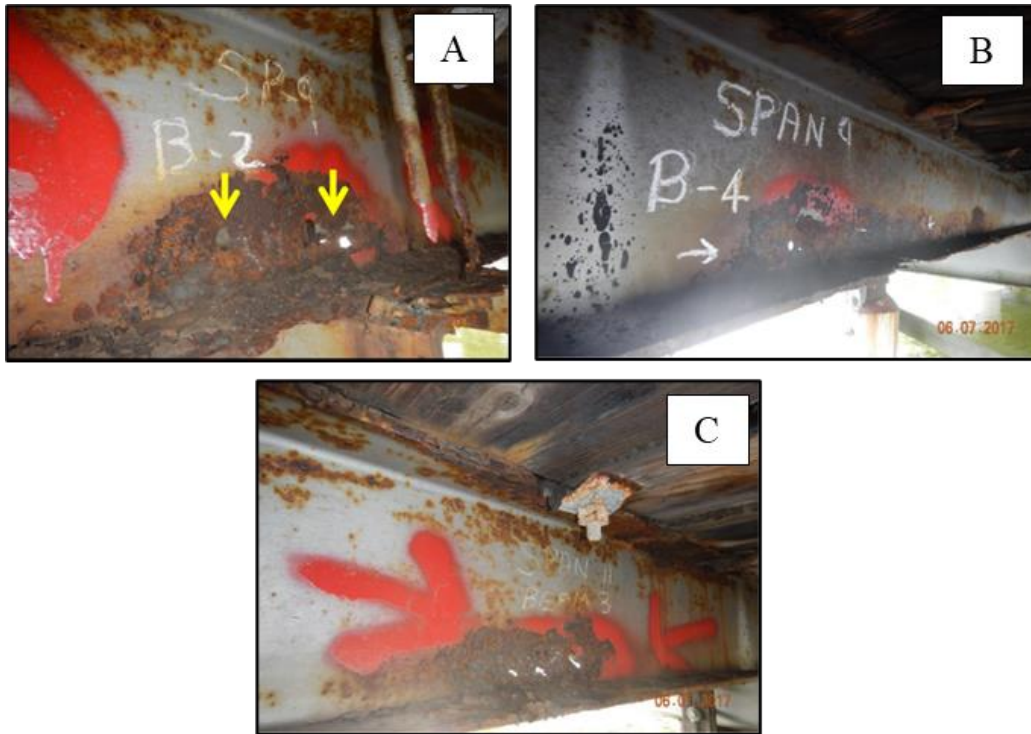
Figure 27. Photographs of the Onancock Bridge in 2017: (A) rust perforation and section loss of bottom flange; (B) rust scale with section loss transitioning from 1/8 in to becoming a knife edge along bottom flange; (C) rust perforation of web at midspan and up to 1/8-in section loss of bottom flange.

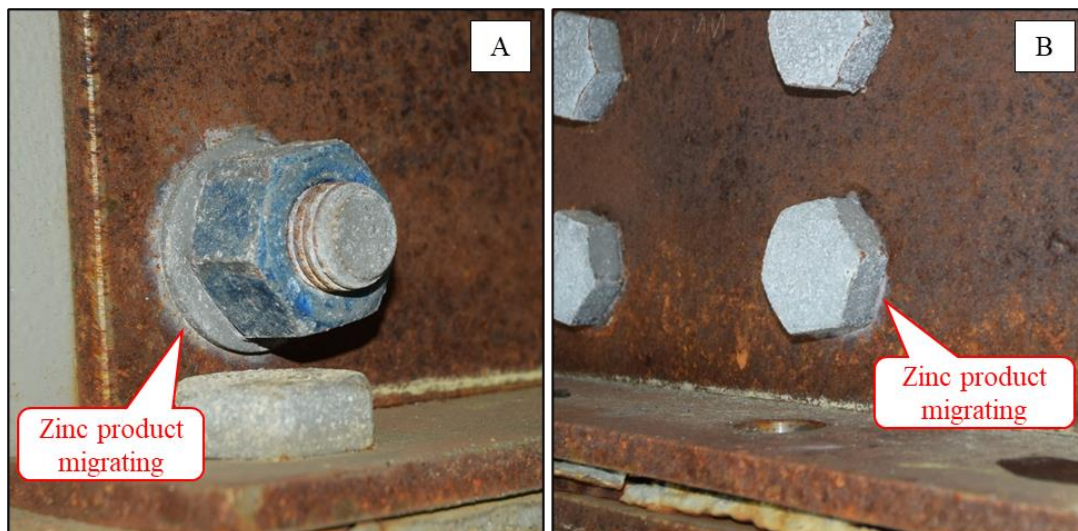
Figure 31. Close-Up Photographs of Bolted Repair Types 1 and 2 Made of 50CR Steel and Galvanized Fastener Assemblies on the Onancock Bridge Showing Zinc Product Migrating From the Galvanized Assembly to the 50CR Steel Plate: (A) nut and washer side of assembly; (b) bolt head side of assembly.

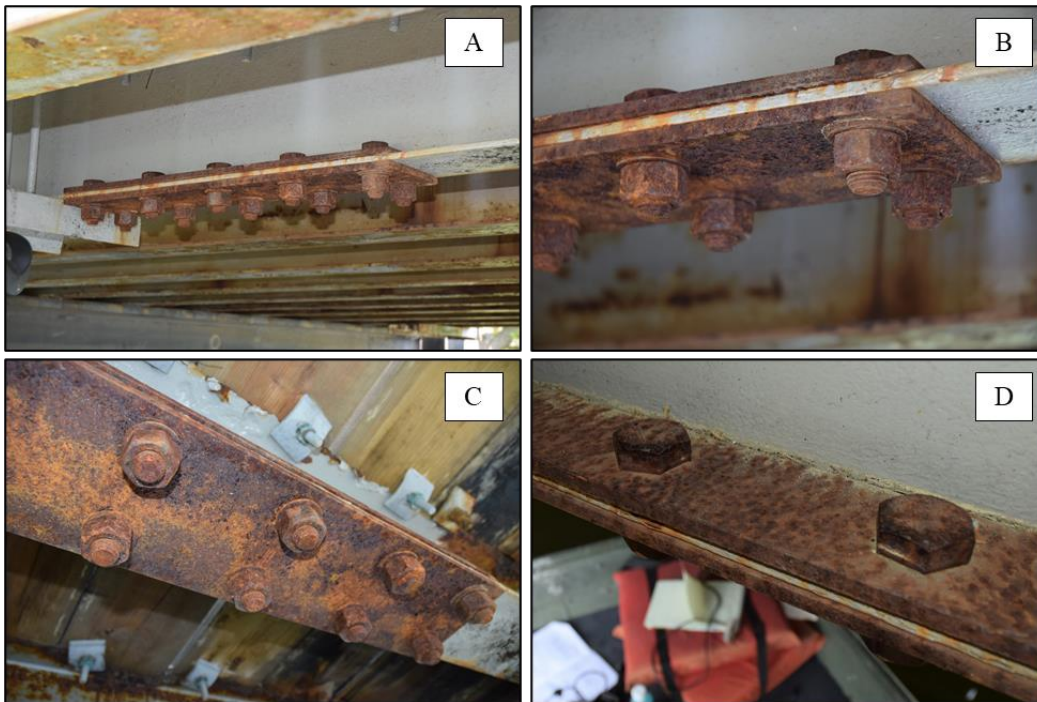
Figure 32. Photographs of Bolted Repair Type 3 Made of Weathering Steel Plate and Fastener Assemblies on the Onancock Bridge: (A) general view; (B) side view close-up; (C) view of bottom of bottom flange; (D) view of top of bottom flange.

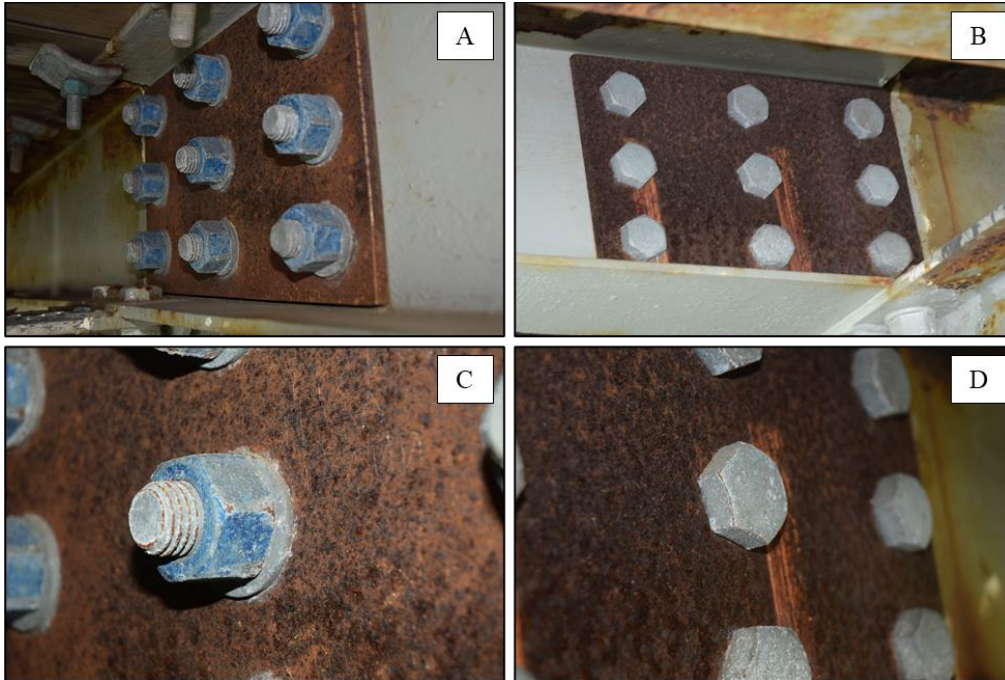
Figure 33. Photographs of Bolted Repair Type 4 Made of 50CR Steel and A588 Steel Plates With A325 Galvanized Fastener Assemblies on the Onancock Bridge: (A) general view of 50CR steel plate; (B) general view of A588 steel plate; (C) close-up of fastener assembly on 50CR steel plate; (D) close-up of fastener assembly on A588 steel plate.
