**FINAL REPORT**

**EVALUATION OF HIGH PERFORMANCE CONCRETE OVERLAYS PLACED  
ON ROUTE 60 OVER LYNNHAVEN INLET IN VIRGINIA**

August 2000  
VTRC 01-R1

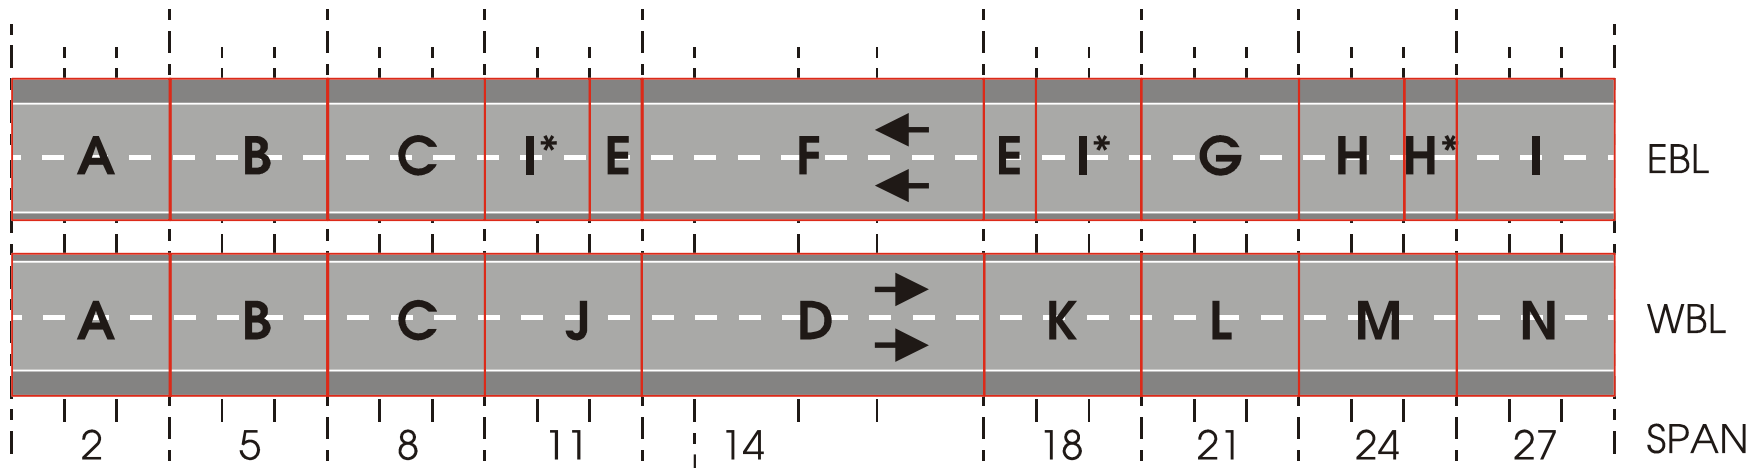
Figure 1. Plan View for Overlays on Two 28-Span Bridges on Rte. 60 Over Lynnhaven Inlet

A site location map for the two bridges is shown in Figure 1. Initially, the westbound bridge (WBL) was overlaid while traffic used the eastbound bridge (EBL). Then, traffic was detoured to the WBL while the EBL was overlaid.

The installation included 13 different concrete mixtures, an overlay with a thickness of only 0.75 in (19 mm), and spans with and without topical treatments of two corrosion inhibitors for a total of 16 different overlays. The overlay types are identified in Figure 1 as follows: 7% silica fume (SF); 5% SF and 35% slag (S); 5% SF and 15% class F fly ash (FA); 15% latex-modified concrete (LMC); 13% SF and 15% FA; 13% SF and 15% FA placed 0.75 in (19 mm) thick; 7% SF and Rheocrete corrosion-inhibiting admixture (CIA) (RCI); 7% SF, Armatec CIA (ACI), and ACI topical treatment (A); 7% SF and ACI; 7% SF, Darex CIA (DCI), and Postrite (P) topical treatment; 7% SF and DCI; 40% S; 7% SF and shrinkage-reducing admixture (CQI); 7% SF and polyolefin fibers (POF); 7% SF and steel fibers (STF); and 7% SF and polypropylene fibers (PPF). With the exception of system F, overlays were required to have a minimum thickness of 1.25 in (32 mm). In addition, system E had a variable thickness that ranged from 1.25 to 0.75 in (32 to 19 mm) to provide good ride quality.
