Forensic Investigation of Two Voided Slab Bridges in the Virginia Department of Transportation's Richmond District

SOUNDAR S.G. BALAKUMARAN, Ph.D., P.E.
Research Scientist
Virginia Transportation Research Council

Final Report VTRC 17-R12

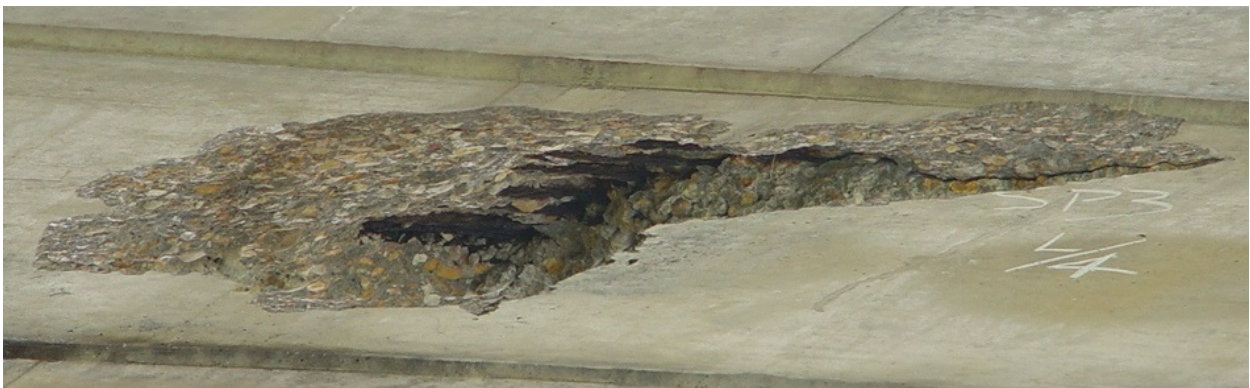
Figure 8. Spalled Concrete and Corroded Prestressing Strands in Beam 4 of Span 3, Near the Quarter-Point Closest to Bent 3, of Adkins Road Bridge

Although no soundings (i.e., chain drag or hammer survey) were conducted prior to load testing, there were no visible cracks or spalls on Beam 3. Unfortunately, the spall with exposed and broken prestressing strand in Beam 5 was not discovered by the research team until the time of instrumentation because of the lack of access over the water during the initial scoping. Thus, no plans were made to instrument this portion of the bridge and there were no additional instruments available to monitor this location.

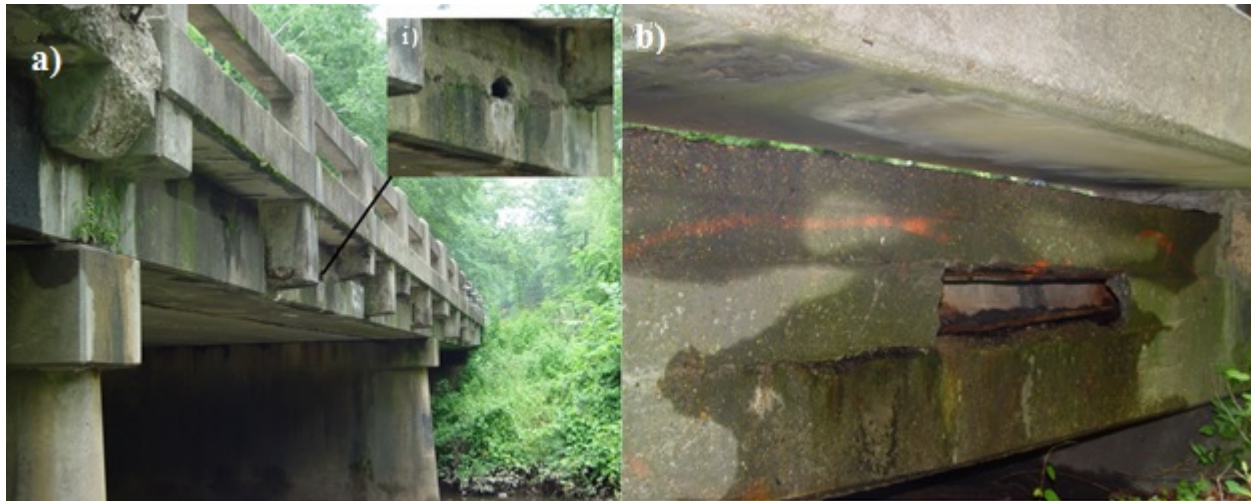
The nine beam lines were numbered consecutively from west (upstream) to east (downstream). The spans were labeled alphabetically starting from the south abutment toward the north abutment. So, for example, Beam 1A was the exterior beam on the upstream side of Span A. A quick visual inspection revealed the apparent pop-out holes on the exterior beams and cracks associated with them. The pop-out at the side of Beam 1A contained a fully corroded broken strand and a fully exposed, highly corroded strand, as seen in Figure 11(b) running longitudinally. Failure of the corner concrete and corrosion of the reinforcement in some of the parapet elements were noted. The damaged parapet column shown in Figure 11 was caused by a vehicle impact.

Figure 11. Qualla Road Bridge: (a) Side View With Magnified View of Hole and Efflorescence (Beam 9B), and (b) Hole on Exterior Beam (Beam 1A)

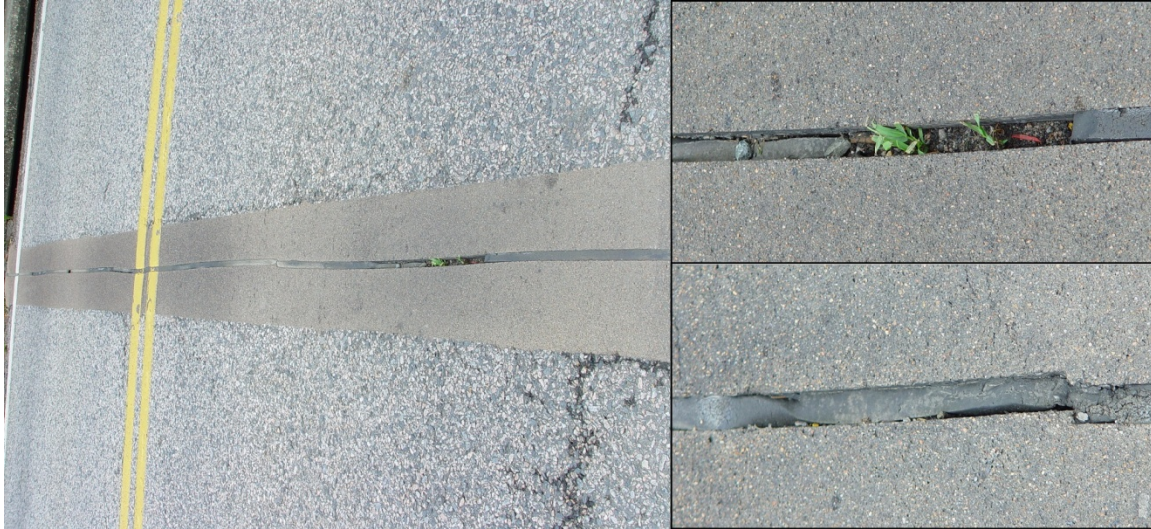
Roadway water, including winter chloride-laden melt water, drained along the bridge deck cross slope to the parapets. The parapets contained a scupper detail that allowed the roadway water to flow down the face of the outside beams and wick across the bottom of the beams. A number of the scupper openings were clogged with dirt and plant growth, resulting in ponding on top of the fascia beam and increased flow at unclogged scuppers. The transverse joints at the abutments and the two piers had been repaired with concrete and sealed with a polymeric sealant. Although the concrete was in good condition, portions of the sealant had failed and allowed water and chloride-laden water to wet some of the ends of the beams. Figure 12 provides more detail.

Figure 12. Transverse Joint of Qualla Road Bridge Repaired With Concrete and Sealant

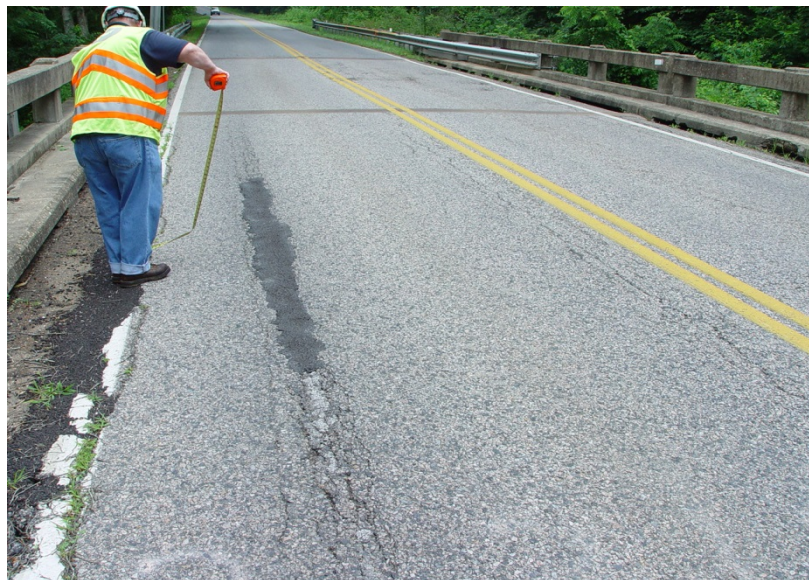
The asphalt concrete overlay was cracked longitudinally for the entire span length along a number of the longitudinal joints, as shown in Figure 13. Water and chloride-laden water had penetrated the cracks and wetted the sides and bottom of the beams. As the beams were adjacent members with an asphalt concrete overlay, the sides of the beams at the joints and the top of the beams were not visible. Both exterior and interior beams had been exposed to sufficient chloride to penetrate to the depth of the reinforcing steel, resulting in corrosion damage, including cracking and spalling of the cover concrete and subsequent loss of prestressing force. The effect of this damage was a reduction of the load-carrying capacity of the beams.

Figure 13. View of Deck of Qualla Road Bridge Over Swift Creek

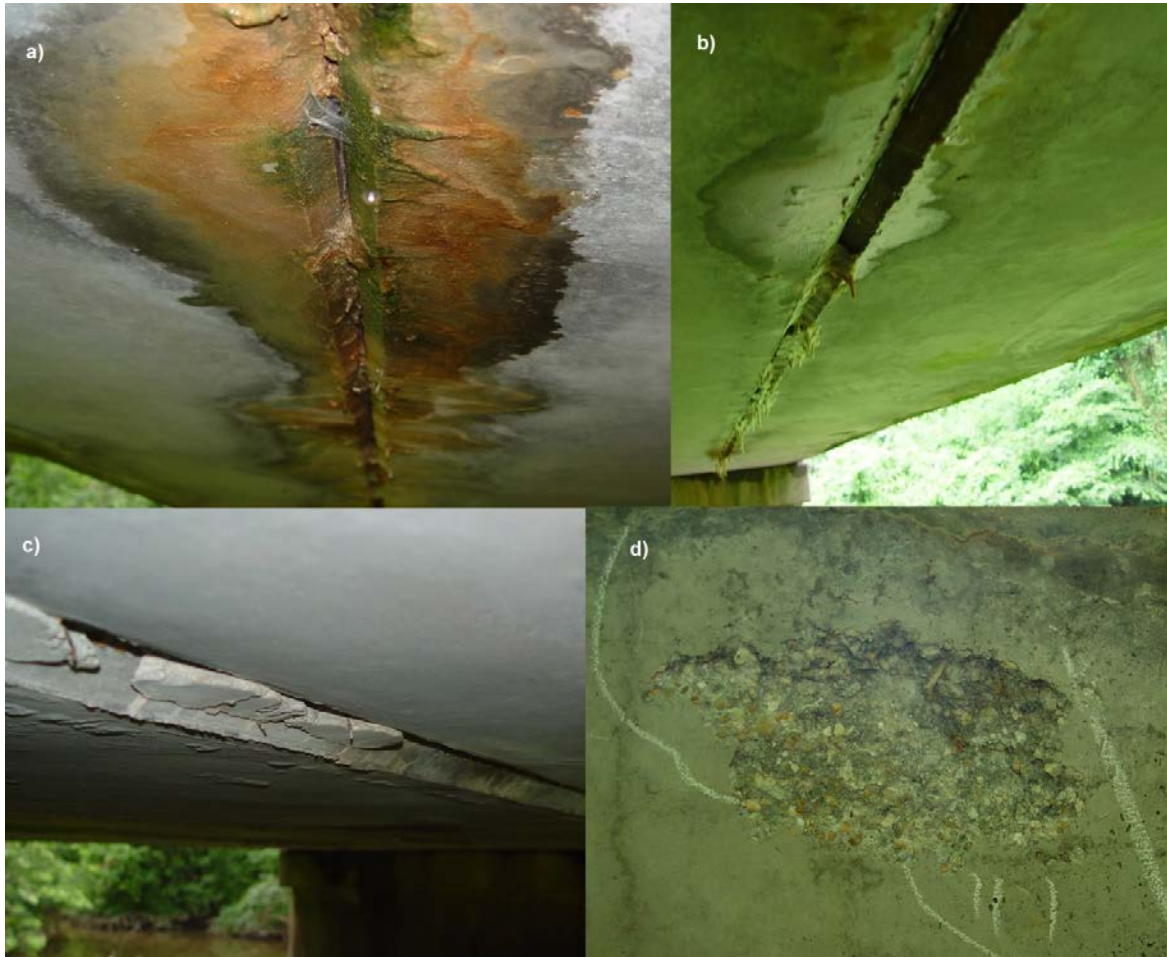
Figure 14 shows typical problems at the bottom of the beams associated with leaking between the adjacent members, including moisture from recent precipitation, as shown in Figure 14(a); salt stalactites, as shown in Figure 14(b); the failure of longitudinal shear concrete joints indicating differential movement between the adjacent beams, as shown in Figure 14(c); and a shallow spall in the soffit, as shown in Figure 14(d).

Figure 14. Visual Survey of Deck Underside of Qualla Road Bridge: (a) Moisture From Recent Precipitation; (b) Salt Stalactites; (c) Failure of Longitudinal Shear Concrete Joints Indicating Differential Movement Between Adjacent Beams; and (d) Shallow Spall in Soffit

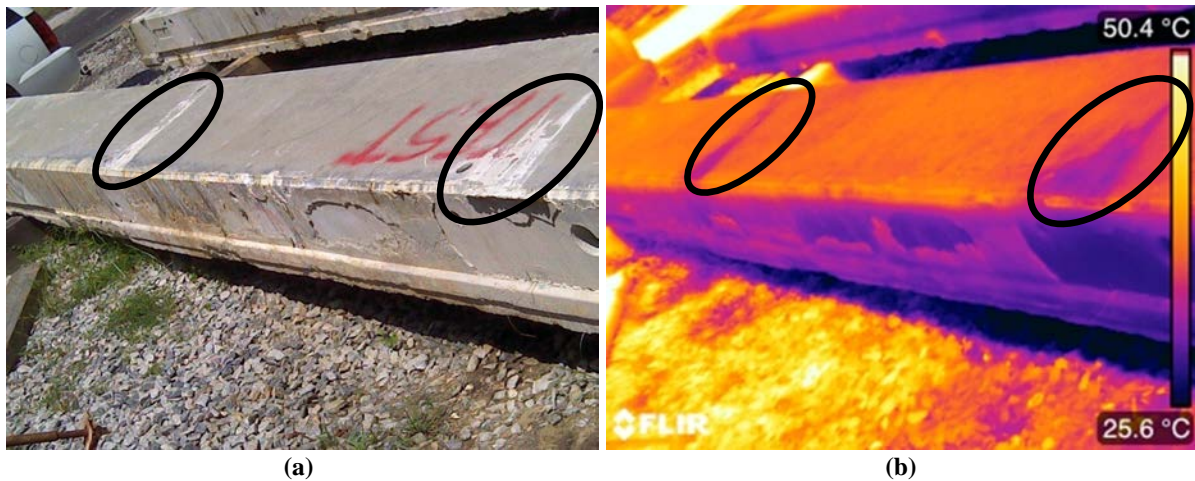
Figure 20. Comparison of (a) Digital Camera and (b) Infrared Camera Images of Bottom of Beam From Qualla Road Bridge. Note the encircled residue-covered locations.

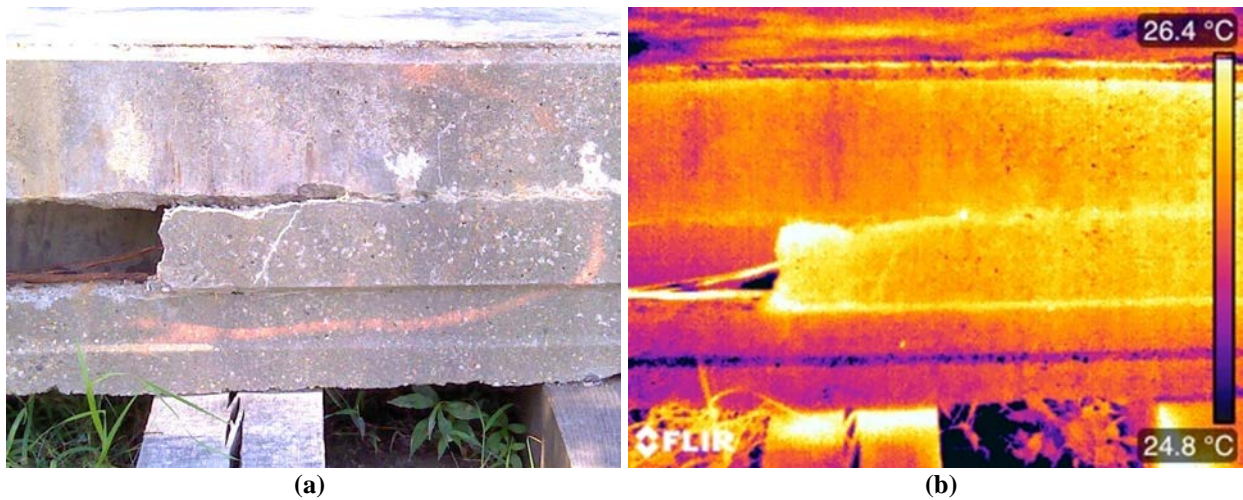
Figure 21. Comparison of (a) Digital Camera and (b) Infrared Camera Images of Spalled Concrete and Exposed Prestressing Strand and Structural Void in Fascia Beam From Qualla Road Bridge

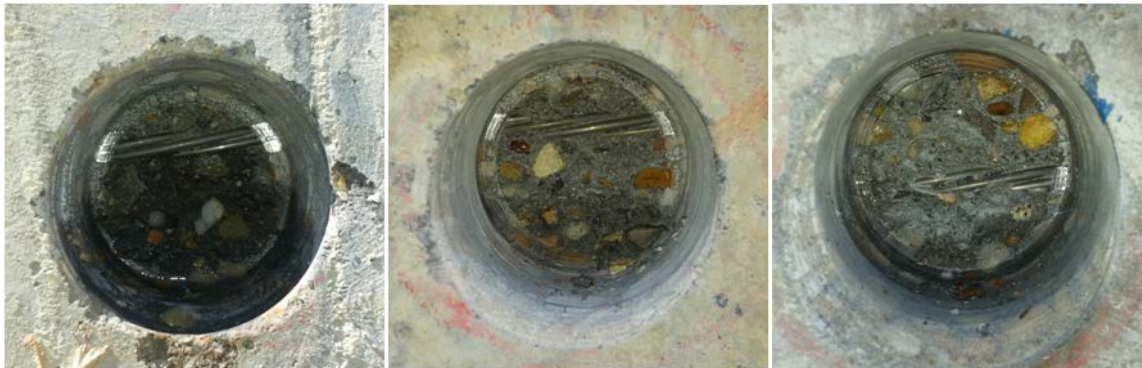
As an aside, the research team discovered two prestressing strands that were sitting inside post-tensioning ducts in two beams. These ducts were used to tie all of the beams transversely as a means of getting the beams to work together as a monolithic unit. Both strands were in reasonably good condition with no noticeable section loss. Although two 3-ft sections of prestressing strand do not provide conclusive evidence, the implications are that water was not getting into the post-tensioning ducts and, thus, the grout in the longitudinal joints between the beams may have been relatively intact and still bonded to the beam concrete prior to demolition.

Figure 22. Condition of Prestressing Strands Through Concrete Coring of Qualla Road Bridge

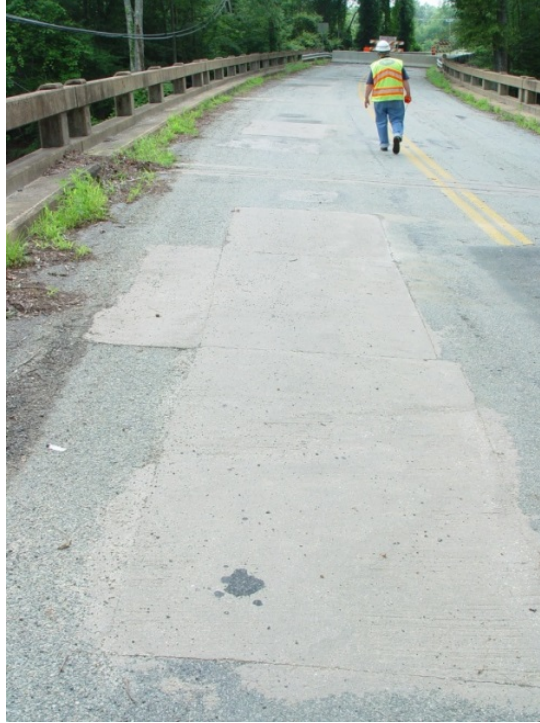
Figure 24. View of Adkins Road Bridge Deck. Vegetation is growing along the scuppers on both sides of the structure.

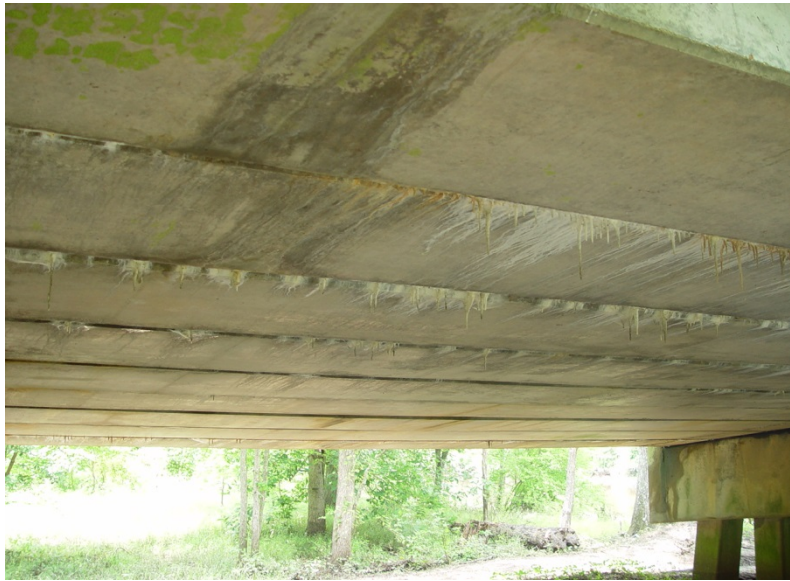
Even with a considerable transverse slope of 5.5 degrees, efflorescence was noted along the beam joints on the elevated side of the bridge as much as on the lower elevation. The stalactites in Figure 26 indicate that moisture had been retained in the top of the deck in the elevated zone and eventually wicked through the longitudinal joints to reach the underside of the beams. The vegetation and organic matter found at the scuppers on both sides of the deck (see Figure 24) probably absorbed and retained the runoff water, which was likely laden with deicing salt in the winter times. The widespread presence of efflorescence because of water leakage indicates the ineffectiveness of the longitudinal joints.

Figure 26. Efflorescence at Underside of Beam Joints of Adkins Road Bridge

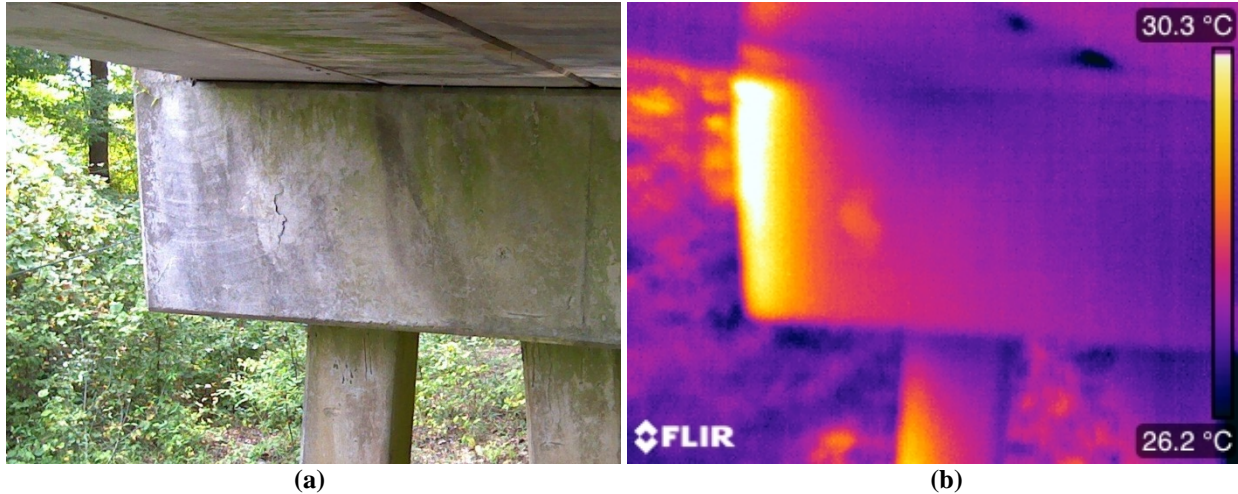
Figure 29. Adkins Road Bridge: Comparison of (a) Digital Camera and (b) Infrared Camera Images of Delaminated Concrete on Bent 3

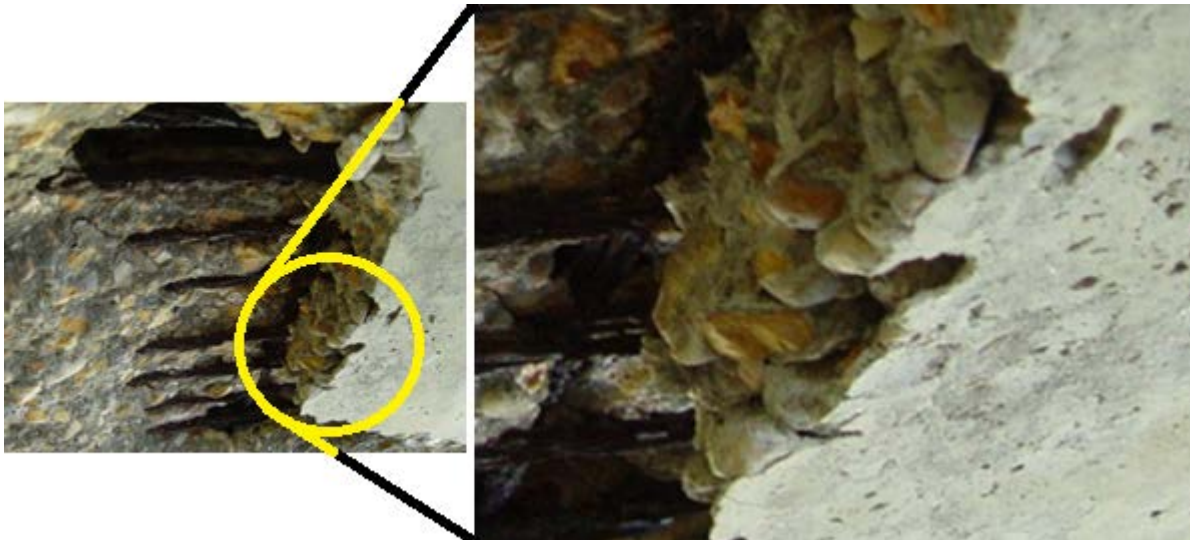
Figure 41. Adkins Road Bridge: Poorly Consolidated Concrete Below Broken Strands Near Quarter-Point Closest to Bent 3 in Beam 4, Span 3

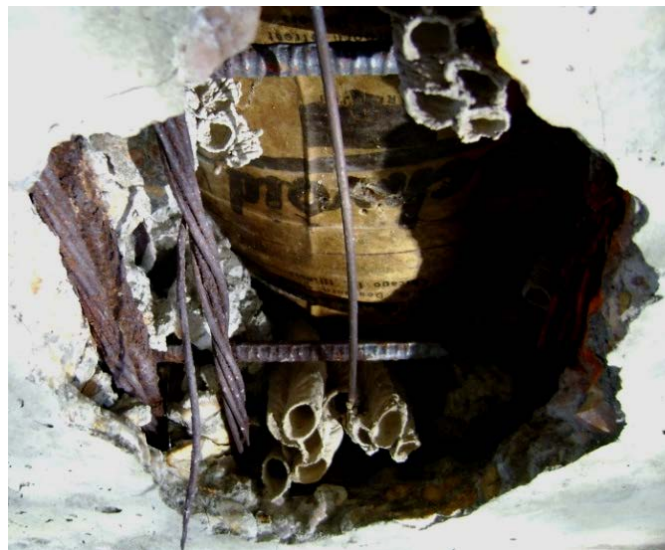
Figure 42. Adkins Road Bridge: Poorly Consolidated Concrete Near Quarter-Point Closest to Bent 2 in Beam 3, Span 3
