**EVALUATION OF TWO CORROSION INHIBITORS USING TWO SURFACE  
APPLICATION METHODS FOR REINFORCED CONCRETE STRUCTURES**

December 2004  
VTRC 05-R16

### Field Study: The Terry Run Bridge

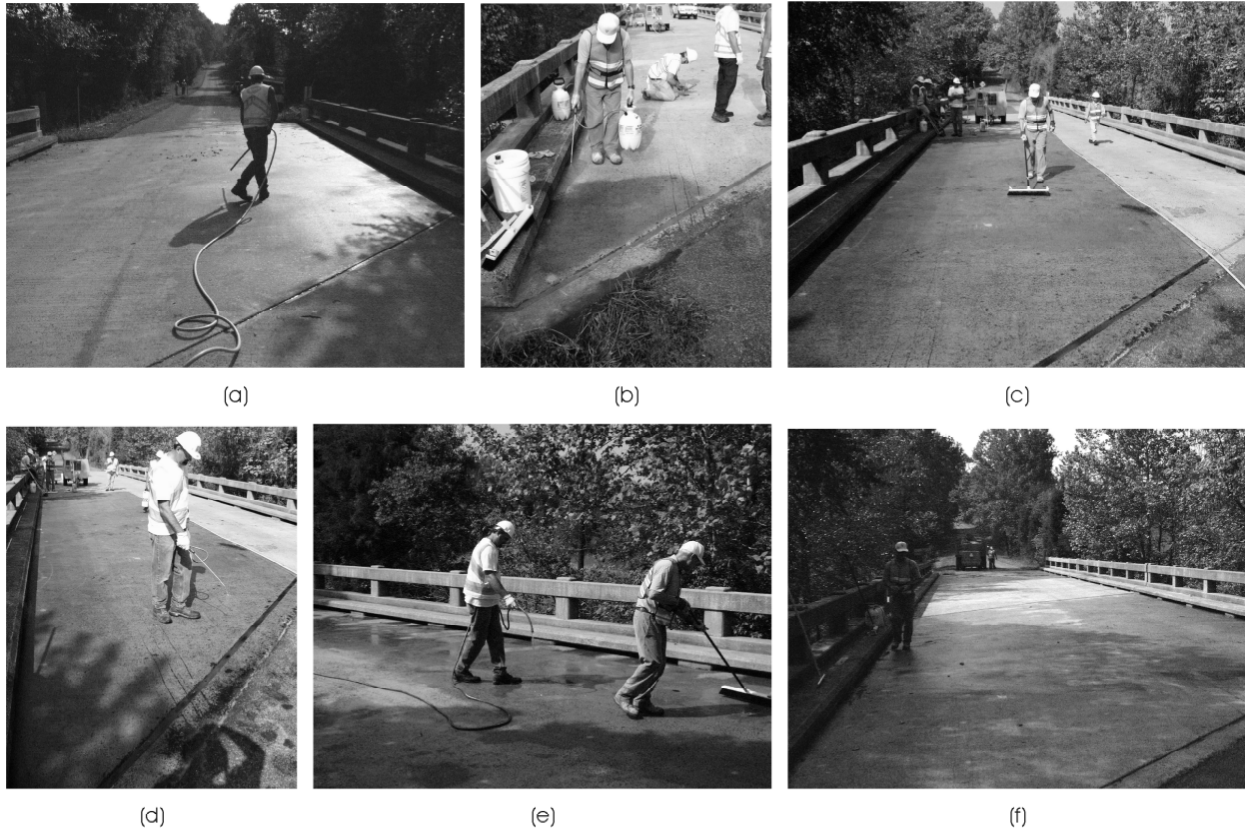
**Figure 2. Application of TPS-II. (a) Bridge deck surface cleaned. (b) Inhibitor applied to surface. (c) Broom used to distribute product across surface. (d) Treated surface kept moist through periodic applications of water. (e) After a second treatment cycle, water used to rinse residue off treated surface. (f) Treatment complete.**

This corrosion mitigation technique involved applying inhibitor to the bridge deck and allowing sufficient time for the inhibitor to diffuse into the concrete before permitting traffic to resume travel in the treated lane. To allow for the movement of traffic across the bridge during the treatment process, one lane was treated at a time instead of the entire span. The application process was as follows (see Figure 2).

1. The bridge deck was cleared of debris and blown clean with compressed air.
2. Product was applied using a compression sprayer until the treated area appeared wet; if too much inhibitor was applied, the area became slippery.
3. A broom was used to distribute the product across the deck surface and work the product into the concrete.

4. The surface was kept moist for 2 hours through repeated applications of water as the inhibitor soaked into the concrete.
5. Repeating steps 2 through 4, a second application was applied before the previously treated area dried. According to Surtreat, future applications of TPS-II could be problematic due to changes in the porosity).
6. The bridge was rinsed with water to remove any residue.

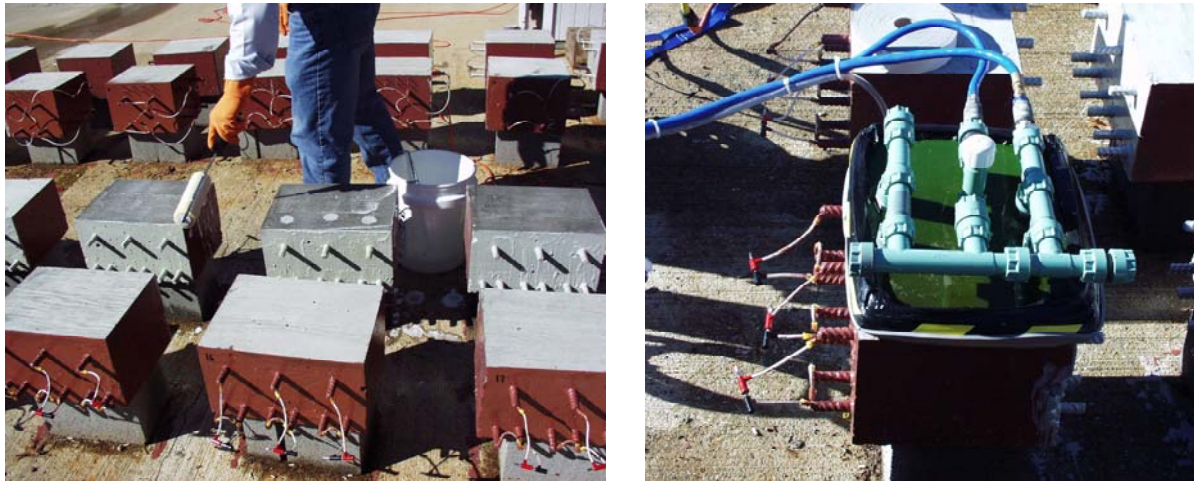
**Figure 3. (a) Inhibitor applied using roller. (b) Inhibitor applied using vacuum/pressure injection.**

1. The two-zone plate is placed on the concrete surface.
2. A vacuum (20 mm Hg) is drawn on the inner and outer zones.
3. The vacuum on the inner zone draws in the inhibitor (such that it is no longer a vacuum).
4. Pressure (22 psi) is forced into the inner zone, which drives the inhibitor into the concrete.

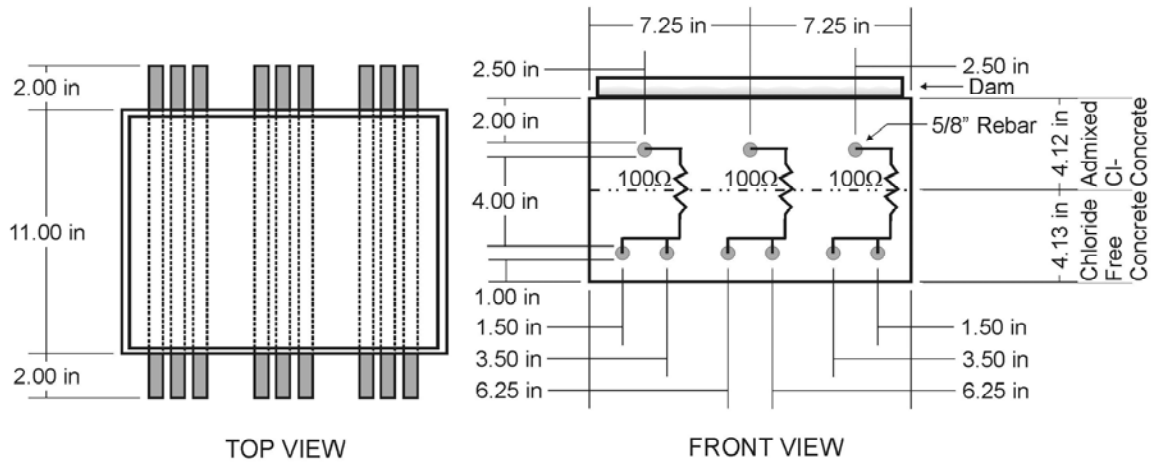
**Figure 4. Illustration of Concrete Specimen with Uniform Cover Depth (modified ASTM G-109 specimen).**

The pressure and vacuum are released, and the injection process is complete. To aid in evaluating the inhibitors, approximately 200 days after treatment, test specimens were ponded with a saturated sodium chloride solution. In addition, compatibility issues between the vacuum/pressure injection system and the FerroGard 903 led to fewer specimens being tested than originally intended. Table 4 lists the specimen and inhibitor type, method of application, amount of inhibitor applied, and the actual number of specimens tested. Illustrations of the test specimens are shown in Figures 4 and 5.

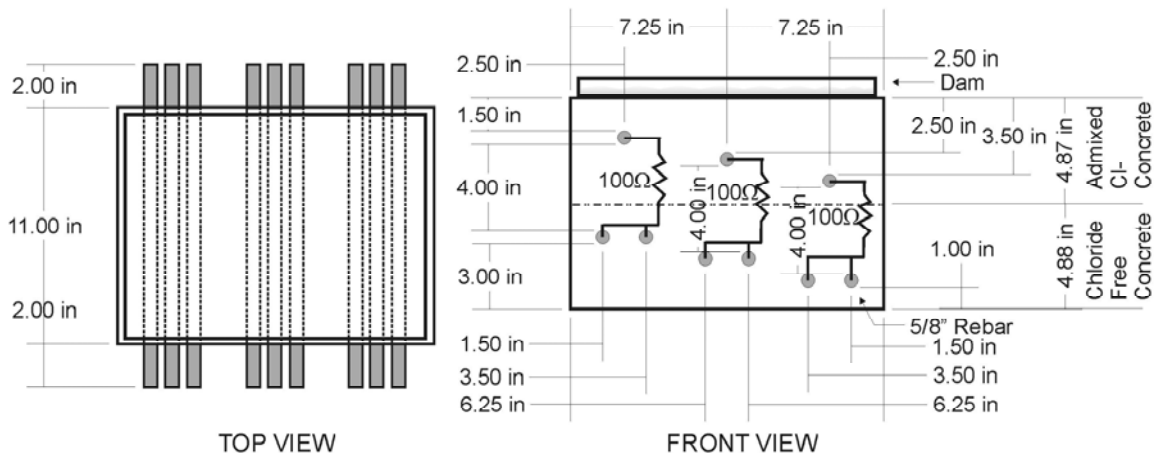
**Figure 5. Illustration of Concrete Specimen with Inclined Cover Depth (modified ASTM G-109).**

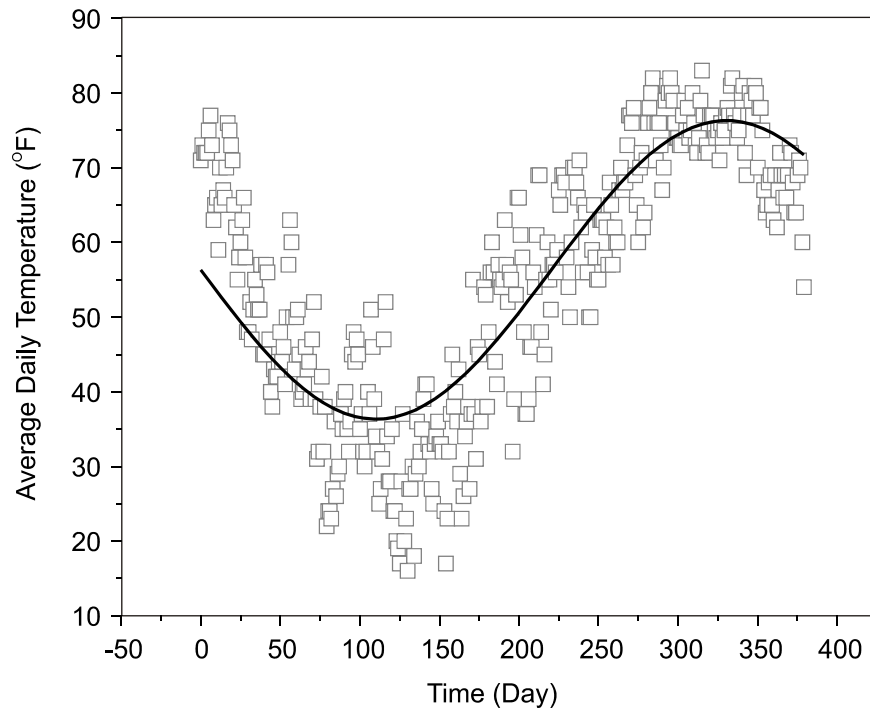
Figure 6. NCDC Reported Regional Temperature for Bridge.

In this region, seasonal changes in the weather influence the values measured using half-cells and the amount of chlorides to which a bridge is exposed because of the use of deicing salts during the colder months. Therefore, the middle span was designated a control span. Figure 6 shows the change in temperature recorded during this study for this region, which was gathered from the National Climatic Data Center (NCDC), Piedmont Research Station. This weather station is approximately 8 miles from the structure.

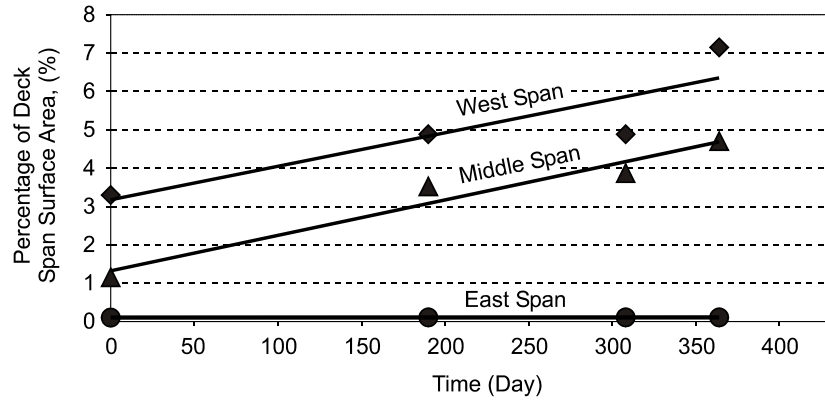
Figure 7. Delamination Percentage of Bridge Spans.

Figure 7 shows the delamination percentage for each span following treatment. Throughout the evaluation period, the percentage of delamination increased in the west and control spans, whereas the percentage of delaminated area in the east span increased very little.

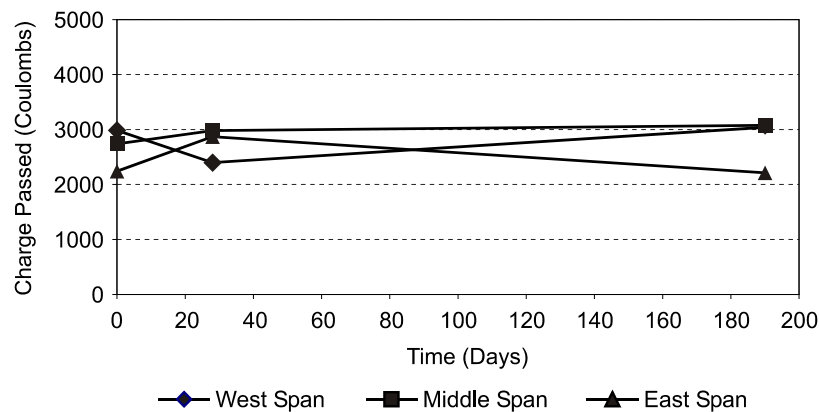
Figure 8. Average Charge Passed Based on Measurements Adjacent to Parapet, Along Wheel Path, and Along Centerline of Bridge Deck.

As shown in Figure 8, overall, an average change in resistance to chloride ion penetration did not occur. All three spans exhibited moderate chloride ion penetrability before and after treatment. It is interesting to note that in Figure 8, the east span initially becomes less resistive and then decreases to its untreated value whereas the west span does the opposite.

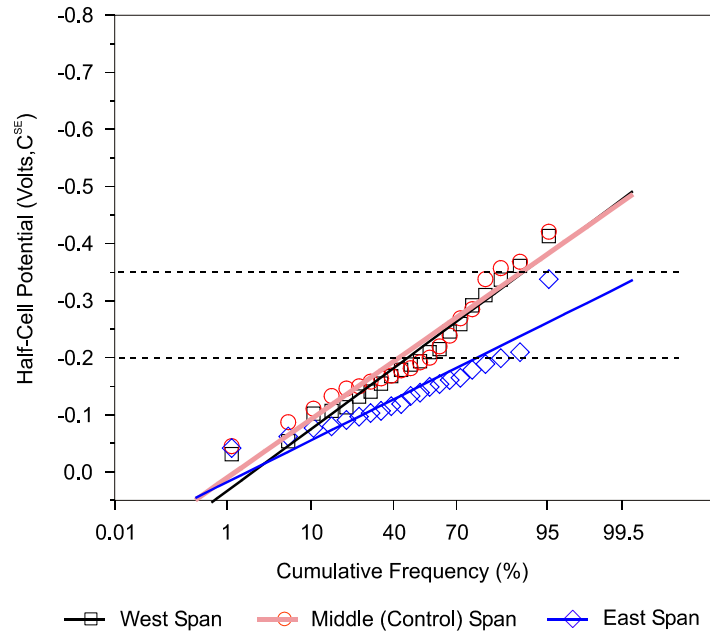
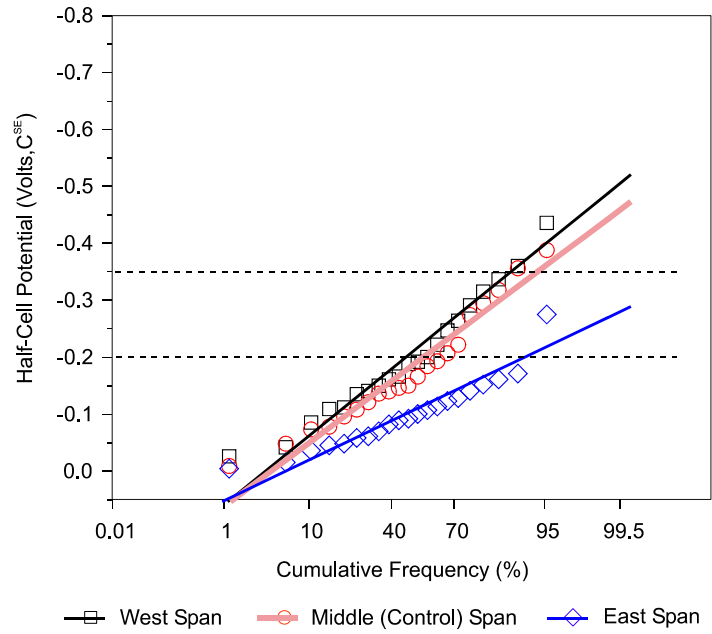
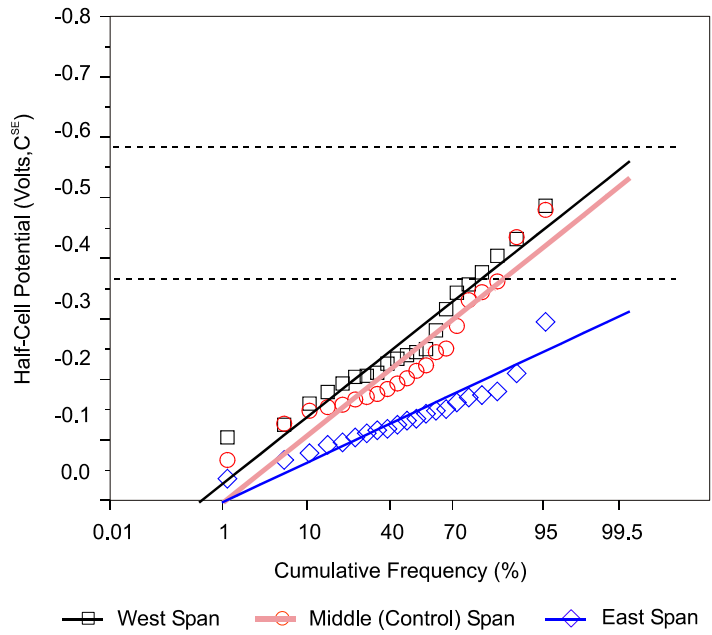
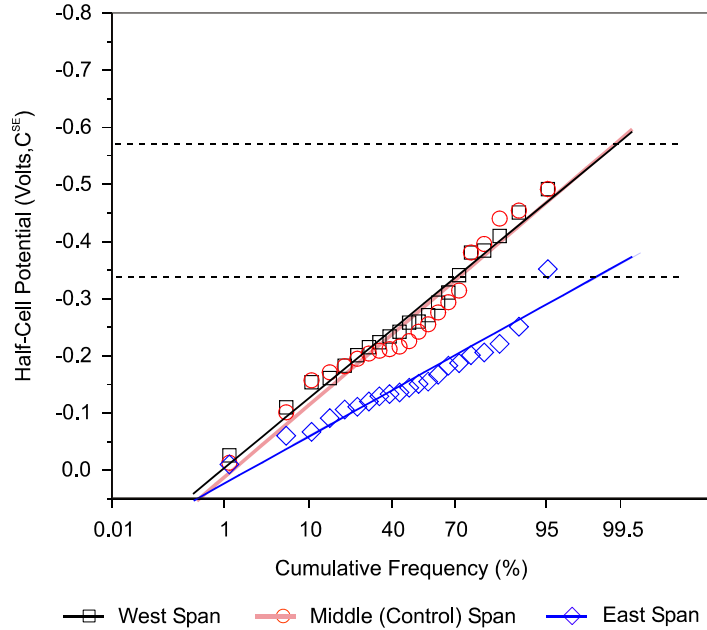
**Figure 9. Comparison of Cumulative Frequency Plots for Spans Before Treatment.**

**Figure 10. Comparison of Cumulative Frequency Plots for Treated and Control Spans After 1 Month.**

**Figure 11. Comparison of Cumulative Frequency Plots for Treated and Control Spans After 6 Months.**

**Figure 12. Comparison of Cumulative Frequency Plots for Treated and Control Spans After 1 year.**

The cumulative frequency plots shown in Figures 9 through 12 indicate how the treated spans changed in relation to the untreated span. It is apparent that during the evaluation period the half-cell potential distribution in the east span (treated) was more positive than the potential in either of the other two spans. It is also apparent that the distribution of half-cell measurements was either the same or more negative for the west span (treated) when compared to the control span (untreated).

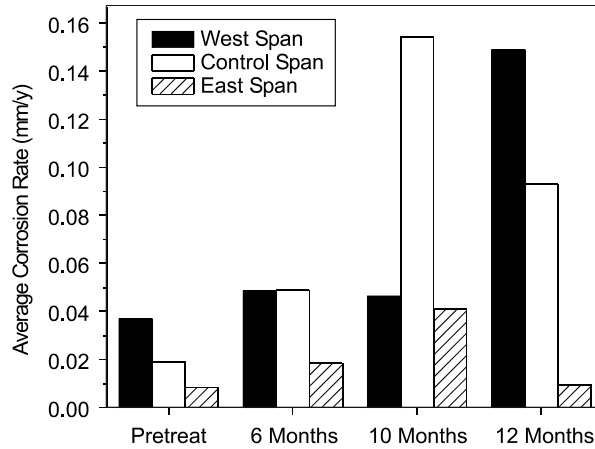
**Figure 16. Average Corrosion Rate for Bridge Following Treatment.**

Figure 16 provides a summary of the average corrosion rate after treating the western and eastern spans of the bridge with the TPS-II. The west span was associated with the largest corrosion rate before the inhibitor was applied and 1 year after treatment. The 6- and 10-month measurements increased only slightly from the pretreatment measurements. It is interesting that the west span did not follow the same trend as did the control and east spans: corrosion activity increased, was the highest (average) at 10 months, and then began to decrease. As was indicated in Figure 6, the measurements at 10 months were made when the average daily temperatures are hottest in this region.

Corrosion rate data from the bridge also supported the findings from the macro-cell measurements. Although the western span did not necessarily follow the same trend as the control span, the corrosion rate did increase from the average initial pretreatment value. More important, the average corrosion rate in the eastern span and the control span followed the same trend. Therefore, the ability to apply the TPS-II to the surface and have it migrate to the reinforcing steel unaided was not demonstrated.

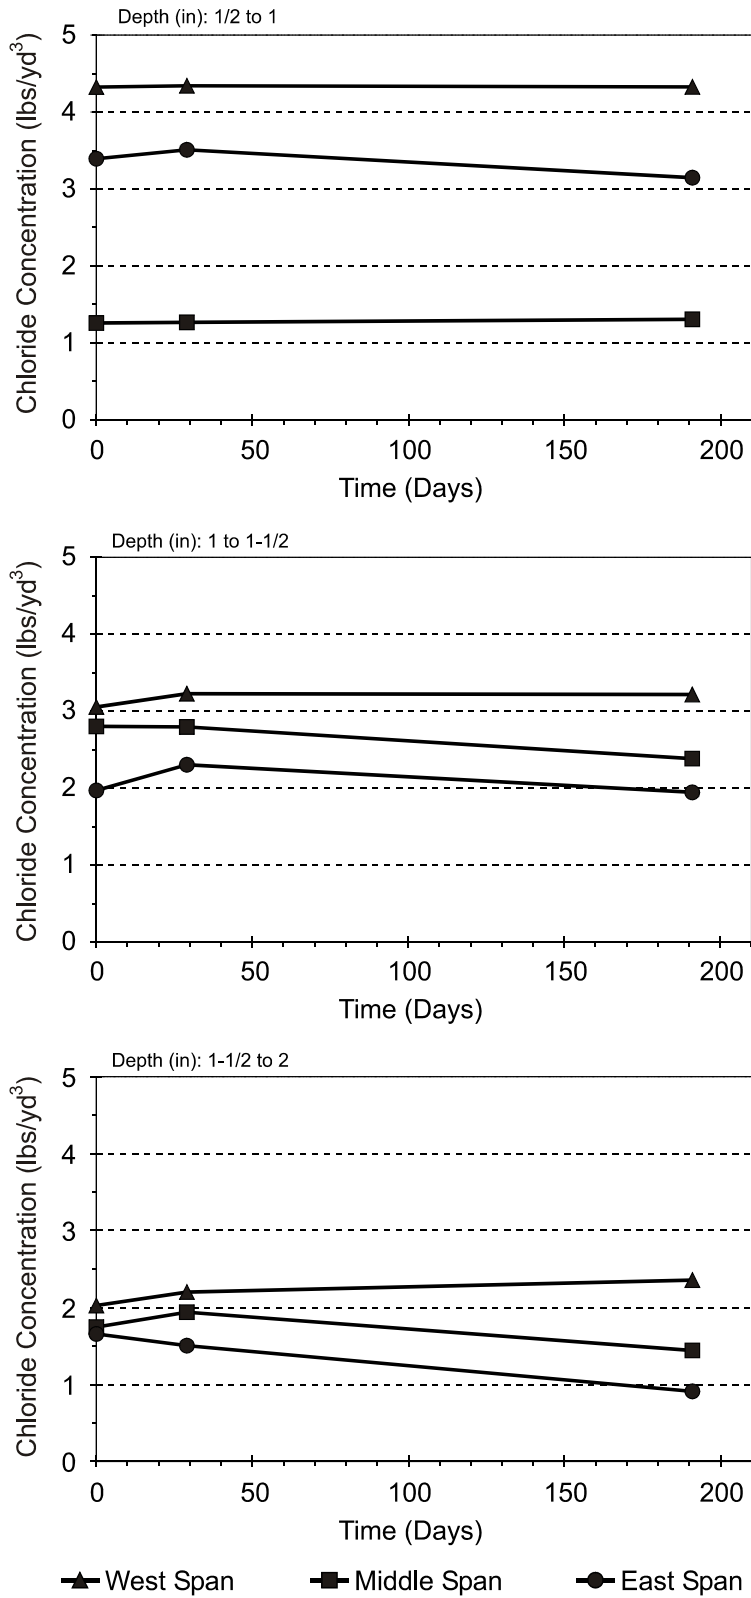
Figure 17. Average Water-Soluble Chloride Concentration at Different Sample Depths.

As is evident in Figure 17, the water-soluble chloride concentration was highest for the west span at each depth when compared with those for the other spans. The east span had the lowest chloride concentration near the reinforcing steel. The chloride concentrations in the western and eastern spans support the nondestructive potential and corrosion measurements, which indicate high corrosion activity in the west span and relatively lower activity in the east span. A clear trend that could be associated with the treatment of the bridge deck was not evident.

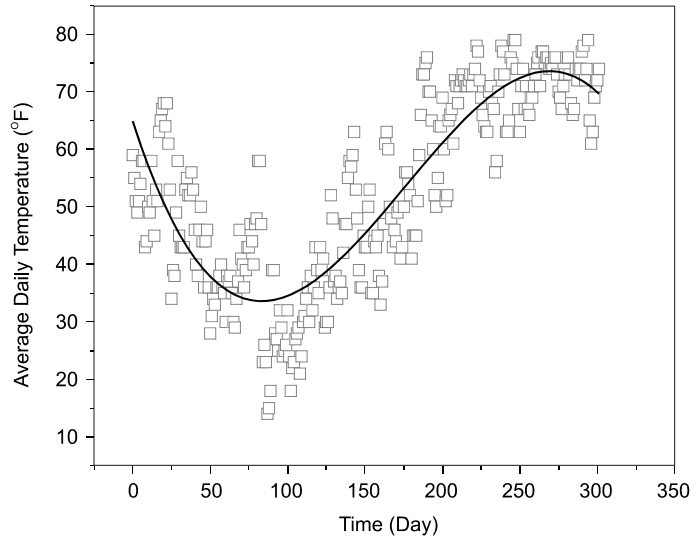
Figure 18. NCDC Reported Regional Temperature for Laboratory Specimens.

The laboratory specimens were outside in a region that undergoes seasonal fluctuations in temperature. In general, the hottest period is during the summer months and coldest during the winter. Figure 18 shows the change in temperature recorded during this study for this region, which was gathered from NCDC, Monticello Station. This weather station is approximately 7 miles from the laboratory specimens.

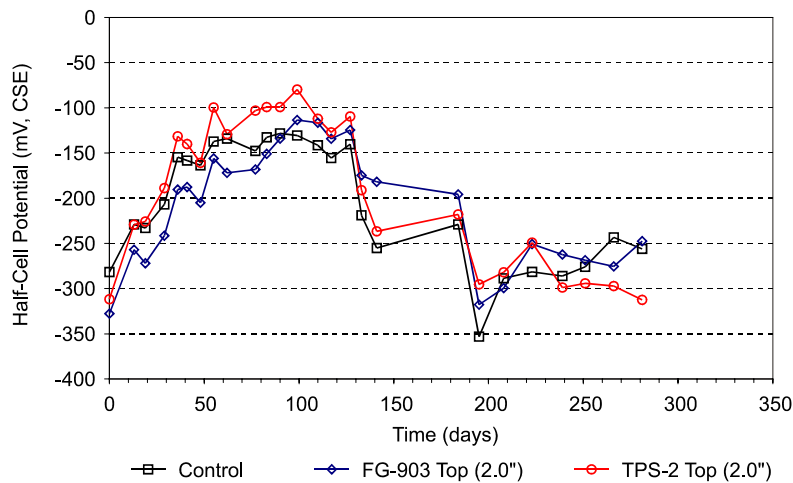
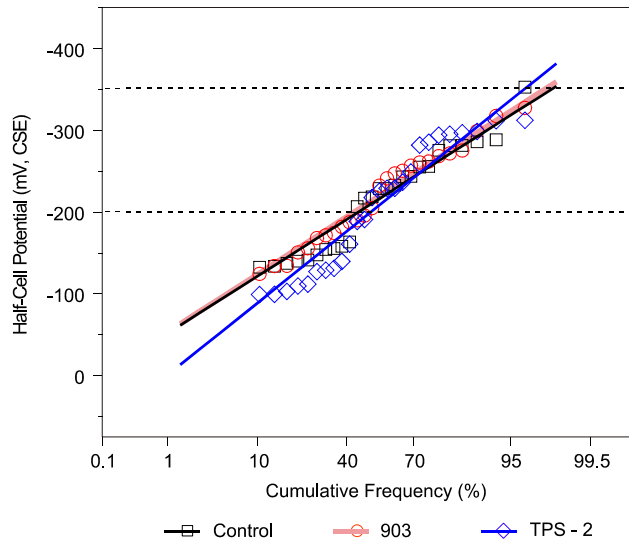
Figure 19. Half-Cell Potential of Specimens With 2-Inch Uniform Cover.

**Figure 20. Cumulative Frequency of Half-Cell Potentials for Group of Uniform Specimens Treated Topically.**

Potential measurements on the uniform specimens indicated that the surface application of these inhibitors did not independently influence the half-cell potentials. As shown in Figure 19, the measured potentials in the samples treated with the surface-applied inhibitor followed the same trend as did the control specimens. In Figure 20, it can be seen that the response of the control and the FerroGard 903 specimens was so similar that the linear fit lines for these data overlay each other. The TPS-II data, however, did vary slightly from those of the control specimen, which resulted in a change in slope of the linear fit line. However, this change did not shift toward a more positive or negative potential but instead was more of a rotation around the center of the graph. This indicates that some of the potential readings became more positive while others became more negative. This can be seen in Figure 19, with the TPS-II specimens having the most positive potential within the first 100 days but then having the most negative during the latter part of this study.

Half-cell potential measurements indicated that applying the corrosion inhibitor to the surface of the concrete and allowing it time to migrate did not significantly alter the potential of the steel. This was evident in both the reinforced concrete specimens cast for this study and the bridge deck evaluated. Comparisons of the half-cell measurements with those of the control specimens indicated that the response of the FerroGard 903 and TPS-II was similar to that of the controls.

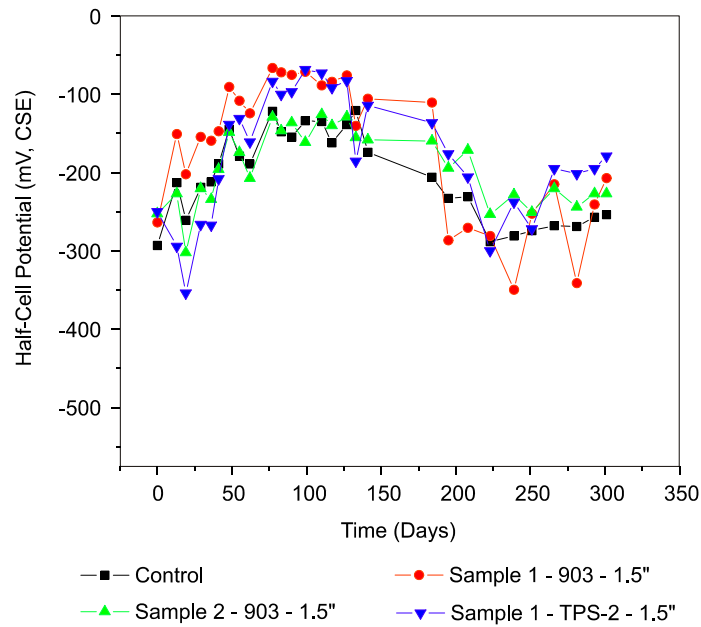
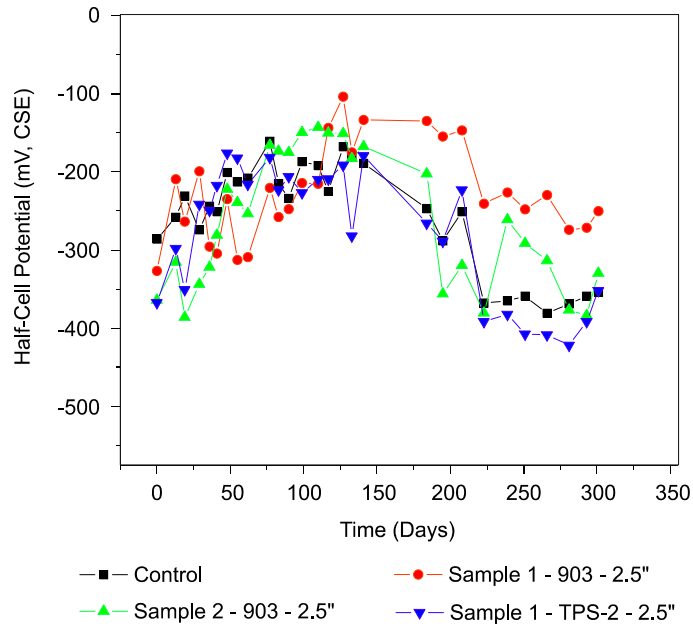
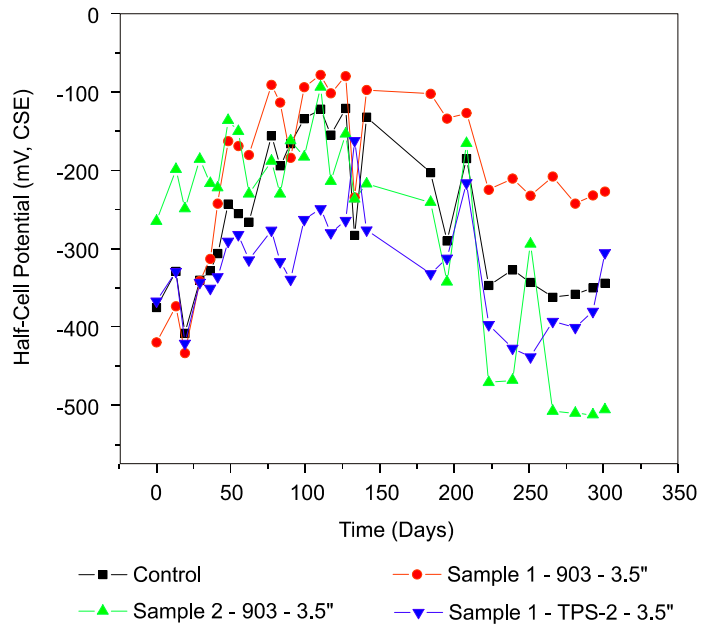
**Figure 21. Influence on Half-Cell Potential of Vacuum/Pressure Injection With Cover Depth of 1.5 Inches.**

**Figure 22. Influence on Half-Cell Potential of Vacuum/Pressure Injection With Cover Depth of 2.5 Inches.**

**Figure 23. Influence on Half-Cell Potential of Vacuum/Pressure Injection With Cover Depth of 3.5 Inches.**

By placing bars at various depths, it was possible to evaluate the ability of the inhibitor to influence the potential of the steel after vacuum/pressure injection. In Figures 21 through 23, a couple of trends are evident for the three different cover depths. First, all treated specimens followed the pattern shown by the control specimens: initially increasing, reaching a plateau, decreasing, then beginning to increase again. There is also not a clear separation between the potential measurements for the control and the treated specimens.

The same trend in potential measurements when the inhibitors were applied to the surface and allowed to migrate in was observed when vacuum/pressure injection was used to apply the inhibitors. Variations in the type of inhibitor used or the depth of cover did not appear to alter the response of the inhibitors when compared to the control specimens.

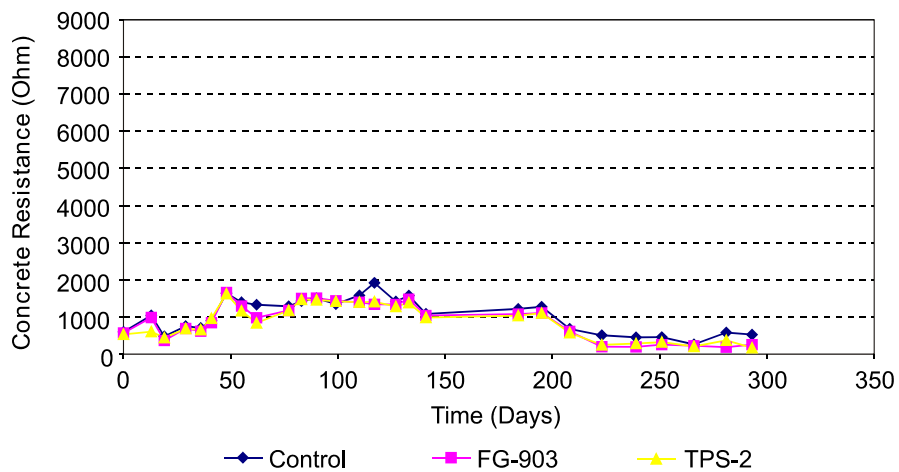
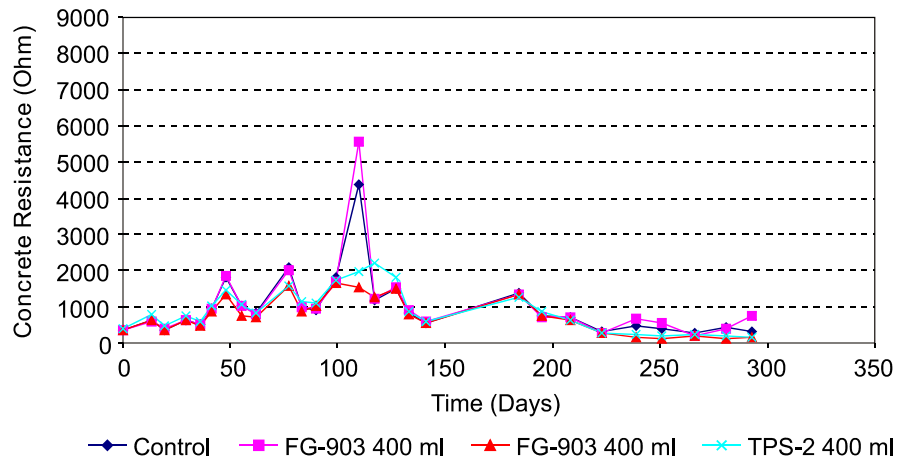
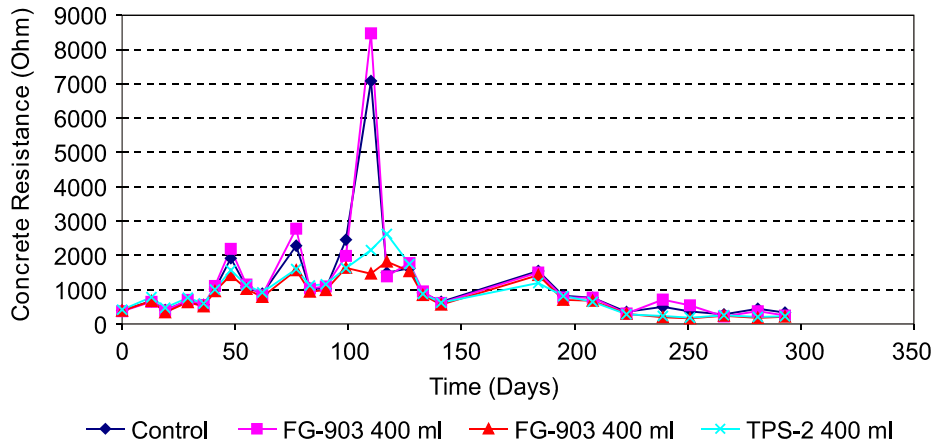
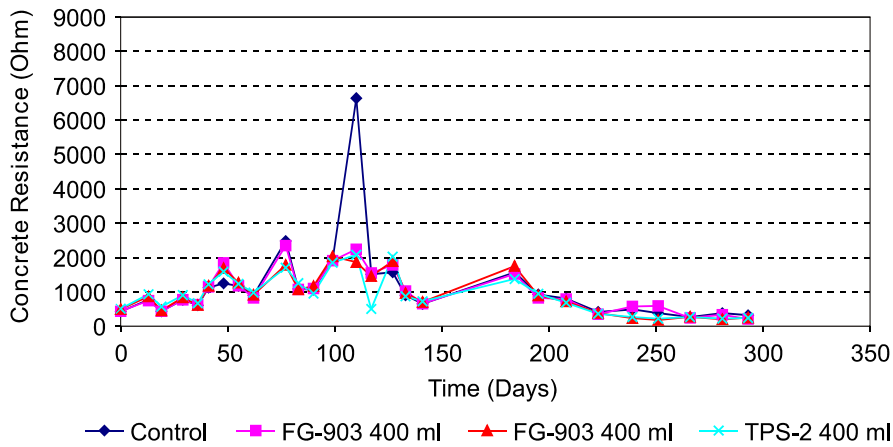
**Figure 24. Effect on Concrete Resistance of Surface Application Following Treatment.**

**Figure 25. Effect on Concrete Resistance of Vacuum /Pressure injection of inhibitor (400 ml) with 1.5-inch Cover Depth.**

**Figure 26. Effect on Concrete Resistance of Vacuum /Pressure injection of inhibitor (400 ml) with 2.5-inch Cover Depth.**

**Figure 27. Effect on Concrete Resistance of Vacuum /Pressure injection of inhibitor (400 ml) with 3.5-inch Cover Depth.**

Upon examining the concrete resistance following treatment, it is clear from Figure 24 that applying the inhibitor to the surface of the concrete does not increase the resistance of the concrete above that of the control specimens. During the entire duration these specimens were monitored, the resistance in the treated specimens remained equal to or less than that of the untreated specimens. In Figures 25 through 27, the data points for the treated specimens when vacuum/pressure injection was used generally did not deviate far from the line for the control specimen. In addition, the data at the one point in these three figures (day 110) where a spike occurs consistently were gathered during the coldest part of the year.
