Report No. VTRC 06-R23	Report Date June 2006	No. Pages 46	Type Report: Final Period Covered: December 2004 – February 2006	Project No.: 75852 Contract No.
Title: Implementation of the Rock Slope Management Project at the Virginia Department of Transportation			Key Words: Rock slope management, rockslide, rockfall, geotechnical asset, asset management, RHRS.	
Authors: Edward J. Hoppe, Ph.D., P.E., and Derek H. Whitehouse, C.P.G.				
Performing Organization Name and Address: Virginia Transportation Research Council 530 Edgemont Road Charlottesville, VA 22903				
Sponsoring Agencies' Name and Address Virginia Department of Transportation 1401 E. Broad Street Richmond, VA 23219				
Supplementary Notes				
<p>Abstract</p> <p>The Virginia Department of Transportation (VDOT) is currently developing an asset management system, identifying various transportation assets for inclusion in the system. Rock slopes along Virginia's highways can be viewed as assets that need to be managed proactively in order to maintain a safe and effective transportation network. The benefits of rock slope management are expected to be similar to those derived from bridge and pavement management systems, includi

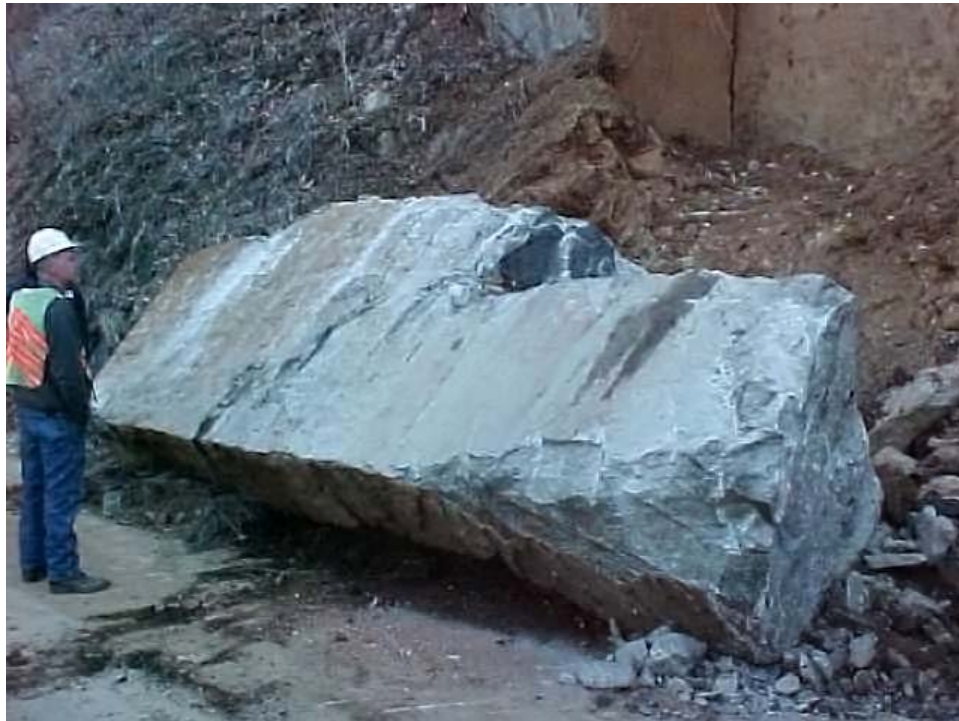
Figure 1. Rockfall at Route 56 Near Crabtree Falls, Nelson County (February 2001)

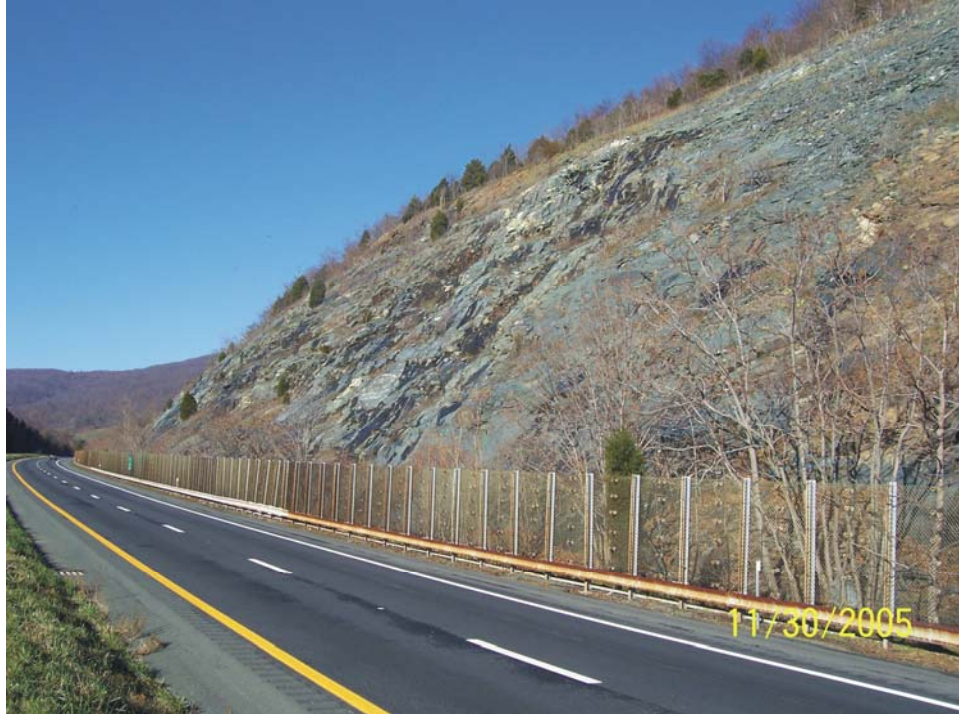
Figure 5. Example of Referenced Photo

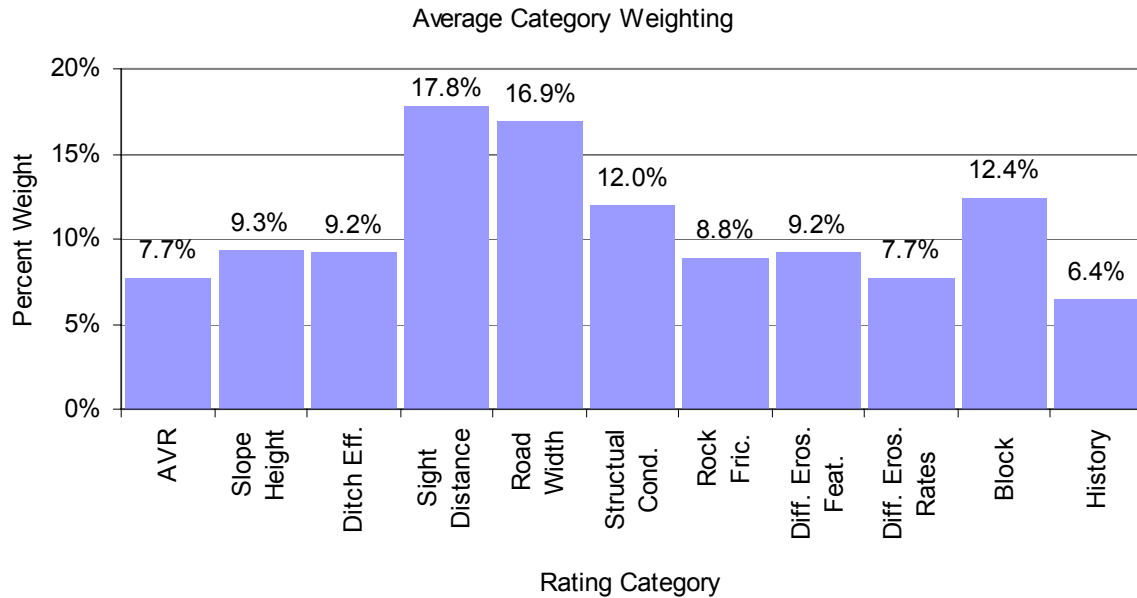
The categories can also be evaluated based on their relative contribution to the overall score. The figure below displays a histogram of the average percentage represented by each category in the Detailed Ratings. This reveals that the two highest contributing categories on average are Sight Distance and Roadway Width, while the Rockfall History contributes the least. For the breakdown below, when both Geologic Character categories were rated (both Case 1, Structural Condition and Case 2, Differential Erosion), the case that provided the highest score combination was used for the score breakdown. See the National Highway Institute RHRS manual for additional explanation of rating Geologic Character.

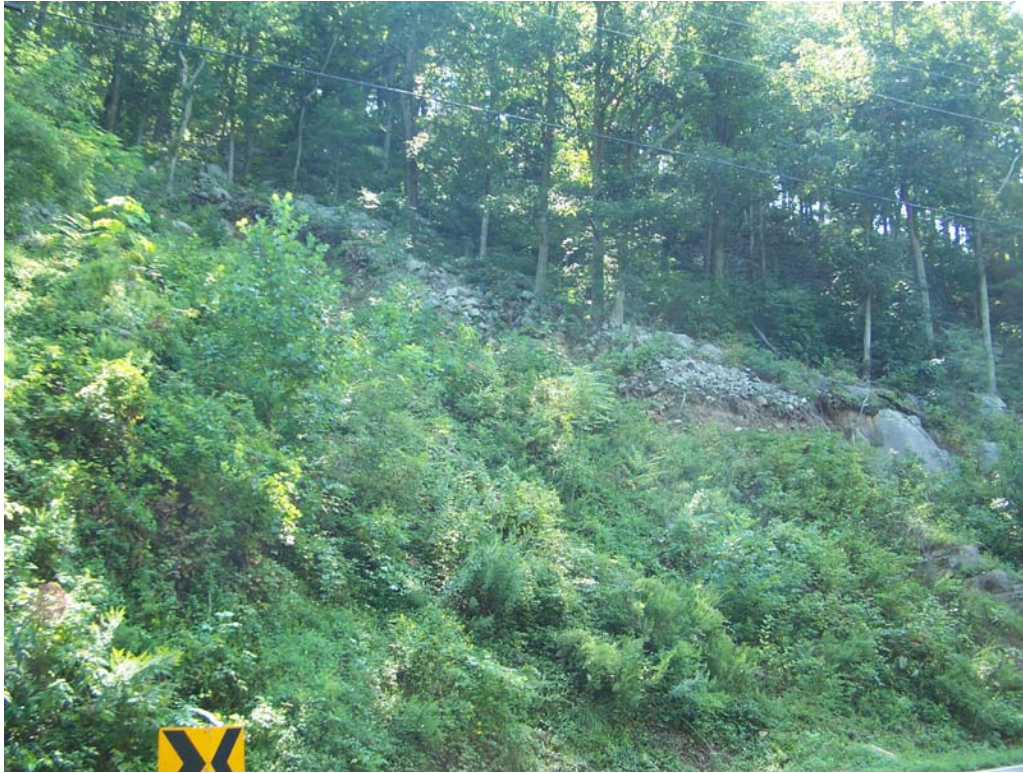
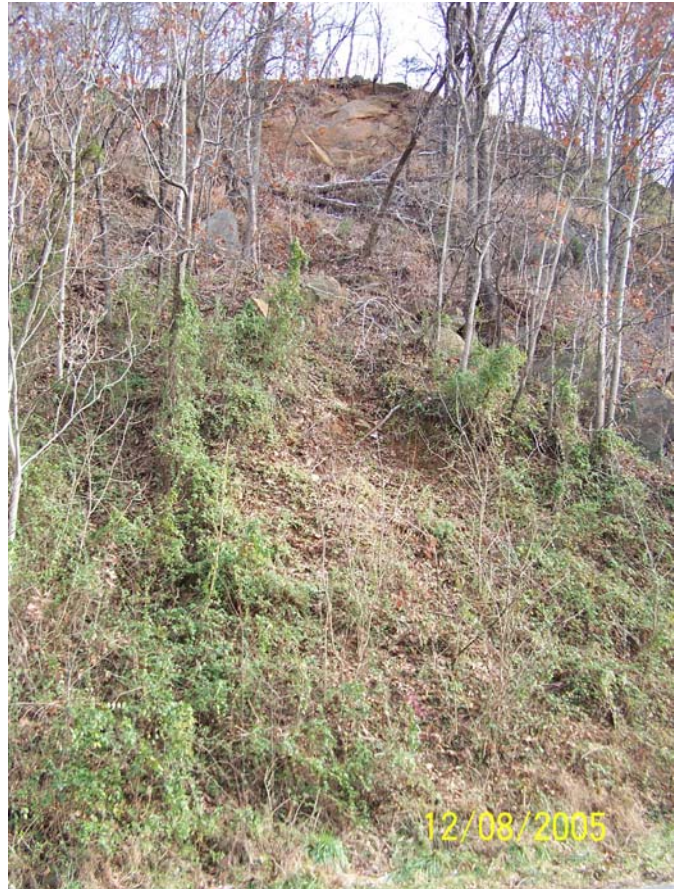
District: Lynchburg
City / County Code: 062 Route Number: 00056 Side: Right
Beginning Latitude and Longitude: 37.854382, -79.039404
RHRS Score: 599

This slope is approximately 160 feet long with a maximum height of about 100 feet. The VDOT conceptual design indicated the ideal option of a Brugg Fence coupled with ditch improvement and scaling with a lower cost option of a concrete barrier placed instead of the Brugg Fence. These design concepts appear appropriate for the rockfall modes present. However, vegetation present on the slope will likely limit the kinetic energy of a falling rock, allowing the application of the lower cost option of a draped mesh with a catch fence. Following computer simulation for verification, install a seven-foot tall fence with a 15-foot drape installed in location such that the mesh ends three to five feet from the ditch line.

The mitigation measures presented provided a temporary solution and included scaling and ditch improvement. A long term mitigation measure for this site would involve reducing the likelihood of rockfall and improving the catchment area capabilities with barriers.

The history of 10-foot blocks and the height they have fallen justify high capacity protective measures. Scaling followed by rock bolting of problematic rock blocks along the crest of the slope would reduce the rockfall potential. For estimation purposes, assume one 10-foot and one 15-foot bolt for every 10 feet of the crest. This quantity would need to be adjusted based on final design investigation. A high capacity Brugg Fence could be considered, with the ditch improved to facilitate cleanout and a concrete barrier placed to control errant drivers from hitting the Brugg fence. If the area from which rockfall originates is less than the 340 foot section length, the Brugg Fence and concrete barrier could be shortened accordingly.

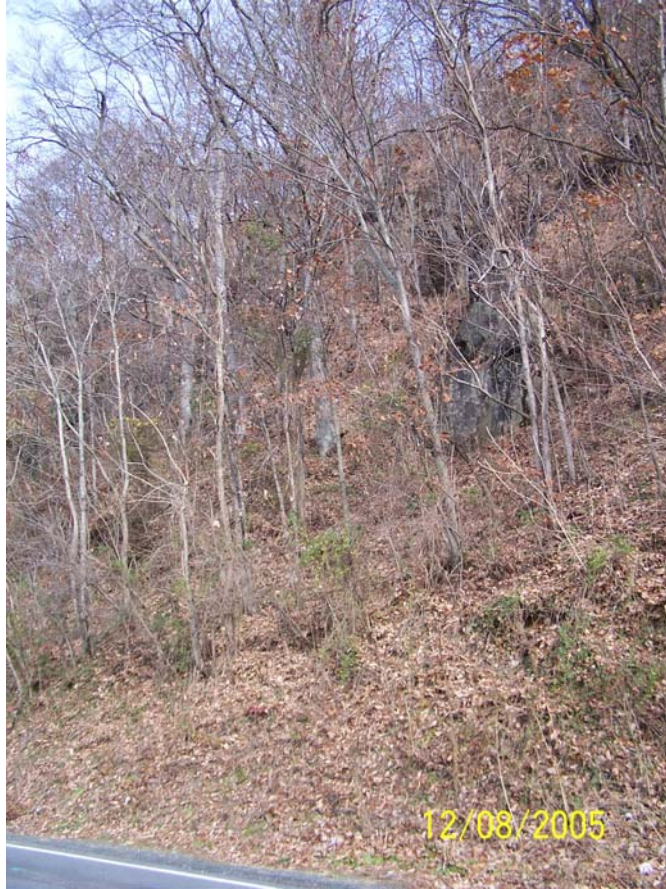
District: Lynchburg
City / County Code: 005 Route Number: 00685 Side: Right
Beginning Latitude and Longitude: 37.420887, -79.138494
RHRS Score: 462

The VDOT conceptual design suggested scaling and ditch improvement to mitigate immediate rockfall hazard. Based on the photos, the rockfall hazards appear to originate from highly fractured outcrops scattered across the slope. To extend the design life, scale back all outcrops so that only tight joints are observed. Following scaling, place a concrete barrier the length of the slope to prevent any small rock from entering the roadway.

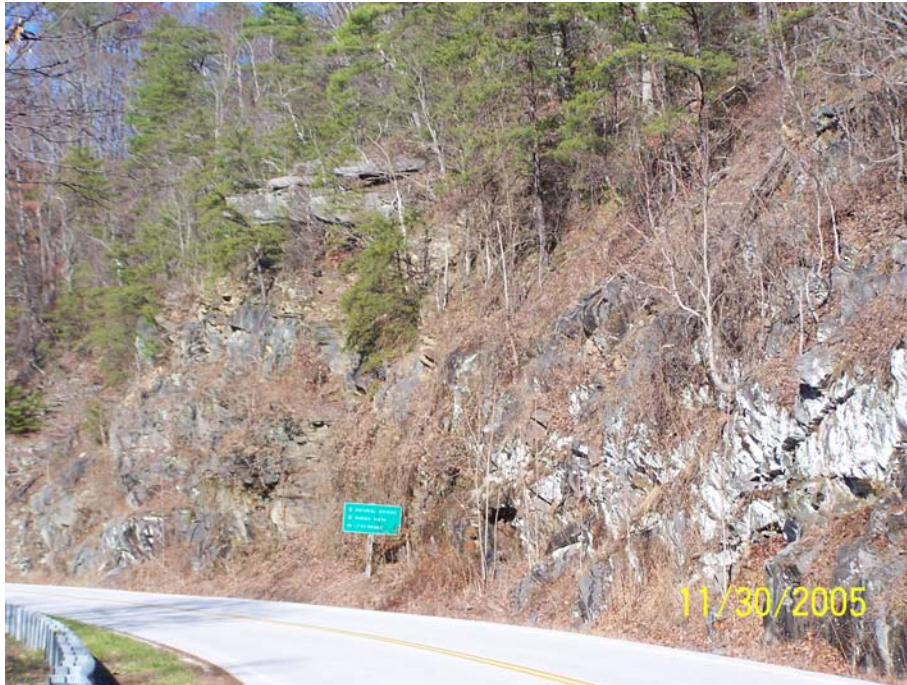
District: Lynchburg
City / County Code: 005 Route Number: 00130 Side: Right
Beginning Latitude and Longitude: 37.589159, -79.379250
RHRS Score: 441

This section is approximately 900 feet long and up to about 125 high. The slope consists of a rockfall chute, large rock overhangs, and fractured bedrock. Rock blocks up to 6 feet have fallen from the slope. The conceptual design provided by VDOT included a Brugg fence, blast scaling, scaling, and ditch improvement. These measures are appropriate for a short- to mid-term mitigation effort. For long-term mitigation, increase the scaling hours, include rock bolt installation, and install a concrete barrier with fence extension. If possible, consider shifting the centerline to the left to increase fallout area. To facilitate a centerline shift, constructing a 5- to 15-foot MSE wall may be beneficial.

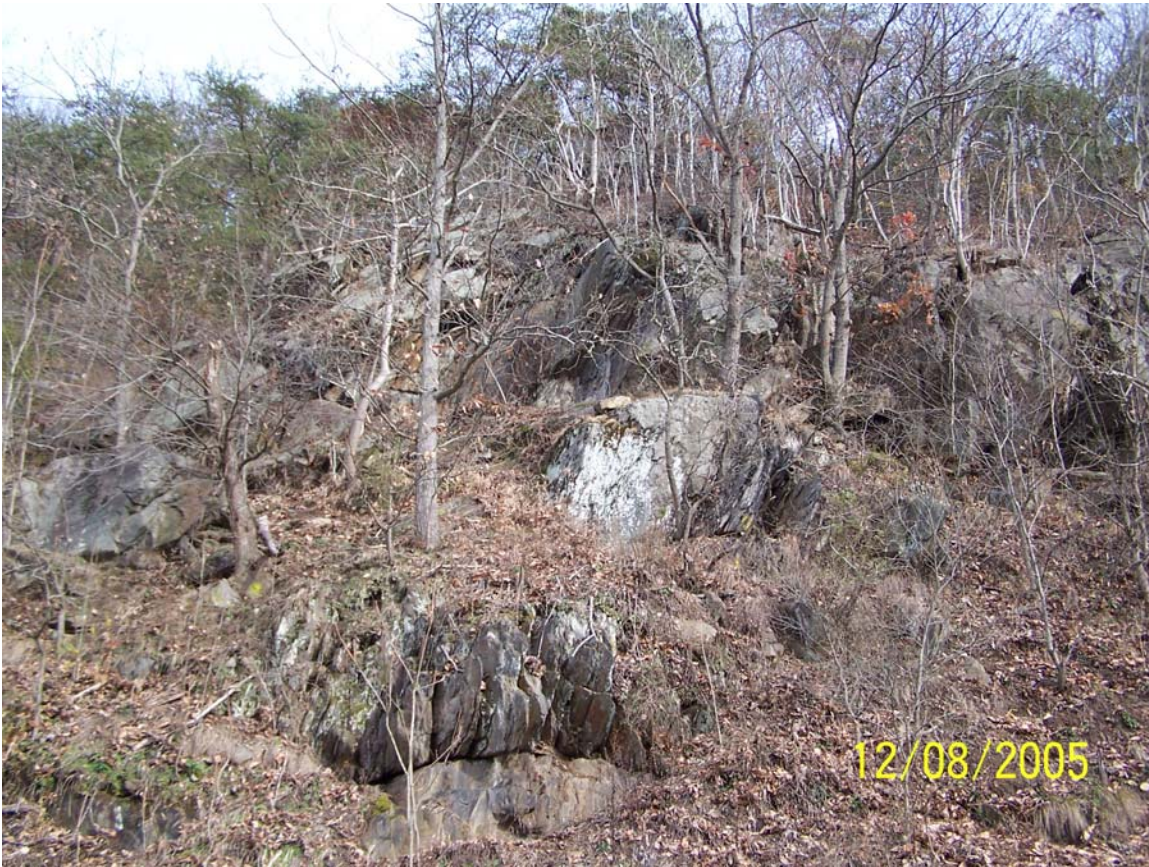
District: Lynchburg
City / County Code: 005 Route Number: 00685 Side: Right
Beginning Latitude and Longitude: 37.423347, -79.139036
RHRS Score: 440

This section is approximately 775 feet long and up to 125 feet high. In 2004, a parked car was partially buried by a rockfall incident. The conceptual design provided by VDOT appeared to focus on short-term mitigation and included scaling and ditch improvement. Long term mitigation efforts should include scaling and rock bolting of the various outcrops that comprise the slope. Loose blocks should be scaled. Following scaling, rock bolts should be installed in problematic and key blocks. Assume fifty 10-foot bolts.

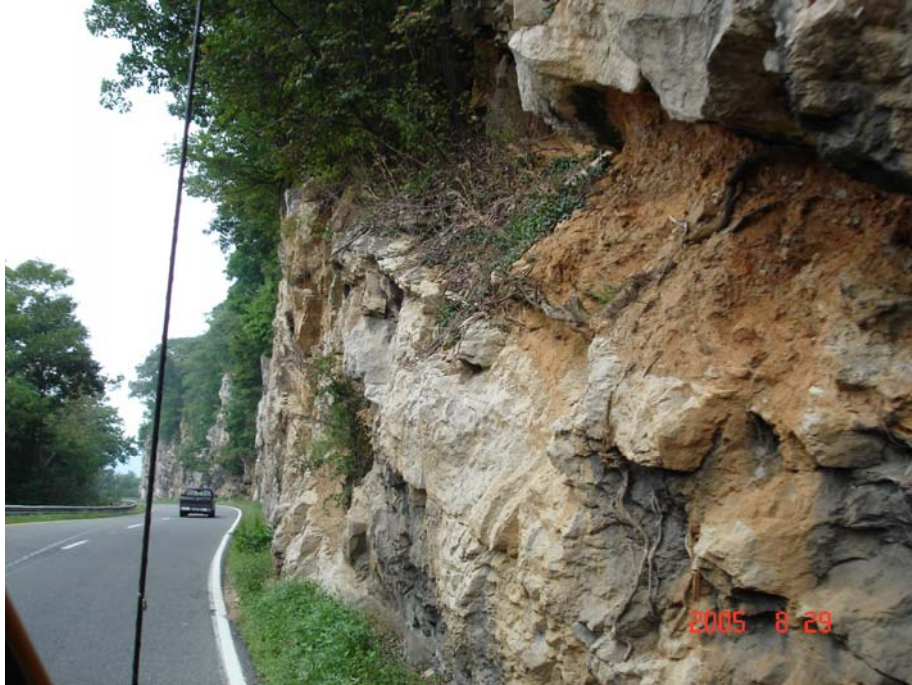
District: Salem
 City / County Code: 035 Route Number: 00460 Side: Right
 Ending Latitude and Longitude: 37.371483, -80.819031
 RHRS Score: 675

This section is approximately 1,940 feet long and up to 85 feet high. Surface area was estimated by VDOT to be approximately 83,000 square feet, which indicates an average height of about 43 feet over the length of the slope. The mitigation options provided by VDOT essentially describe a scaling and draped mesh application. The large blocks described that are produced by the slope would likely overwhelm and destroy the draped mesh without additional mitigation. Creating a catchment area using presplit blasting techniques would provide an ideal rockfall mitigation but would likely cost over 1 million dollars. Measures in addition to the scaling and draped mesh include applying shotcrete to protect erodible seams, such as the one shown above and the possibility of rock bolt placement in problematic rock blocks. For estimation purposes and assuming approximately 5% of the surface area would require shotcrete, use 4,200 square feet of shotcrete, 800 feet of rock bolts, 83,000 sq ft of draped mesh and a 200 sq ft per hour scaling production rate. The total cost for this concept would be on the order of \$650,000.

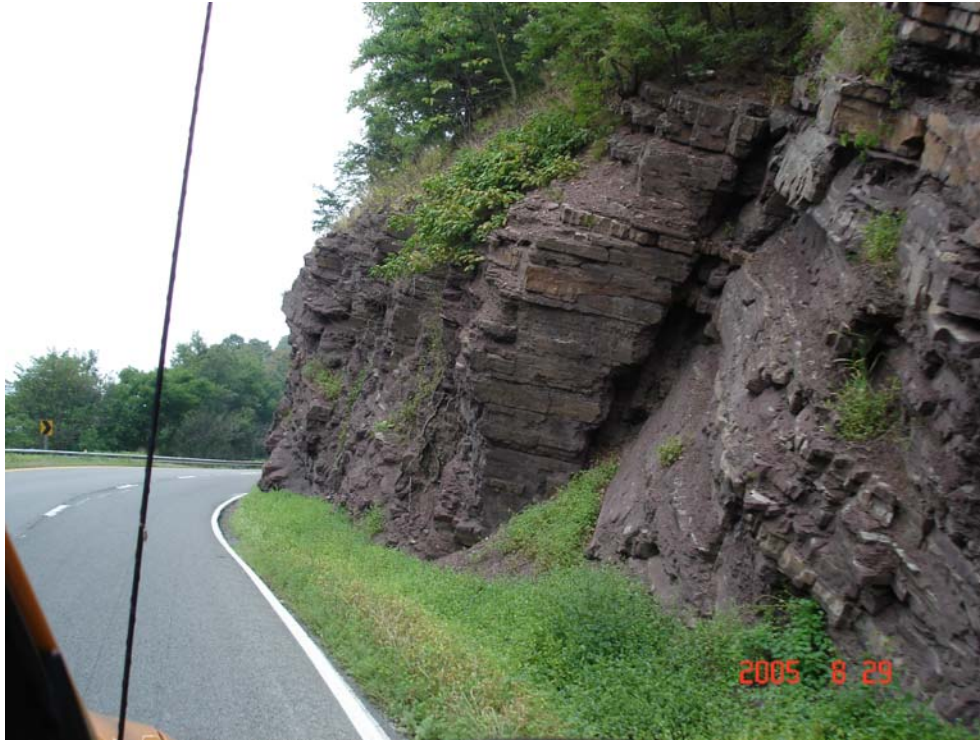
District: Salem
City / County Code: 035 Route Number: 00460 Side: Right
Starting Latitude and Longitude: 37.347103, -80.807250
RHRS Score: 651

Mitigative measures were performed at this site in the late 1990's and appeared to primarily consist of scaling activities. The rockfall section is approximately 2,350 feet long and is up to about 100 feet high. The rockfall activity is reported as often containing about 24 tons of rock in an average event. Draped mesh was identified by VDOT in this study for placement. The draped mesh would contain the common small rockfalls that occur, but it could be damaged or destroyed by the 24-ton events that have been described.

If this area continues to be an on-going problem, constructing a 20-foot wide fallout area with a 0.5H:1V cut slope could be considered. At approximately \$20 per cubic yard, the cost would be on the order of two to three million. Placing draped mesh over slope would be approximately \$700,000, but may be damaged by the large volumes reported.

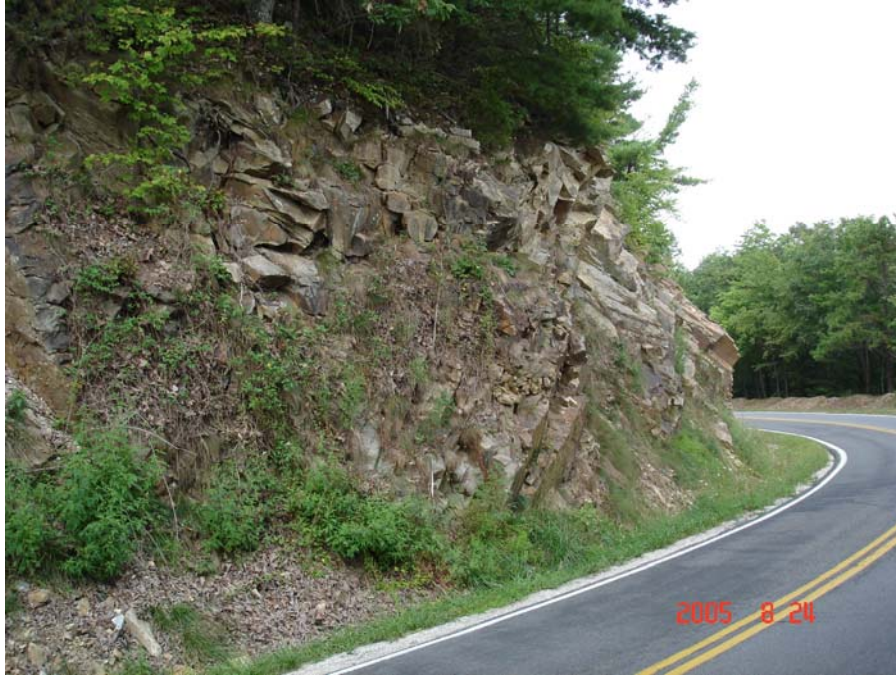
District: Salem
City / County Code: 011 Route Number: 00043 Side: Right
Starting Latitude and Longitude: 37.508425, -79.664297
RHRS Score: 632

This slope is approximately 600 feet long and up to 40 feet high and contains many open, adversely oriented discontinuities. The surface area estimated by VDOT is about 12,000 square feet. The mitigation concepts from VDOT include scaling, draped mesh, shotcrete, and ditch improvement. Due to the large rock blocks present at the site (4½ feet), the planned draped mesh could be damaged on occasion. Following scaling, rock blocks larger than 2½ feet that serve as key blocks should be rock bolted to improve slope stability and reduce the potential for damage to the draped mesh. Assume one 10-foot rock bolt for every 300 square feet of slope and a scaling production rates of 100 square feet per hour.

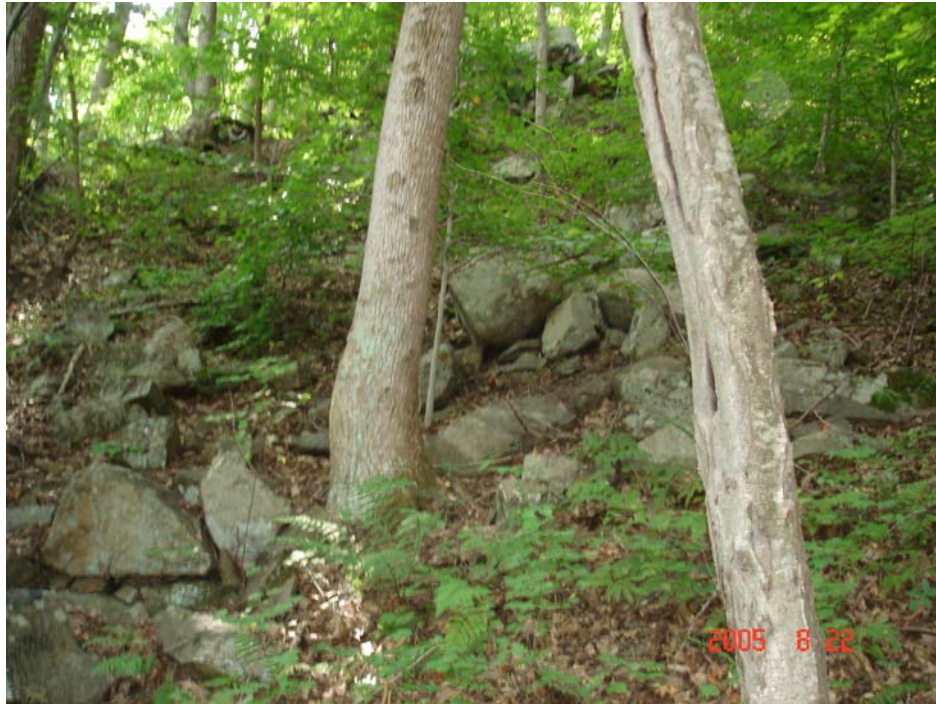
District: Salem
City / County Code: 009 Route Number: 00501 Side: Right
Starting Latitude and Longitude: 37.516575, -79.342603
RHRS Score: 604

This section is approximately 1,050 feet long with a natural hillside above the cut slope up to 100 feet high and appears to be the source of rockfall. The hillside above the cut consists of talus and colluvial boulders. The conceptual mitigation elements provided by VDOT include scaling, draped mesh, and a Brugg fence or a chain link fence.

The size of rock found on this slope would make a chain link fence inadequate for stopping the majority of rolling rocks. A modified catch fence, similar to draped mesh with a catch fence but using heavy duty Brugg nets with a backing of gabion mesh to restrict smaller rocks, could be placed at the top of the cutslope, assuming that a relatively continuous line of elevation is available for fence placement. The Brugg panels would drape down the face to within three feet of the ditch line and would be self-cleaning. Scaling production on the hillside should be 100 square feet per hour.

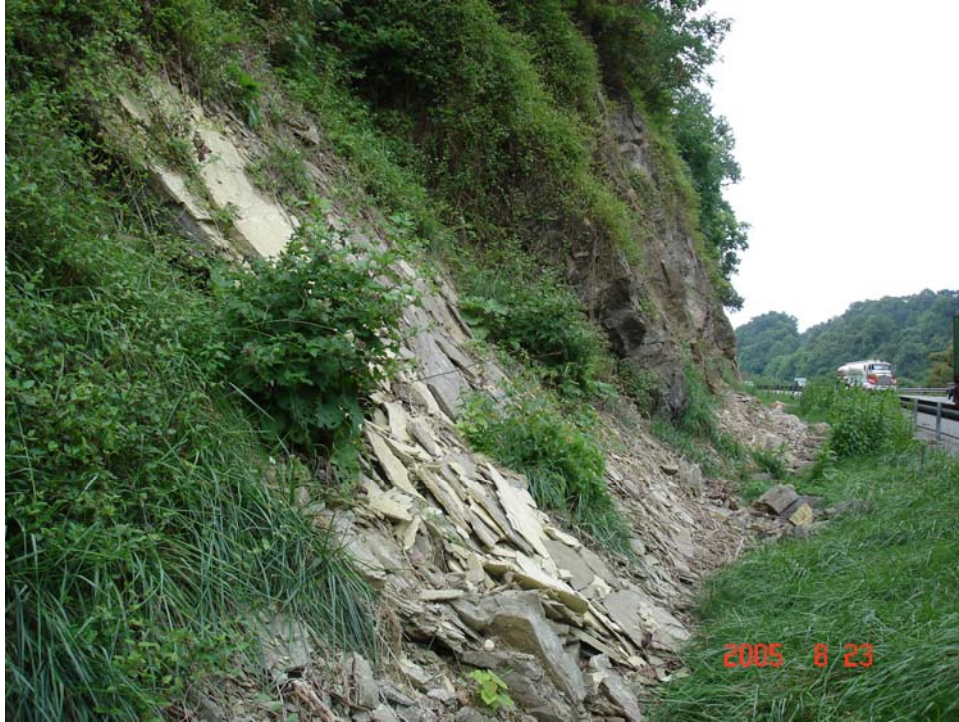
District: Salem
City / County Code: 060 Route Number: 00081 Side: Right
Starting Latitude and Longitude: 37.099375, -80.556489
RHRS Score: 519

The section is about 350 feet long and 30 feet high with approximately 5,200 square feet of face. The mitigation options provided include scaling, draped mesh, double guard rail, Brugg fence, and ditch improvement. Rock block size is up to 4½ feet. Based on the 30-foot slope height and reverse ditch shape, the Brugg Fence does not appear to be needed. Following scaling, key blocks should be bolted to secure blocks larger than 2 feet to the slope to prevent damage to the draped mesh. Assume one 10-foot bolt will be required for every 200 square feet of face, or about 26 rock bolts.

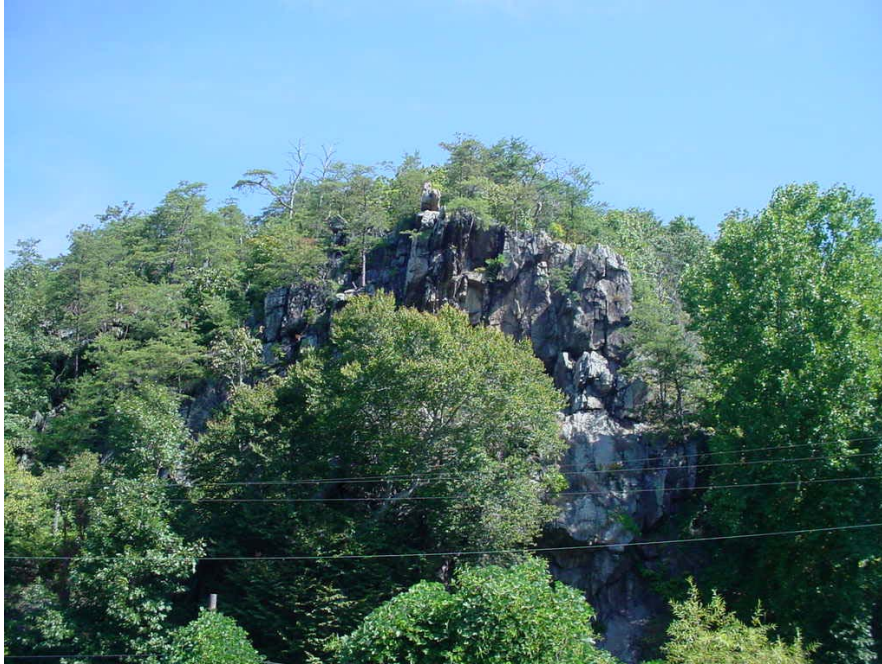
District: Culpeper
City / County Code: 032 Route Number: 00656 Side: Right
Starting Latitude and Longitude: 37.712661, -80.556489
RHRS Score: 597

The rockfall section is approximately 650 feet long and 105 feet high and appears to be a natural outcrop adjacent to the roadway. Maintenance personnel state that rockfall has not fallen and reached the road in 20+ years. However, the presence of continuous, steeply dipping joints poses a threat of rockfall. VDOT’s conceptual design involved signage, scaling, and draped mesh.

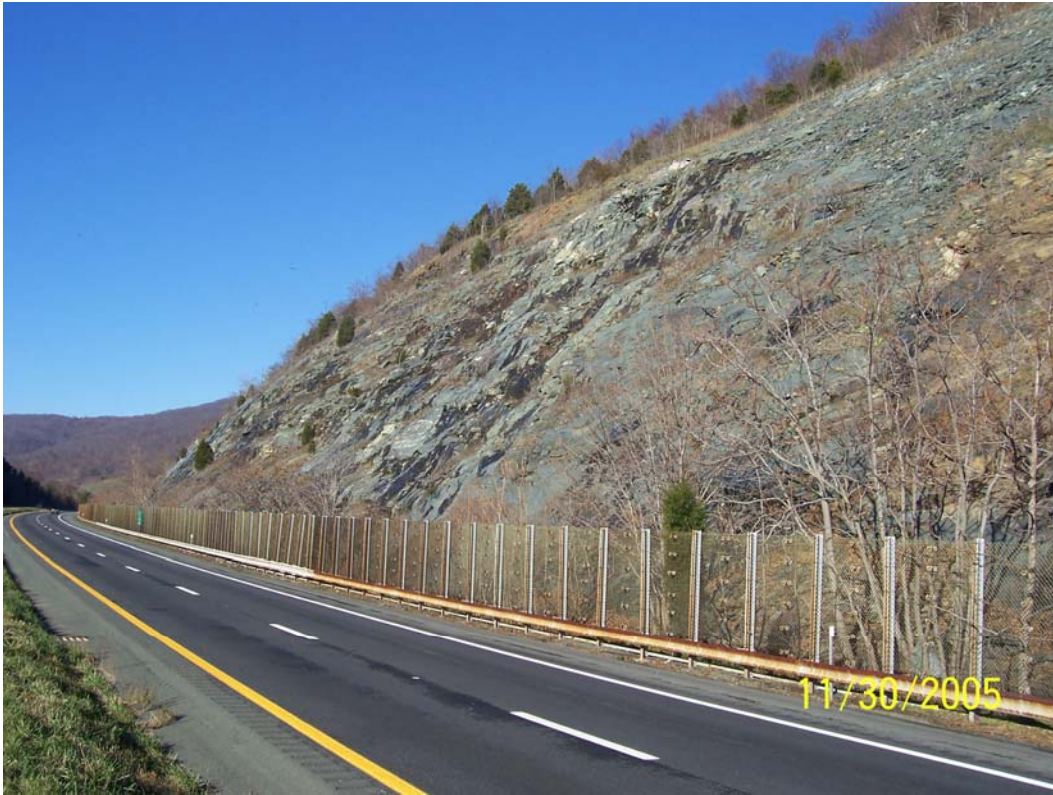
District: Culpeper
City / County Code: 002 Route Number: 00064 Side: Right
Starting Latitude and Longitude: 38.043101, -78.804024
RHRS Score: 438

The rockfall section is nearly 1,800 feet long and up to 205 feet high. The fallout area is 25 feet wide. A guard fence is in place and retains most rockfalls. Based on the photos, the guard fence appears to be in good condition and does not appear to have sustained repeated damage. The conceptual design from VDOT included scaling and applying draped mesh to the entire slope.

Based on the success of the guard fence preventing most rockfalls from reaching the roadway, but because rock blocks up to a maximum of 4 feet has been observed, a Brugg fence is preferable to and less expensive than the draped mesh concept, and only minor scaling would be required. For the cost estimate, a low capacity Brugg fence has been used, but final design should include rockfall modeling to determine the required design capacity.

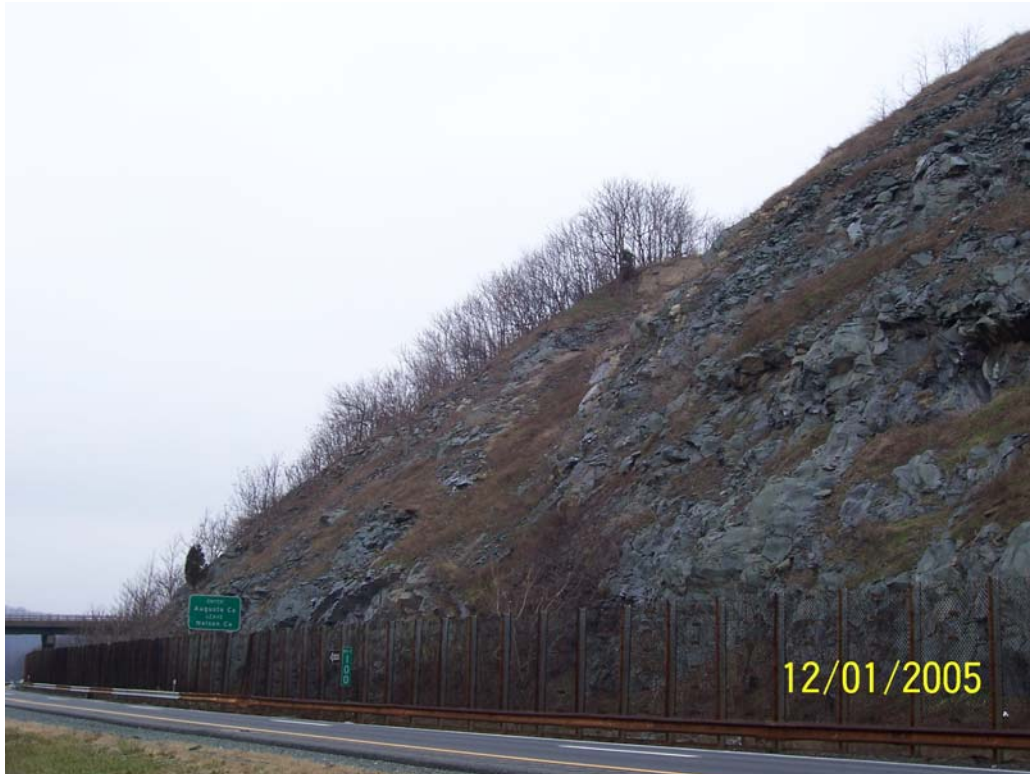
District: Lynchburg (in Culpeper District's RHRS Database)
City / County Code: 062 Route Number: 00064 Side: Right
Starting Latitude and Longitude: 38.033077, -78.854862
RHRS Score: 425

The rockfall section is about 1,150 feet long and up to 150 feet high. A guard fence has been installed and retains most of the rockfall. Based on the photos, the guard fence appears to be in good condition and does not appear to have sustained repeated damage. The conceptual design from VDOT included scaling and applying draped mesh to the entire slope.

Based on the guard fence preventing most rockfalls from reaching the roadway, but because rock blocks up to a maximum of 3 feet has been observed, a Brugg fence is preferable to and less expensive than draped mesh, and only minor scaling would be required. For estimate purposes, a low capacity Brugg fence has been used, but final design should include rockfall modeling to determine the required design capacity.

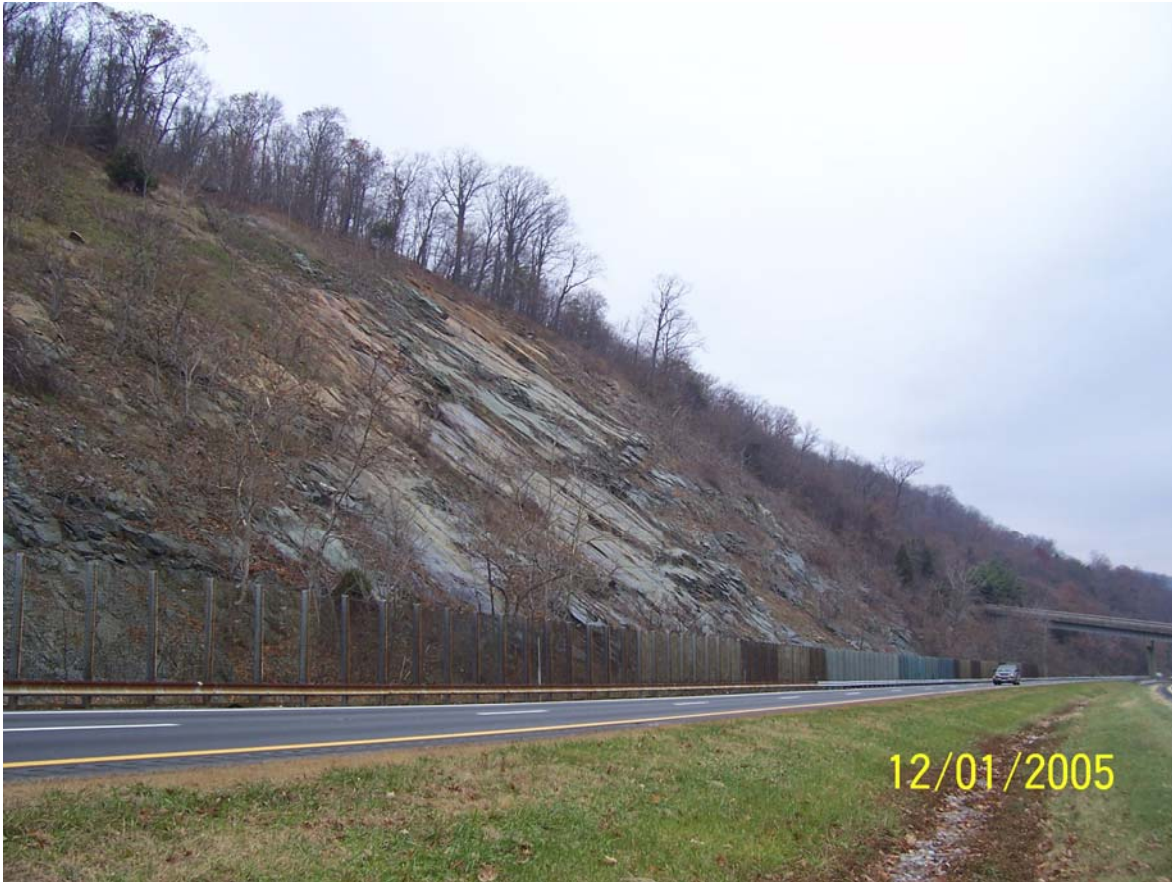
District: Lynchburg (in Culpeper District's RHRS Database)
City / County Code: 062 Route Number: 00064 Side: Right
Starting Latitude and Longitude: 38.038777, -78.837411
RHRS Score: 375

This rockfall section is about 1,050 feet long and up to about 160 feet high. Numerous daylighting joints intersect the cut slope creating large slabs that dip out of the slope roughly perpendicular to the cut. The conceptual design from VDOT recommended draped mesh. The size of slabs that have formed are such that draped mesh could be damaged or destroyed should a slab detach.

Following the scaling of loose rock blocks, untensioned rock bolts, or dowels, can be installed at key locations to prevent slabs from mobilizing. For estimate purposes, approximately one hundred 3-foot dowels were estimated.

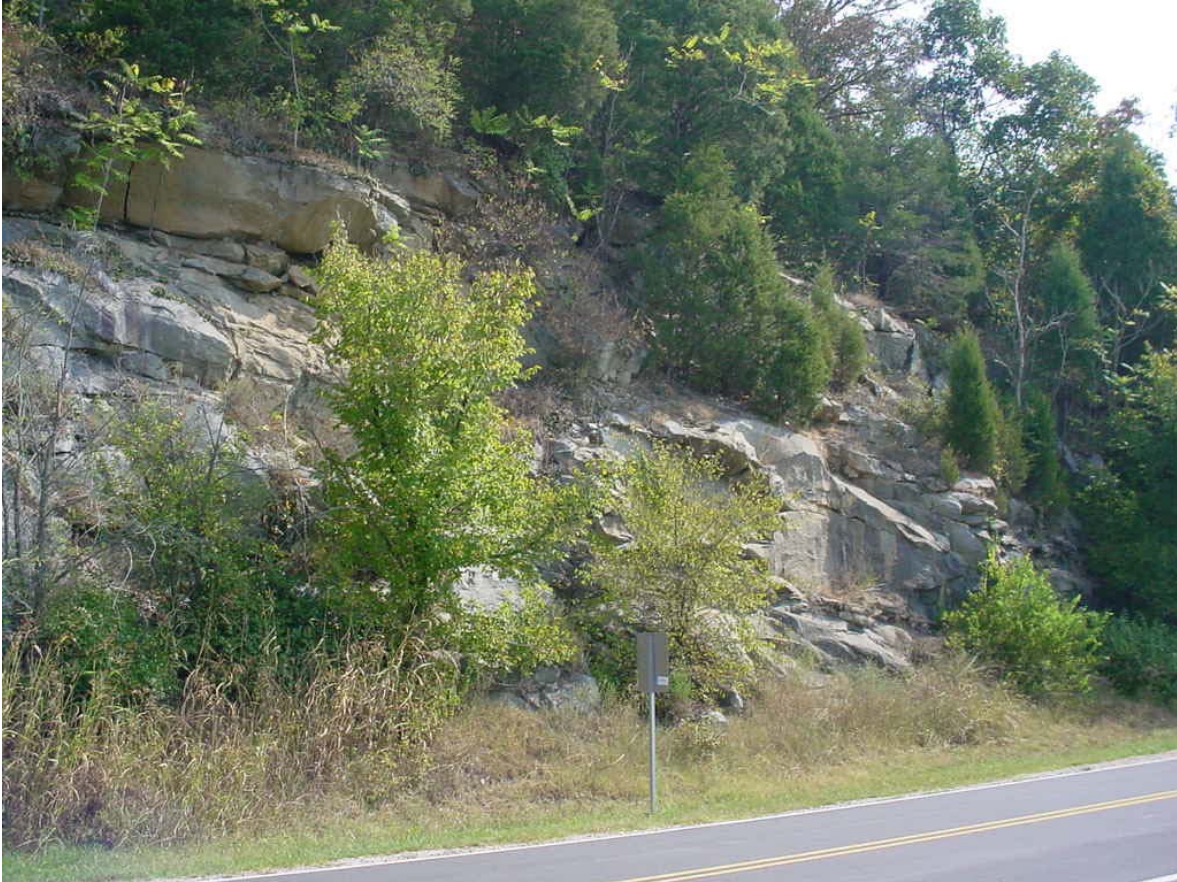
District: Culpeper
City / County Code: 032 Route Number: 00006 Side: Right
Starting Latitude and Longitude: 37.750308, -78.158318
RHRS Score: 356

This rockfall section is about 750 feet long and up to about 45 feet high. A portion of the section consists of an outcrop with low angle surfaces and discontinuities dipping out of the slope. For the portion of the slope with the highest potential for rockfall, scaling the slope of loose rock blocks, as VDOT recommended, would reduce the potential for rockfall. Strategically placed dowels would also improve stability. Final design efforts should evaluate the benefits of installing rock bolts to support key blocks and rock slabs,

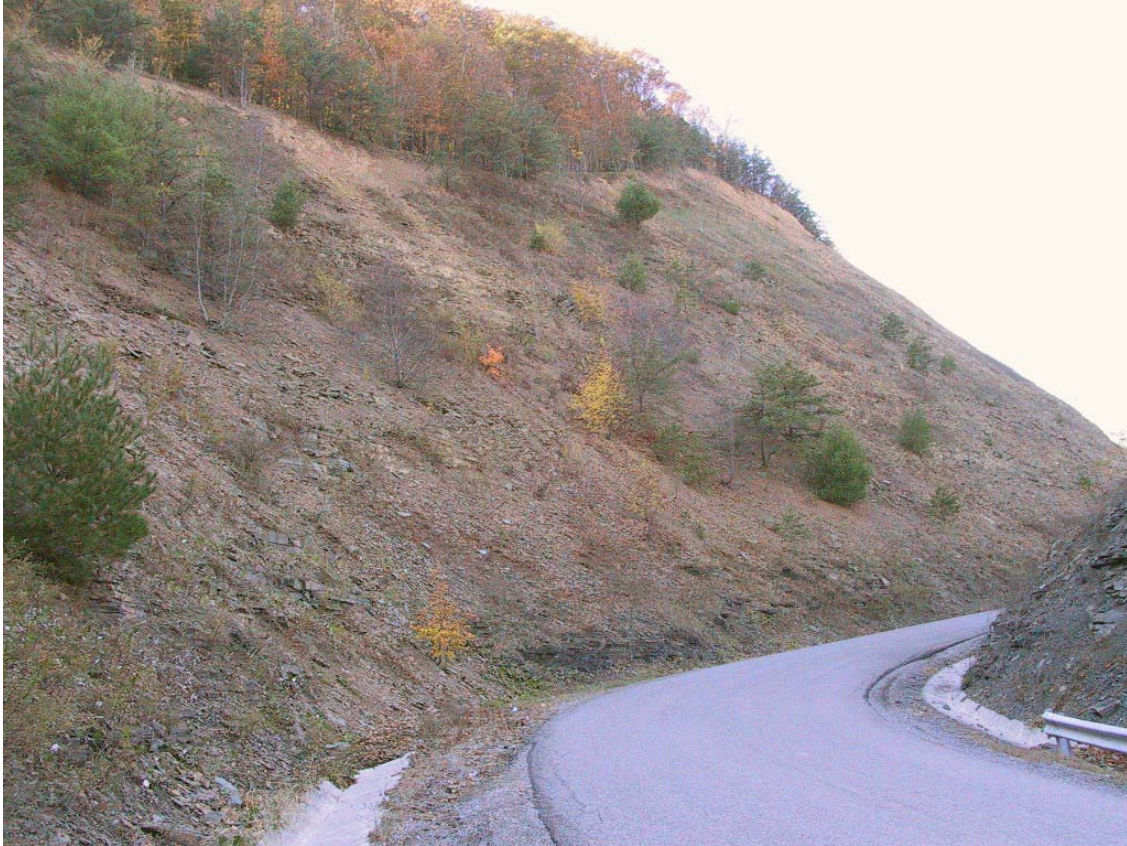
District: Bristol
City / County Code: 010 Route Number: 00612 Side: Left
Starting Latitude and Longitude: 37.138073, -81.130267
RHRS Score: 495

This slope is approximately 1,230 feet long and up to about 225 feet high. VDOT’s conceptual design included draping mesh over the entire slope. This approach is appropriate for the one-foot rock size present, but can be cost prohibitive due to the large surface area. Installation of a 7-foot tall, self-cleaning, draped mesh catch fence the length of the slope with a 15-foot drape is a less costly alternative. Minor scaling prior to the installation of the fence may be appropriate. This design requires careful consideration of fence placement so that it is not placed directly below any potential launch features.

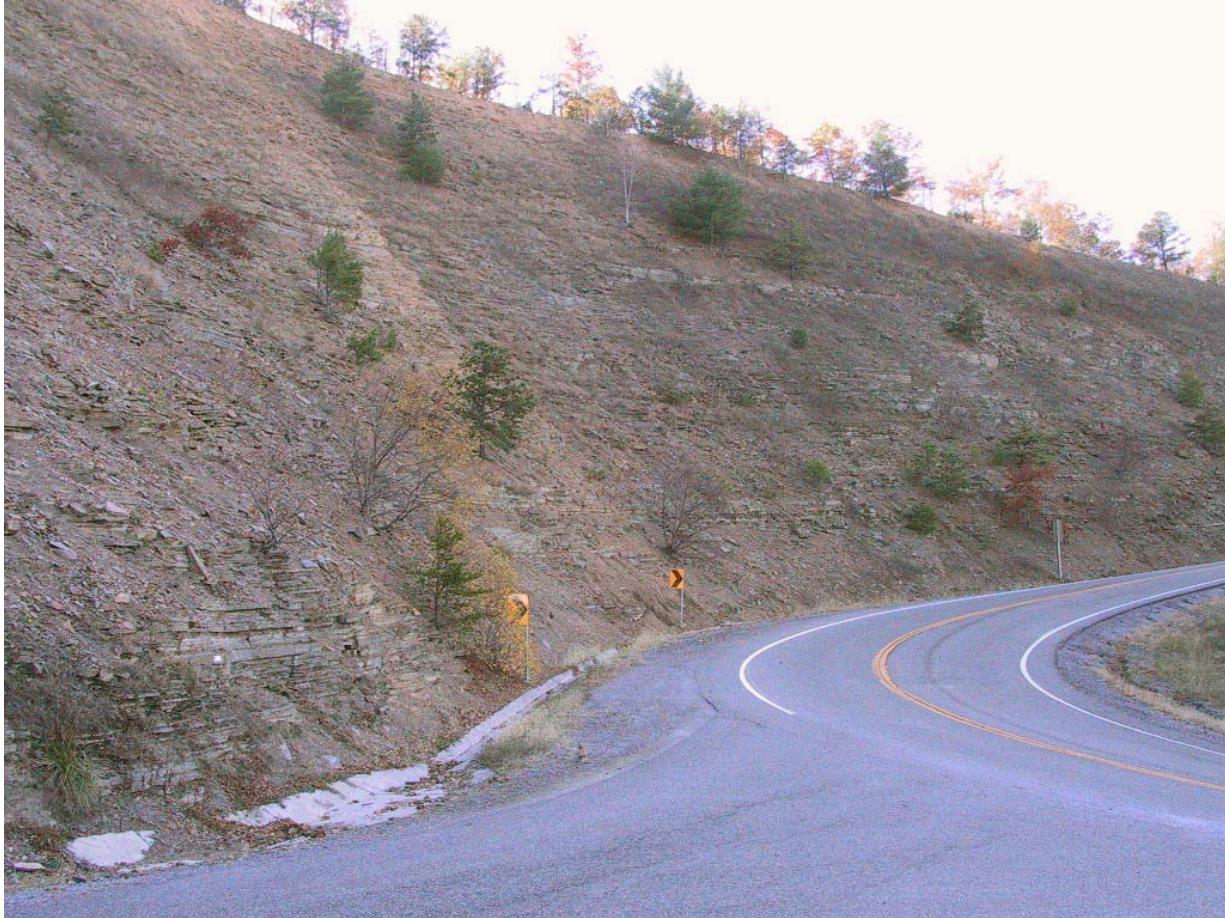
District: Bristol
City / County Code: 010 Route Number: 00052 Side: Right
Starting Latitude and Longitude: 37.137379, -81.132545
RHRS Score: 450

This slope is approximately 750 feet long and up to about 160 feet high. VDOT’s conceptual design included draping mesh over the entire slope. This approach is appropriate for the one-foot rock size present, but is cost prohibitive. Installation of a 7-foot tall, self-cleaning, draped mesh catch fence the length of the slope with a 15-foot drape is a less costly alternative. Minor scaling prior to the installation of the fence may be appropriate. This design requires careful consideration of fence placement so that it is not placed directly below any potential launch features.

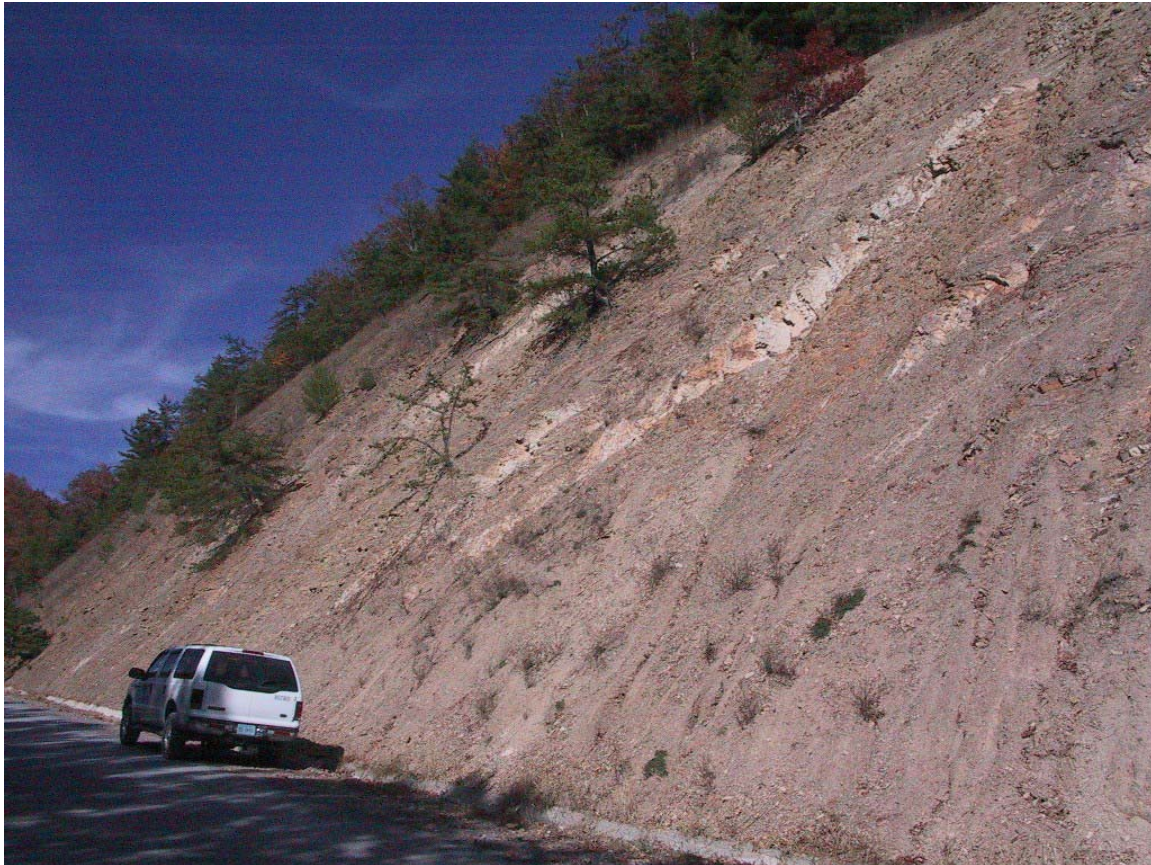
District: Bristol
City / County Code: 010 Route Number: 00612 Side: Left
Starting Latitude and Longitude: 37.140318, -81.124929
RHRS Score: 437

This slope is approximately 770 feet long and up to about 85 feet high. VDOT’s conceptual design included draping mesh over the entire slope. This approach is appropriate for the one-foot rock size present, but it represents a more costly alternative. Based on the photograph, most rockfall produced by this slope is very small and there are few launch features on the slope. The small rock size, expected modest bounce heights, and well-shaped catchment ditch suggest that a concrete barrier at the ditch edge would contain a high percentage of rockfall. If rockfall modeling shows the potential for bounce heights greater than the concrete barrier could intercept, a fence extension on the barrier could be added.

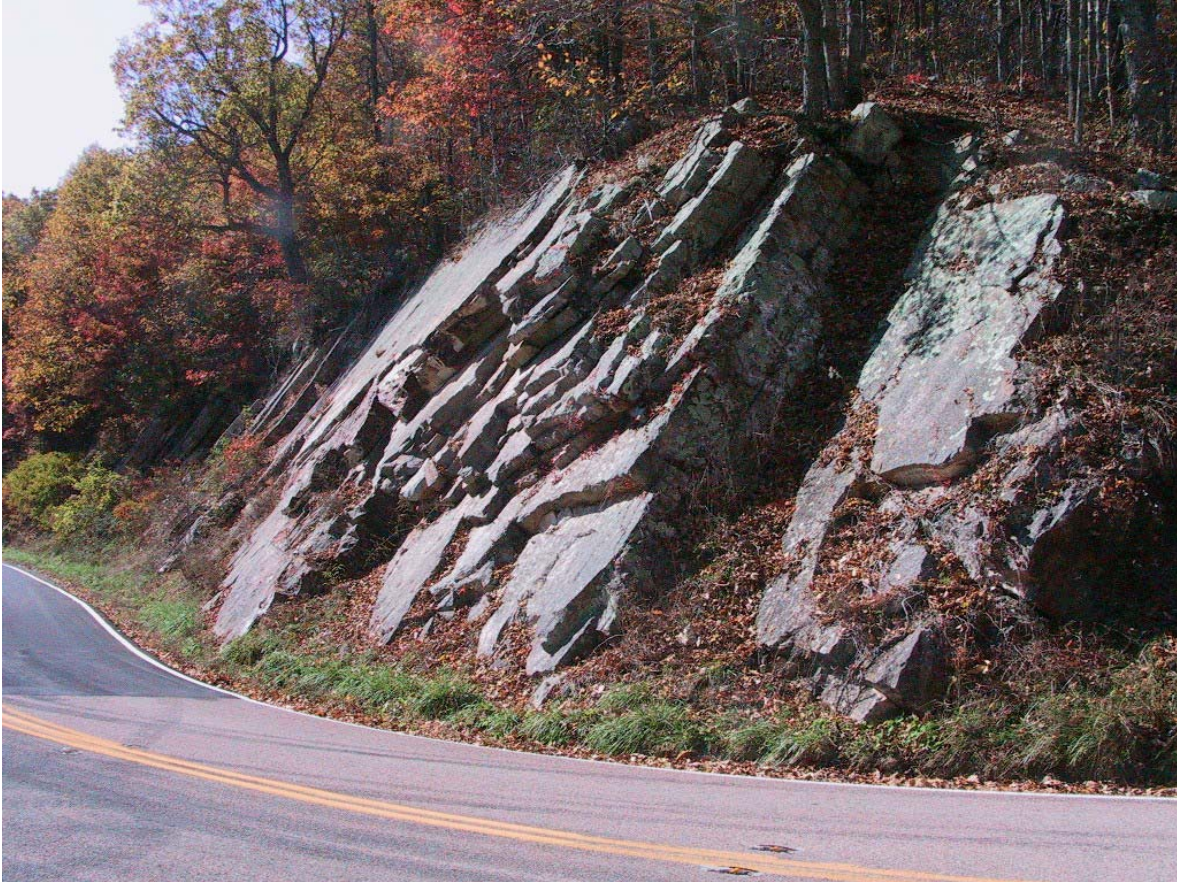
District: Bristol
City / County Code: 092 Route Number: 00016 Side: Left
Starting Latitude and Longitude: 37.040474, -81.518791
RHRS Score: 392

This slope is approximately 250 feet long and up to about 35 feet high. The conceptual design provided by VDOT involved excavating about six feet of rock along the dip slope to create a modest rockfall catchment area, which is a reasonable approach. Due to the occasional nature of rockfall and the steeply dipping planar features, scaling followed by installation of rock bolts to tie the potential rock slabs together and keep them from detaching from the slope would be a less costly option. Assume ten-foot bolts installed on ten-foot centers wherever the rock slabs are not supported at the ditch grade, as in the photo above.
