Report No. VTRC 06-R23	Report Date June 2006	No. Pages 46	Type Report: Final Period Covered: December 2004 – February 2006	Project No.: 75852 Contract No.
Title: Implementation of the Rock Slope Management Project at the Virginia Department of Transportation			Key Words: Rock slope management, rockslide, rockfall, geotechnical asset, asset management, RHRS.	
Authors: Edward J. Hoppe, Ph.D., P.E., and Derek H. Whitehouse, C.P.G.				
Performing Organization Name and Address: Virginia Transportation Research Council 530 Edgemont Road Charlottesville, VA 22903				
Sponsoring Agencies' Name and Address Virginia Department of Transportation 1401 E. Broad Street Richmond, VA 23219				
Supplementary Notes				
<p>Abstract</p> <p>The Virginia Department of Transportation (VDOT) is currently developing an asset management system, identifying various transportation assets for inclusion in the system. Rock slopes along Virginia's highways can be viewed as assets that need to be managed proactively in order to maintain a safe and effective transportation network. The benefits of rock slope management are expected to be similar to those derived from bridge and pavement management systems, includi

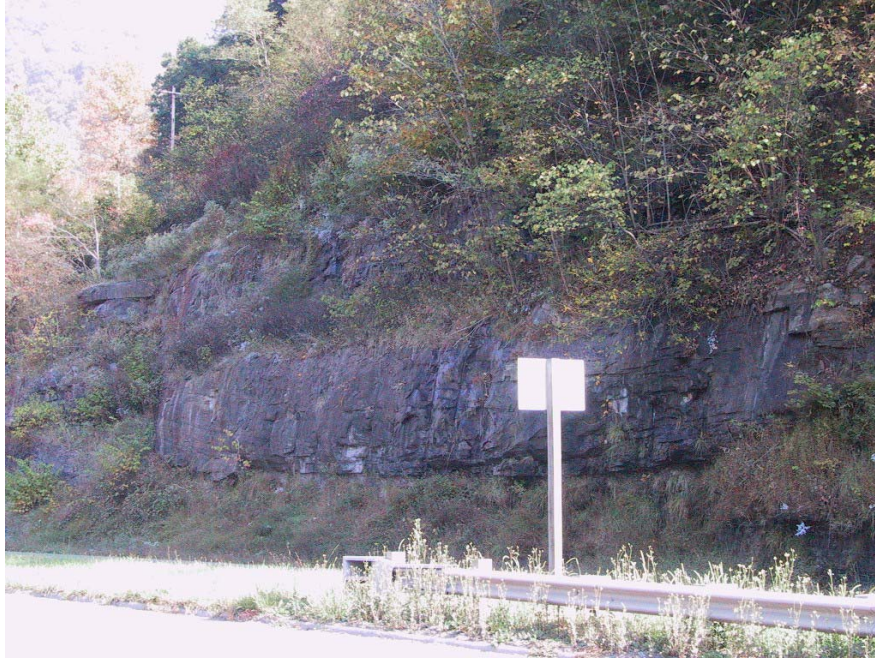
District: Bristol
City / County Code: 013 Route Number: 00460 Side: Left
Starting Latitude and Longitude: 37.214957, -82.006997
RHRS Score: 376

This slope is approximately 680 feet long and up to about 80 feet high. VDOT indicates that the rockfall problem is generated from above the sandstone face. The conceptual design included a draped mesh catch fence installed along the top of the sandstone cut following scaling. This design appears to adequately address the rockfall issues described except that the three-foot maximum block size could overwhelm a mesh catch fence. Consider replacing the gabion mesh with ring or cable nets backed by the gabion mesh to catch smaller rock. To reduce quantities, evaluate draping 20 to 25 feet of cable nets from the top of the posts. The nets would not drape to the ditch. Make sure no launch features are present lower on the slope below the end of the mesh. Construct a reverse shaped ditch and install a concrete barrier at the side of the road for the length of the section.
