Virginia Transportation Research Council

Performance of a Pile-Supported Embankment

1. Report No. FHWA/VTRC 06-R36	2. Government Accession No.	3. Recipient's Catalog No.	
4. Title and Subtitle Performance of a Pile-Supported Embankment		5. Report Date June 2006

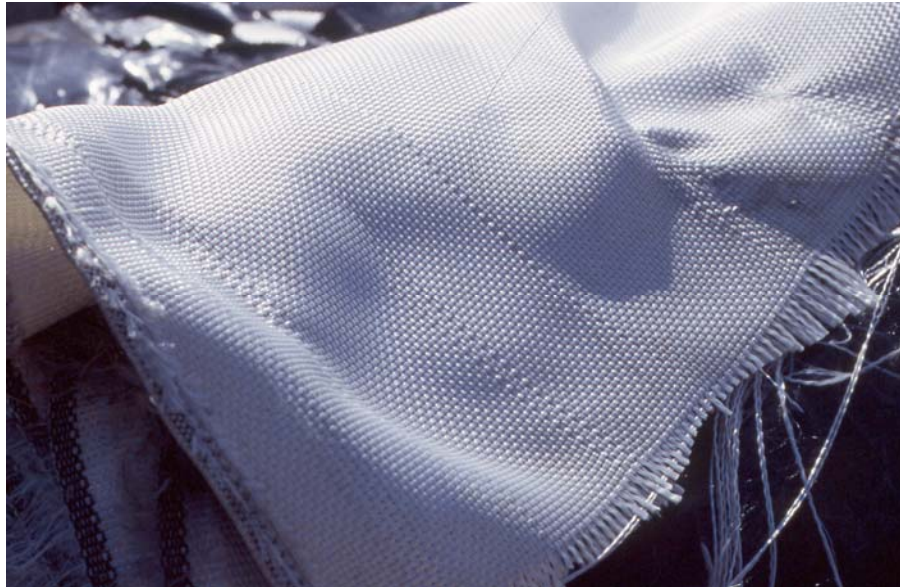
Figure 2. High-Strength Reinforcement Geotextile

The reinforcing fabric design was based on the method recommended in British Standard BS 8006. Four layers of geogrid (the upper two placed only in the side slopes) with a minimum strength of 18.5 kips per ft (270 kN/m) were initially specified for placement over pile caps, with 6 in (0.15 m) of fill separating each layer and pile cap. Ultimately, Huesker Comtrac 200.200 polyester woven geotextile, as shown in Figure 2, was used in construction. Its physical properties are listed in Table 1. Geotechnical estimates indicated a strain of 2 percent or less at all locations in high-strength geotextile materials.²

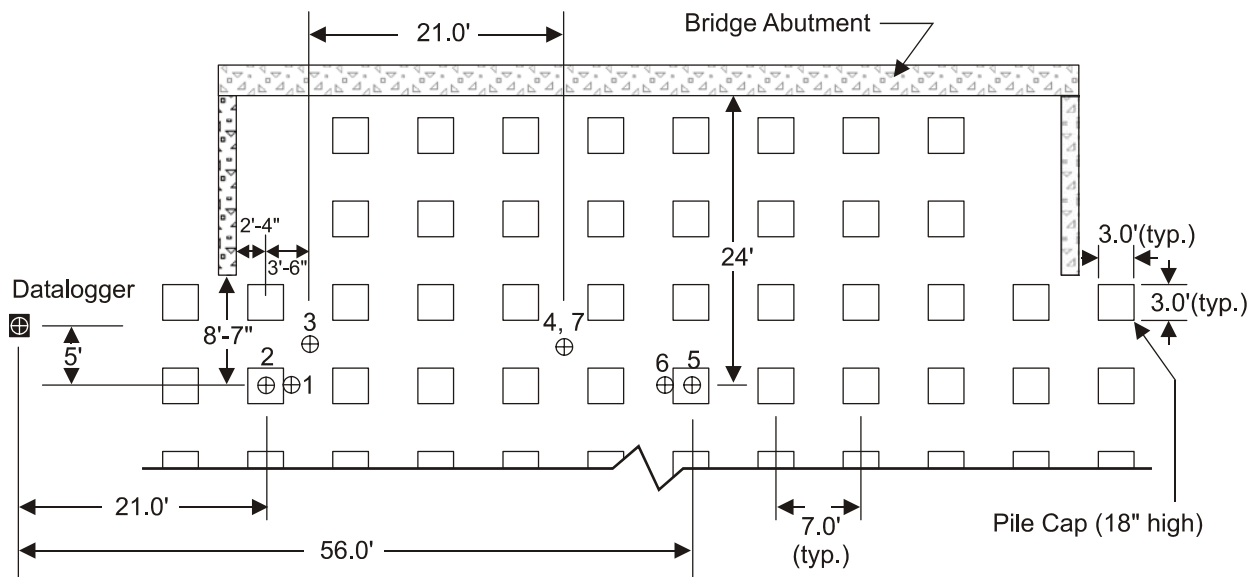
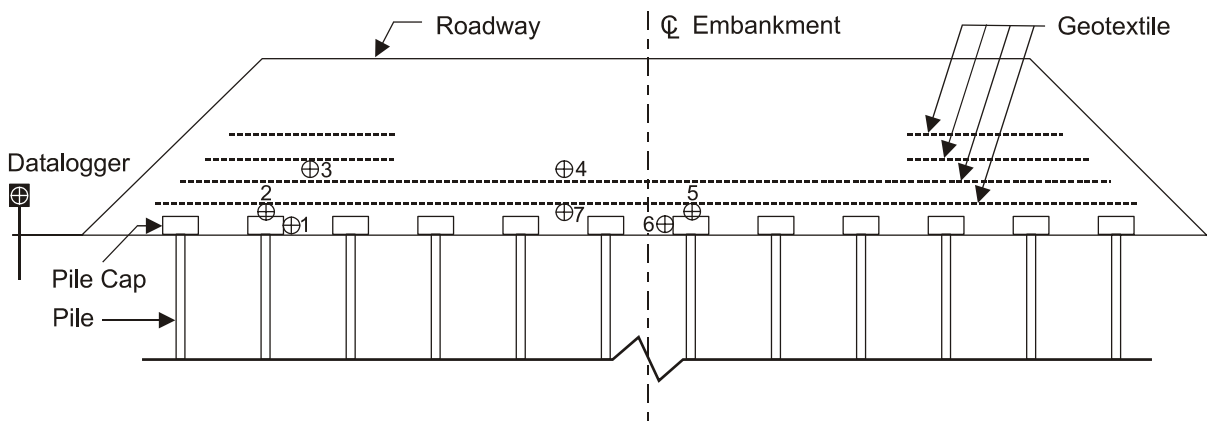
Figure 3. Pile-Supported Embankment Plan and Elevation Views

Plan and elevation views of the pile-supported embankment at the approach to the Mattaponi River Bridge are shown in Figure 3. The height of embankment at that point is approximately 6 ft (1.8 m). The roadway width is 68 ft (21 m). The total length of the pile-supported embankment is approximately 400 ft (120 m).

⊕ - Earth Pressure Sensor

Figure 2 also shows the layout of the field instrumentation implemented in this study. VTRC personnel decided to measure earth pressures at various points in the embankment using seven pressure cells interfaced with an electronic datalogger. Vibrating wire earth pressure cells, Model 4800, manufactured by Geokon were installed as shown in Figure 2. They were connected to the Campbell Scientific CR-10X datalogger, sampling once an hour. Geokon pressure cells were constructed from two circular stainless steel plates, 9 in (230 mm) in diameter, welded along the periphery and separated by a narrow gap filled with hydraulic fluid. A pressure transducer was used to convert fluid pressure into an electrical signal that was subsequently recorded by the datalogger.

Lateral pressure sensors 1 and 6 were installed on the sides of pile caps at the edge of the embankment and at the center, respectively. Pressure sensors 2 and 5 were installed at the corresponding tops of pile caps to measure vertical stresses. Pressure sensors 4 and 7 were installed at the midpoint between pile caps to measure vertical stresses on top and below the geotextile layers, respectively. Pressure sensor 3 was installed at the midpoint area close to the edge of the embankment and at approximately the same level as sensor 4.

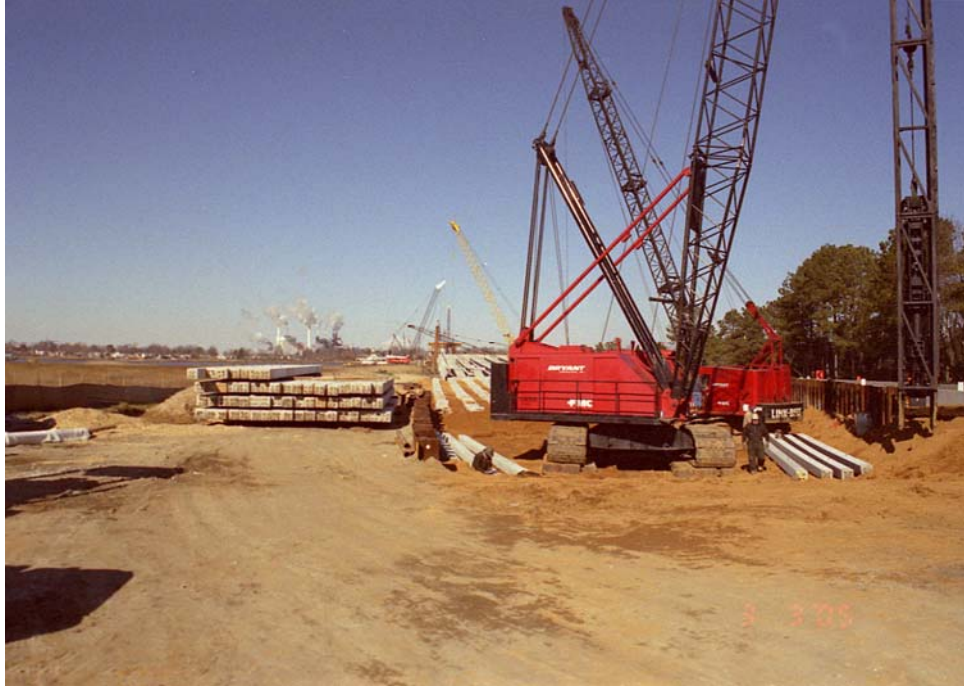
Figure 4. Pile Installation

The embankment design called for square 12 by 12 in (0.31 by 0.31m) precast, prestressed concrete piles, driven at 7 ft (2.1 m) on centers, topped with 36 by 36 by 18 in (0.91 by 0.91 by 0.46 m) pile caps. It was recommended that piles be driven to an allowable capacity of 60 tons. No bitumen coating of piles was specified. Precast concrete pile caps were rested on top of the piles (6 in [0.15 m] recess), without any bonding, because no uplift was anticipated.

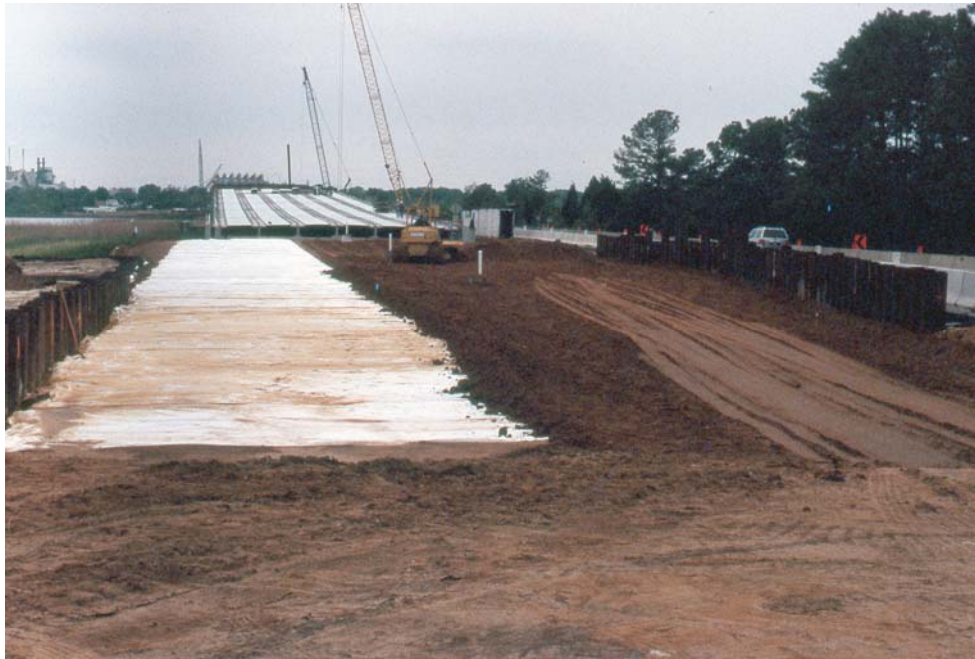
Figure 8. Reinforcing Fabric and Settlement Pipes

In addition to earth pressure cells, one elevation sensor was installed over sensor 4. The purpose of this elevation sensor was to measure differential settlement between the pile cap and the geotextile at the midpoint location. The sensor was constructed using a water-filled polyethylene tubing, 0.25 in (6.3 mm) in diameter, connected to an Omega PX820 pressure transducer. A small air hole was provided at the uppermost part of the tubing loop to allow the gage to register the hydrostatic pressure of the water column. The elevation sensor was calibrated in the laboratory to correlate the pressure of the water column with the elevation change. The transducer (settling part) was attached to a circular aluminum plate 10.5 in (0.267 m) in diameter and 0.125 in (3.2 mm) thick. The elevation sensor was not interfaced with the CR-10X datalogger. It was sampled manually during site visits. The sensor required a battery to supply the excitation voltage and a precision voltmeter to read the output.

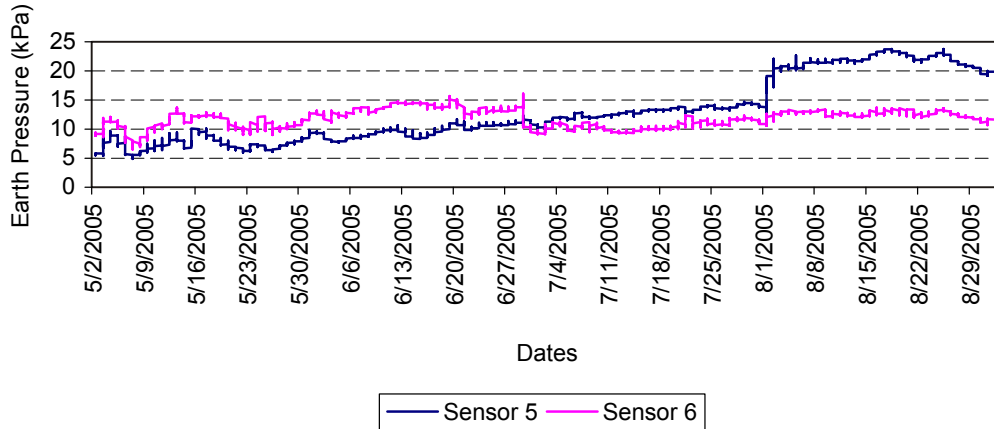
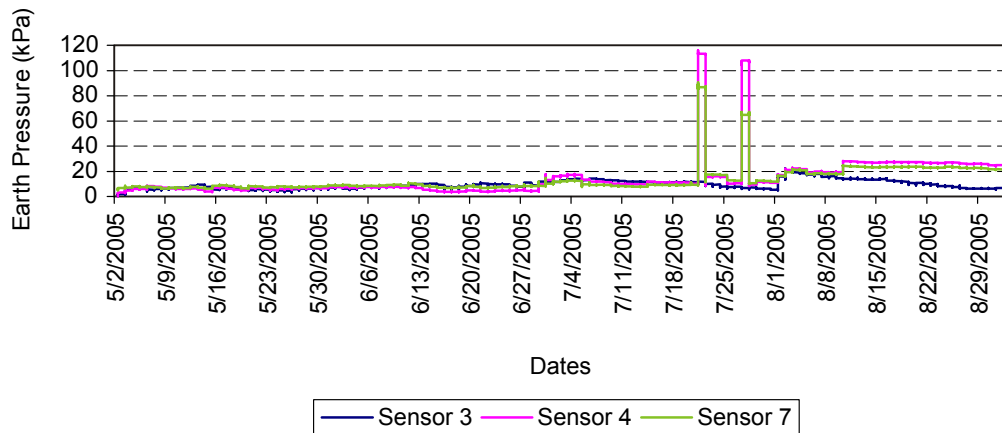
Figure 10. Earth Pressures Recorded from 5/2/05 to 8/31/05

Data collected from earth pressure cells are presented in Figures 10 through 12. The embankment served as an access route for the bridge project, with numerous vehicles and equipment traversing or stationed on top of the embankment. This may explain a number of recorded pressure spikes. Some distinct construction events that correlate with the recorded earth pressure responses were as follows:

- *7/21/2005 to 7/22/2005 and from 7/27/2005 to 7/28/2005.* Large-capacity cranes (120 tons) were stationed in the vicinity of sensors 4 and 7. These cranes were used for the bridge construction.

- *8/2/2005.* Large pile of loose crushed stone (approximately 5 ft [1.5 m] high) was placed in the vicinity of sensors 4, 7, 5, and 6.
- *9/14/2005.* Crushed stone bedding for the approach slab was placed near the bridge backwall.

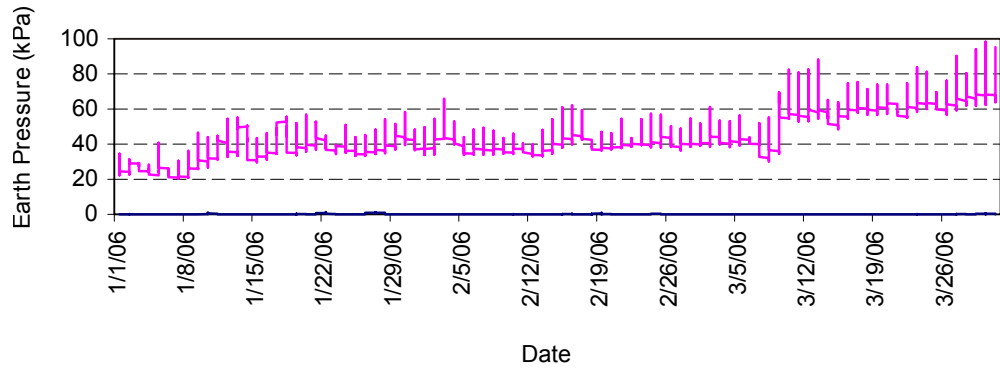
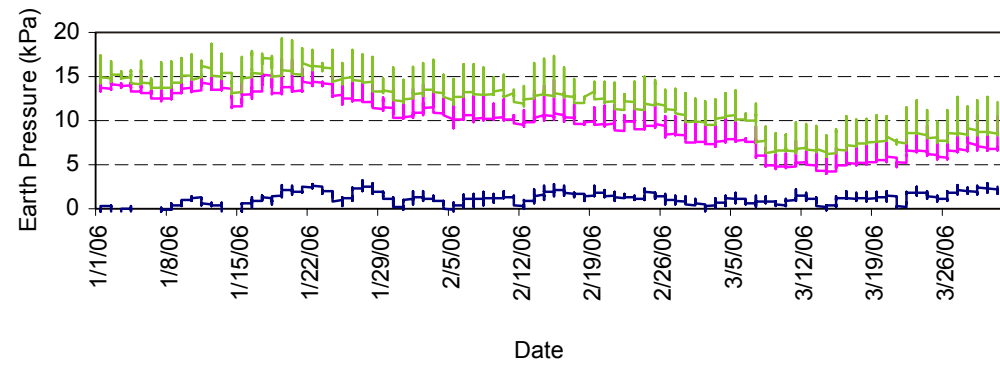
Figure 12. Earth Pressures Recorded from 1/1/06 to 3/31/06

- *10/21/2005.* Approach slab was cast (20 ft [6 m] long, 15 in [0.38 m] high).
- *3/8/2006.* Cement-treated aggregate (CTA) layer (6 in [0.152 m] thick) was placed on the embankment.

- *3/16/2006.* Base (5 in [0.127 m] and intermediate layers (2.5 in [0.064 m] thick) were placed. The remaining 1.5-in (0.381-m) layer of asphalt surface mix is scheduled for July 2006.

Earth pressure data indicate a significant increase in the load transfer to pile caps at the onset of pavement layer construction, which begun on March 8, 2006. At the same time, sensors 4 and 7 (midpoint between caps) registered lower stresses. Figure 15 shows the stress concentration ratio, expressed as the stress applied on top of a pile cap divided by the stress exerted between caps. It can be seen that the stress concentration ratio increases from approximately 1.3 to 9 and then drops off to approximately 7. The stress concentration ratio is an indicator of the effectiveness of the ground improvement scheme. A high ratio means that more load is transferred to the columnar reinforcement, thus reducing the load that needs to be carried by the weak (untreated or unsupported) soil.
