## Forensic Investigation of Brick Paver Crosswalks at Court Square in Charlottesville, Virginia

Report No. VTRC 07-R18	Report Date February 2007	No. Pages 28	Type Report: Final Period Covered: February 2006–December 2006	Project No. 82394
				Contract No.
Title: Forensic Investigation of Brick Paver Crosswalks at Court Square in Charlottesville, Virginia				Key Words: crosswalk, paver, forensic investigation, hot-mix asphalt, portland cement concrete, construction
Authors: Brian K. Diefenderfer and Khaled A. Galal				
Performing Organization Name and Address:  Virginia Transportation Research Council 530 Edgemont Road Charlottesville, VA 22903				
Sponsoring Agency's Name and Address  Virginia Department of Transportation 1401 E. Broad Street Richmond, VA 23219				
Supplementary Notes				
<p>Abstract</p> <p>This report documents the findings of a forensic investigation to determine the causes of premature failures noted in brick paver crosswalks in the Court Square area in Charlottesville, Virginia. Brick paver crosswalks were installed in late November to early December 2004 and began to show signs of permanent deformation within approximately 18 months after installation.</p> <

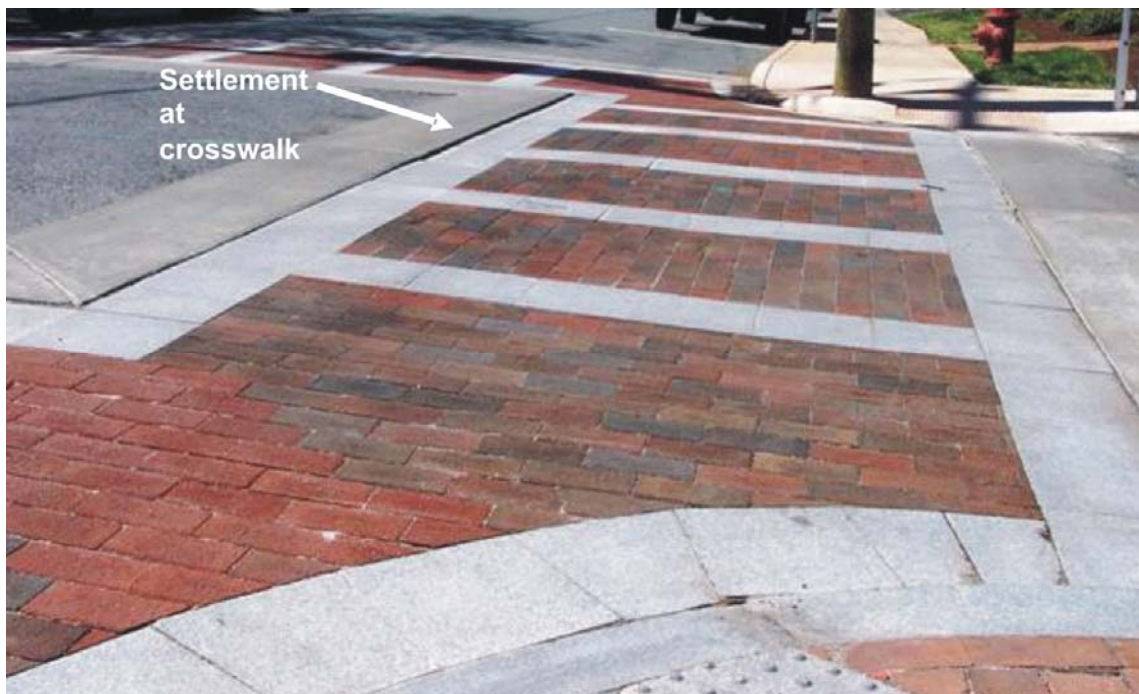
**Figure 1. Example of Paver Crosswalks at Charlottesville's Court Square**

The as-designed crosswalk pavement structure consisted of a 3-inch-thick clay brick paver, a neoprene-modified asphalt adhesive, a 1-inch-thick layer of a surface HMA mixture (VDOT mix SM-1), a 6-inch-thick layer of a base HMA mixture (VDOT mix BM-3), and 10 inches of compacted aggregate (VDOT aggregate designated 21-A), all placed on top of the existing subgrade. Stone dust was used for joint sand (City of Charlottesville, 2002). The gradation specifications for the HMA materials and the aggregate base material, based on the 1993 edition of VDOT's *Road and Bridge Specifications* (VDOT, 1993), are presented in Appendix A, Tables A1 and A2, respectively. The brick pavers were surrounded by granite blocks that were bordered by concrete bulkheads to act as an edge restraint against lateral movement. An example is shown in Figure 1.

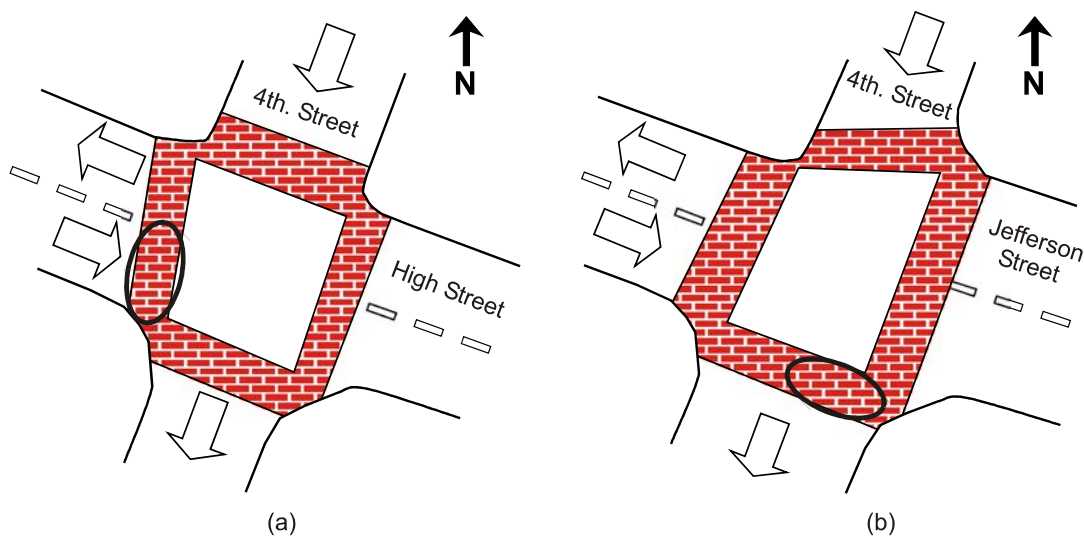
**Figure 2. Location of Field Investigation at (a) 4th and High and (b) 4th and Jefferson. Areas from which specimens were collected are circled.**

The samples obtained from 4th and High were collected from the crosswalk on the west side of the intersection, an area trafficked by eastbound traffic on High Street. An overview of this intersection is presented in Figure 2a. The samples obtained from 4th and Jefferson were collected from the crosswalk on the south side of the intersection, an area trafficked by southbound traffic on 4th Street. An overview of this intersection is presented in Figure 2b. The traffic at both locations travels at low speeds (ranging from stopped to approximately 25 mph). Although no traffic records were available for 4th Street or Jefferson Street, High Street carries approximately 14,000 vehicles per day with approximately 3% trucks (VDOT, 2004) and is used as a major east-west thoroughfare by all vehicle types. An estimated equivalent single-axle load (ESAL) count of 153,720 per year was calculated. Although exact traffic counts were not available for 4th and Jefferson, based on visual observation, the daily traffic volume at 4th and High far exceeds the daily traffic volume at 4th and Jefferson.

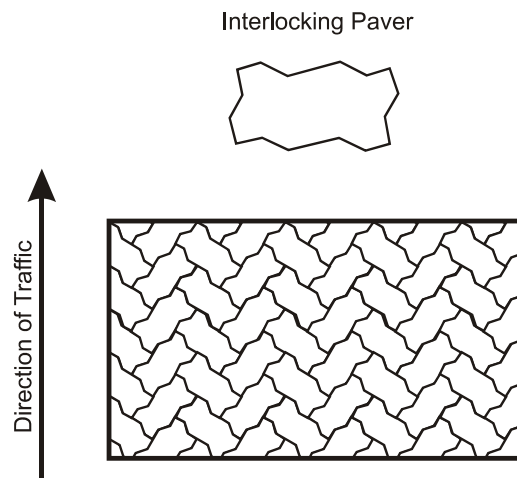
Figure 3. Example of an Individual Interlocking Paver and Its Use in a Pavement Surface

rotation and lateral displacement if an interlocking paver is used. Figure 3 shows an example of an individual interlocking paver and its use as a pavement surface. The ICPI recommends a paver thickness of 3 1/8 inches (80 mm) for pavers exposed to vehicular traffic (ICPI, 1995b).

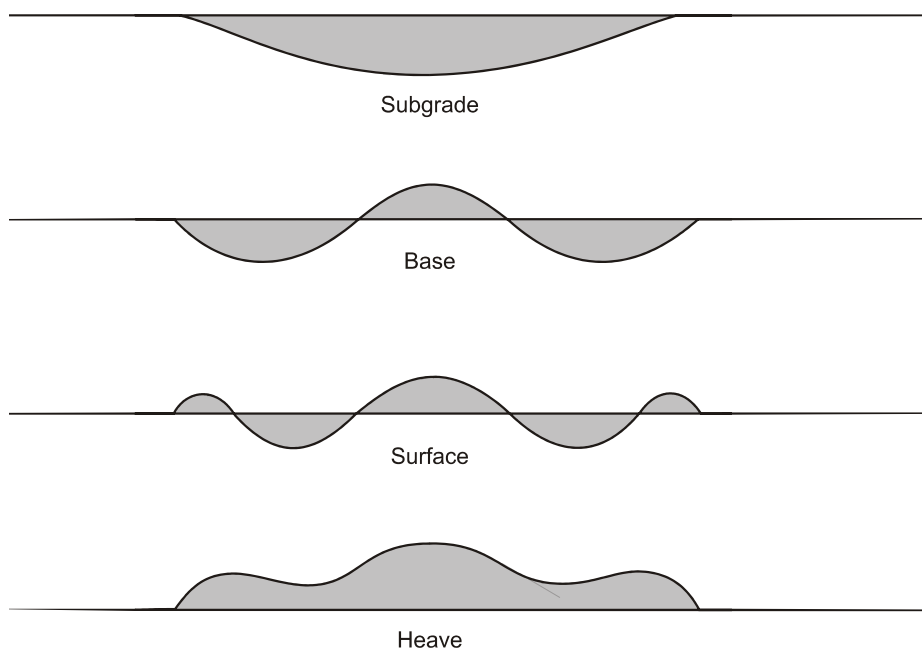
Figure 5. Transverse Profiles Showing Four Types of Permanent Deformation (after White et al., 2002)

Examples of typical permanent deformation types including unbound material (subgrade) rut failure are shown in Figure 5. White et al. (2002) investigated in-service pavements and summarized work on the contribution of various layers in a flexible pavement to permanent deformation. The authors investigated many rutted flexible pavements and sought to determine if it was possible to relate the transverse surface profile with permanent deformation in specific layers. They found that permanent deformation is caused by a combination of material densification and shear-related deformation. These mechanisms may occur in any of the

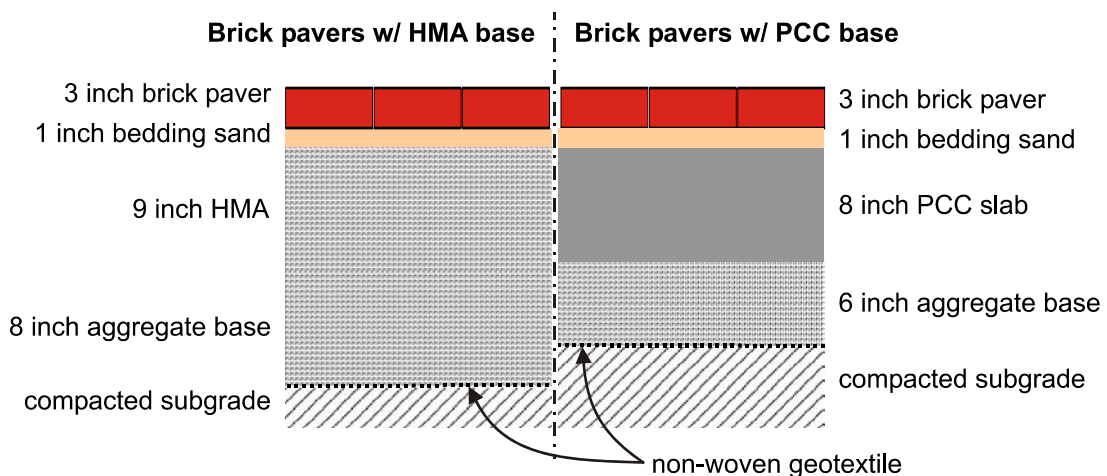
The design with an HMA base consists of a 3-inch brick-style paver, a 1-inch layer of bedding sand, 9 inches of HMA, and 8 inches of crushed aggregate (may be treated with cement or asphalt). If desired, the upper 12 inches of the subgrade may be treated with either lime or cement if the subgrade is in poor condition. The design with a PCC base consists of a 3-inch brick-style paver, a 1-inch layer of bedding sand, an 8-inch PCC slab, and 6 inches of crushed aggregate. Both designs include placing a layer of non-woven geosynthetic fabric between the crushed aggregate and the subgrade.

**Figure 6. Schematic of Proposed Replacement Crosswalk Design Using Both an HMA and a PCC Base**

proposed designs are based on traffic levels for the expected traffic conditions at this location and a design life of 20 years. A schematic of these designs is shown in Figure 6.

The bedding sand should be placed at a 1-inch thickness and vibrated in place using a plate-type vibrator. If necessary, additional sand should be placed following vibration such that the final thickness of the bedding sand is 1 inch. If confinement of the bedding sand is a concern, a non-woven geosynthetic material can be placed on top either the HMA surface layer or the PCC slab and wrapped up the sides of the excavated area to help ensure that the bedding sand remains confined throughout the life of the crosswalk. The apparent opening size of the geosynthetic must be specified to ensure that loss of the bedding sand does not occur.

VDOT Class A3 or A4 concrete would be suitable for the crosswalk design using the PCC base. The PCC option may be suitable if underground utilities are located close to the surface where a heavy roller to compact the HMA might pose concerns. Another design option, the use of cast-in-place stamped concrete, may be considered for use in areas of high traffic volumes. A typical design may consist of 8 to 10 inches of tinted concrete using concrete (having a 28-day compressive strength between 3,000 and 4,000 psi) that may be reinforced if desired. Details of a similar crosswalk are described in the following section.

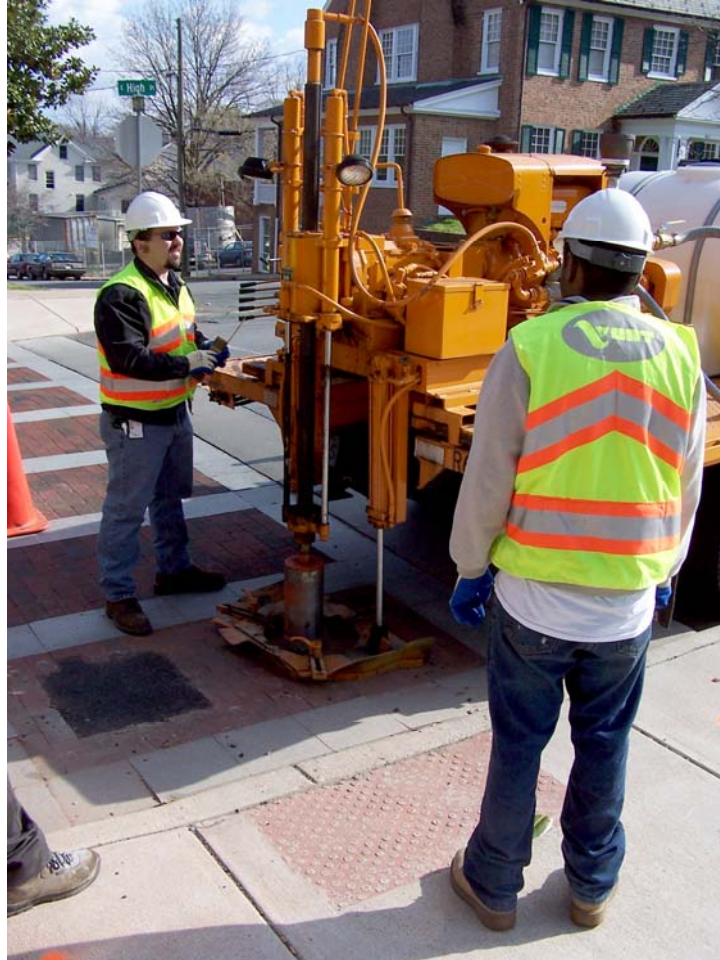
**Figure B1. Specimen Collection by Coring at Intersection of 4th Street and High Street**

The cored HMA samples were tested to determine their bulk specific gravity, air void and asphalt binder content, and gradation. An example of the coring process at 4th and High is shown in Figure B1, Appendix B. The loose aggregate and subgrade samples were tested to determine their gradation, in-situ moisture content, and Atterburg limits. Knowing these properties is critical to establish a range of the moduli of the in-situ materials. The brick crosswalk responses (stresses, strains, and deflection) can be estimated and used to determine the failure mechanism(s). Samples from the aggregate base and subgrade were collected by a dry process and immediately placed into plastic specimen bags that were then sealed. An example of the collection of the aggregate base at 4th and High is shown in Figure B2, Appendix B.

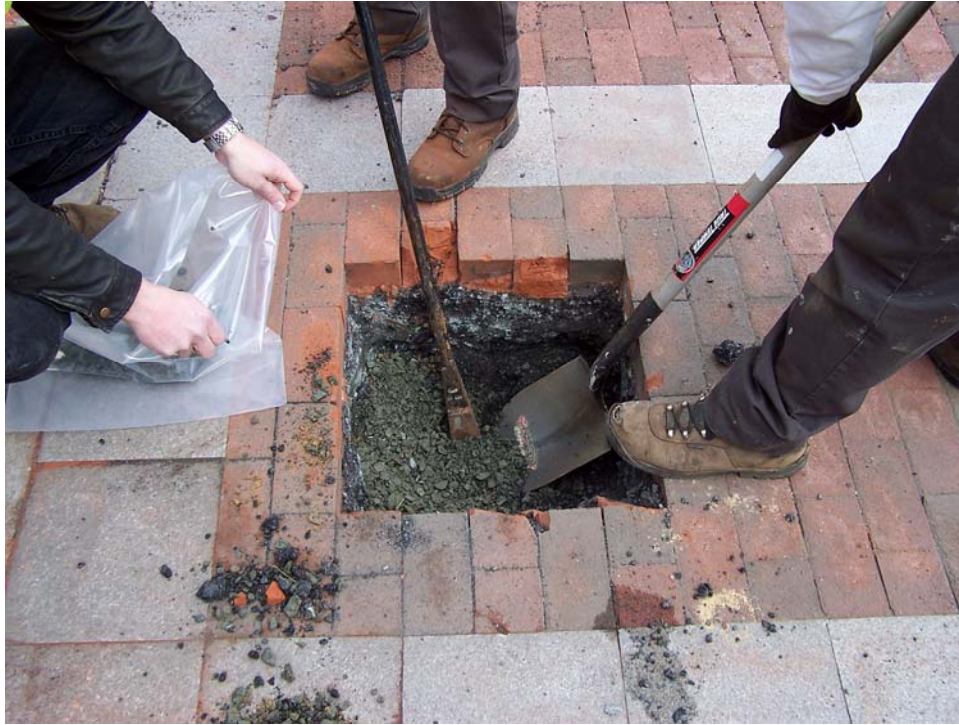
**Figure B2. Specimen Collection of Aggregate Base at Intersection of 4th Street and High Street**

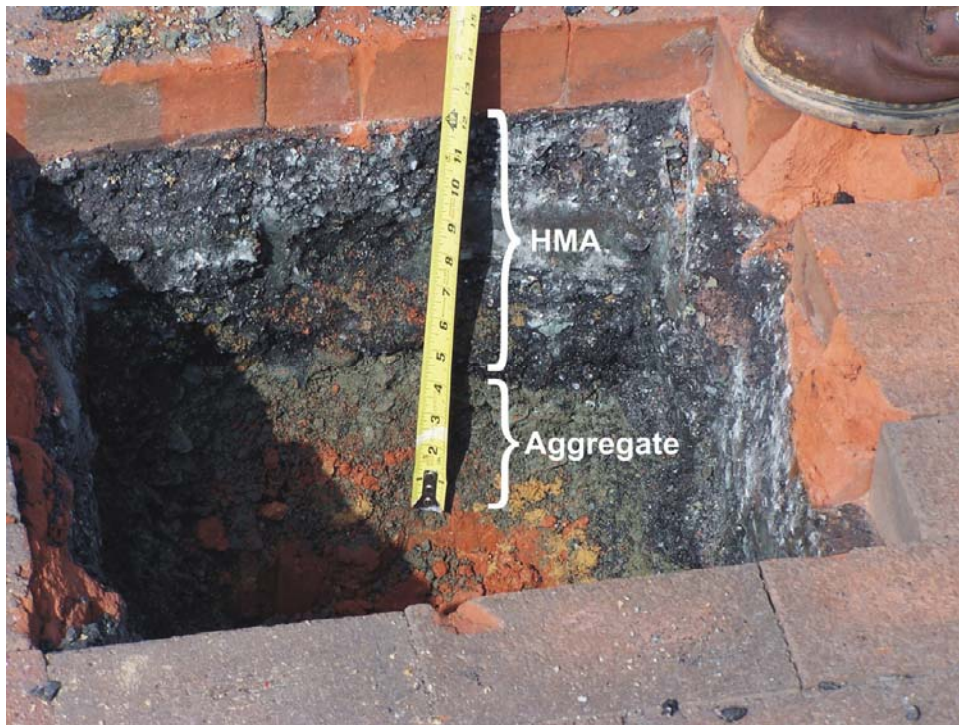
A visual example of a non-uniform pavement layer thickness is shown in Figure B3, Appendix B. This photograph shows the excavation process at 4th and High. The thickness of the 21-A aggregate base material is shown to be approximately 5 inches at this location. In the other locations for sampling, the layer thickness was approximately 8 to 9 inches. Another example includes two cores collected at 4th and Jefferson. Figure B4, Appendix B, shows Specimens 6 (top of the figure) and 8 (bottom of the figure), which were collected approximately 24 to 30 inches apart. It can be seen that Specimen 6 contains some larger diameter aggregate particles in the bottom half of the core (left-hand side of the core). However, Specimen 8 appears to contain only smaller diameter particles. In addition, the HMA material in Specimen 6 is nearly 1.5 inches longer than in Specimen 8. These two observations would indicate that the pavement performance and the ability to which compaction was achieved could be vastly different for these two locations. The difference in thickness of the HMA portions of the core may also indicate poor grade control at the surface of the 21-A aggregate base layer (although this could be the result of underground obstructions, such as utilities, that are unknown to the authors).

**Figure B3. Measurement of HMA and 21-A Aggregate Base Layer at Intersection of 4th Street and High Street (approximately 7 and 5 inches, respectively)**

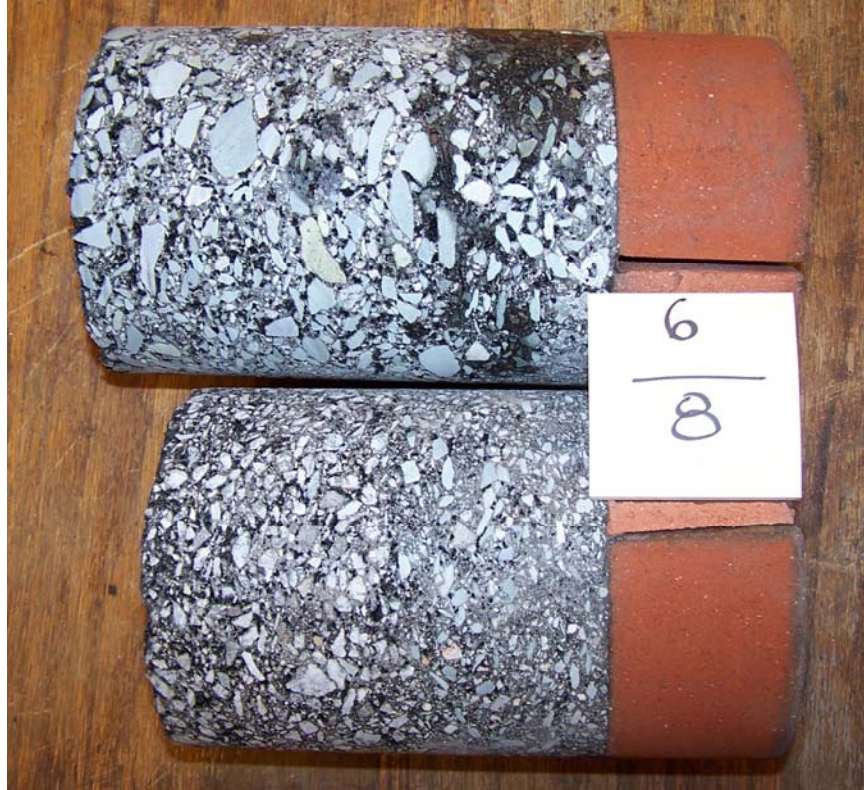
**Figure B4. Example of Non-Uniformity in Particle Size Distribution and HMA Layer Thickness (specimens collected at intersection of 4th Street and Jefferson Street)**
