# Evaluation of a Rectangular Rapid Flashing Beacon System at the Belmont Ridge Road and W&OD Trail Mid-Block Crosswalk

**LANCE E. DOUGALD**  
Research Scientist

Final Report VCTIR 15-R22

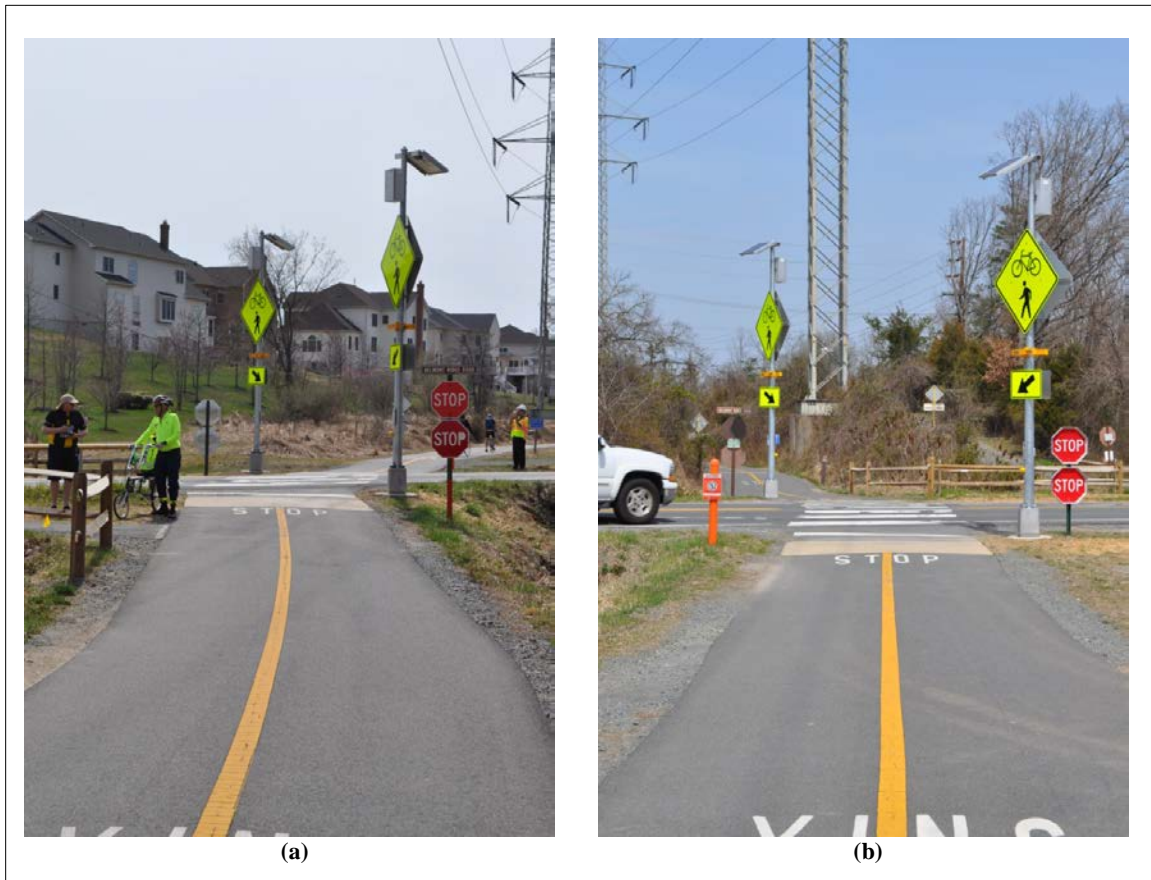
Figure 2. Eastbound Approach (a) and Westbound Approach (b) of W&OD Trail at Belmont Ridge Road

The trail, which runs east/west in relation to Belmont Ridge Road, has yellow skip lines that run down the centerline of the trail. As the trail approaches the road crossing in both directions, the skip lines become solid lines. In addition to the centerline, other pavement markings on both approaches of the trail include advance rumble strips, stencils of “ROAD XING” and “STOP,” and a STOP bar. Signage on the trail includes an advance STOP warning sign with a placard stating “CAUTION HIGH SPEED HIGH VOLUME TRAFFIC CROSSING AHEAD” and double-mounted STOP signs at the crossing. A high-visibility zebra crosswalk exists where the trail crosses Belmont Ridge Road. Figure 2 shows the eastbound and westbound approaches of the W&OD Trail.

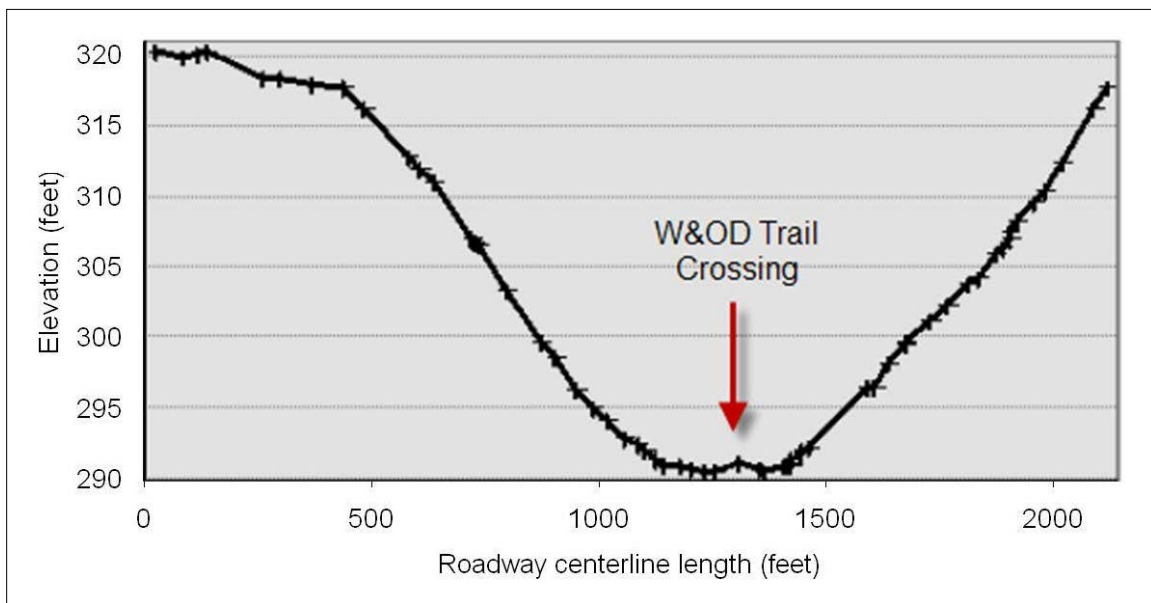
**Figure 3. Road Profile of Belmont Ridge Road in Relation to W&OD Trail Crossing**

The geometry of Belmont Ridge Road consists of downhill grades on both north and south approaches to the crossing. Figure 3 shows the road profile in relation to the W&OD Trail crossing. The sight distance of the W&OD Trail crosswalk on the northbound and southbound approaches is approximately 660 and 1,750 feet, respectively. The northbound approach has a horizontal curve that decreases the viewing distance of the crossing, as opposed to the southbound approach, which has a relatively straight line of sight to the crossing.

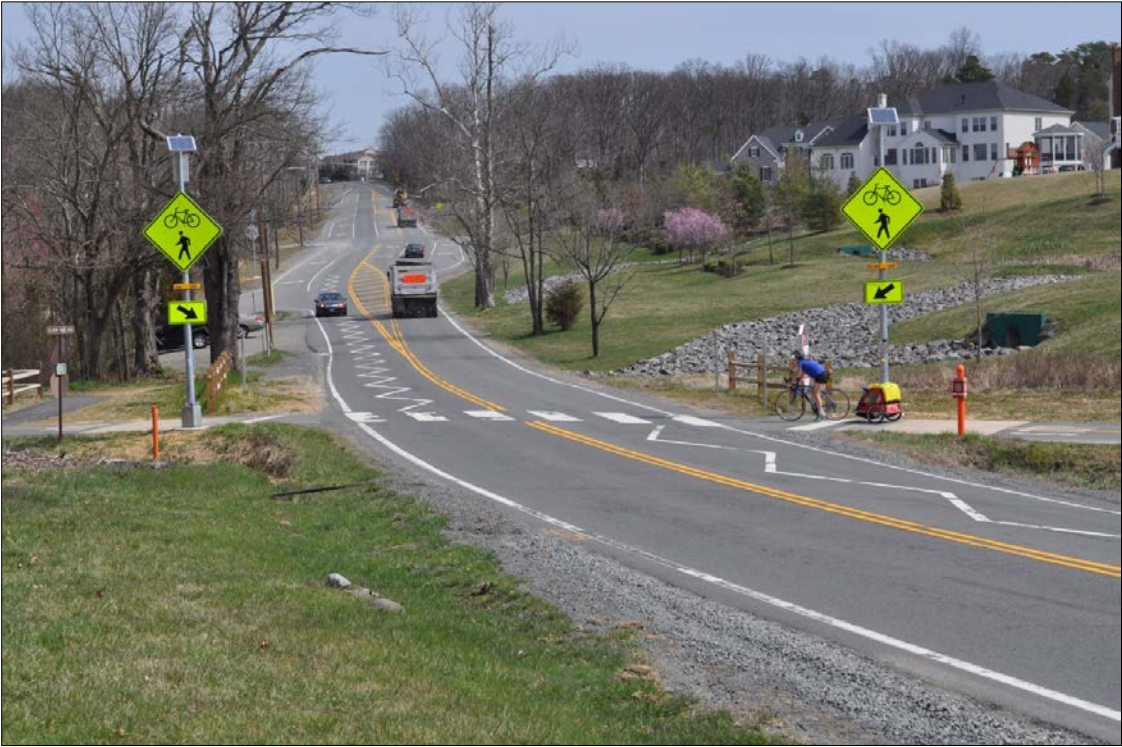
Figure 5. RRFBS and Signage at W&OD Trail Crossing

The RRFB system includes two poles located on the east and west side of Belmont Ridge Road at the intersection with the W&OD Trail crosswalk (see Figure 5) and two poles in advance of the crossing located 553 and 520 feet from the crosswalk in the northbound and southbound travel directions, respectively. At the crosswalk, each pole is mounted with double-sided W11-15 fluorescent yellow-green bicycle/pedestrian signs; W16-7P arrow signs; and high performance SB345 RRFBs. In addition, each pole has an SC315 network controller, a solar

panel to power the network controller for wireless transmission to RRFBS on the upstream poles, and a pressure activated push button that is compliant with the Americans with Disabilities Act (ADA) and MUTCD. Above the push button is an R10-25 push button sign (see Figure 6).

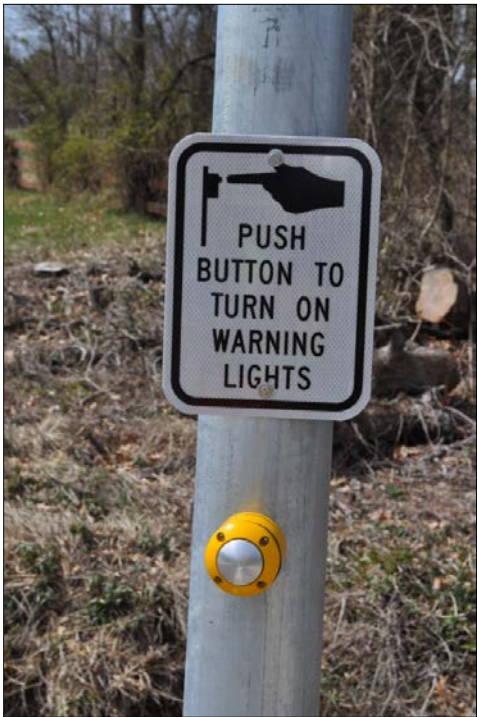
Figure 6. RRFB Push Button and Sign

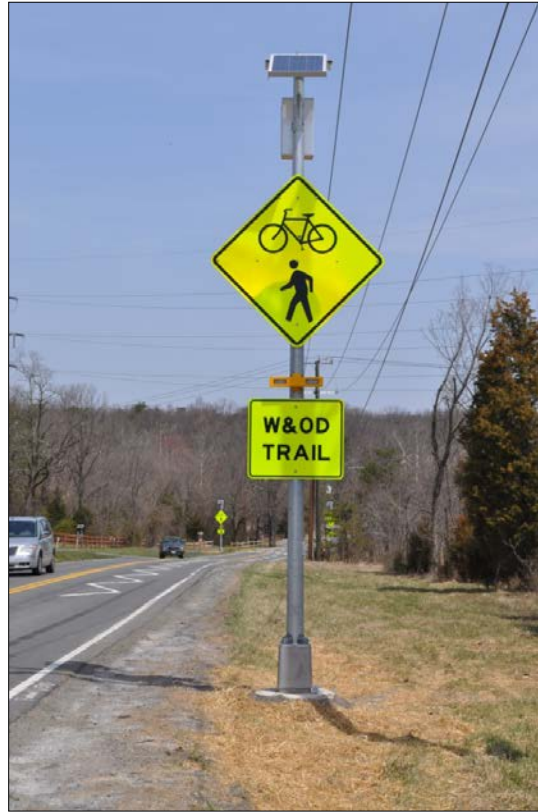
**Figure 7. Advance Warning RRFB and Signage on Northbound Approach of Belmont Ridge Road**

The upstream poles are mounted with W11-15 fluorescent yellow-green bicycle/pedestrian signs, W&OD TRAIL placards, and high performance SB345 RRFBs. Similar to the poles at the crossing, each upstream unit has an SC315 network controller and a solar panel to power the network controller for wireless communication transmission from the units at the crossing. Figure 7 shows the advance warning device on the northbound approach. A schematic of all the units on Belmont Ridge Road is shown in Appendix C.

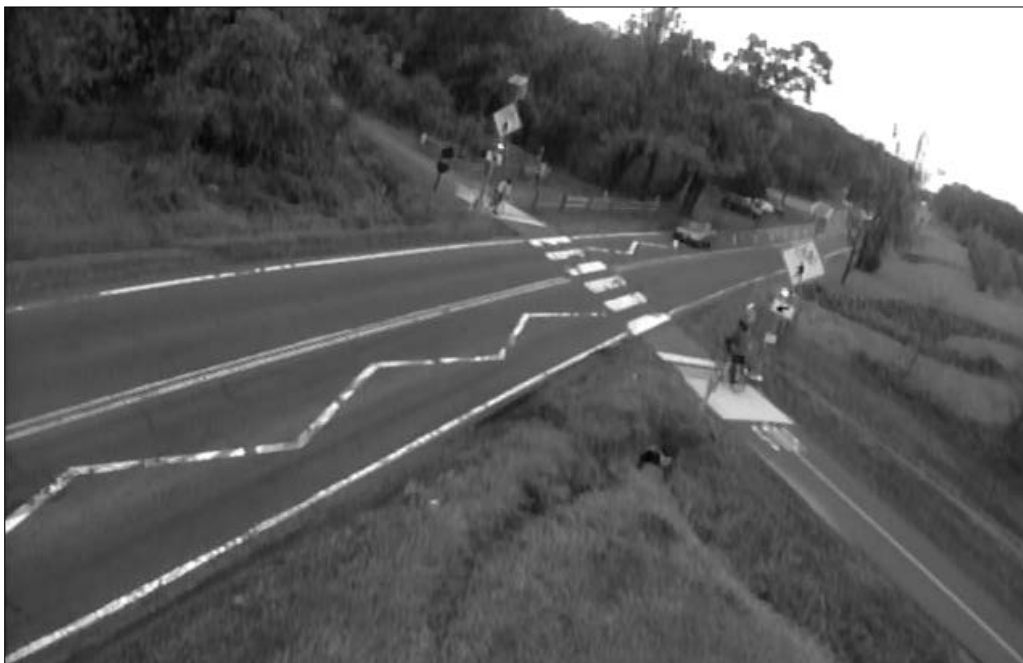
**Figure 8. Camera View of Intersection of Belmont Ridge Road and W&OD Trail**

With the assistance of VDOT’s on-call contractor, trail and roadway activity on each approach was analyzed via inconspicuously mounted cameras 3 weeks, 5 months, and 1 year after installation of the RRFB system. A black and white camera was elevated on a tripod with a 10-foot pole and placed approximately 150 feet south of the trail on the east side of Belmont Ridge Road. The height of the camera allowed for viewing the RRFBs and all four approaches of the intersection of the W&OD Trail and Belmont Ridge Road. Figure 8 shows the camera view of the intersection. The camera is attached by a cable to two self-contained digital video recorders (DVRs) in a waterproof case and a battery providing 120 hours of continuous recording. SD cards were inserted in the DVR as the recording media for the video.

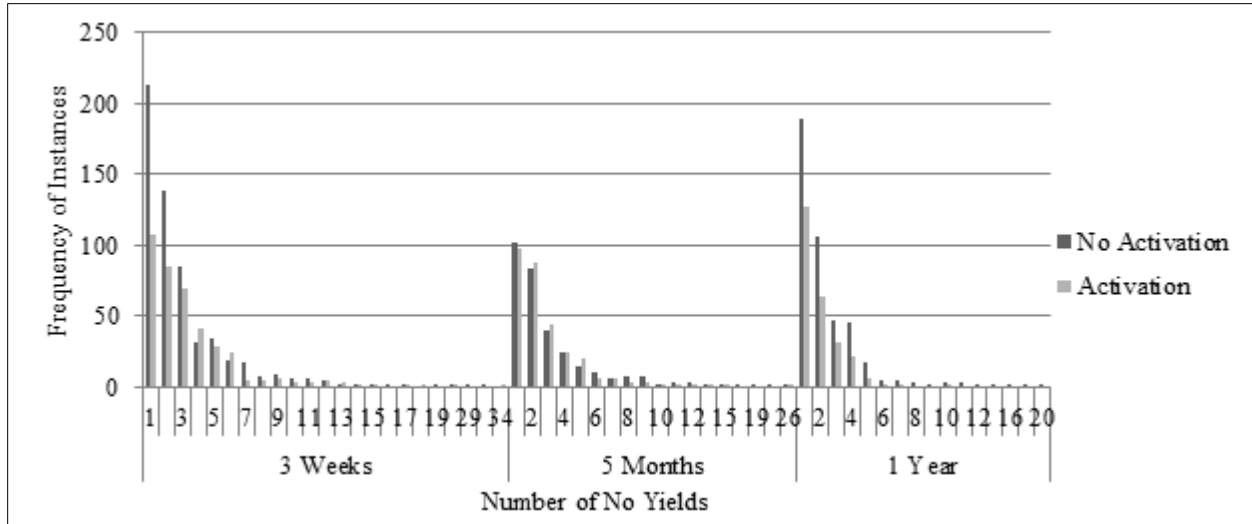
**Figure 11. Frequency of Number of No Yields When Flashers Were Activated Versus Not Activated**

Video and on-site observations showed that leading motorists can have an influence on the behavior of trailing motorists especially if the vehicles are in close proximity to each other. For example, in situations where there was a platoon of vehicles progressing toward the crosswalk, there may have been a very low yield rate whether or not the flashers were activated. To analyze the effect of flasher activation versus non-activation on vehicle platoons, Figure 11 shows the frequency of the number of “no yields” when flashers were activated versus not activated for all crossing modes combined. For each grouping of “number of no yields” in the 1-year after period, the frequency of instances of no yields without flasher activation was greater than the frequency with activation.

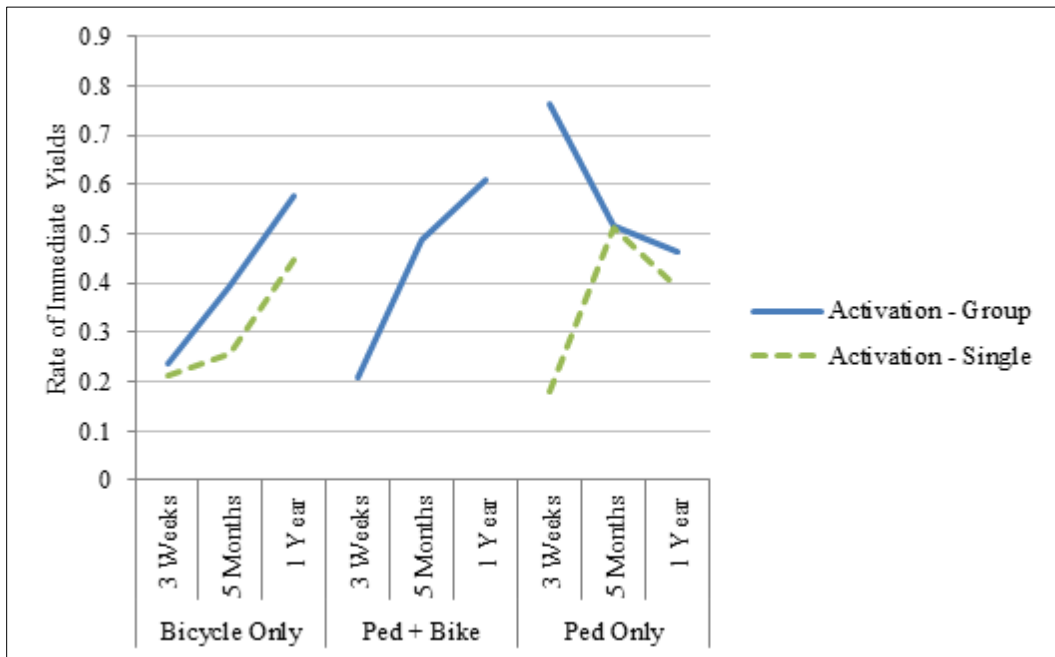
Figure 14. Rate of Immediate Yields With Activation for Groups and Single Crossers

Additional analyses were performed that compared the effect that groups of crossers had on immediate yields versus single crossers both with and without activating the RRFB system. Figures 13 and 14 show the no activation and activation cases, respectively. A comparison of the two figures shows that except for the 3-week after period, the immediate yield rates with activation for both groups and single crossings remained consistently higher than the immediate yield rates with no activation. Further, and as expected, groups of crossers tended to influence motorist behavior more than single crossers whether or not the flashers were activated. It is interesting to note that from the 3-week to 1-year period, groups of crossers in the Bicycle Only and Ped + Bicycles modes had steep increases in the immediate yield rate when the flashers were activated (0.24 to 0.58 percent and 0.21 to 0.61 percent, respectively), whereas the Ped Only mode had a steep decrease in immediate yield rate over time (0.76 to 0.47 percent).

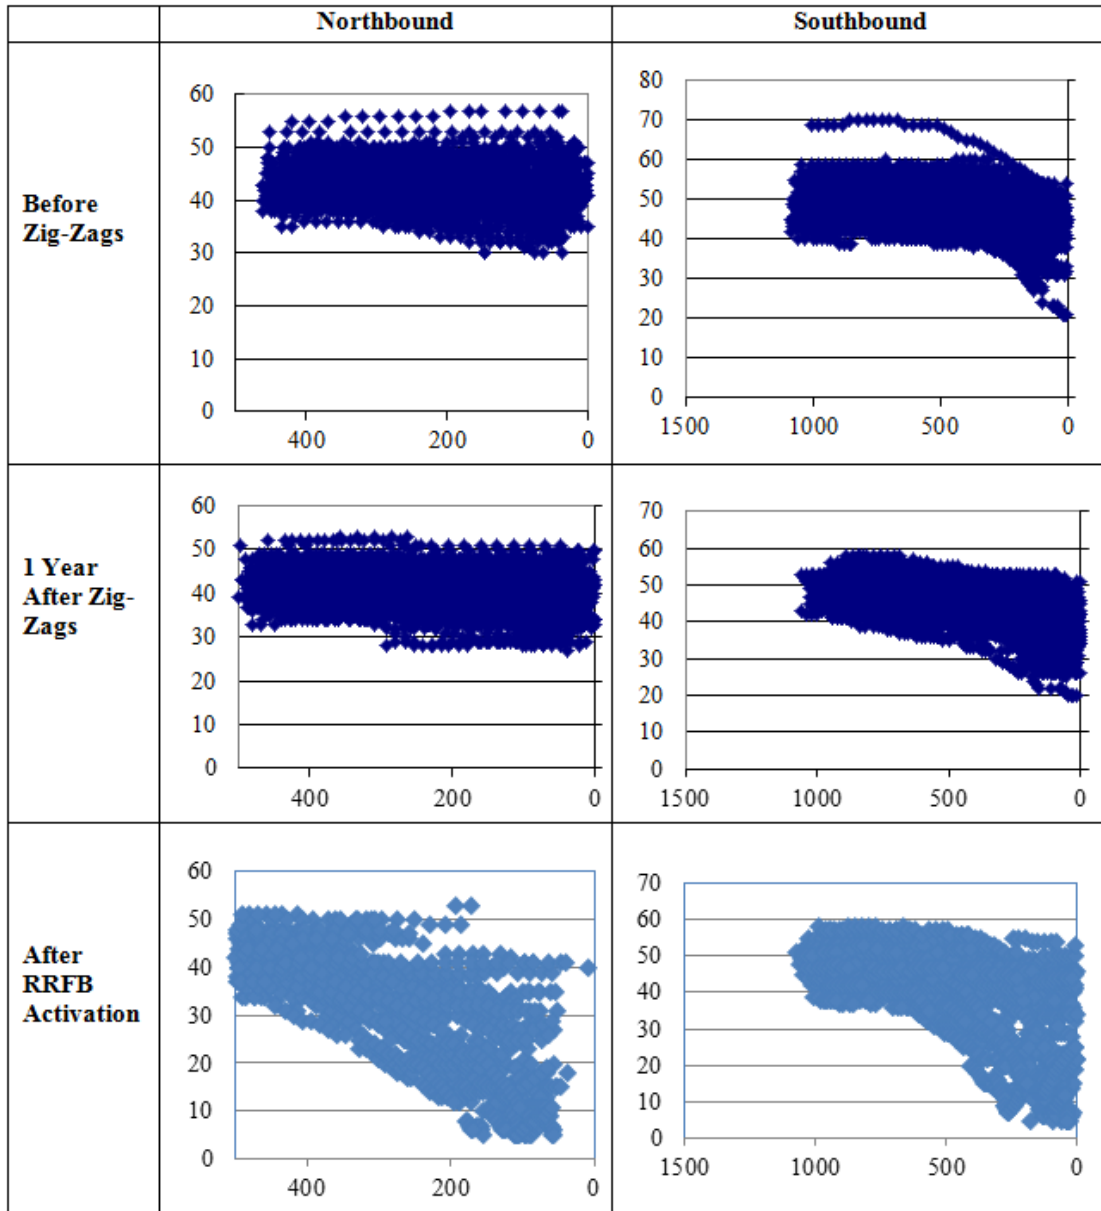
Figure 15. Scatter Plot of Speed Data Points

To obtain more information on motorist behavior and reaction when the RRFBs were activated, vehicle speeds were obtained by an observer using a LIDAR gun as vehicles progressed toward the crosswalk in both the northbound and southbound travel directions on Belmont Ridge Road. Speed data were recorded as a text file and exported to an Excel spreadsheet. Figure 15 shows a scatter plot comparison of individual data points (speed and range) for all vehicles tracked before the zig-zag markings were installed, 1 year after zig-zag

installation, and after RRFB activation. The y-axis on each embedded scatter plot is speed in miles per hour and the x-axis is the distance in feet from the crossing. As can be seen from the scatter plots, RRFB activations had a much larger effect on motorists' speed as they approached the crosswalk. It should be noted that the number of individual speed data points was much lower in the "RRFB activation" period because of the high number of yielding events that occurred when the system was activated. As previously discussed, the intent was to capture vehicle speeds as motorists progressed through the crosswalk. Therefore, data points were excluded when there were yielding events. Because of the higher yield rates, the sampling of valid data points was lower.

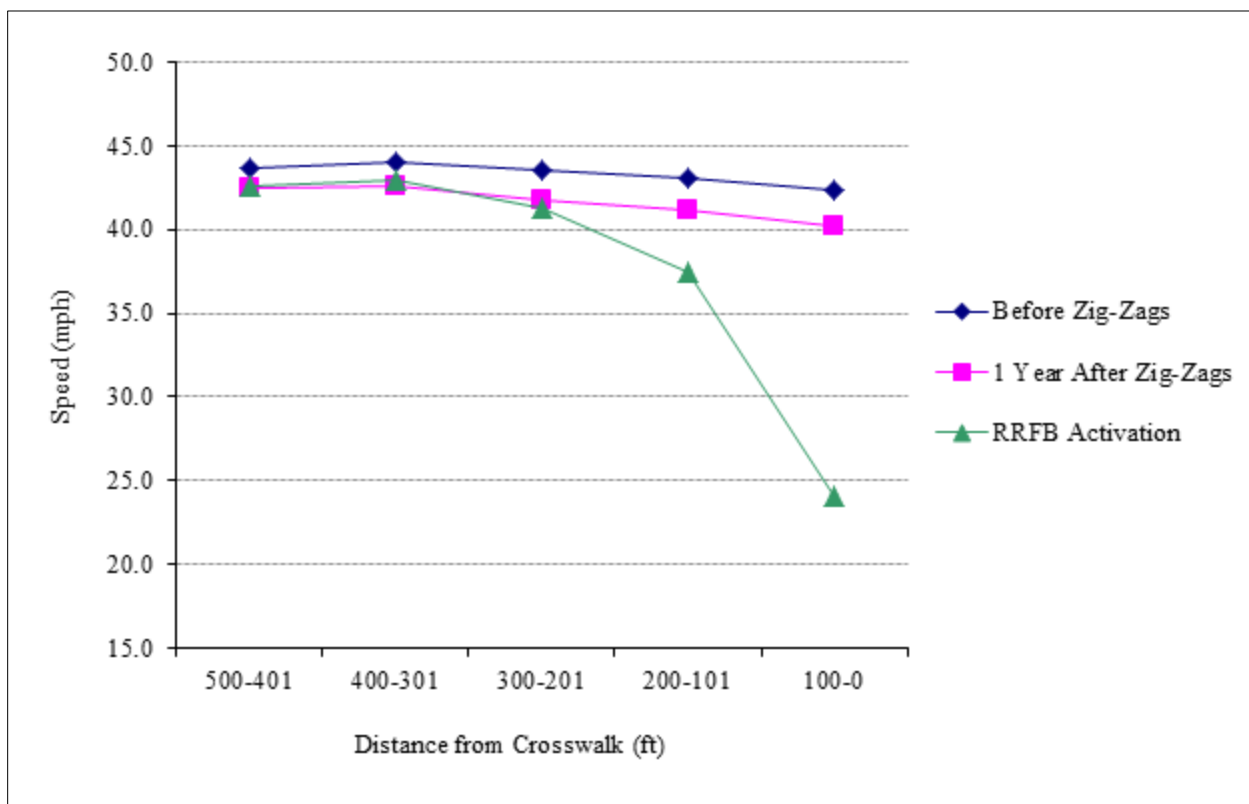
Figure 16. Mean Speed Profiles From LIDAR Data on Northbound Approach of Belmont Ridge Road

Speed profiles obtained from the LIDAR data for the northbound approach on Belmont Ridge Road are shown in Figure 16. The figure shows that when the RRFB was activated, mean speeds from 500 to 300 feet were not much different than in the before and 1-year after zig-zag installation periods. However, as motorists neared the crossing location at 200 feet to the crosswalk, mean speeds dropped a statistically significant amount compared to the before and 1-year after zig-zag installation periods.

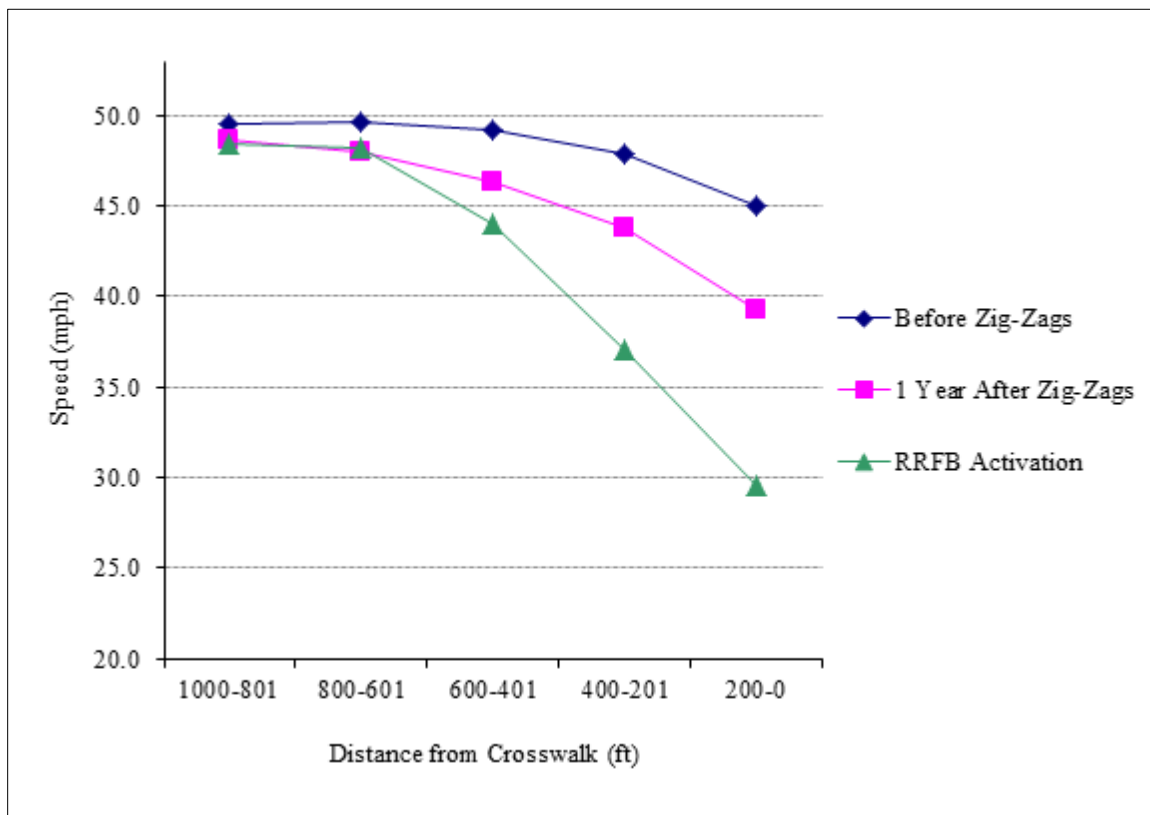
**Figure 17. Mean Speed Profiles From LIDAR Data on Southbound Approach of Belmont Ridge Road**

For the southbound approach, mean speed profiles are shown in Figure 17. As was the case with the northbound approach, RRFB activations resulted in significant decreases in mean speeds as motorists approached the crossing location. Mean speeds in all three scenarios were statistically different from each other in the 400 to 201 and 200 to 0 distance bins.
