Virginia's First Corrosion-Resistant ASTM A1010 Steel Plate Girder Bridge

STEPHEN R. SHARP, Ph.D., P.E.
Senior Research Scientist
Virginia Transportation Research Council

Final Report VTRC 20-R10

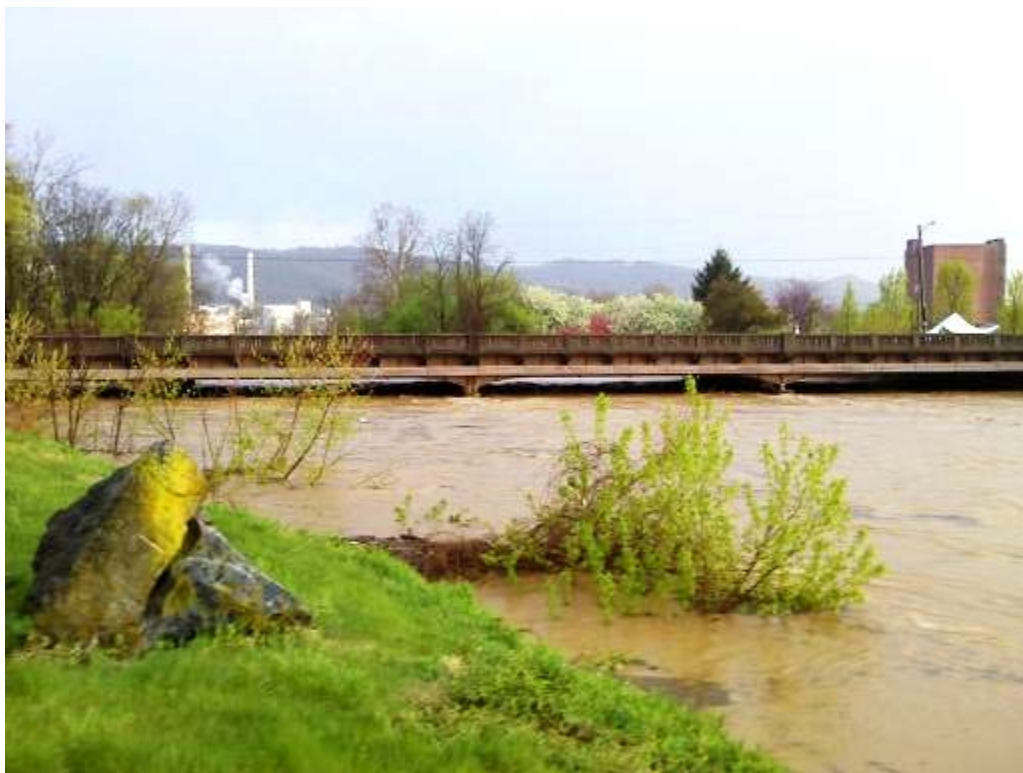
Figure 1. Photograph of Original Route 340 Bridge With High Water and Chemical Plant in Background

The original Route 340 Bridge, located in Waynesboro, Virginia, and built in 1934 with steel girders, had undergone significant corrosion and deterioration such that the bridge was posted for a weight limit of 15 tons. Originally, uncoated weathering steel was considered for the replacement bridge girders but was not selected because of two conditions of the bridge environment. First, the bridge was located downstream of a chemical plant. Second, the bridge had a low water clearance; the low chord of the bridge was typically about 9 ft above the South River and would be reached by water during a 10-year storm event. These conditions were in areas in which uncoated weathering steel had not performed well historically and its use was not recommended in FHWA's Technical Advisory 5140.22 (FHWA, 1989). Figure 1 shows the original Route 340 Bridge with high water and the chemical plant in the background.

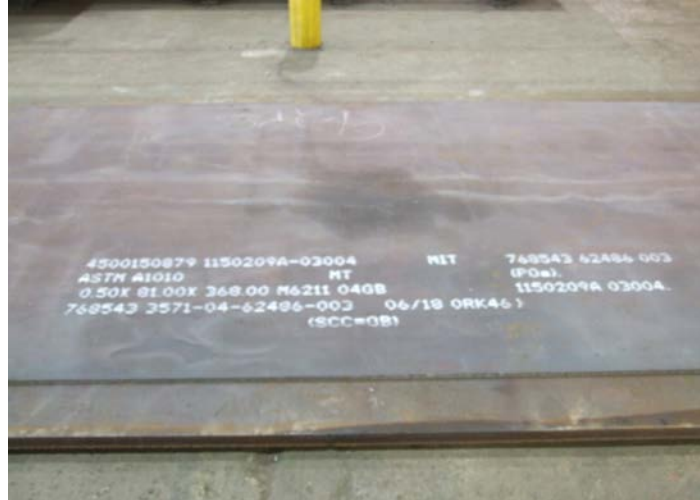
Figure 3. A1010 Steel Plate (½ in) Waiting to Be Moved to Cutting Table to Be Plasma Cut on Down Draft Table

ASTM A1010 steel plate (Figure 3) was specified for the Route 340 Bridge. ASTM A1010 stipulates the properties required for martensitic stainless steels that are used in structural applications (ASTM, 2013) with a maximum plate thickness of 2 in. At the time of fabricating the Route 340 Bridge, A1010 steel plate was produced using the normalizing and tempering heat treatment. The steel producer determined that using this heat treating approach resulted in the consistent mechanical properties. Normalizing and tempering, with a maximum tempering temperature of 1400°F, was a requirement of ASTM A1010 at the time (ASTM, 2013).

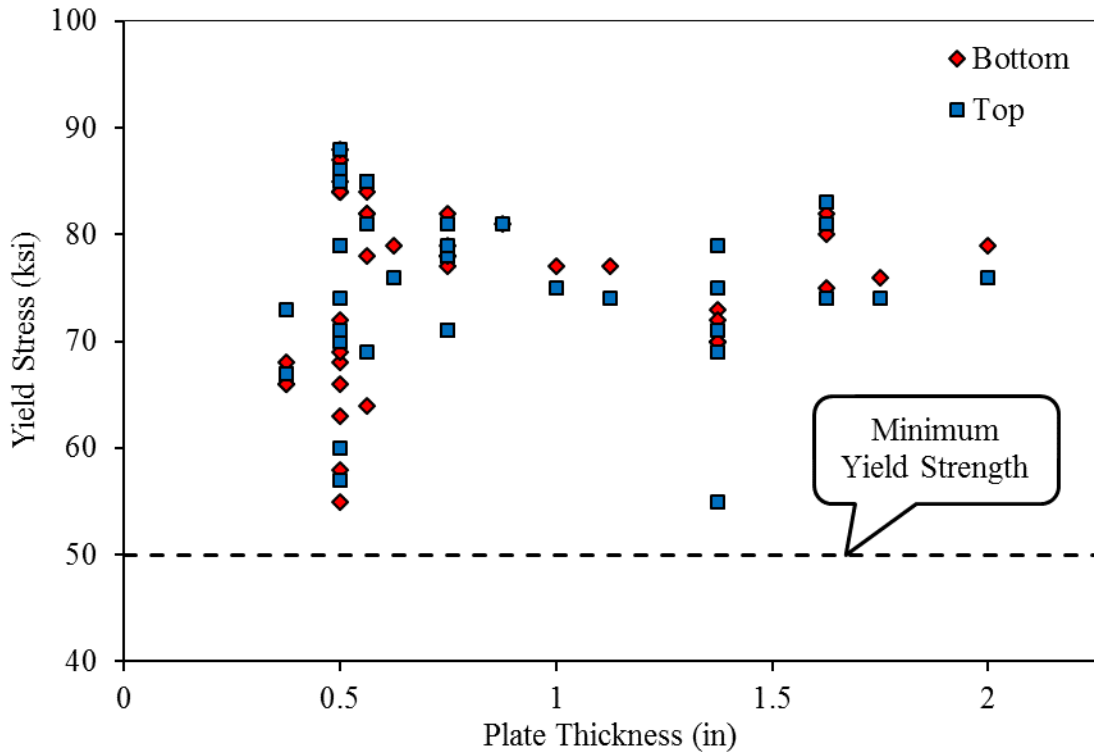
Figure 4. Plot of Yield Stress vs. Plate Thickness From Mill Test Reports

The data from the steel supplier mill test reports were analyzed and compared for differing plate thicknesses for the following mechanical properties: yield strength, tensile strength, elongation, CVN, and Brinell hardness. Figure 4 shows a plot of yield strength vs. plate thickness. As shown in the figure, all test values met the minimum yield strength requirement of 50 ksi. There were no obvious trends between the test specimens taken from the top or the bottom of the plate. Overall, the yield strength appeared more consistent with thicker plates, aside from one data point with a lower relative yield strength at a thickness of 1 $\frac{3}{8}$ in.

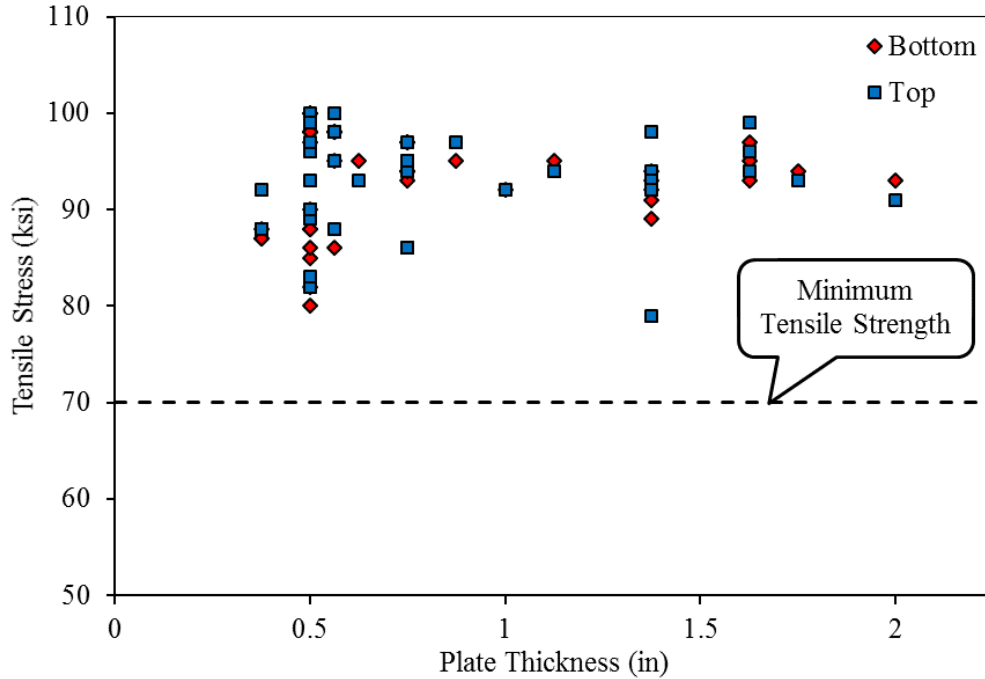
Figure 5 shows a plot of tensile strength vs. plate thickness. Trends appeared to be similar for the tensile strength data compared to the yield strength. All values met the required tensile strength of 70 ksi. There did not appear to be any obvious trends between the data from the top or from the bottom of the plate.

Figure 5. Plot of Tensile Stress vs. Plate Thickness From Mill Test Reports

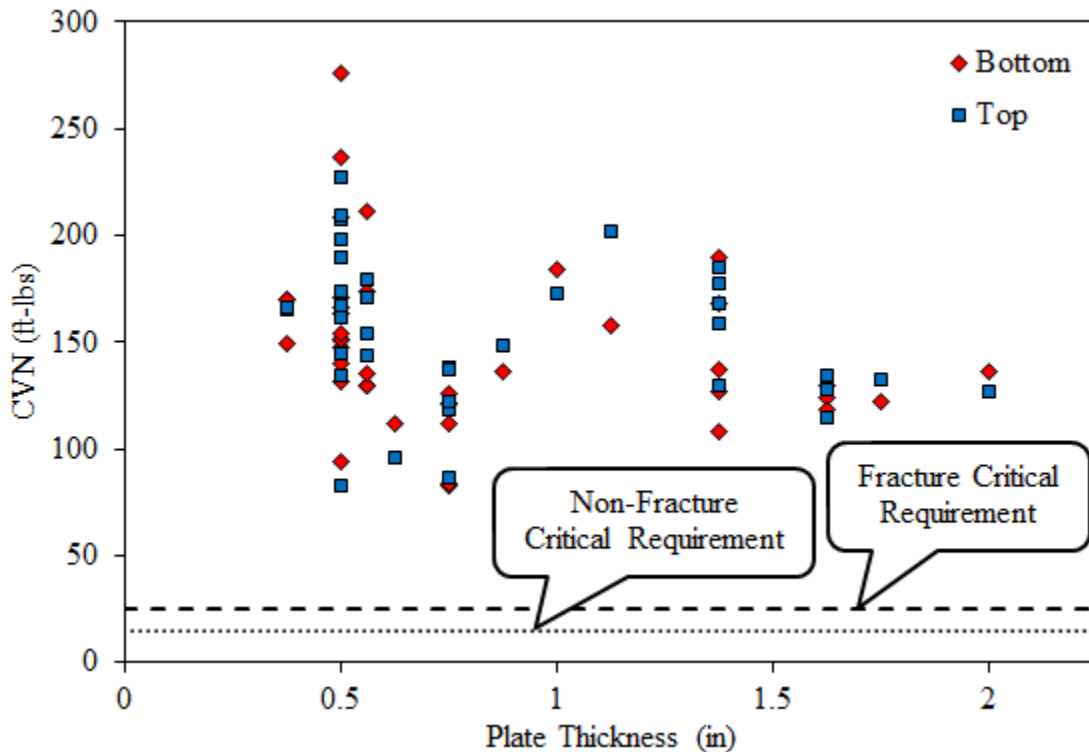
Figure 7 shows a plot of CVN vs. plate thickness. The CVN values are averages from three samples taken at each test location at the top and at the bottom of the plate that were tested at 40°F. All CVN values exceeded the requirements of 15 ft-lb for non-fracture critical members and 25 ft-lb for fracture critical members by a substantial amount, displaying the good fracture toughness exhibited by A1010 steel plate. There did not appear to be a large difference in CVN between the top and the bottom test locations, though the CVN values became more consistent as the plate thickness increased past approximately 1.5 in.

Figure 7. Plot of Average CVN Tested at 40°F vs. Plate Thickness From Mill Test Reports. CVN = Charpy V-notch.

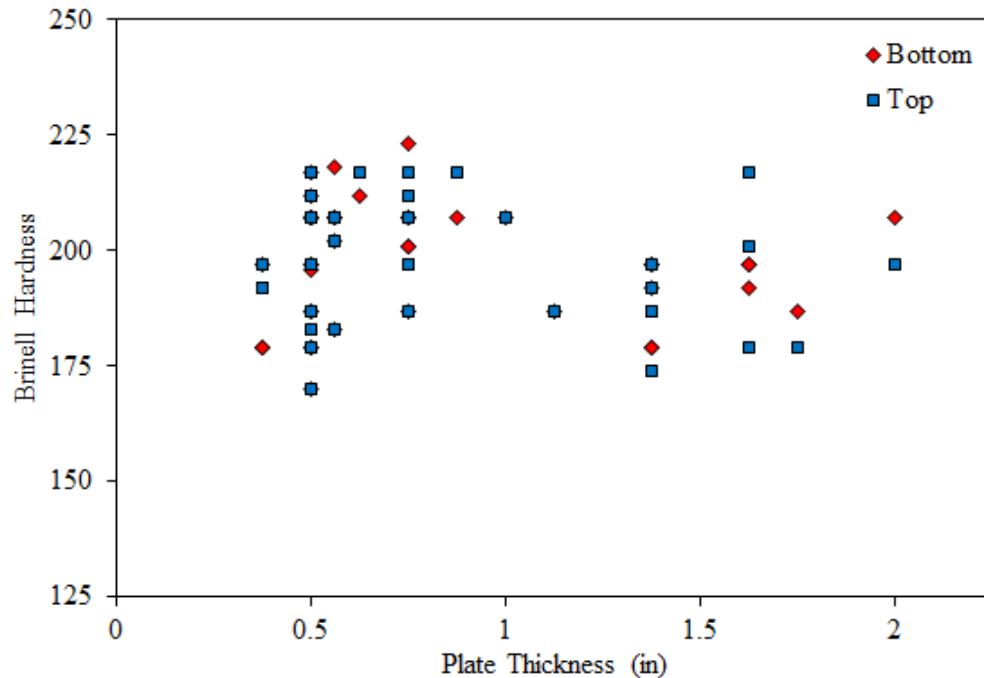
Figure 8 shows a plot of Brinell hardness vs. plate thickness. The most current (2017) version of ASTM A709 (ASTM, 2017) does not have any hardness requirements for steel plates. However, the 2009 historical standard ASTM A1010 (ASTM, 2009), which was superseded by the current 2018 version (ASTM, 2018), had a maximum limit of 250 Brinell hardness. Although this value is not a current requirement, all test results from the mill test reports met this requirement. There did not appear to be any obvious trends in the hardness values when either the test location or the plate thickness was considered. All Brinell hardness values were within a range of approximately 160 to 225.

Figure 8. Plot of Brinell Hardness vs. Plate Thickness From Mill Test Reports

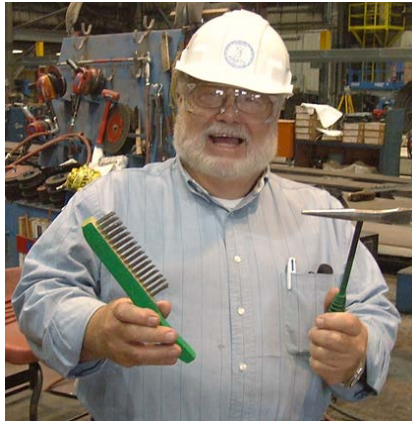
Figure 11. Hand Tools Marked With Green Paint to Indicate They Are Dedicated for Use on ASTM A1010 Steel Plate

Another change to VDOT practice covered in VDOT’s special provision required the fabricator to use “new tools (grinding and sanding disk, weld cleaning tool) or tools dedicated for ASTM A1010,” and carbon steel tools had to be approved by the engineer. For example, new bits were used for drilling, and common hand tools were marked to ensure that only dedicated tools were used (Figure 11). The purpose of this requirement was to reduce the chance of contaminating the weld regions with carbon, and the fabricator achieved this goal.

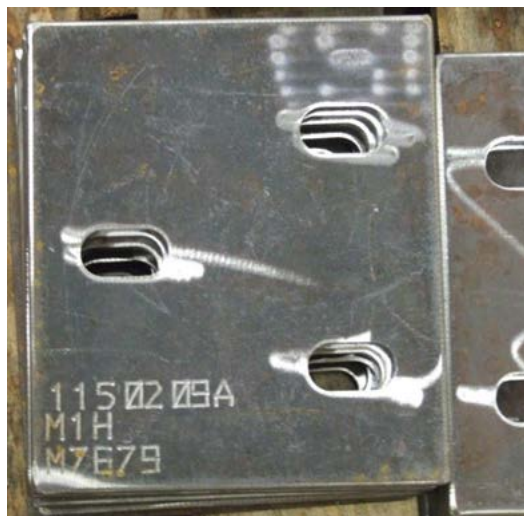
Figure 12. Identification Marking and Machining of A1010 Steel Plates Using Conventional Equipment

Earlier work by the Oregon DOT indicated that the machinability and marking of A1010 steel plate were similar to those of ASTM A709 Grade 50 steel (Seradj, 2012). Although dedicated bits were used on the Route 340 Bridge to meet the requirements in VDOT’s special provision, it can be seen in Figure 12 that standard bridge components were fabricated with conventional equipment. For future projects, dedicated stainless steel tools will likely be required only for weld regions.

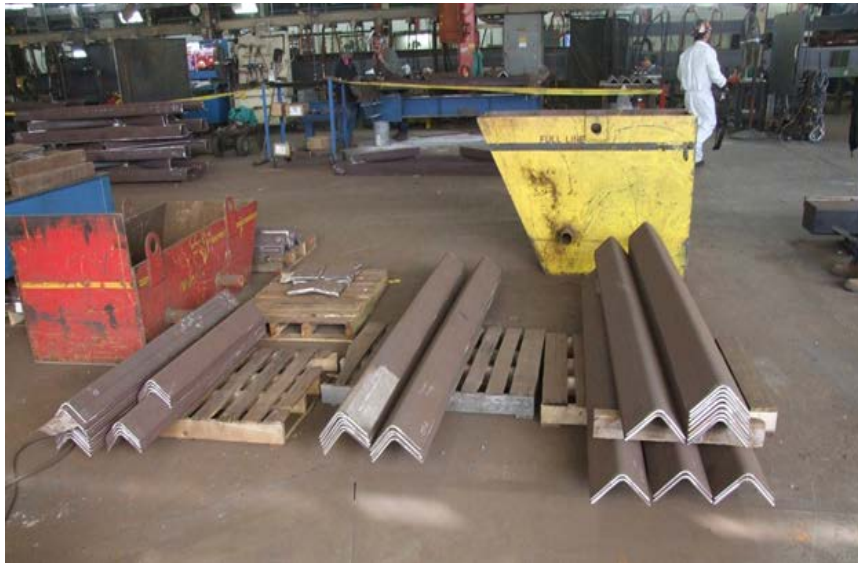
Figure 13. A1010 Steel Plate After Bending But Prior to Assembly

In early 2016, the fabricator proposed bending A1010 steel plate into secondary members, rather than welding it into built-up members. The fabricator demonstrated to VDOT that the plate could be successfully bent to the specified radius. The bends were then inspected using visual inspection and UT to confirm that no indications were present in the bends. MT was also used to inspect 10% of the bent members; it also showed no indications along the bends. Successful bending of A1010 steel plate allowed the bent plates to be used in place of traditional structural shapes, thereby providing alloyed corrosion resistance to these secondary members. Examples of the bent plate cross frames, diaphragms, and water line supports are shown in Figures 13 through 15.

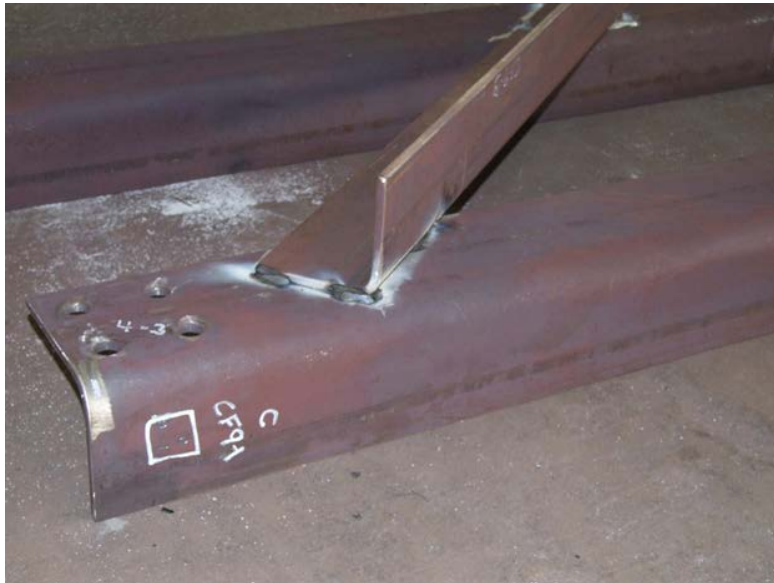
Figure 14. Close-up of A1010 Steel Bent Plate Cross Frame With Welded Connection

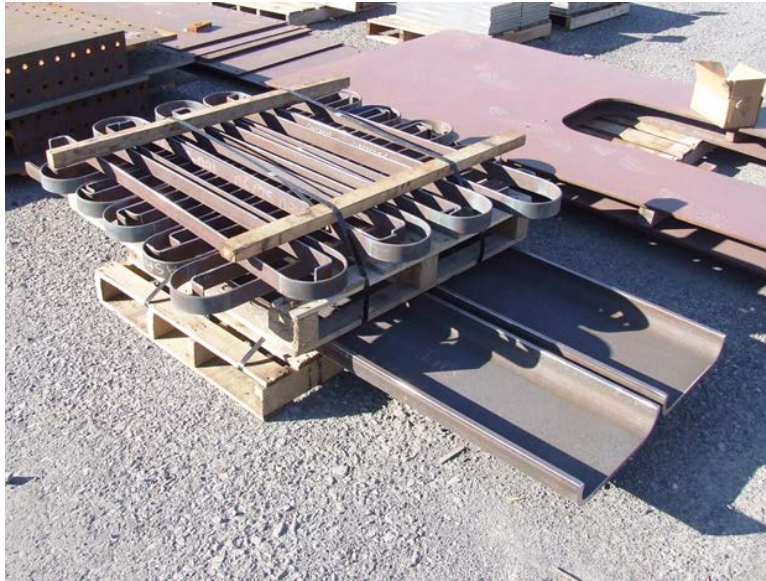
Figure 15. Water Line Support Brackets and Partially Fabricated Diaphragm After Bending

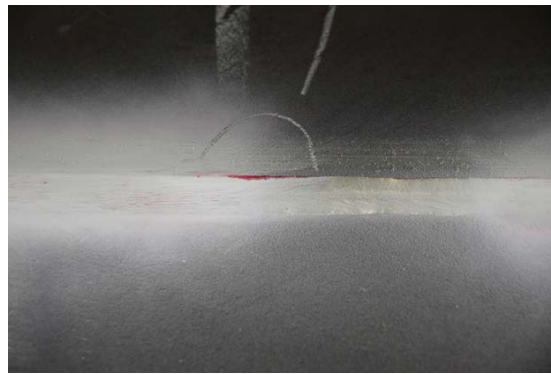
PT was used to inspect both butt and fillet welds for surface indications. As shown in Figure 17a, the contrast between the red penetrant and the white developer allowed for an easy visual identification of areas requiring closer inspection. Figure 17b shows a surface indication that requires repair before the girder is considered acceptable. As expected, PT provided successful results for the fillet welds, although the dye residue was difficult to clean from the welds, which caused it to continue to seep out long after testing took place. MT worked well for evaluating the A1010 steel plate, especially after bending, but it could not be used to inspect the CJP welds because the electrode material is non-magnetic.

Figure 17. Penetrant Testing: (a) used to inspect longitudinal web-to-flange weld and transverse stiffener-to-girder weld; (b) close-up of indication found on web-to-flange weld

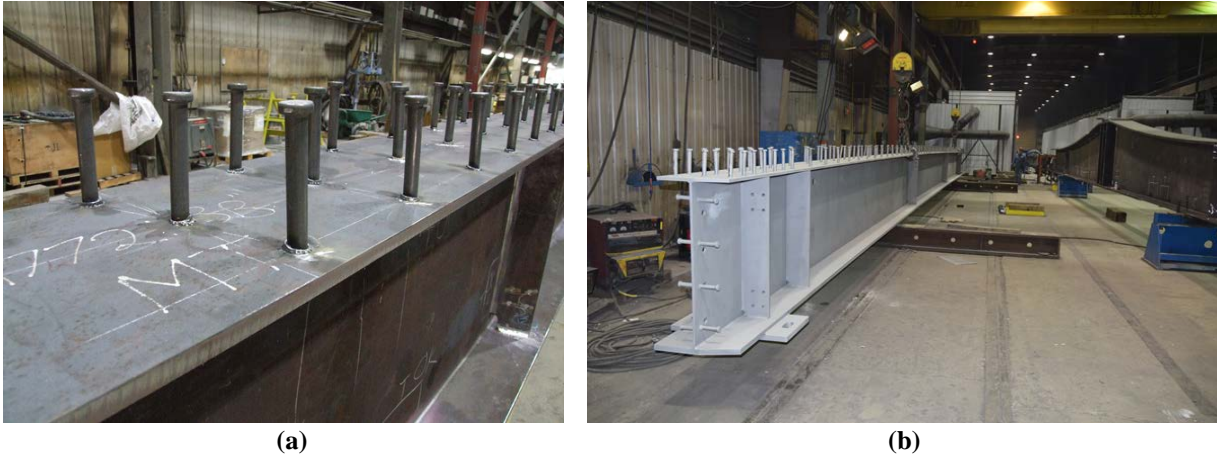
Figure 18. Carbon Steel Shear Studs: (a) top flange of beam; (b) top flange and web after mill scale removal

be beneficial to investigate this issue in greater detail. It is not known if this issue was related to the A1010 steel plate or was simply a result of welding studs to either side of a thin web plate. Overall, welding the shear studs in the shop environment was successful. For future A1010 steel plate bridges, studs could also be welded in the field, depending on Occupational Safety and Health Administration (OSHA) regulations.

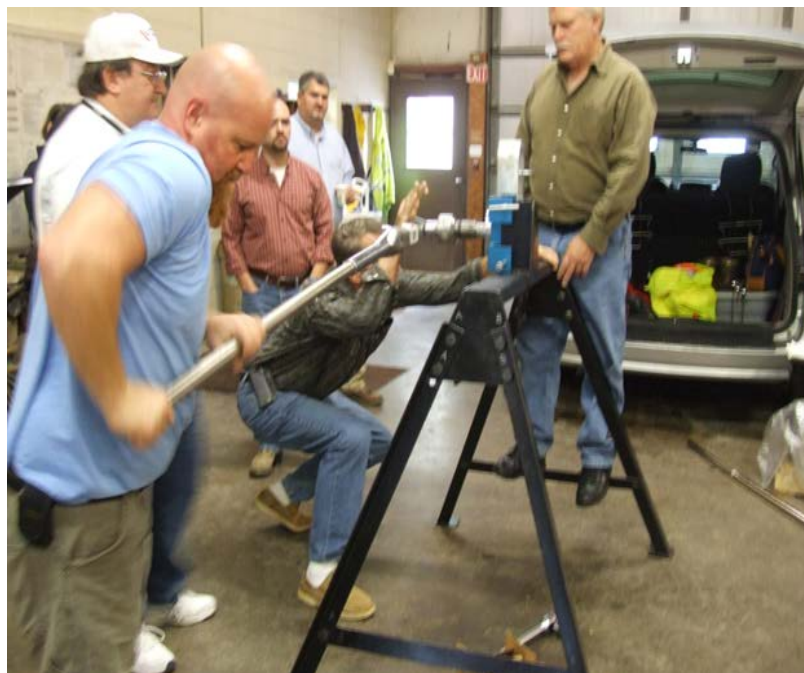
Figure 24. Acceptance Testing of ASTM A193 Grade B8 Class 2 Bolts

The bolt installation process went smoothly in the field. Although the rotation and torque requirements were different for the Grade B8-2 bolts than for the standard ASTM A325 bolts, the contractor did not encounter any major issues with the modified tightening procedure. One unexpected challenge that did occur was that the paint from the paint marker used to mark the starting and finishing lines for the nut rotation did not adhere to the stainless steel nuts. Once the nuts began to be tightened, the paint from the marker would rub off such that it was no longer visible. This was resolved by marking the face of the nuts with a center punch tool so that a permanent mark would remain on the nut through tightening. After the nuts were marked with a center punch, the bolt installation process continued without any other challenges. A photograph of the bolted splice installation is shown in Figure 25. Tables of average daily torque values for the bolts during installation are provided in Appendix B.

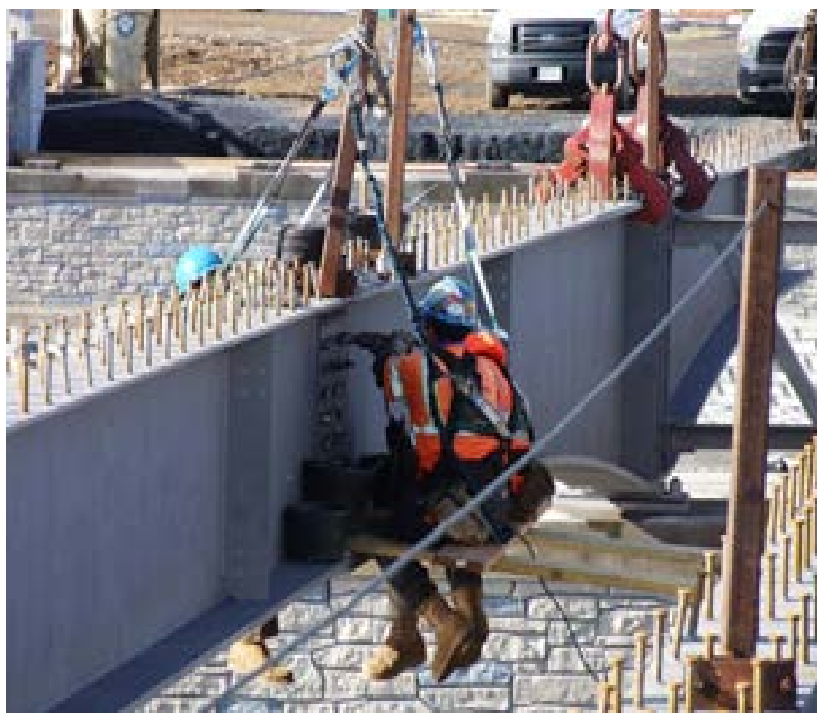
Figure 25. Installation of Stainless Steel Fasteners on Bolted Splice

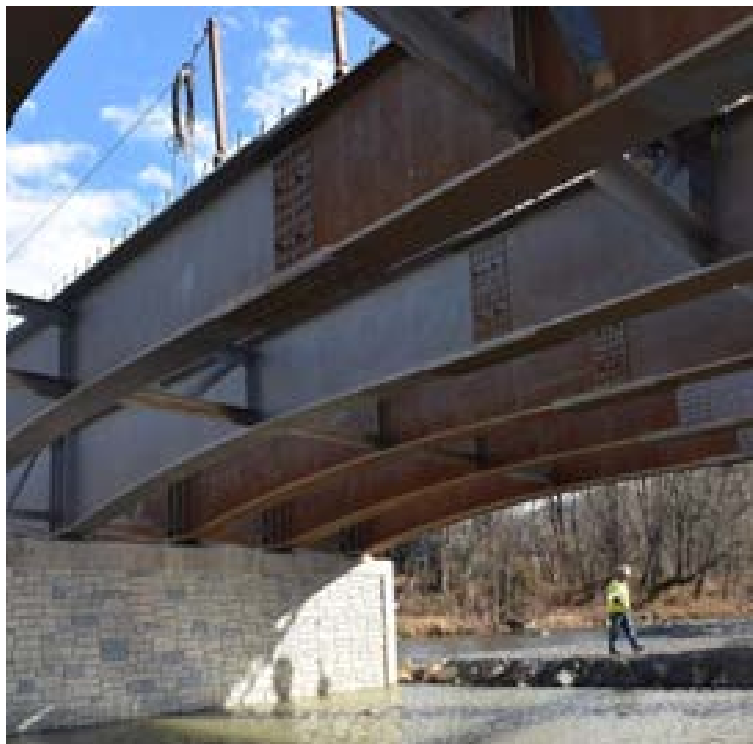
Figure 26. Various Stages of Patina on Steel Girders

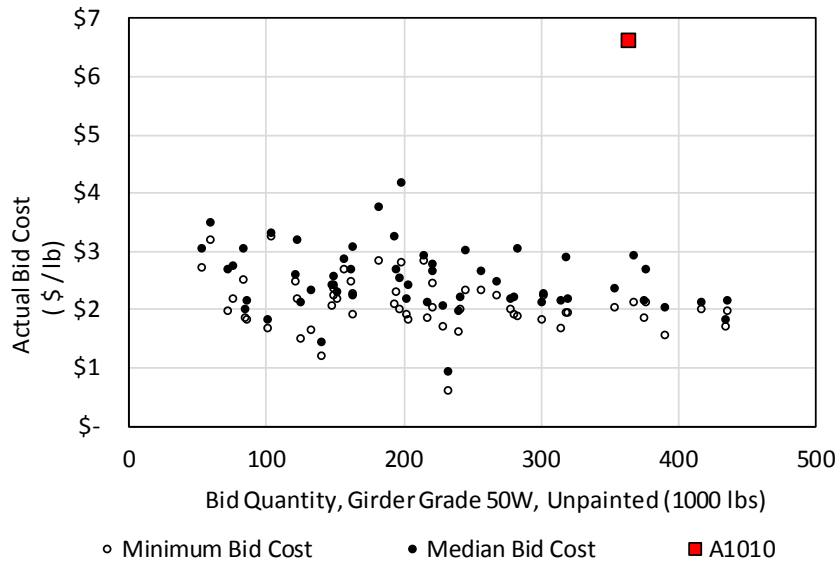
As a baseline, the scatter plot in Figure 28 shows actual minimum and median unit bid costs for unpainted Grade 50W steel girders (VDOT Item 61812) over 2008-2019; the A1010 steel plate girder unit cost is also shown. The few projects with more than 500,000 pounds of steel were excluded as irrelevant, given the size of the Route 340 Bridge project. In Figures 29 and 30, the baseline unpainted Grade 50W steel girder bid costs in Figure 28 are escalated by the painting or galvanizing cost premiums indicated by the fabricator (24% or 41%, respectively). Figure 30 also shows the unique 2011 Genito Road Bridge galvanized Grade 50W girder unit bid costs (in 2019 dollars). These results show that the actual unit cost of the A1010 steel plate girders in the Route 340 Bridge project was far higher than the hypothetically escalated cost of painted or galvanized Grade 50W steel girders according to the fabricator's cost premiums.

Figure 28. VDOT Project Bid Quantities and Costs, Girders Grade 50W (VDOT Item 61812), Unpainted, 2008-2019 (2019 \$)

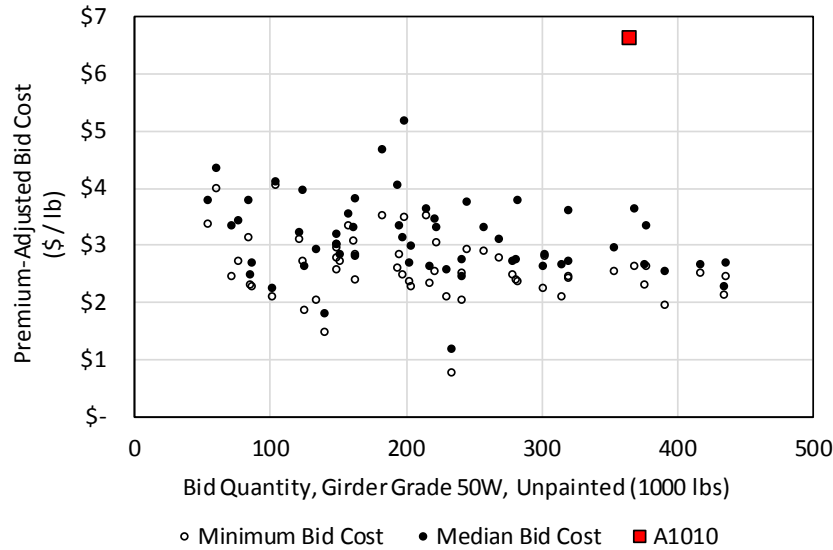
Figure 30. VDOT Project Bid Quantities and Costs, Girders Grade 50W (VDOT Item 61812), Unpainted, With Galvanizing Cost Premium Added, 2008-2019 (2019 \$)

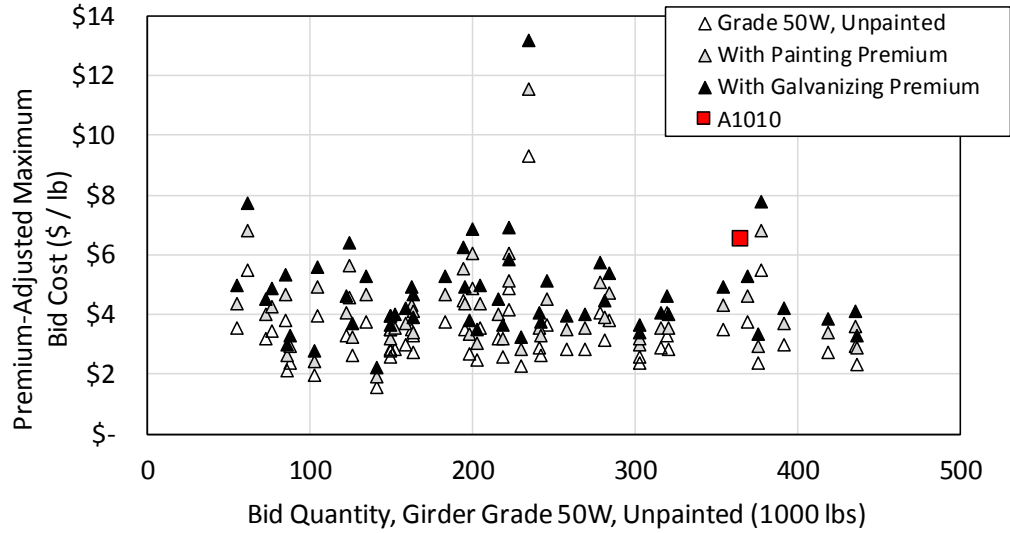
Figure 31. VDOT Project Bid Quantities and Maximum Unit Bid Costs, Girders Grade 50W (VDOT Item 61812), Unpainted, With Galvanizing and Painting Cost Premiums Added, 2008-2019 (2019 \$)

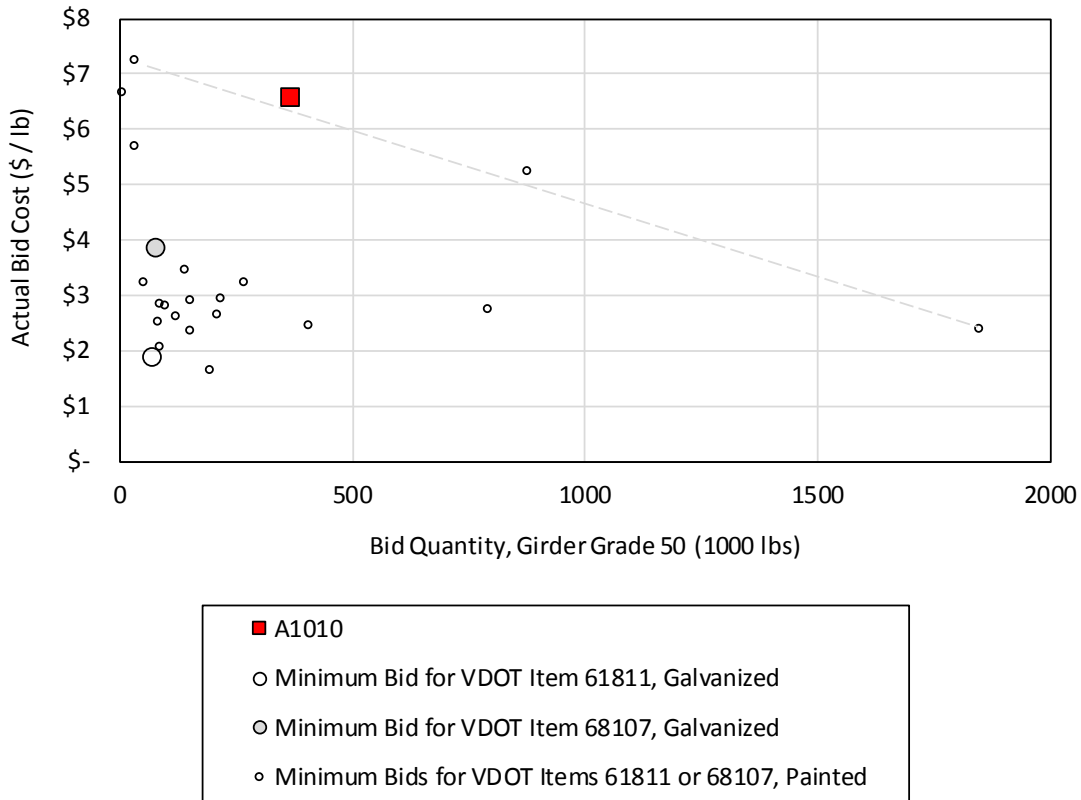
Figure 32. VDOT Project Bid Quantities and Minimum Unit Bid Costs, Girders Grade 50 (VDOT Items 61811 and 68107), Painted or Galvanized, 2008-2019 (2019 \$). The dotted line indicates a linear downward trend in upper minimum bid values for VDOT Item 61811, Painted, as bid quantities increase.

It is more interesting to compare the A1010 steel plate girder unit cost with VDOT’s actual unit costs of Grade 50 steel girders that were actually bid with protective surface treatments. Figure 32 shows minimum bid cost data for painted Grade 50 steel girders (VDOT Items 61811 and 68107 in Table 5) compared to the unit cost of the A1010 steel plate girders in the Route 340 Bridge, all in 2019 dollars. Each item code featured a single galvanized girder project during the period 2008-2019, and minimum bids for these projects are also shown. Figure 32 suggests that the estimated unit cost of the A1010 steel plate girders is consistent with an upper limit of actual minimum unit bid costs (dotted line) for painted Grade 50 steel girders in VDOT’s experience.

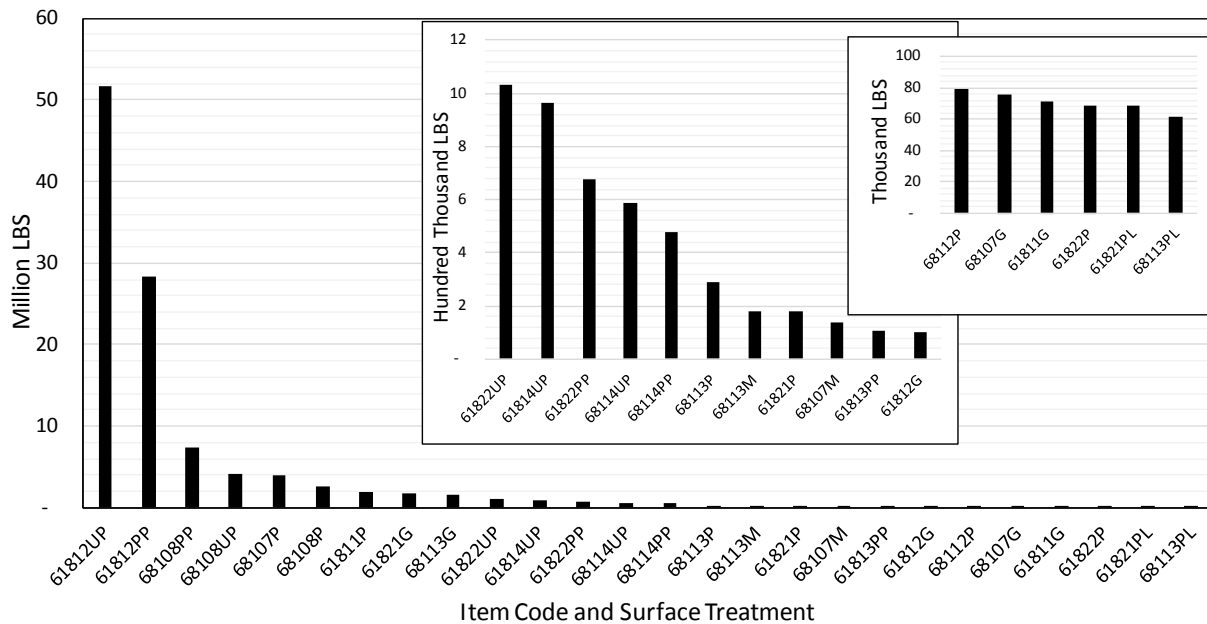
Figure 33. Total Bid Quantities of Girders and Beams in Competitive Bid VDOT Projects by Item Code, 2008-2019. G = galvanized; M = metalized; P = painted; PL = plain; PP = partial paint; UP = unpainted.
