Roadside Truck Placard Readers for Advanced Notice and Response at Safety-Critical Facilities: Phase 2

Virginia Tech Transportation Institute

Final Report VTRC 23-R18

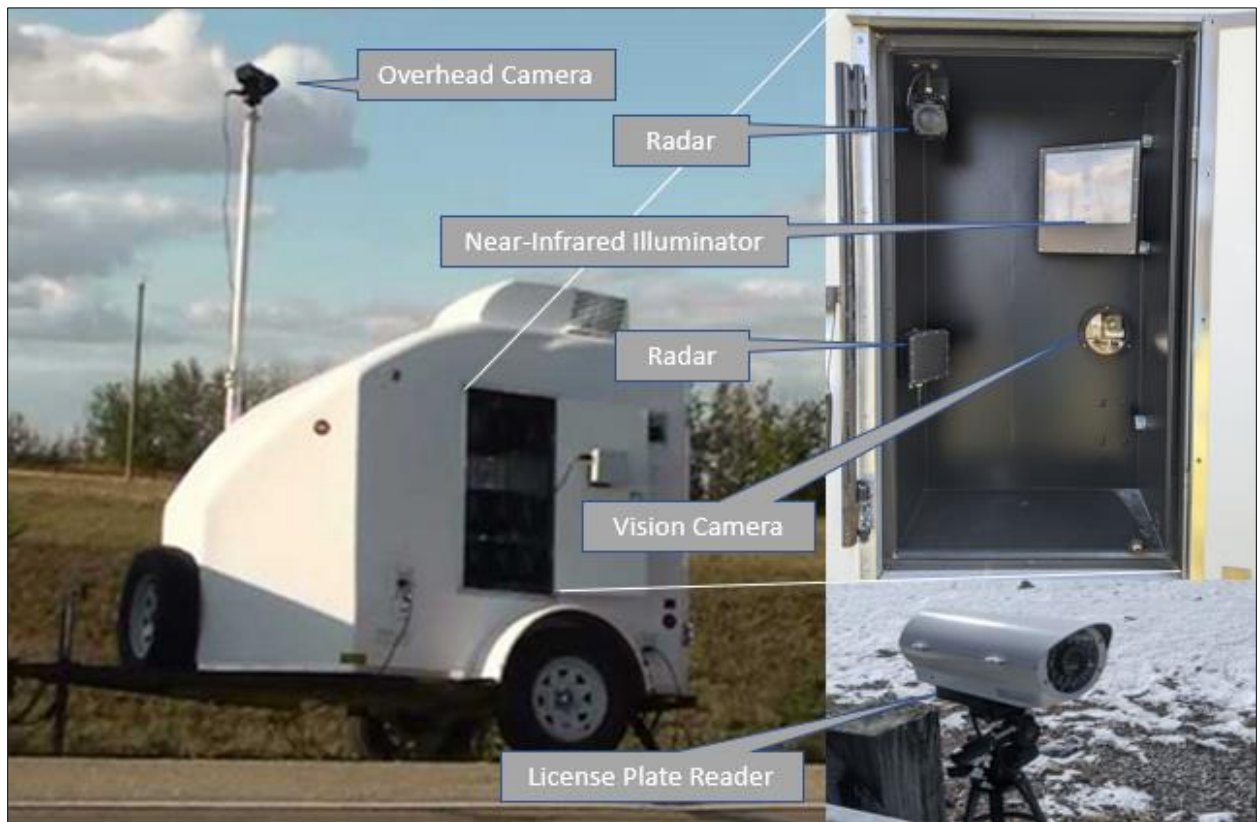
Figure 1. Mobile Automated Placard Reader System (APRS) Trailer with System Component Types and Locations Shown

Two types of APRSs were used for the testing performed in this study. Both systems were manufactured by IIS, the vendor identified during the previous phase of this work. A mobile version of the APRS was acquired by the Virginia Tech Transportation Institute (VTTI) under a multi-month lease agreement. This unit, and key system components, are shown in Figure 1.

The mobile APRS shown previously in Figure 1 was leased from IIS by VTTI to facilitate its evaluation in this study. This trailer-based unit is fully functional and designed for use by law enforcement officers and others for short periods of time (i.e., 1 to 2 days). A separate DOT-type trailer was configured as a base for sensors used to validate APRS operation and to provide additional information on environmental and traffic conditions that might affect APRS performance (Figure 4). The trailer was equipped as described below:

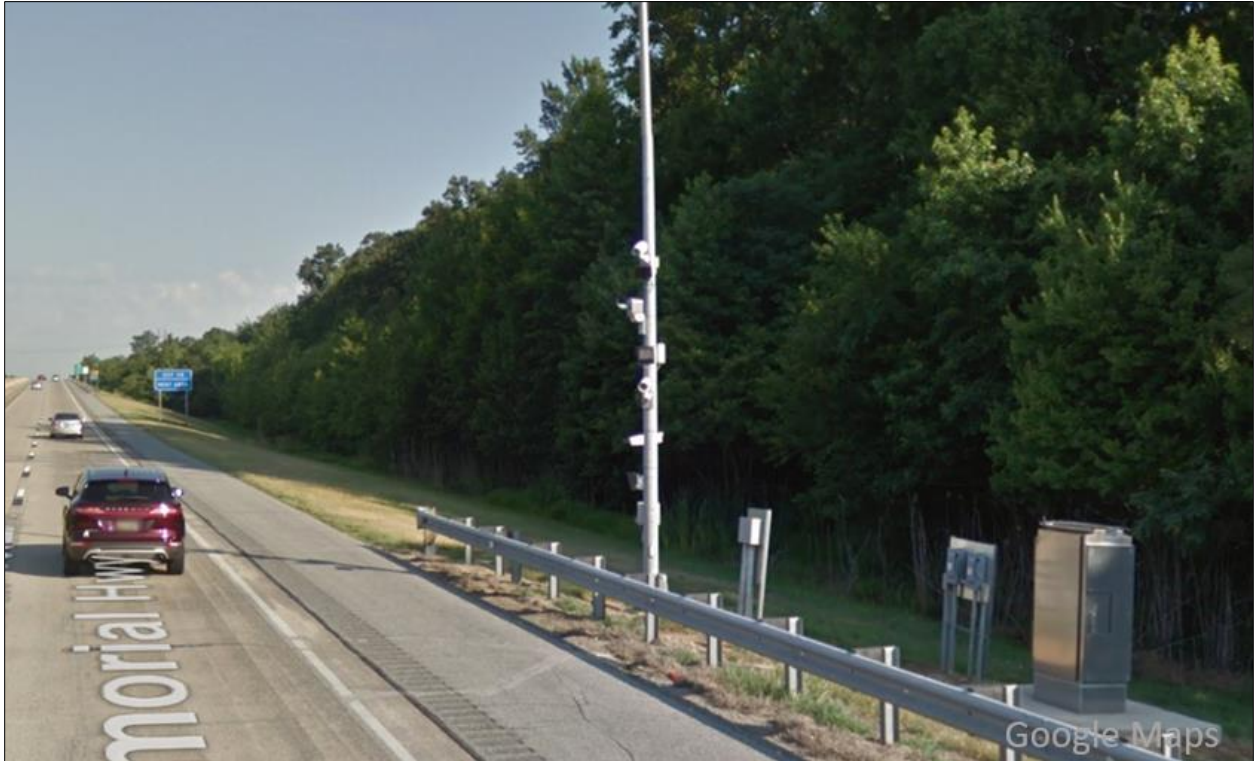
Figure 2. Permanent APRS Installation at the Delaware Site Along DE-1

Access to data from a second, permanent, APRS installation was provided by the vendor when testing with the mobile system proved unreliable during several deployments due to multiple system breakdowns and repairs. This APRS is located on Delaware State Route 1 (DE-1) near the town of Smyrna (Figure 2).

The primary differences between these systems other than their mobility relate to power provision, the location of system sensors, and how vehicles are detected and classified. The mobile system is powered by batteries charged before and/or during system operation, all sensors other than the license plate reader (LPR) are located on the trailer (Figure 1), and radar sensors are used on the trailer to detect vehicle presence and provide size classification. The permanent systems typically receive power from an electric utility connection, and aboveground sensors are mounted on one or more poles located at the roadside (Figure 2). Also, in-pavement (e.g., inductive loop) sensors are typically employed for vehicle detection and classification.

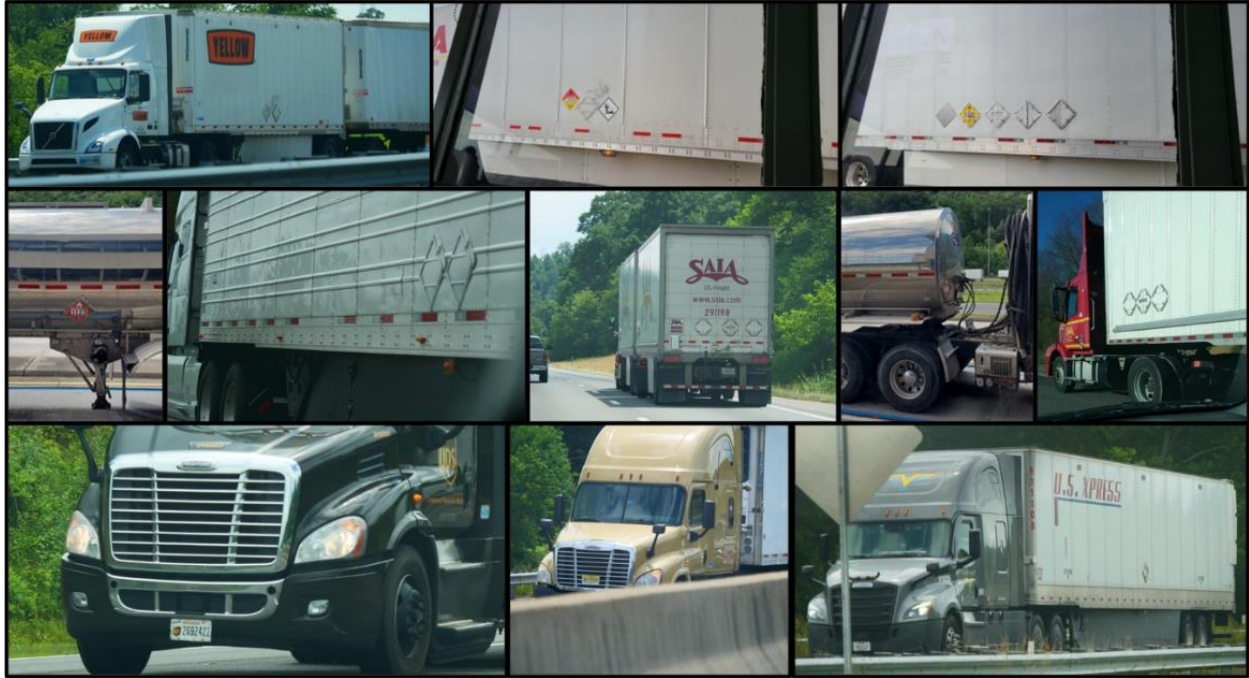
Figure 3. Sample of Photographs Acquired During the Usage Survey

The primary reason for undertaking this task was to inform how experimenters would present placards to the APRS during testing performed on the Virginia Smart Roads in a subsequent task by more accurately representing the range of conditions likely to be observed during real-life testing. The research team became more familiar with the operation of the APRS and recognized that only those placards visible from the side of the vehicle were relevant and that longitudinal location did not affect APRS operation. Therefore, an informal visual analysis performed on acquired images from approximately 100 placard-equipped trucks focused primarily on placard height, rotation angle, and condition (Figure 3). It should be noted that this survey was conducted during a period of relatively fair weather; the impacts of winter weather and salt application, which may add to the potential for placard obscuration, were not observed.

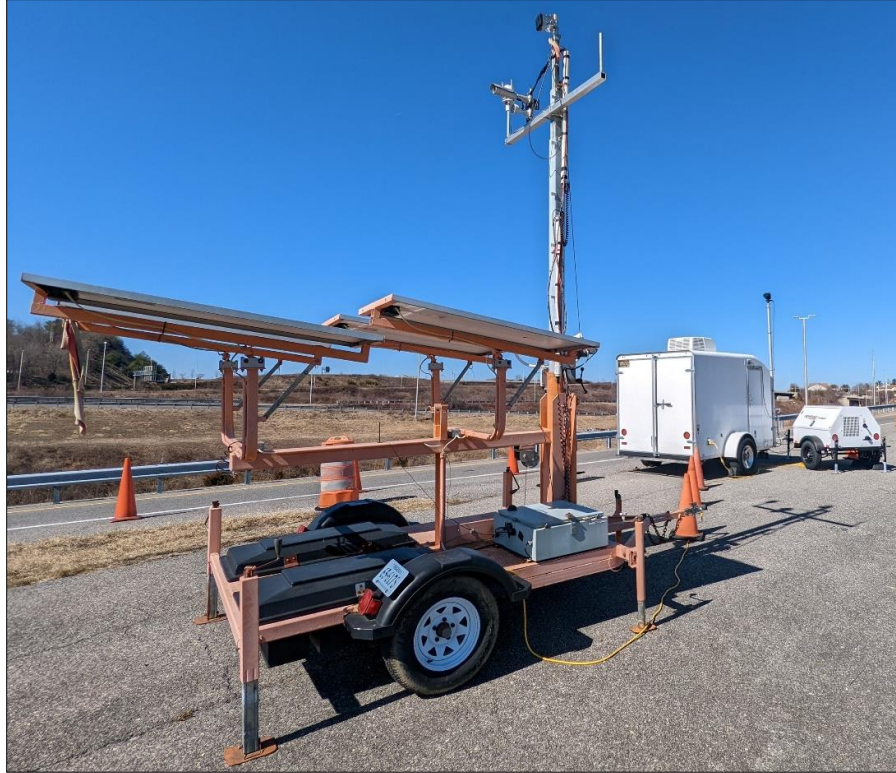
Figure 4. View of the Sensor Trailer with the Mobile APRS and Generator Shown in the Background

- Solar photovoltaic panels, batteries, and related power conversion electronics to provide power to onboard sensors, data loggers, and cellular communications equipment.
- A stowable and extendable mast that was used for sensor mounting and elevation.
- A high-mounted camera to collect video of passing traffic and environmental conditions.
- A weather station providing environmental condition data, including temperature, humidity, light level, and wind speed and direction.
- A visibility sensor to determine sight distances.
- A Wavetronix SmartSensor HD® radar to measure traffic speeds, detect individual vehicles, and determine their size and lane position (i.e., inner, outer).
- A data logger for collection of data from all sensors. This data logger also featured a cellular modem to enable remote data sharing.

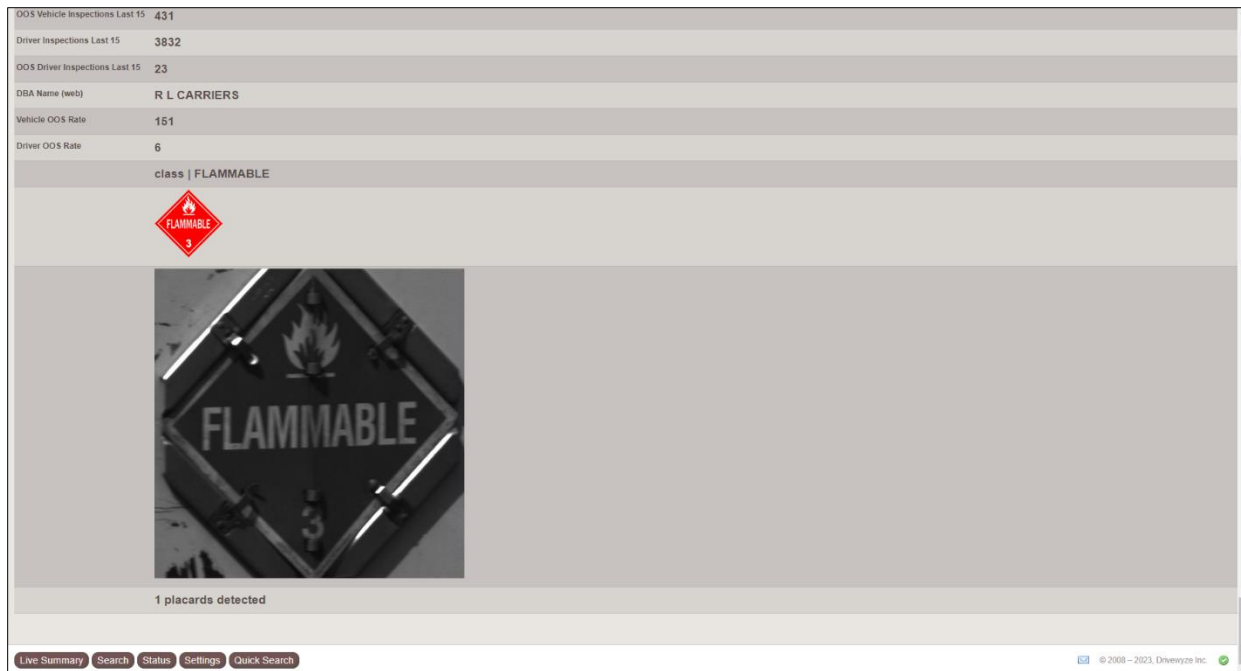
Figure 7. Screen Capture of the Vehicle Queue Detail of the Same Vehicle in Figure 6, Viewing the Bottom of the Page, Containing Details of the Attached Placard Including an Image and Identification

Individual entry pages display pertinent information for the subject vehicle, with the more common information being placed at the top of the page, such as the images captured by the APRS of the vehicle, the classification of these images, and any applicable alerts (Figure 6). More information is given below, with details on any HAZMAT placards that were on the vehicle placed at the bottom of the page (Figure 7).

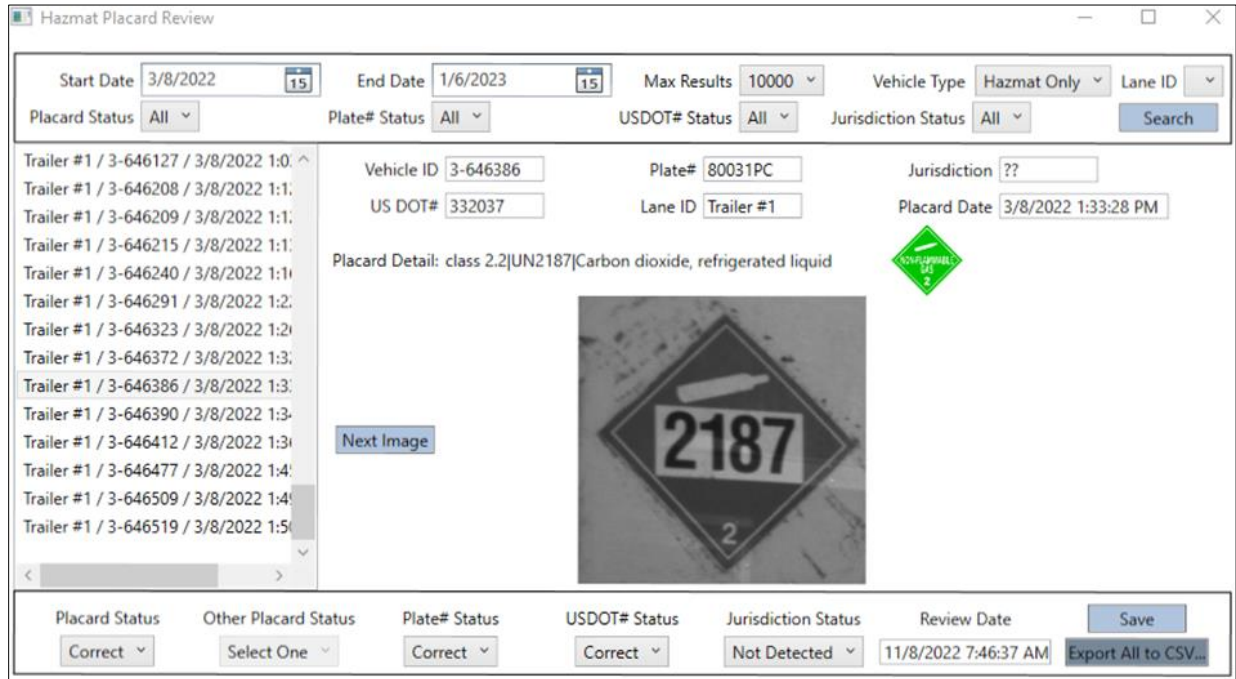
Figure 8. Screen Capture of VTTI’s HAZMAT Placard Review Website Data Scraping Software Tool

Data reductionists reviewed classification and graphical data for each event to determine APRS accuracy. Reduced data from this tool was appended to the existing scraped APRS data at VTTI. This dataset was then used for subsequent data analysis.

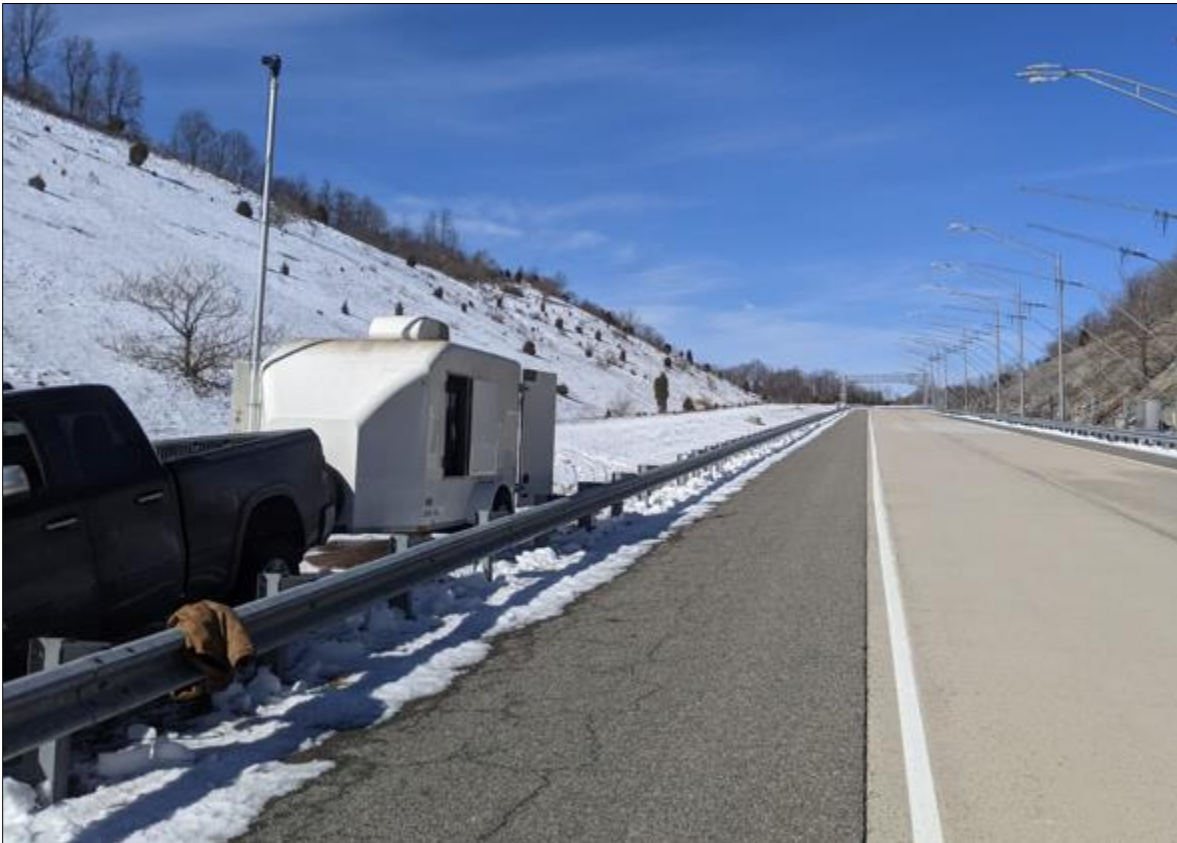
Figure 9. View of the APRS Trailer Configuration Used for Virginia Smart Roads Testing

The APRS trailer system was tested on the Virginia Smart Roads to evaluate its performance across a wide range of HAZMAT placard types and to minimize any “noise” in the acquired data by controlling test conditions to the extent practicable. The APRS trailer was positioned at a location along the Highway section of the Virginia Smart Roads to emulate its likely implementation on I-77 as far as protection behind a barrier (guardrail) and lateral distance from the APRS cameras and the targeted travel lane; in this case, the near lane (Figure 9). Power was provided by a utility connection already present at the site. A vendor representative provided assistance with the setup and verified that the APRS was operating normally.

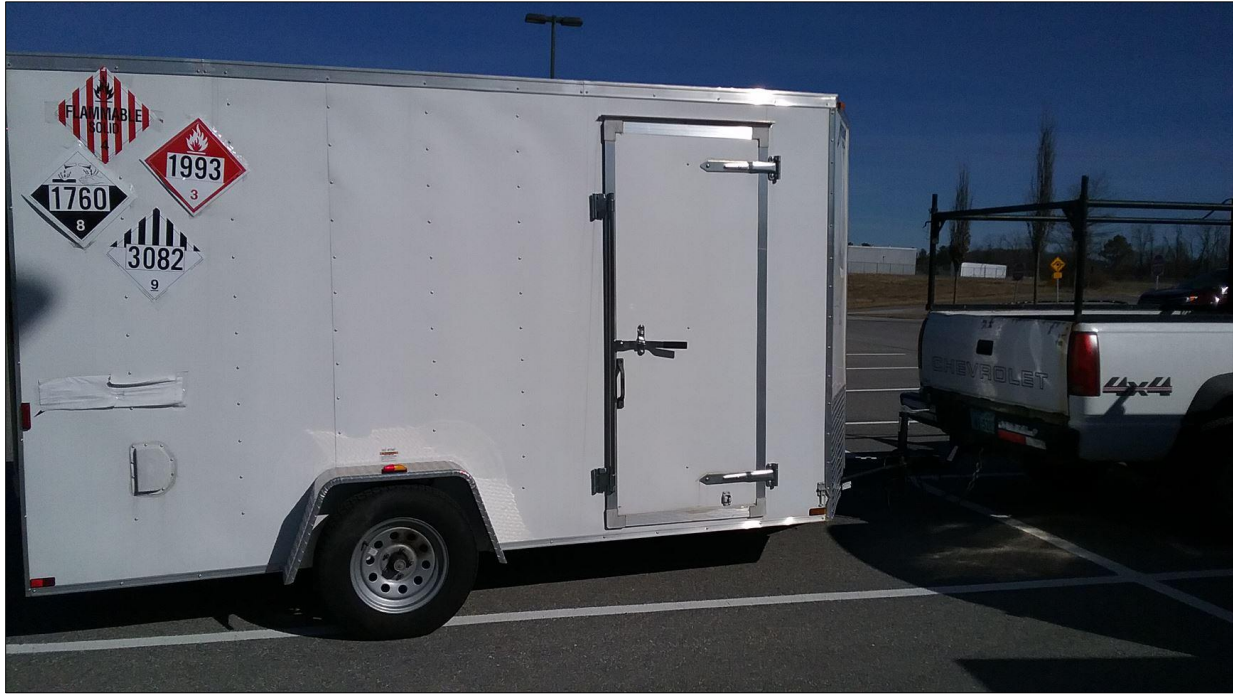
Figure 10. Placards and Trailer Used for Virginia Smart Roads Evaluation

A box trailer and pickup truck tow vehicle were employed as a placard mounting and testing platform after preliminary testing using a Class 8 tractor/trailer combination revealed it to

be a suitable surrogate (Figure 10). The use of the pickup truck and trailer combination provided for much quicker and less costly experimentation when compared to the use of a tractor/trailer and commercially licensed driver. Placards were mounted on the trailer in configurations guided by the findings of the HAZMAT placard use field survey.

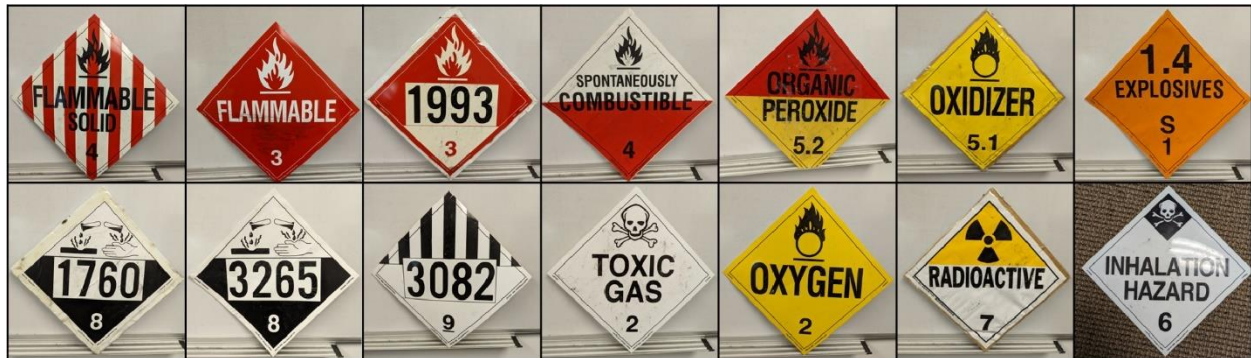
Figure 11. Placards Used in the Virginia Smart Roads Evaluation

Testing was conducted under a variety of environmental conditions with vehicle/trailer speeds of 65 mph. Samples of placards in random combinations were mounted on the trailer and the driven by the APRS trailer in the closest lane. The placards were chosen as a representative subset of the range that might be viewed during APRS operation on public roads (Figure 11). Although anecdotal observation of APRS performance was favorable, a portion of the data was lost before it was downloaded from the vendor’s website due to yearly scheduled data management operations.

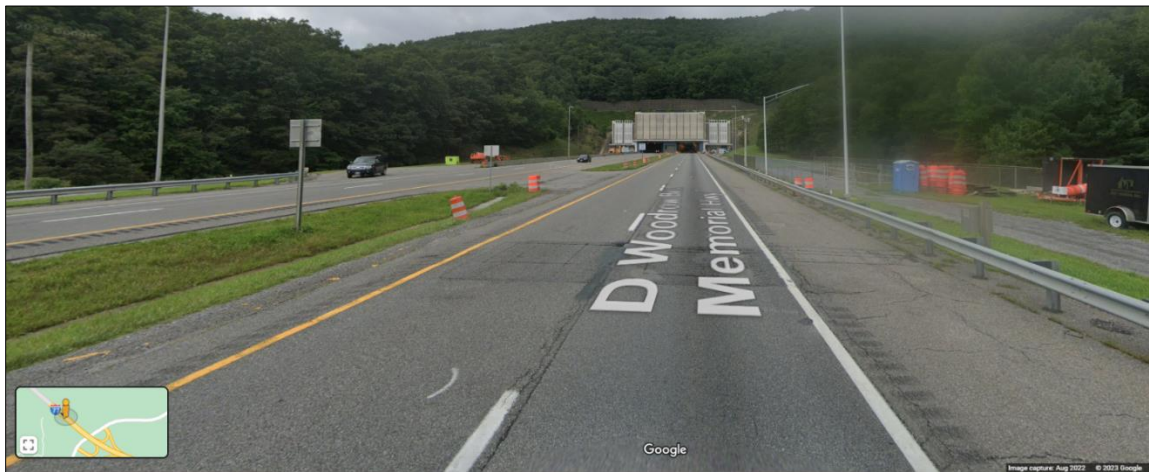
Figure 15. View of the South Entrance of Big Walker Tunnel on I-77 Near the APRS Deployment Site

The most suitable location, and where the APRS and other equipment were eventually deployed during testing, was a relatively flat and secure patch of grass on the northbound side, roughly 600 to 700 feet from the entrance to the Big Walker Tunnel (Figures 14 and 15). This site best fulfilled all locating criteria requirements except for the availability of utility power.

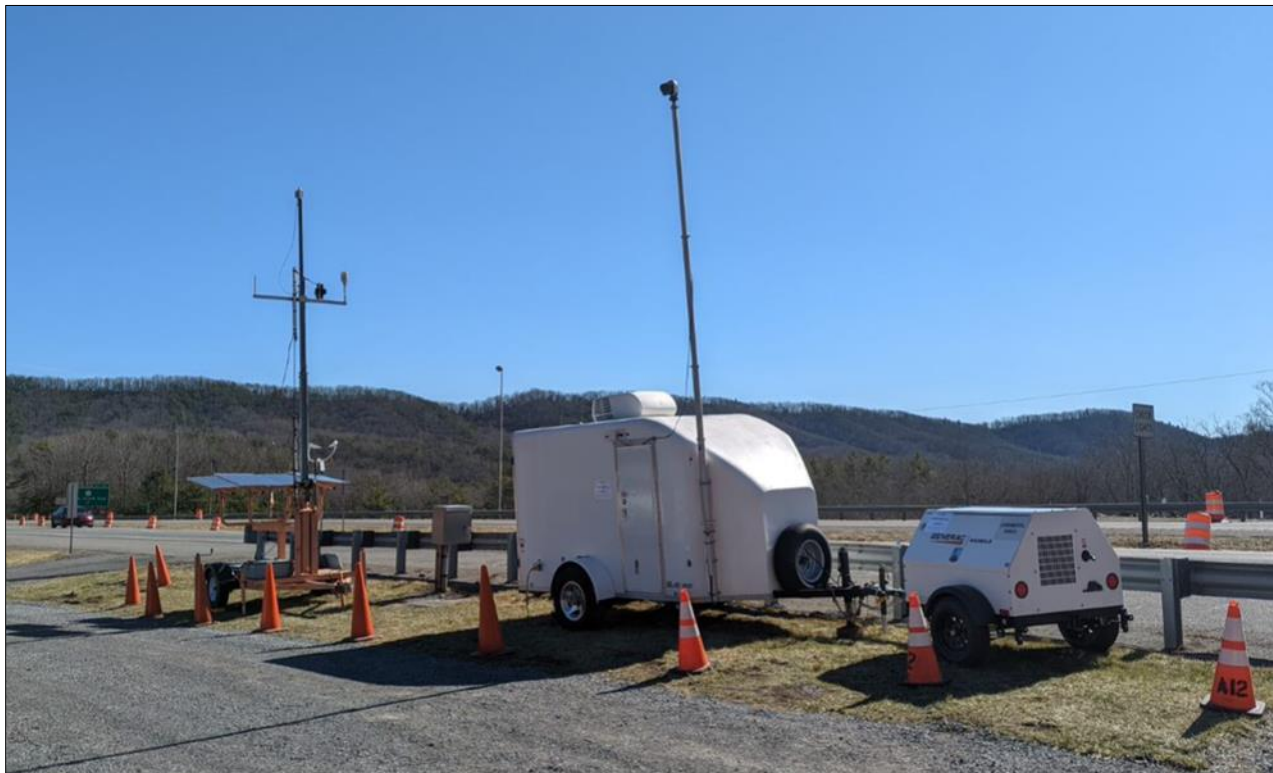
Figure 16. APRS Trailer and Supporting Equipment Installed Adjacent to the Northbound Outer Lane of I-77 Near the Walker Mountain Tunnel

After determining the best area for testing, the APRS trailer was deployed there to collect data (Figure 16). The first deployment to this location spanned from February 28, 2022, to March 8, 2022. The trailer's sensors and cameras were set up along the side of the road to capture passing commercial vehicles in the outer lane. The APRS vendor was consulted on this deployment. A second, later deployment at this location did not yield any data due to equipment malfunction.

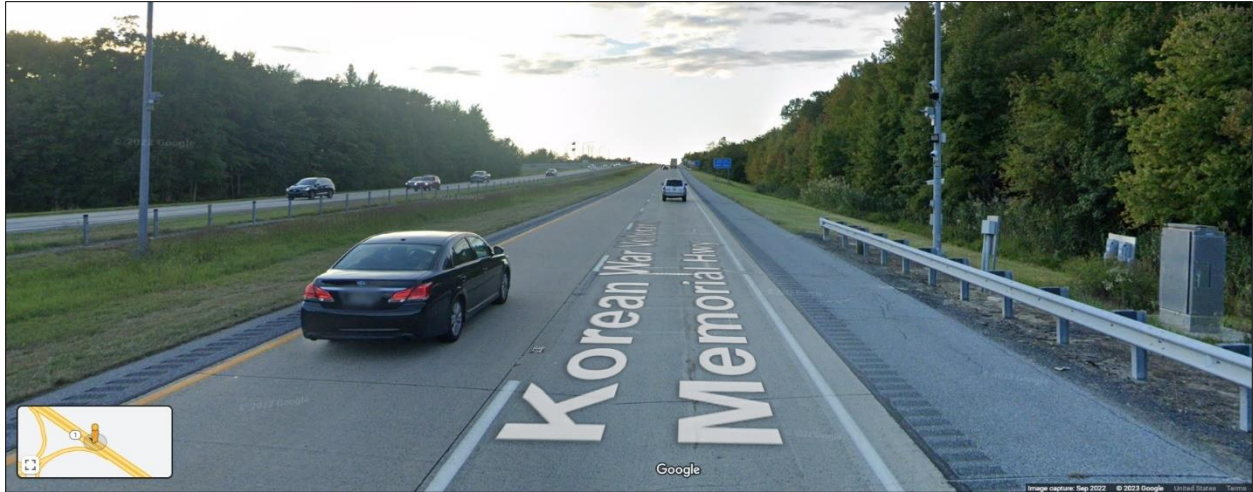
Figure 18. Google Street View Image of APRS on State Route 1 in Delaware

In a survey of the Delaware locations, the APRS located on State Route 1, roughly 1 mile north of the town of Smyrna (Figure 17 and 18), was chosen among these sites because of its location near a reliable weather station at Dover Air Force Base (AFB), approximately 20 miles south of the site. No closer reputable weather stations were found. Data from this site were retrieved from the APRS vendor's website for the time period of January 1 through June 30, 2022. For this site, data were collected, reduced, and analyzed based on weather events from historic data extracted from the nearby weather station site at Dover AFB. The previously mentioned VTTI HAZMAT Placard Review tool was used for APRS data collection at this site.

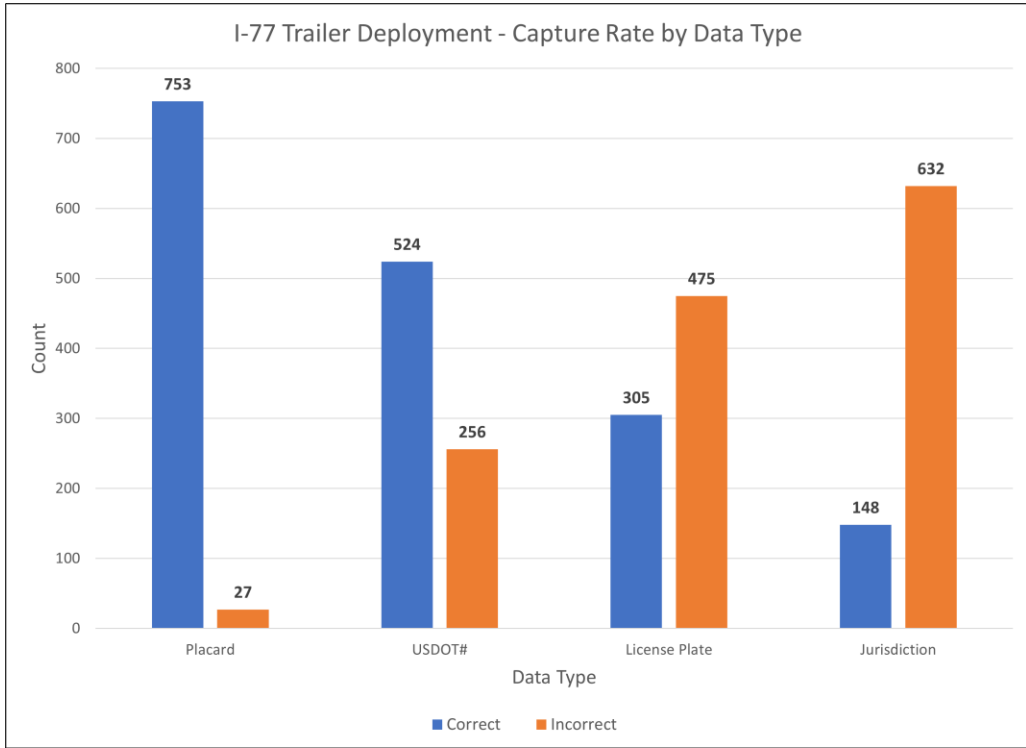
Figure 19. I-77 Trailer Deployment, Validation by Data Entry Type

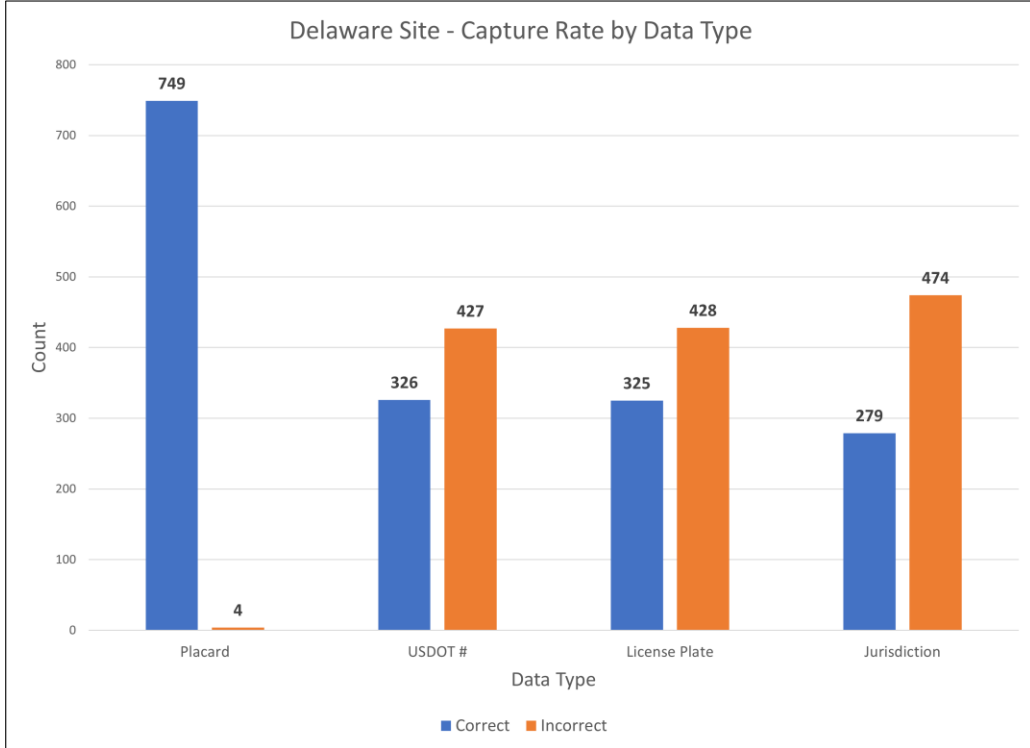
Figure 20. Delaware Site, Validation by Data Entry Type

Placard			License Plate		
	Count	Percent		Count	Percent
Correct	749	99.5%	Correct	325	43.2%
Incorrect	4	0.5%	Incorrect	428	56.8%
USDOT No.			Jurisdiction		
	Count	Percent		Count	Percent
Correct	326	43.3%	Correct	279	37.1%
Incorrect	427	56.7%	Incorrect	474	62.9%

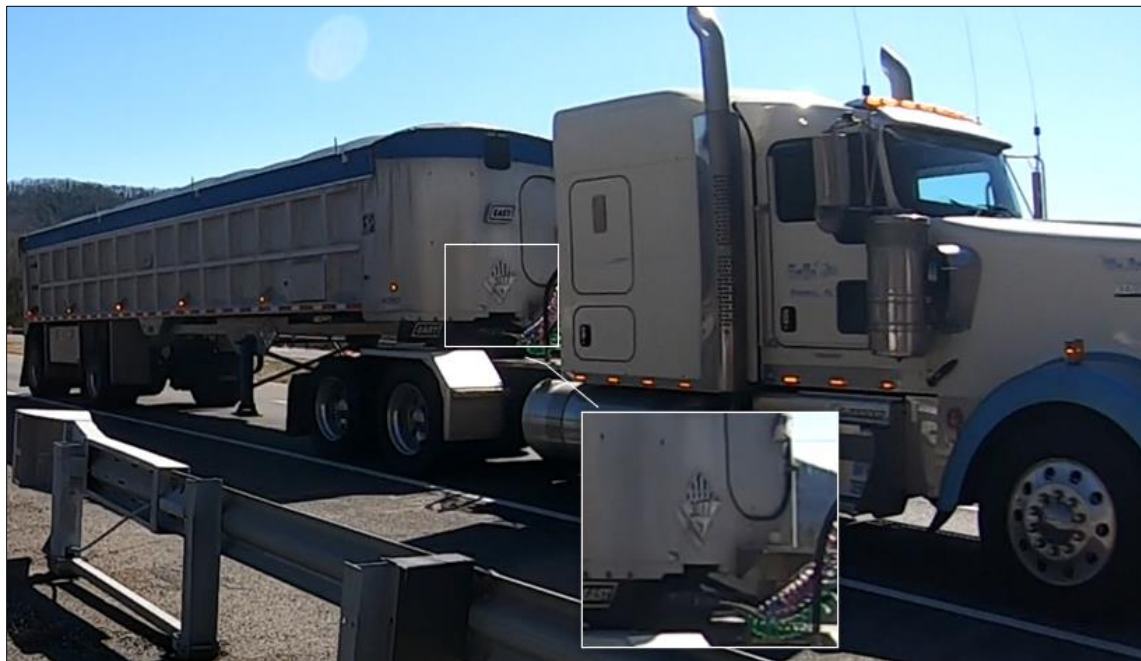
Figure 22. Potential False Negative, Still Image from Captured Footage Showing the Only Visible Placard on the Vehicle, Meaning Likely Not a False Negative

In the HAZMAT-placard-focused survey, the video footage was reviewed for every passing commercial vehicle in the outer lane (Table 10). In the 40 minutes of footage, 13 total commercial vehicles passed by the APRS that the reviewer determined had a placard attached to the trailer. Of those, 11 were captured by the APRS. This would mean a capture rate of 84%. However, in further analysis and research on USDOT guidelines on proper placard placement, it is likely that at least one of these two vehicles not captured were in violation of these guidelines. The first vehicle had only one placard visible by the reviewer, on the front of the trailer, between it and the truck cab, which contradicts the requirement that all HAZMAT carrying vehicles “must be placarded on each side and each end” (Figure 22) (General Placarding Requirements, 2023). The other entry was a propane truck with a placard printed on the curved tank on the rear of this vehicle (Figure 23). Other propane tanks were shown to have passed by the APRS and were captured without issue, so it is unknown why this truck was not captured by the trailer. But if the former truck, likely in violation of USDOT guidelines, was removed from the analysis, the capture rate of passing HAZMAT placard trucks would be 91.7% (11 out of 12 captured).

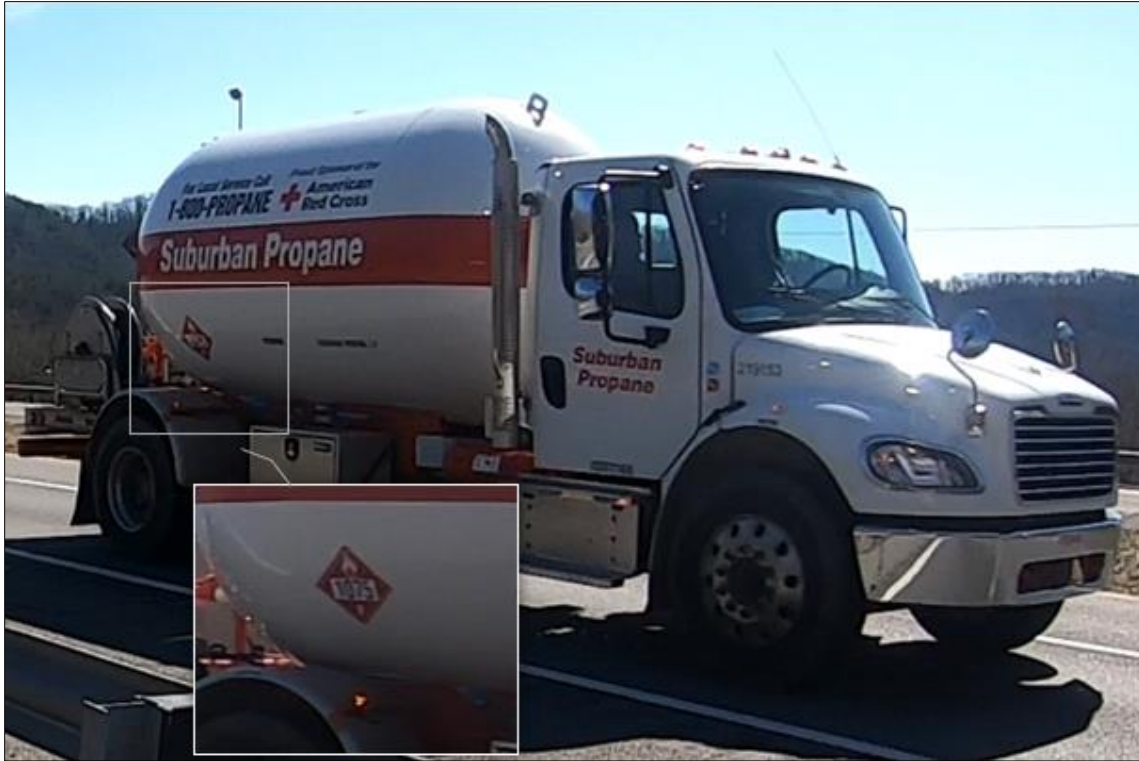
Figure 23. Example of a False Negative, Still Image from Captured Footage Showing the Placard Clearly Visible, Likely Meaning a True False Negative
