1. Report No. FHWA/VA-94-IR1	2. Government Accession No.	3. Recipient's Catalog No.	
4. Title and Subtitle Field Study of a Shredded-Tire Embankment		5. Report Date June 1994

FIELD STUDY OF A SHREDDED-TIRE EMBANKMENT

June 1994
VTRC 94-IR1

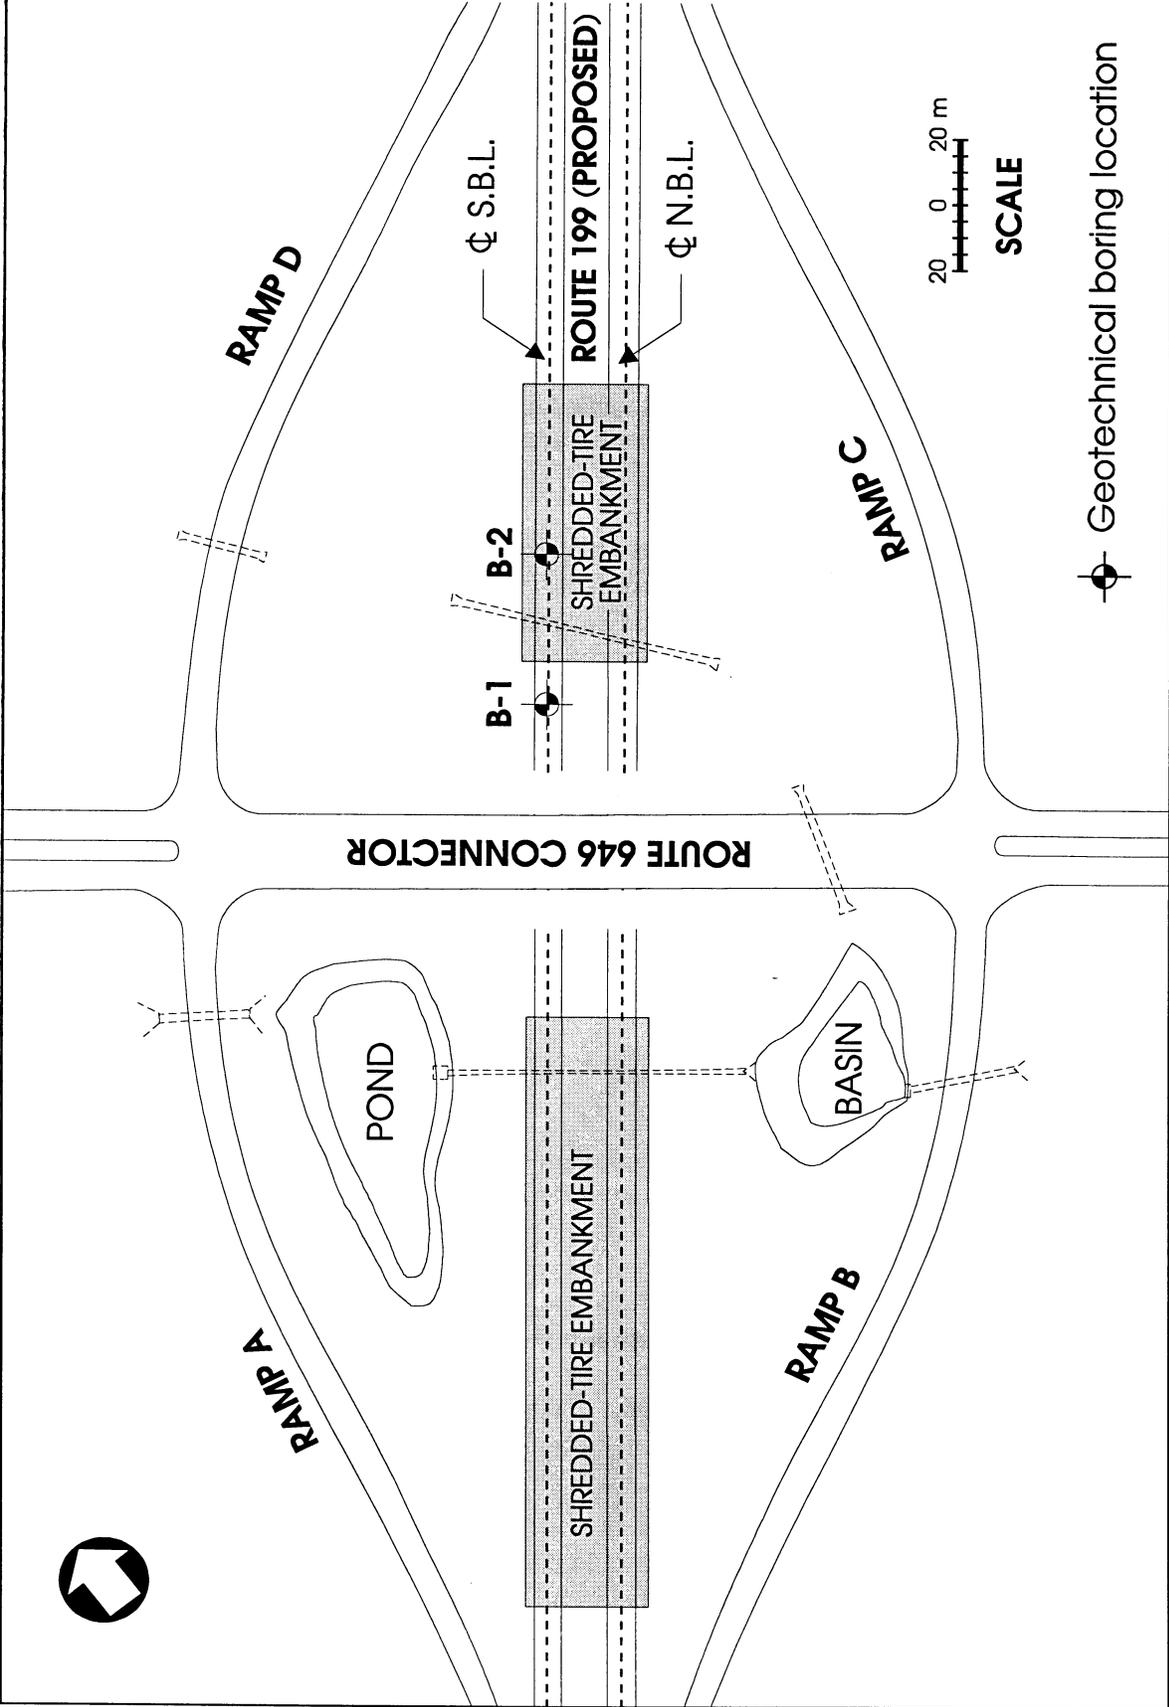
Figure 2. Project Site.

In the summer of 1993, two embankments were built adjoining the Rte. 646 connector, as shown in Figure 2. One embankment contained a section of shredded tires approximately 160 m long. This embankment was constructed south of the Rte. 646 connector. The other embankment, constructed to the north, contained a section of shredded tires approximately 80 m long. Shredded-tire embankment sections were built using an approximate 50/50 volumetric ratio of rubber to soil. Specifications for a shredded-tire fill are included in Appendix A. A typical embankment cross-section is shown in Figure 3.

Future area development plans involve construction of a bridge over the Rte. 646 connector, linking both embankments. In the interim, all traffic along Rte. 199 will be routed on the four circumferential ramps, as shown in Figure 2.

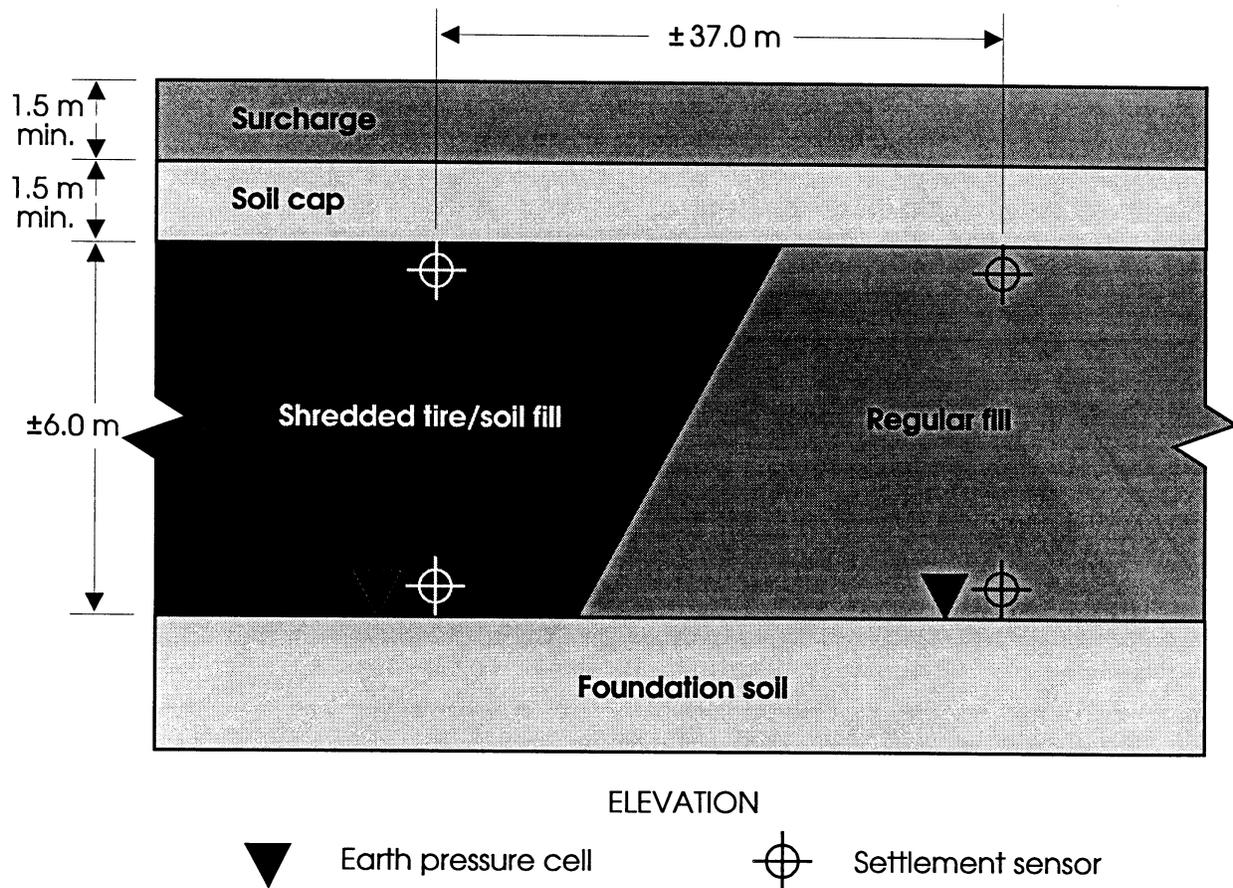
Figure 4. Elevation of Embankment.

The instrumentation installed at the north embankment consists of two earth pressure cells and four settlement sensors interfaced with an electronic datalogger. Both the conventional and shredded-tire embankment sections were instrumented at locations B-1 and B-2, as shown in Figure 2. Earth pressure cells were installed at the base, and settlement sensors were placed at the base and the top. The earth pressure cells and settlement sensors are equipped with temperature probes. Sensor locations are indicated in Figures 4 and 5. The wiring diagram is shown in Figure 6.

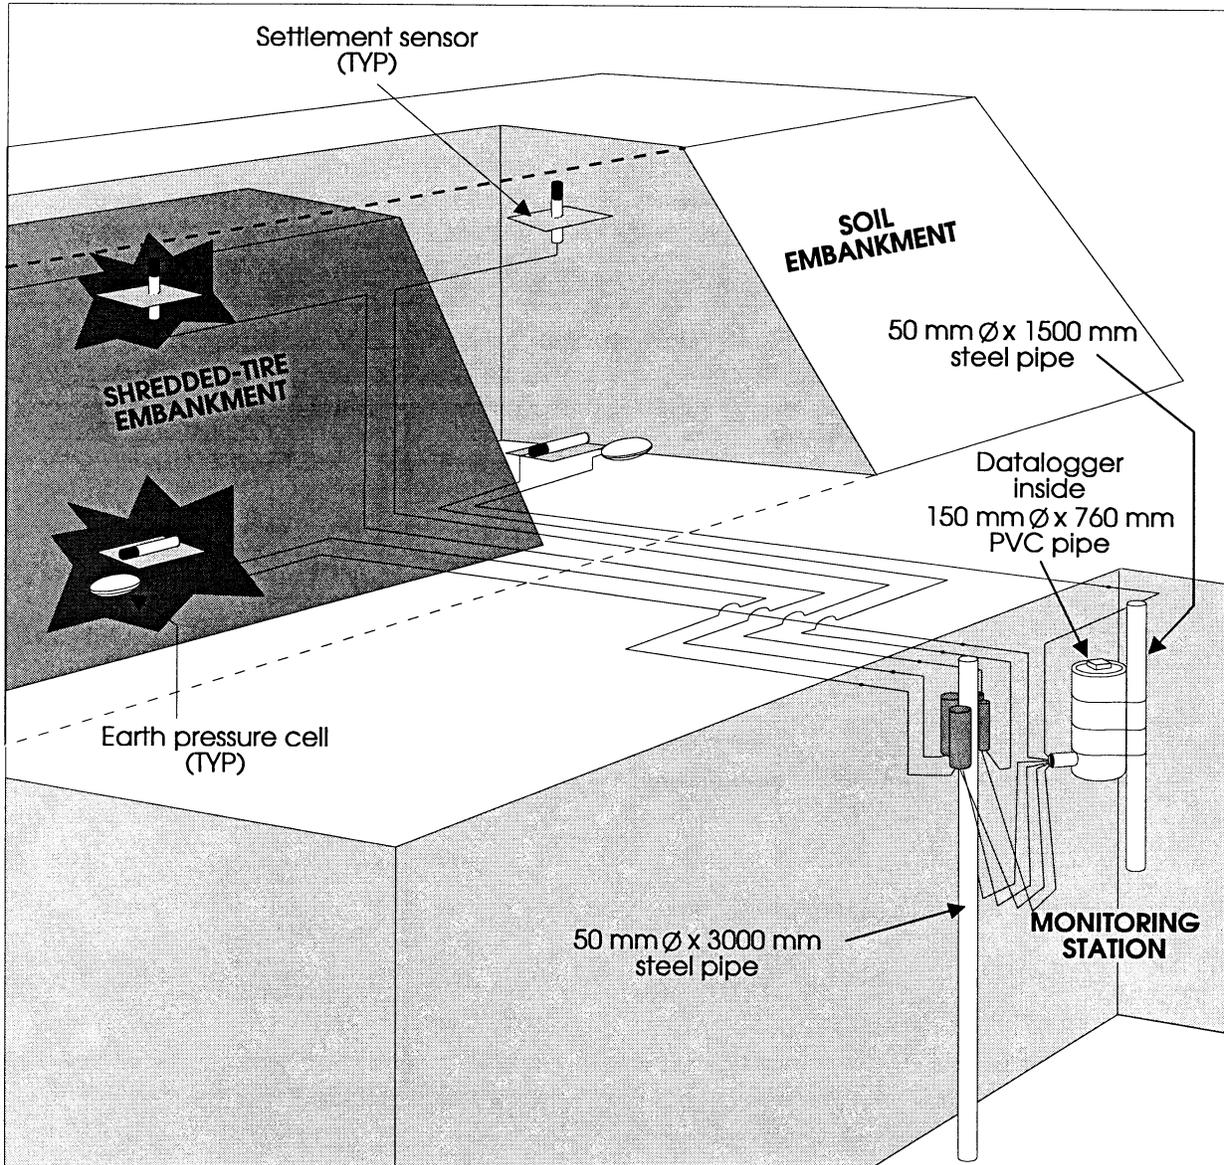
Figure 5. Instrumentation Setup.

The purpose of the installation was to enable the long-term, remote collection of a large volume of settlement, pressure, and temperature data. All instrumentation, except for a 163 x 41 mm solar cell, is located underground. The datalogger used in the study has a NIST traceable calibration. To secure the subsurface operation, the datalogger was placed in a waterproof enclosure consisting of a section of PVC pipe. During the construction phase, data were collected at half-hour intervals. Currently, the datalogger is programmed to sample every 2 hours. All sensors are of the “vibrating wire” type to minimize the long-term drift. The principle behind a settlement sensor operation is illustrated in Figure 7. Settlement sensors are attached to 300 x 300 mm steel plates.

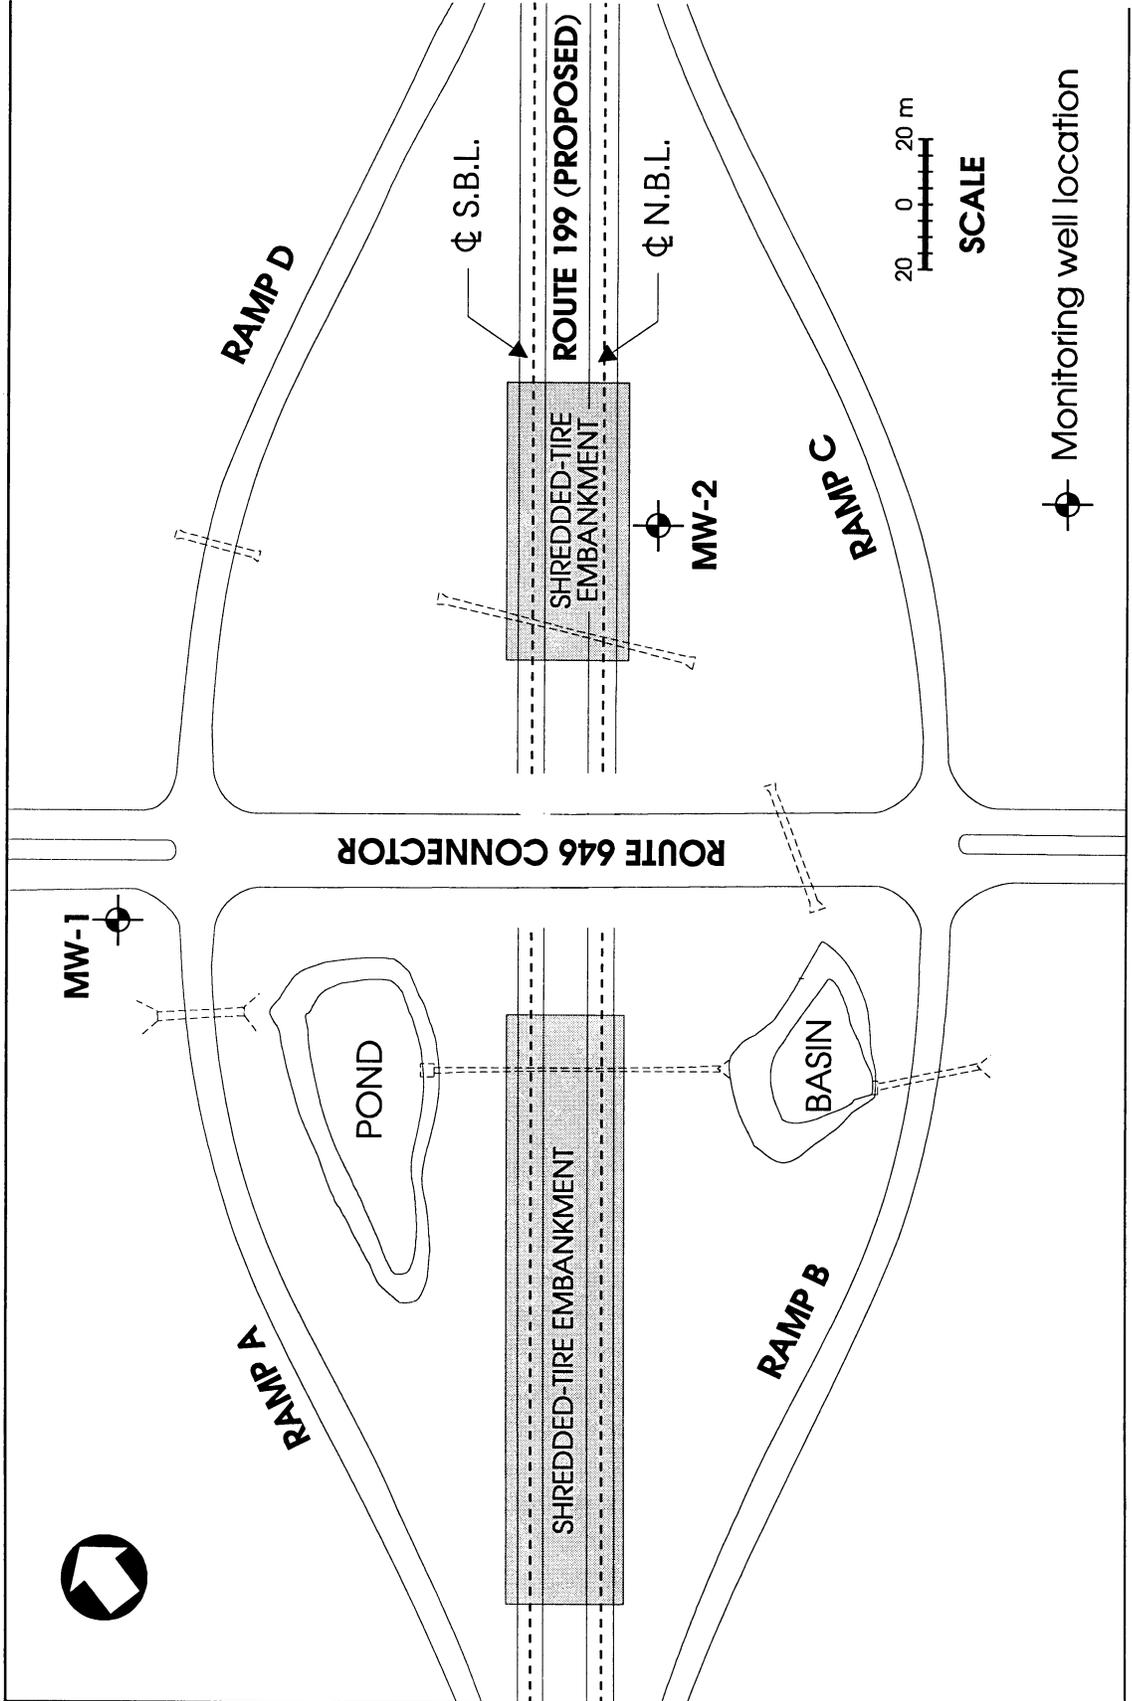
Figure 8. Location of Monitoring Wells.

The scope of the study was expanded to include groundwater monitoring for contaminants that might be leached from the tire core. One monitoring well was installed hydraulically upstream of the shredded-tire section, and one well was installed at the toe of the section. The location of the monitoring wells is shown in Figure 8. Groundwater sampling is being conducted in accordance with the Virginia Department of Environmental Quality Solid Waste Management

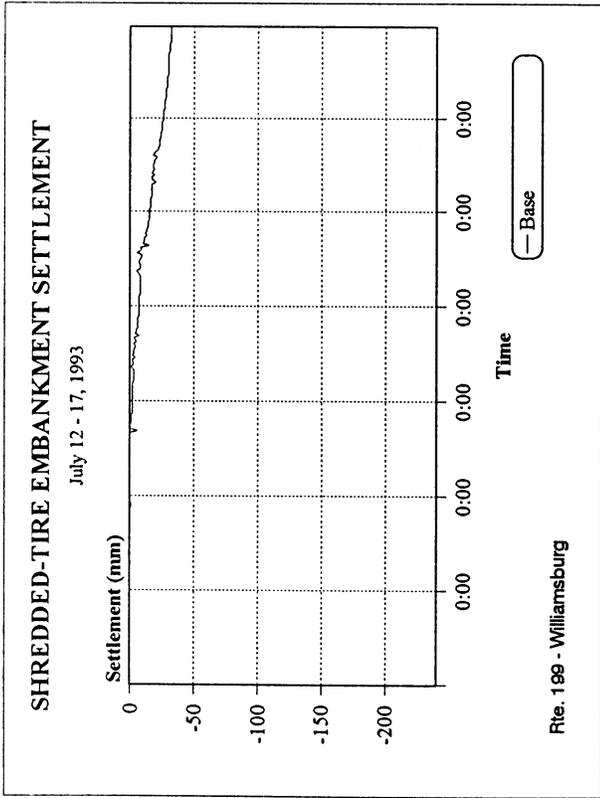
Note: Sensors installed on 7/12/93. Embankment construction began on 7/13/93.
Time 0:00 corresponds to midnight.

The settlement of the foundation soil and the vertical stress exerted by the embankment on the foundation soil have been monitored from the outset of construction. Both sections of the embankment have been monitored. Appendix C contains the results of settlement, vertical stress, temperature at the base elevation, and temperature at the monitoring station approximately 1 m below the ground surface. Data were collected at half-hour intervals during construction and at 2-hour intervals thereafter. At the end of construction, the upper settlement sensors were activated and all settlement readings were re-zeroed to indicate simultaneously postconstruction settlements of the top of the embankment and the foundation soil. The results included in Appendix C cover the period of 7/12/93 to 11/20/93.
