FINAL REPORT

EVALUATION OF A VIDEO IMAGE DETECTION SYSTEM

1. Report No. FHWA/VA-94-R22		2. Government Accession No.		3. Recipient's Catalog No.	
4. Title and Subtitle Evaluation of a Video Image Detection System				5. Report Date May 1994

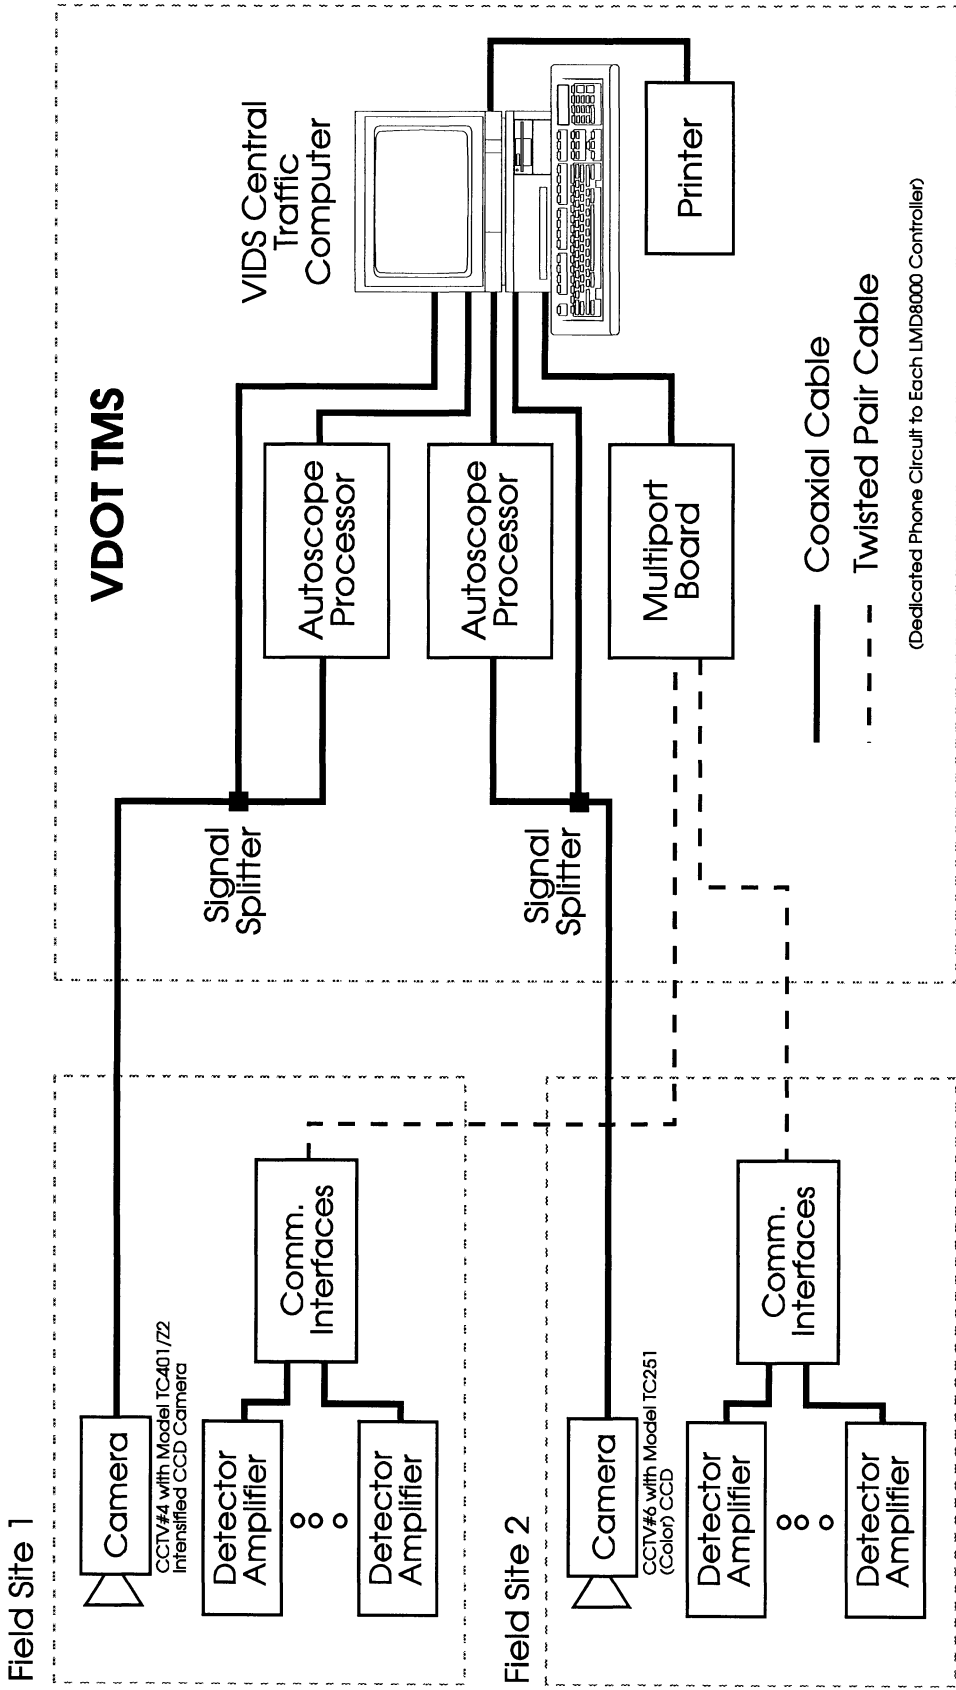
Figure 1. VIDS system general configuration.

The planning and design of the VIDS was completed by FSI.⁴ The system's configuration is depicted in Figure 1. The loop detectors, detector amplifiers, and communication interfaces were installed to permit a comparison between the performance of the Autoscope and the loop detectors with respect to traffic monitoring and incident detection at each site. The VIDS Central Traffic Computer, which was an IBM PS2 Model 80, was equipped to accommodate up to 16 Autoscoopes and to display and receive full motion video. The operating system (IBM's OS/2) combined multi-tasking support with graphical user interface. The VIDS software consisted of two servers, VIDS and SQL. The VIDS server processes communications information, records detector data, and monitors the detectors. Microsoft SQL Server software is the database management system.

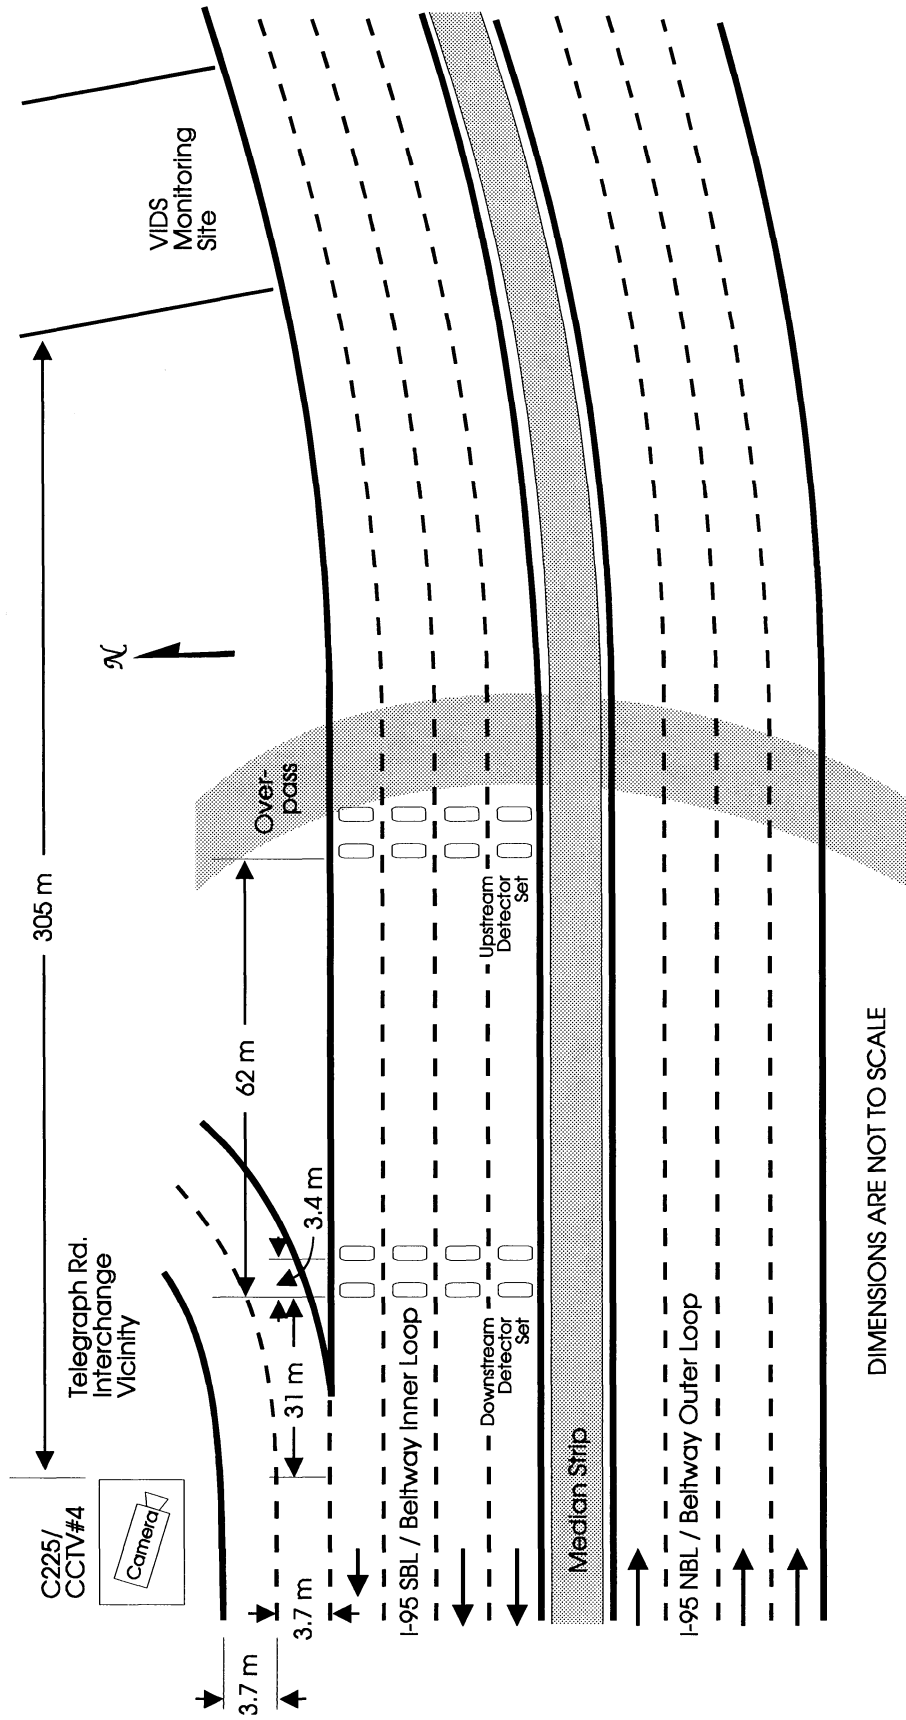
Figure 2. VIDS camera and loop detector placement at Site 1.

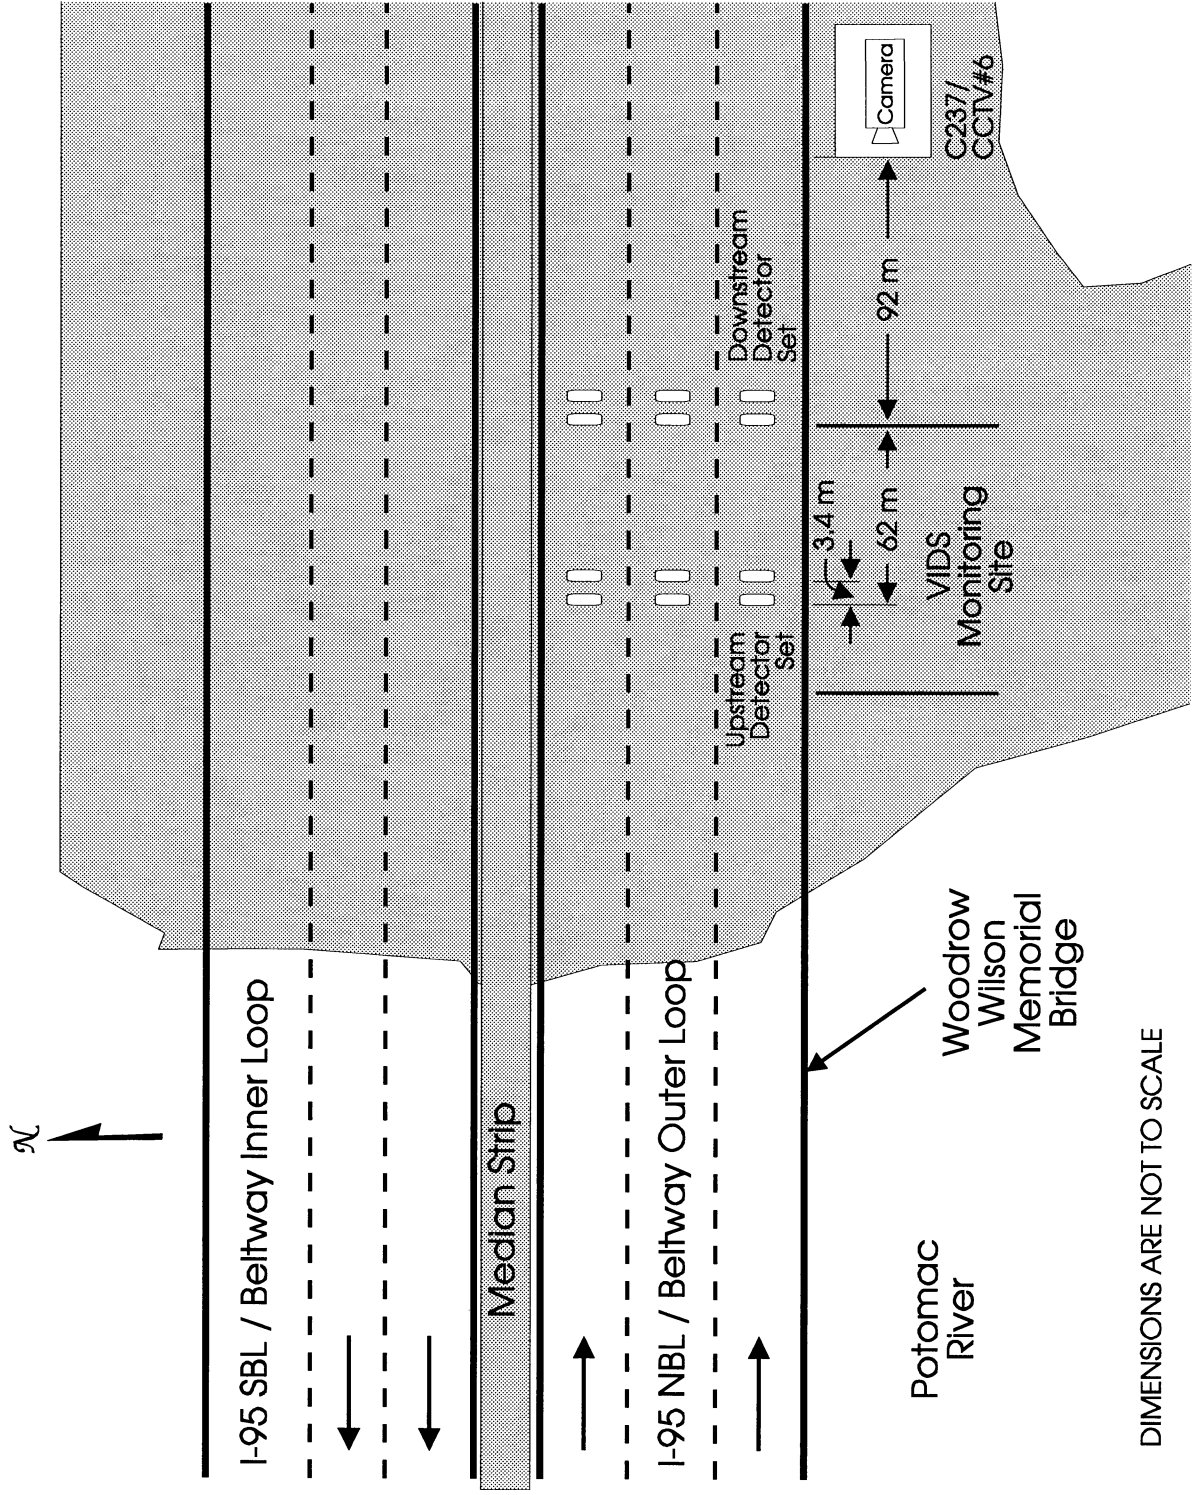
Figure 3. VIDS camera and loop detector placement at Site 2

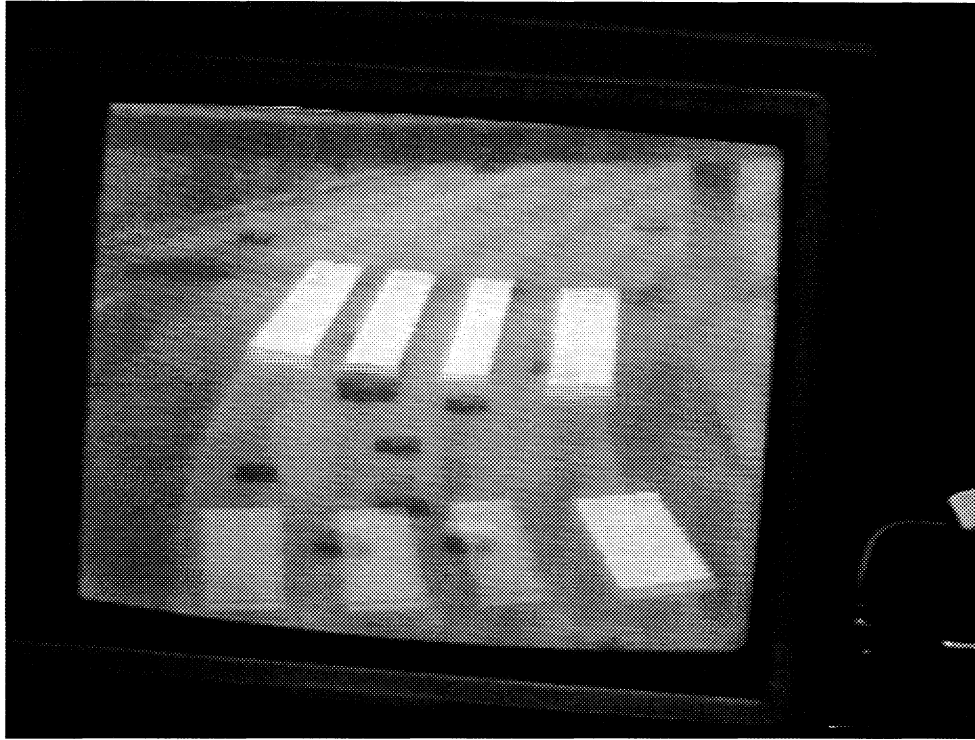
Figure 4. Autoscope detector configuration at the Telegraph Rd. site.

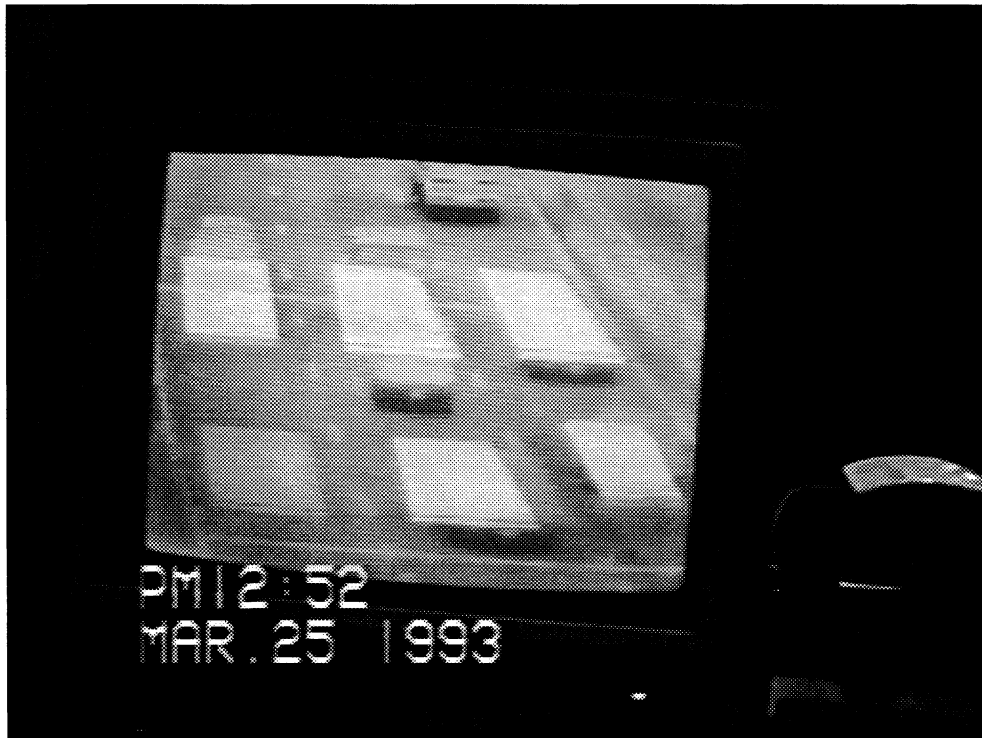
Figure 5. Autoscope detector configuration at the WW Bridge site.

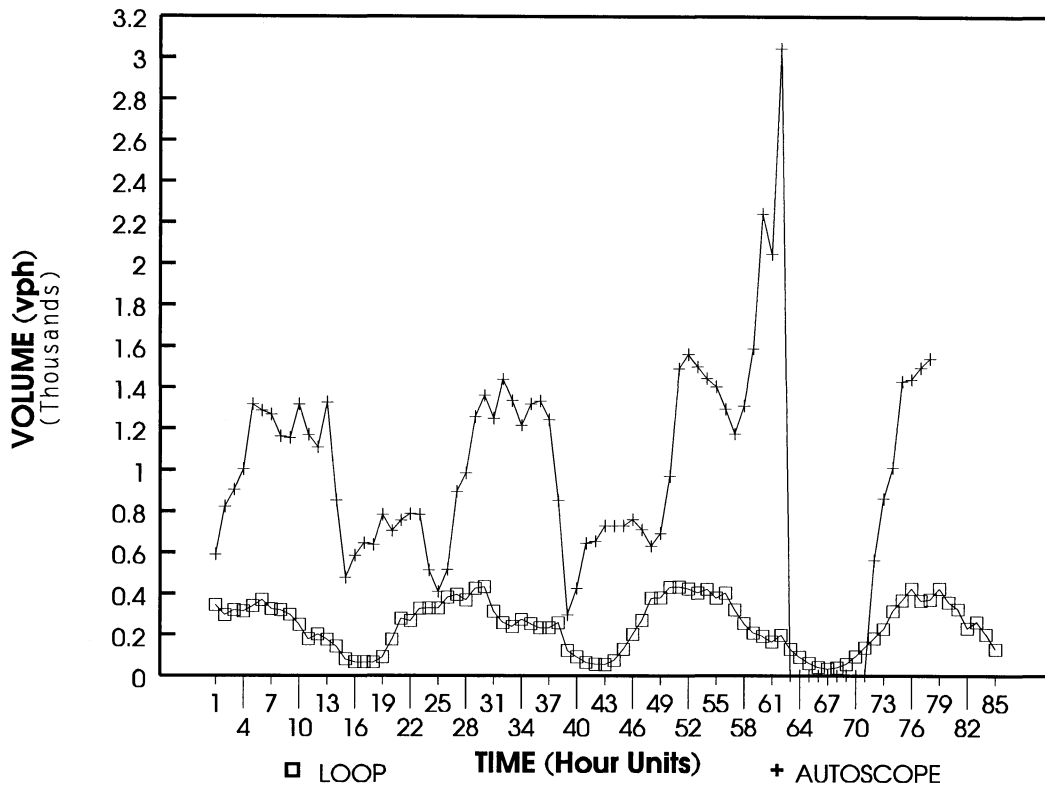
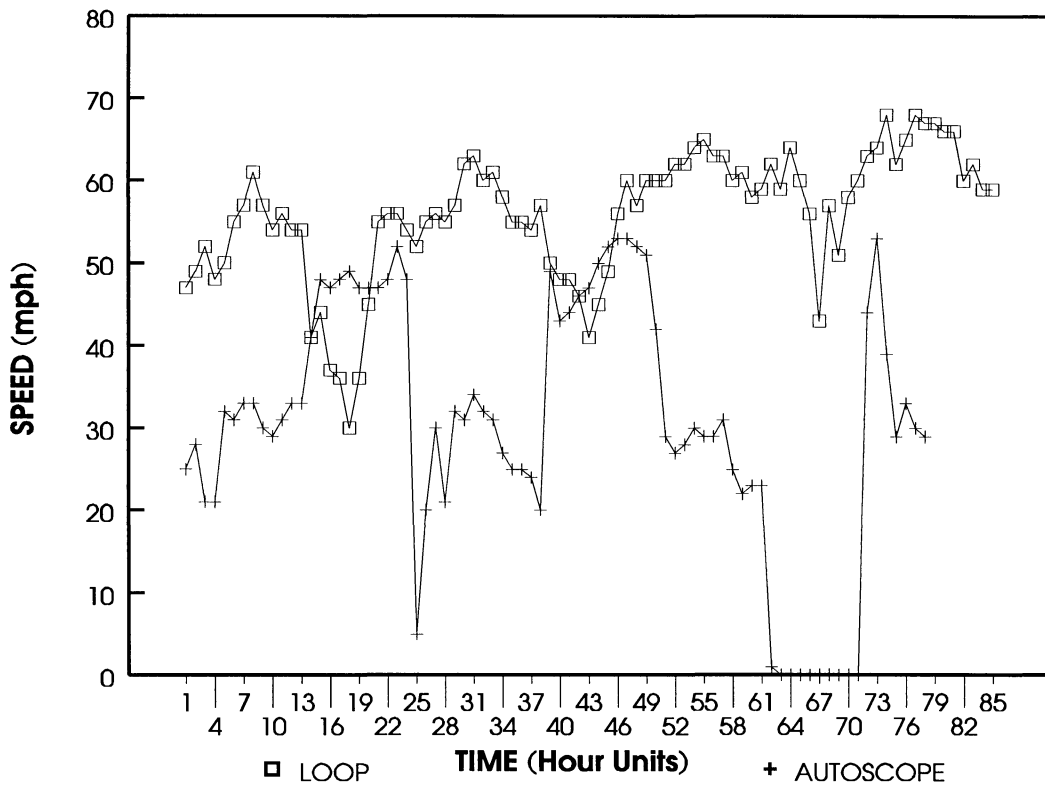
Figure 6. Volume and speed of lane 1 at Telegraph Rd.

Volume and speed data for the Autoscope and loop detectors by lane for the week ending March 9, 1993, are graphically displayed in Figures 6 through 9. The Autoscope volumes are higher than the volumes generated by the loop detectors. Also, the Autoscope speeds are generally lower than those produced by loop detectors. The Autoscope speeds in lane 2 track the loop detector speeds closer than the other lanes. In general, the loop volume and speed data

appear in a smooth and consistent pattern, whereas the Autoscope data are erratic for each of the four lanes.

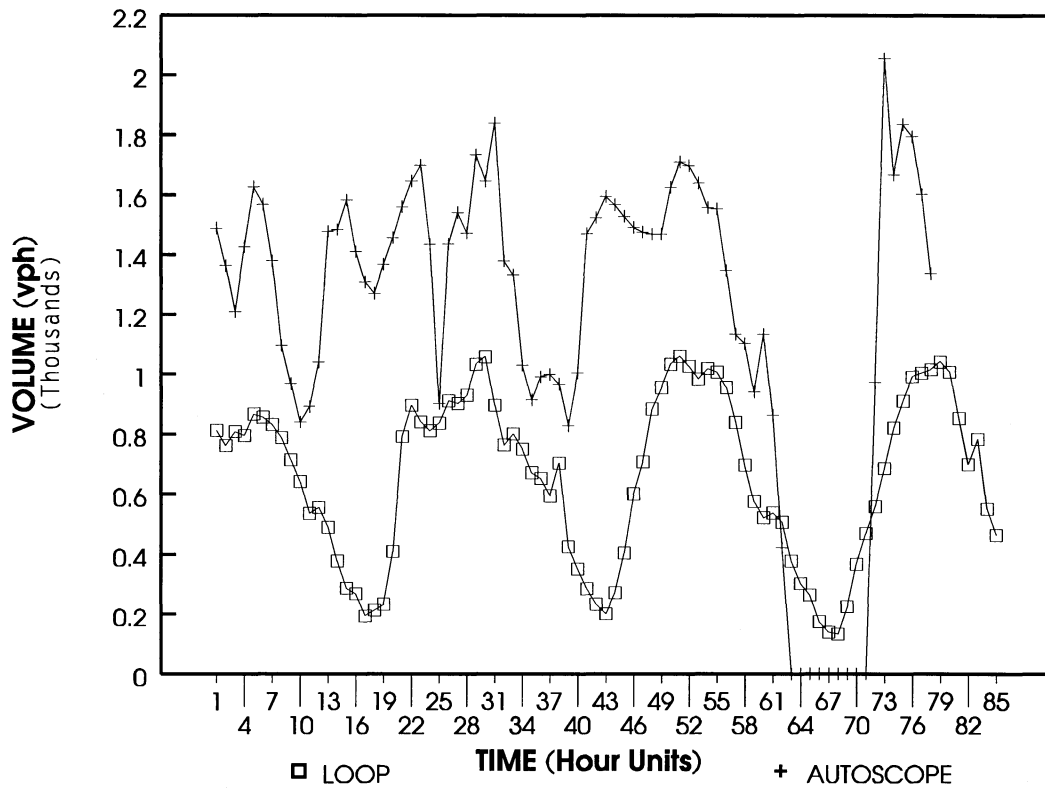
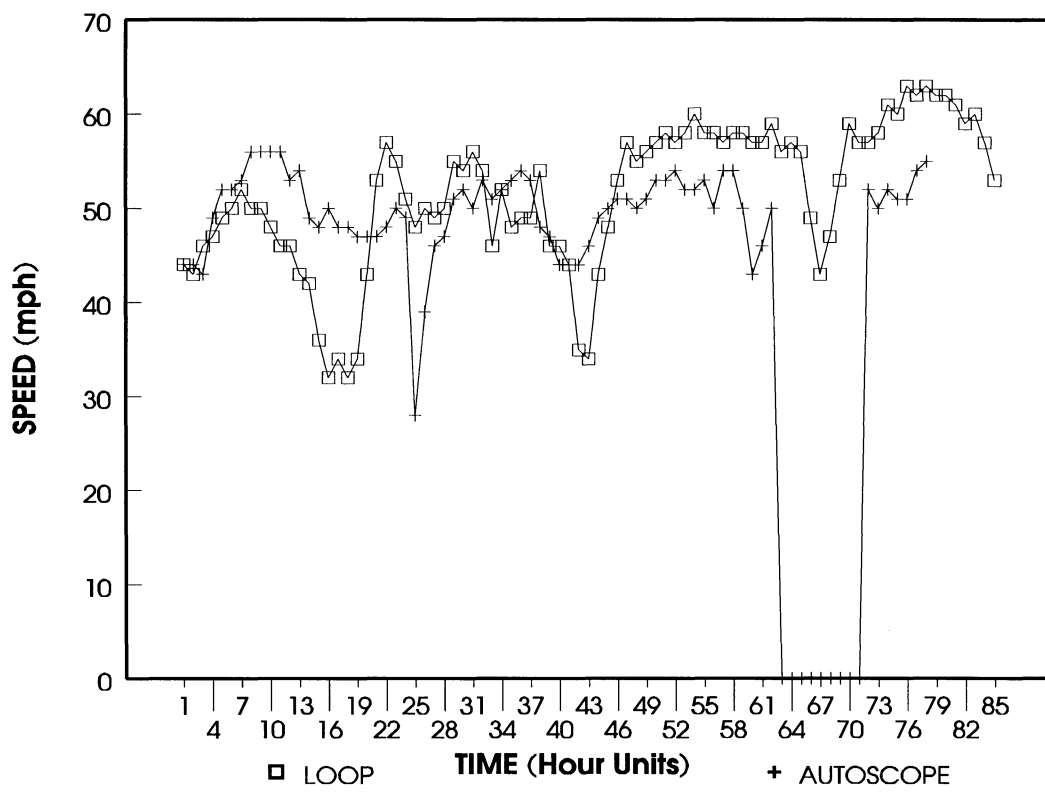
Figure 7. Volume and speed of lane 2 at Telegraph Rd.

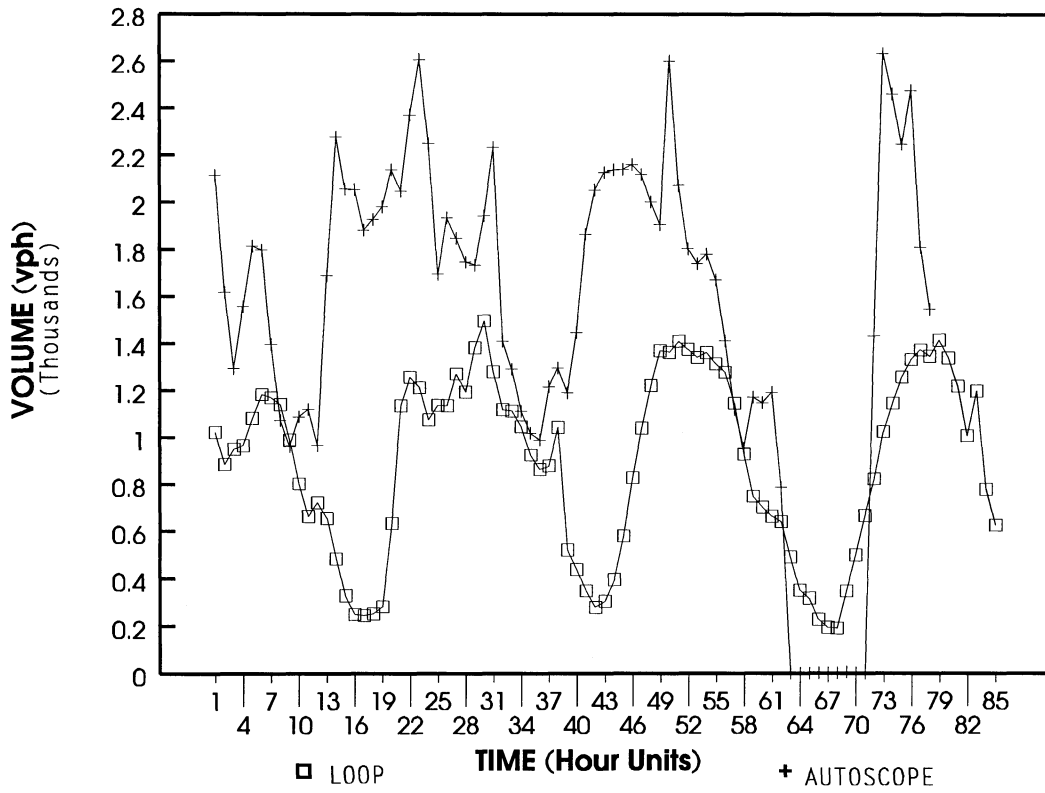
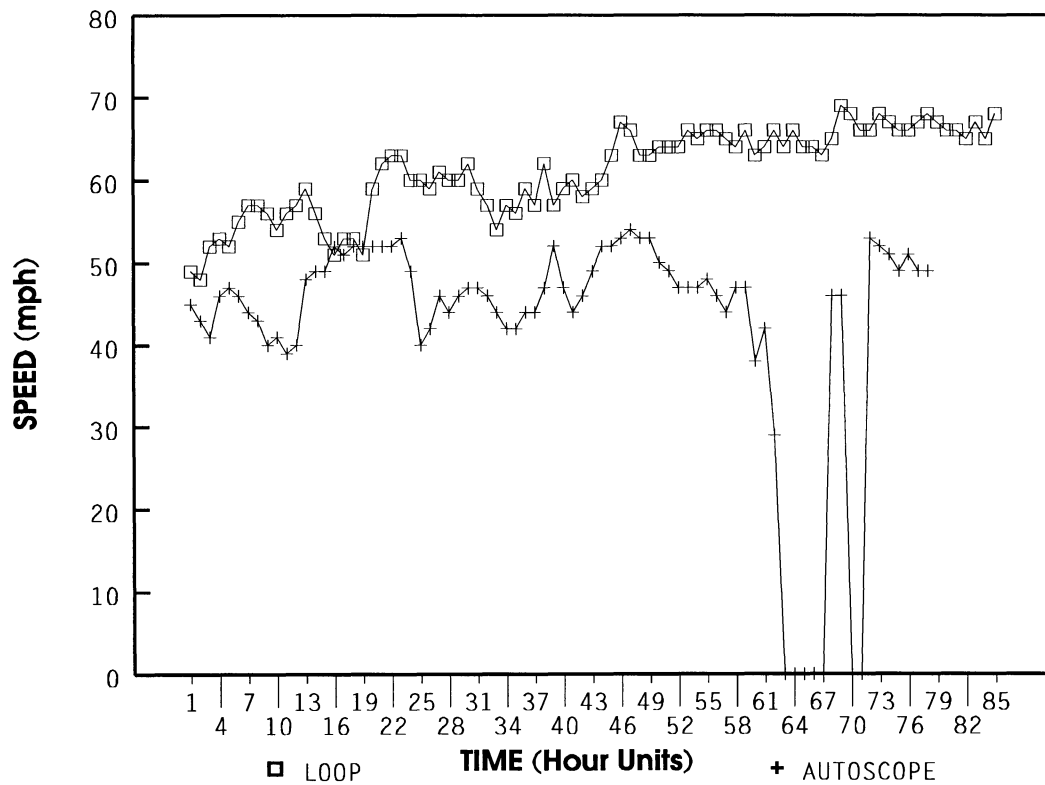
Figure 8. Volume and speed of lane 3 at Telegraph Rd.

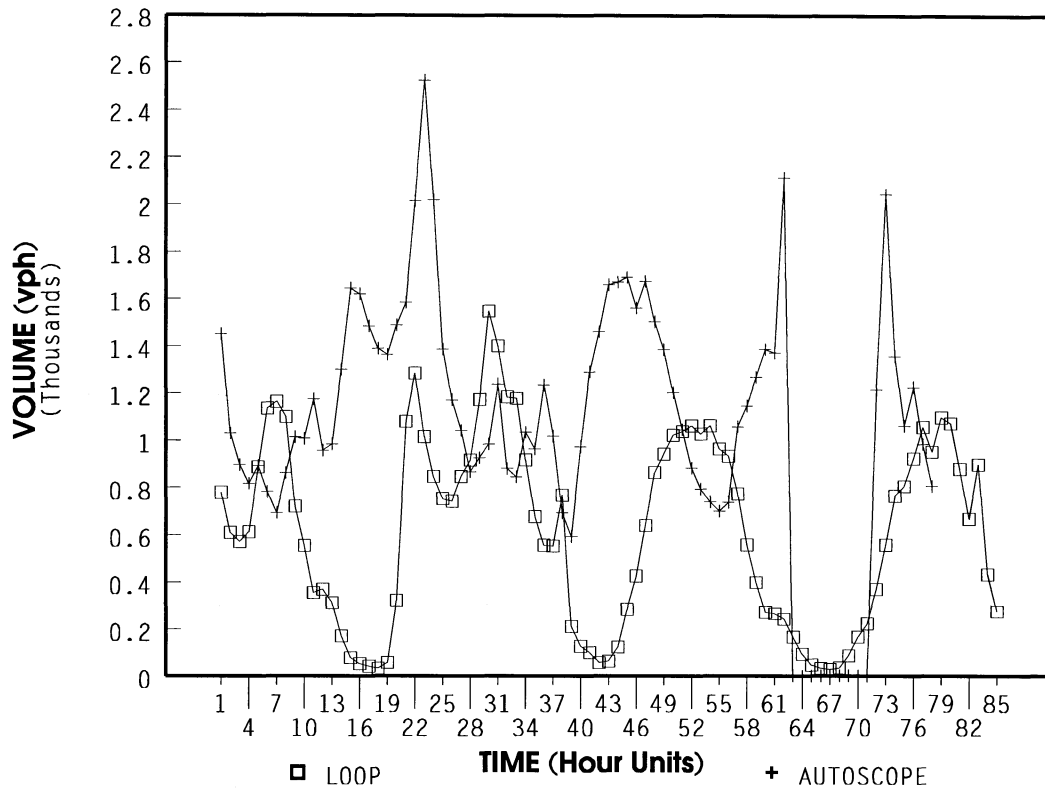
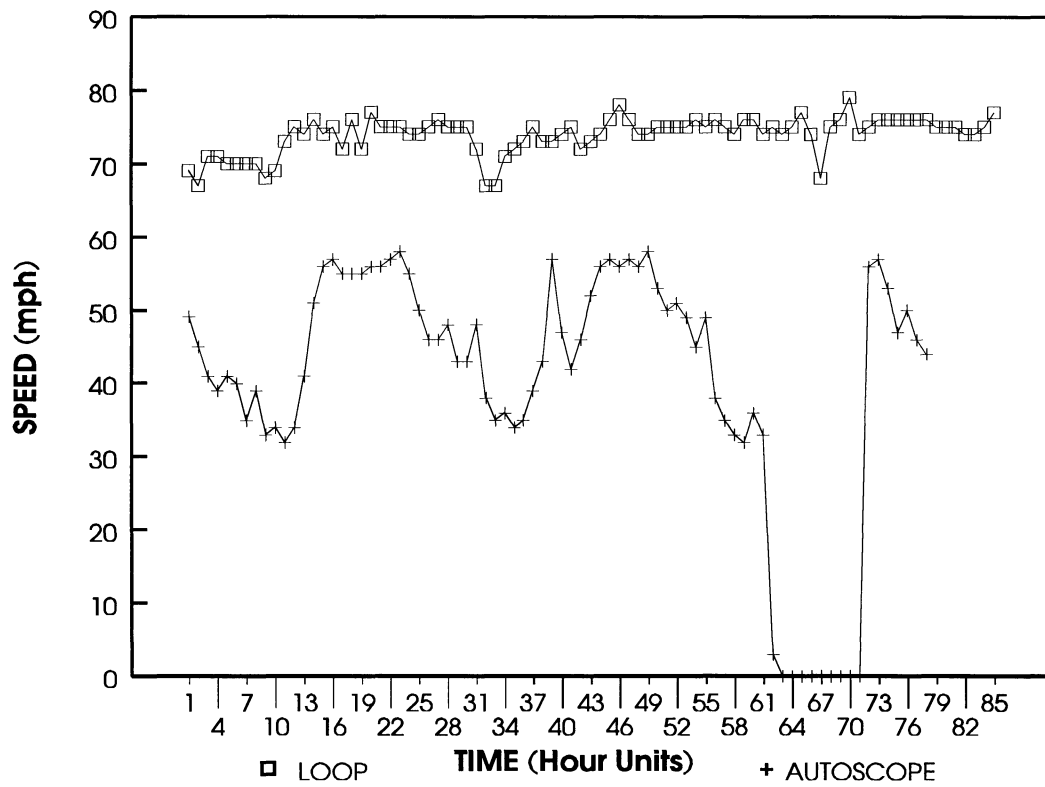
Figure 9. Volume and speed of lane 4 at Telegraph Rd.

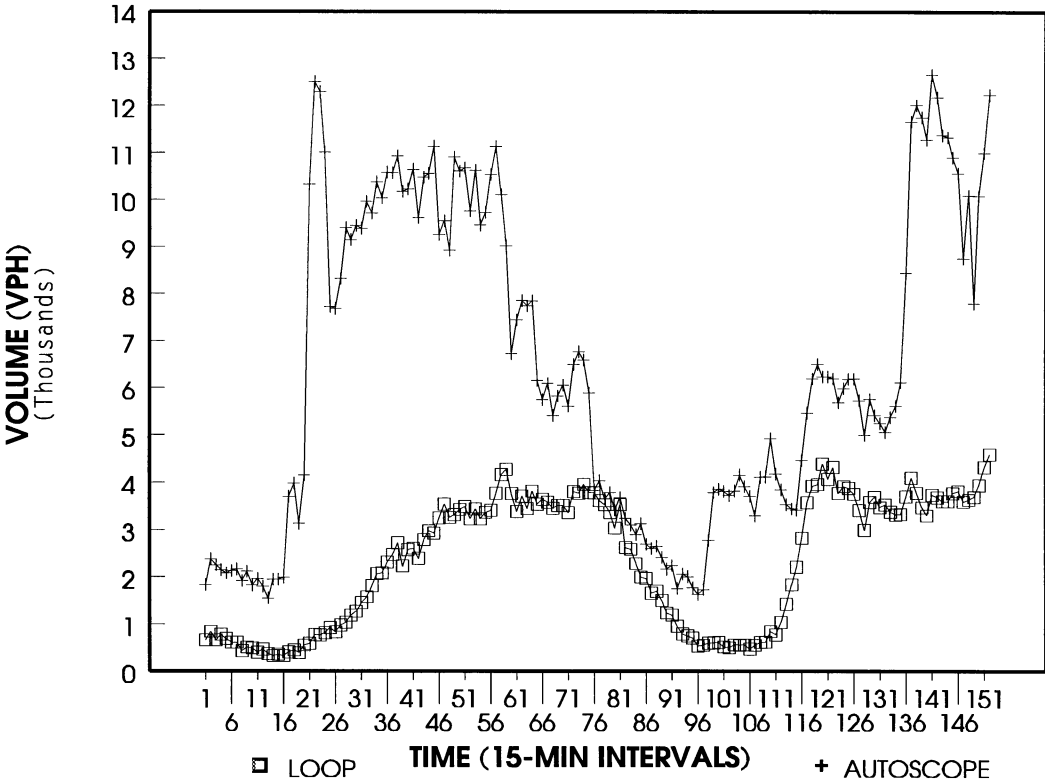
Figure 10. Upstream link volumes at Telegraph Rd.

Link or approach volumes and speeds for the week ending April 12, 1993, are shown in Figures 10 through 13. The loop detector volume curves are similar, as would be expected for upstream and downstream volumes at the same site. The Autoscope upstream and downstream volumes are different. The speed data yield the same similarities and differences as the volume data.

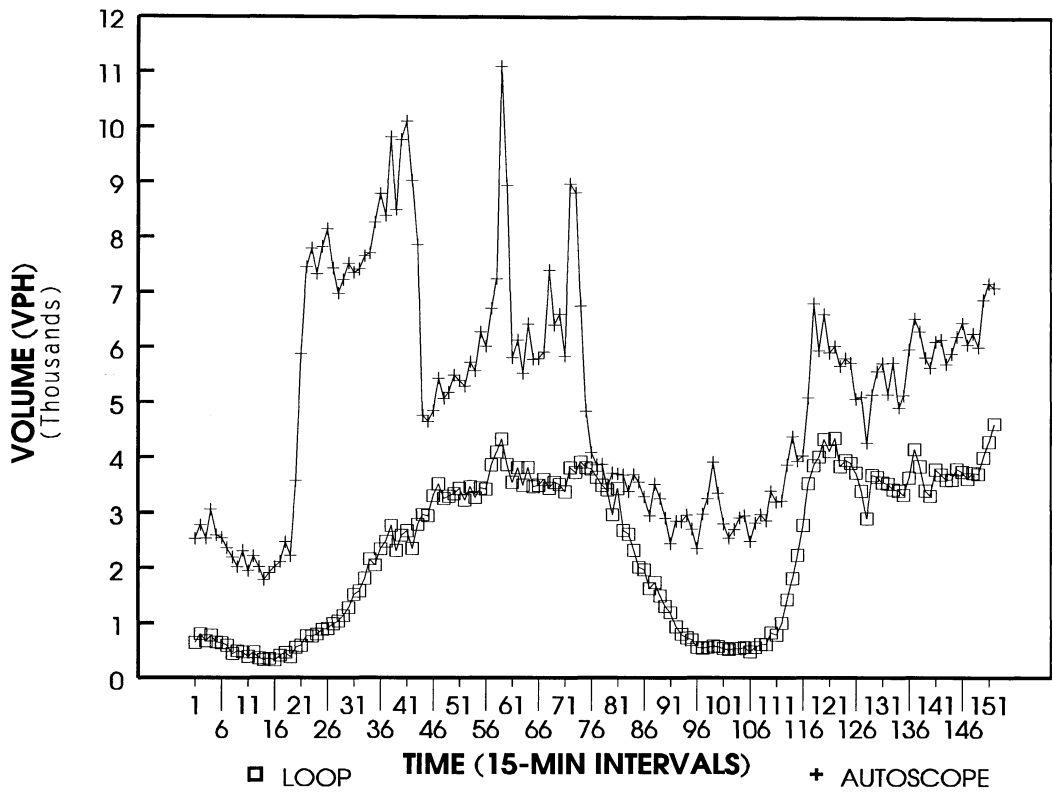
Figure 11. Downstream link volumes at Telegraph Rd.

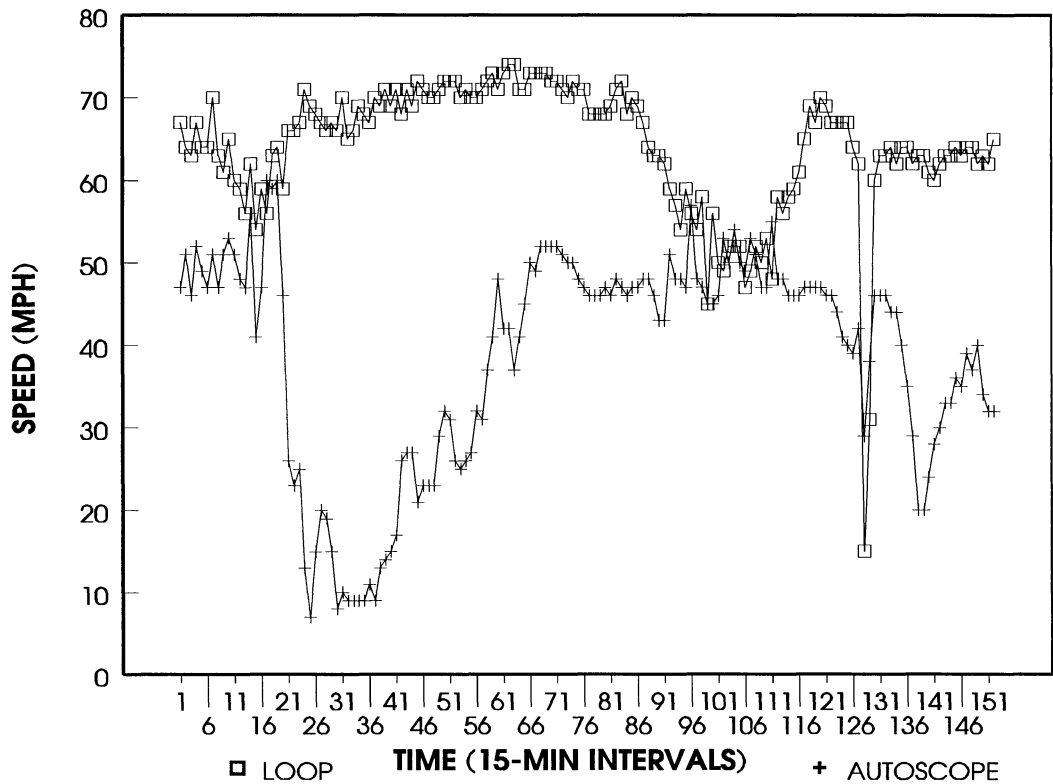
Figure 12. Upstream link speed at Telegraph Rd.

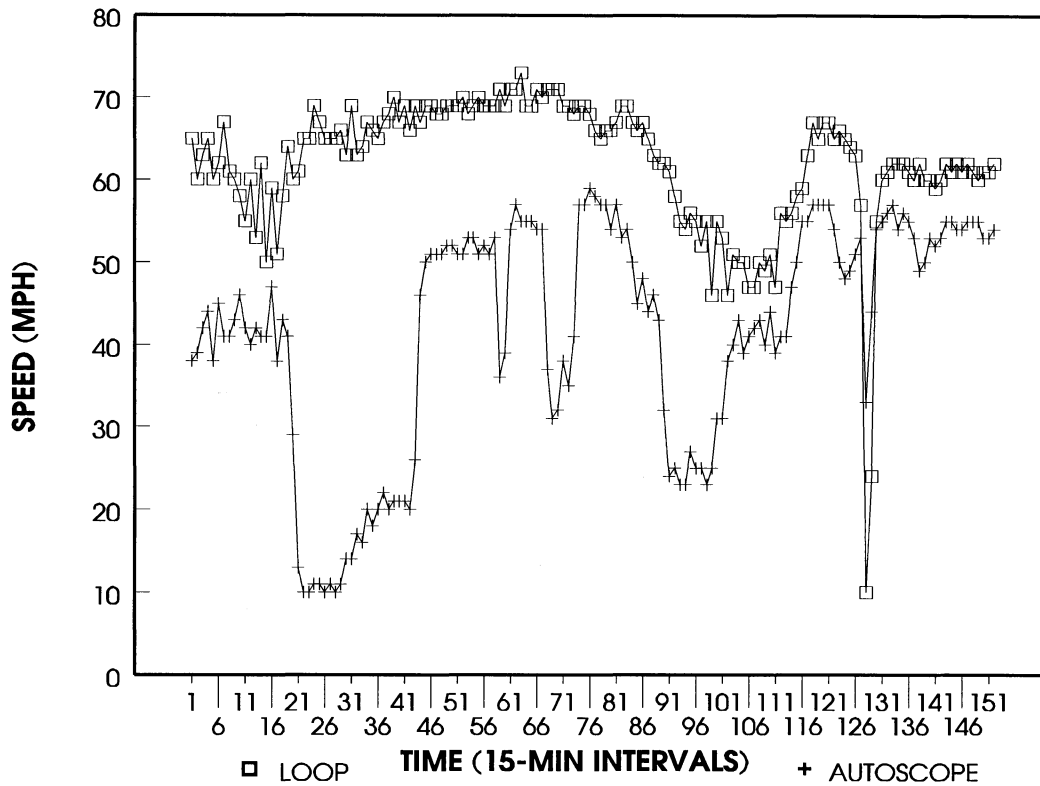
Figure 13. Downstream link speed at Telegraph Rd.

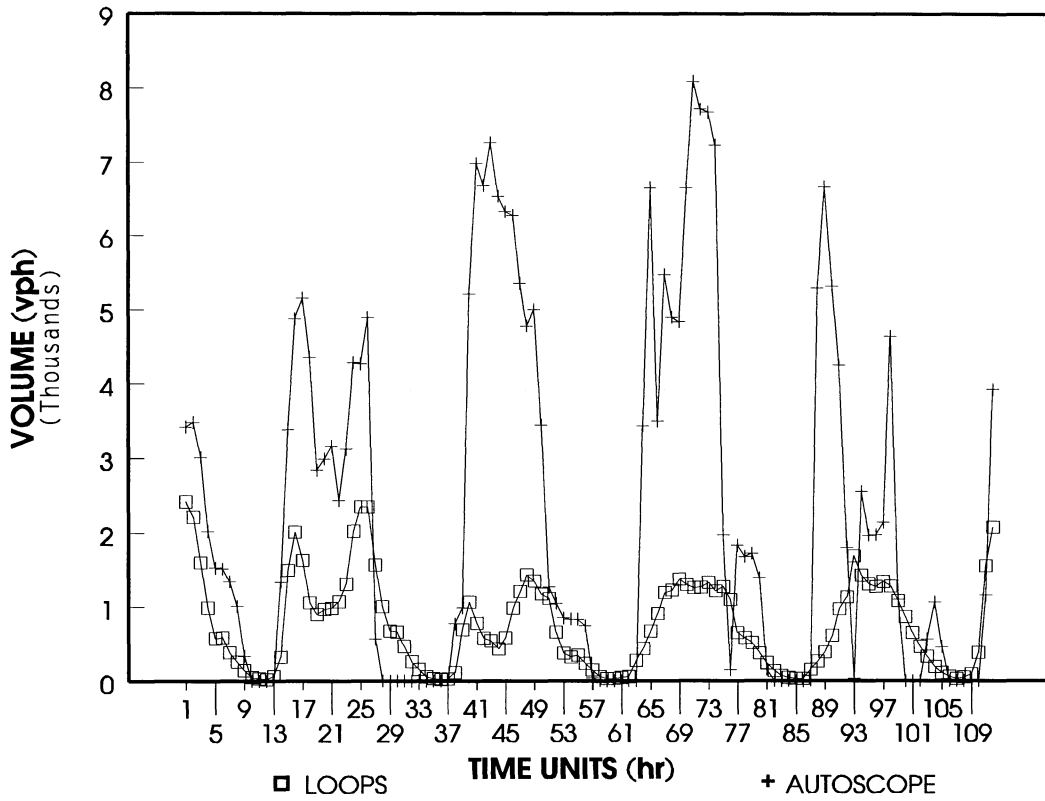
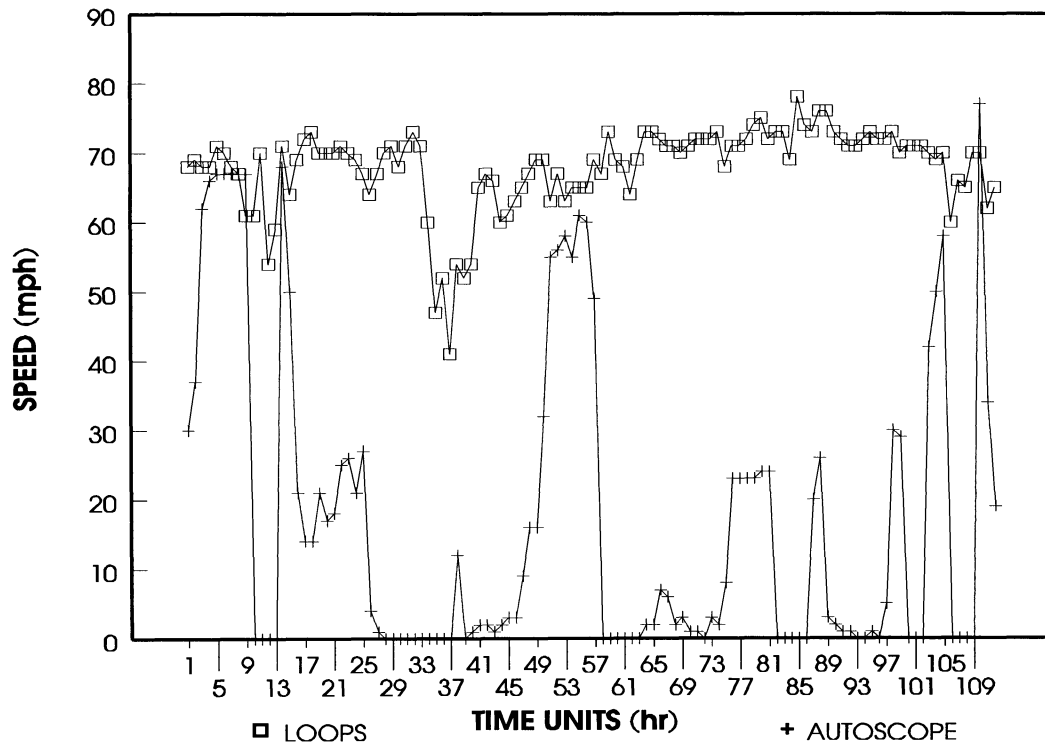
Figure 14. Volume and speed of lane 1 at WW Bridge.

Volume and speed data for the Autoscope and loop detectors by lane from the week ending March 1, 1993, are in Figures 14 through 16. The percentage of difference between the Autoscope and loop detector data is greater than the difference at site 1. It is not known why the Autoscope speed data have many zero values. Statistics for lane 1 that also portray this difference are presented in Table 4. Occlusion may be the major factor in the high Autoscope volume counts. The additional counts caused by occlusion may be higher than those caused by the longer distance from the camera to the monitoring site at site 1. Also, site 2 was especially a problem because of the need to move the camera for surveillance of the bridge. Pavement markings were placed on the pavement to mark the perimeter of the Autoscope detectors interactively drawn on the screen. Although the markings assisted in returning the camera to its Autoscope monitoring position, it was difficult to accurately restore the camera to its original position. This repositioning of the camera may be one reason the difference in the two detectors is greater at site 2. The data collection period was limited to about 3 months for site 2 because it was useless to continue data collection under these conditions.

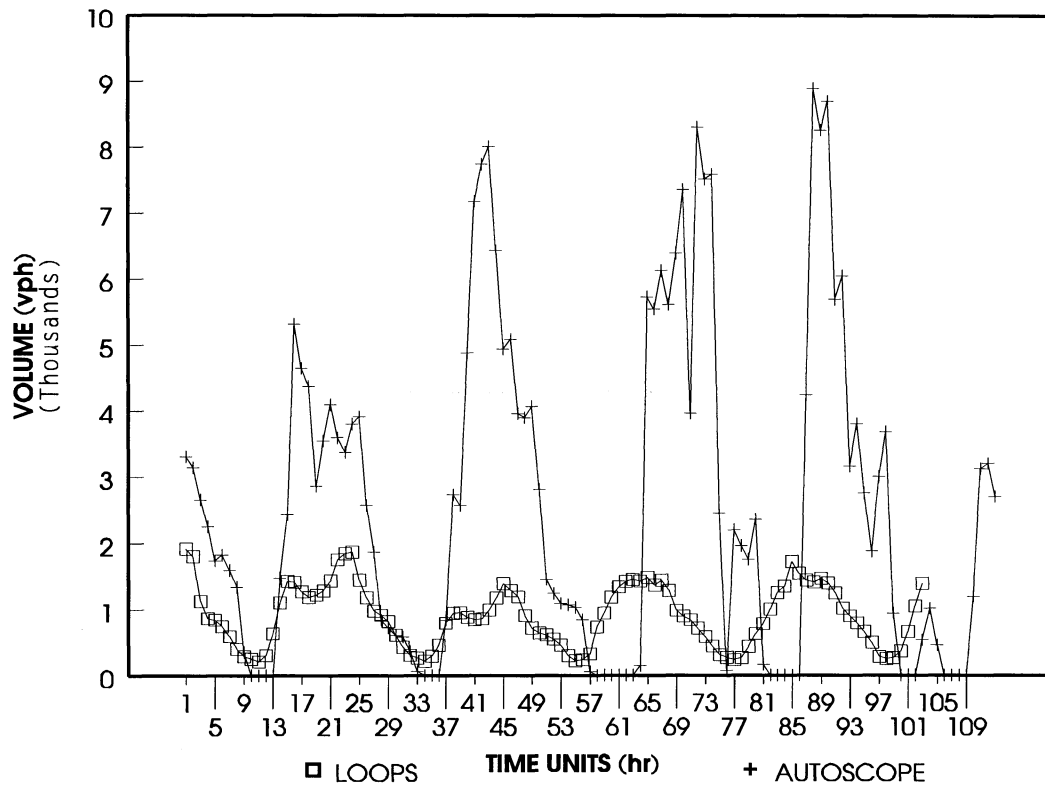
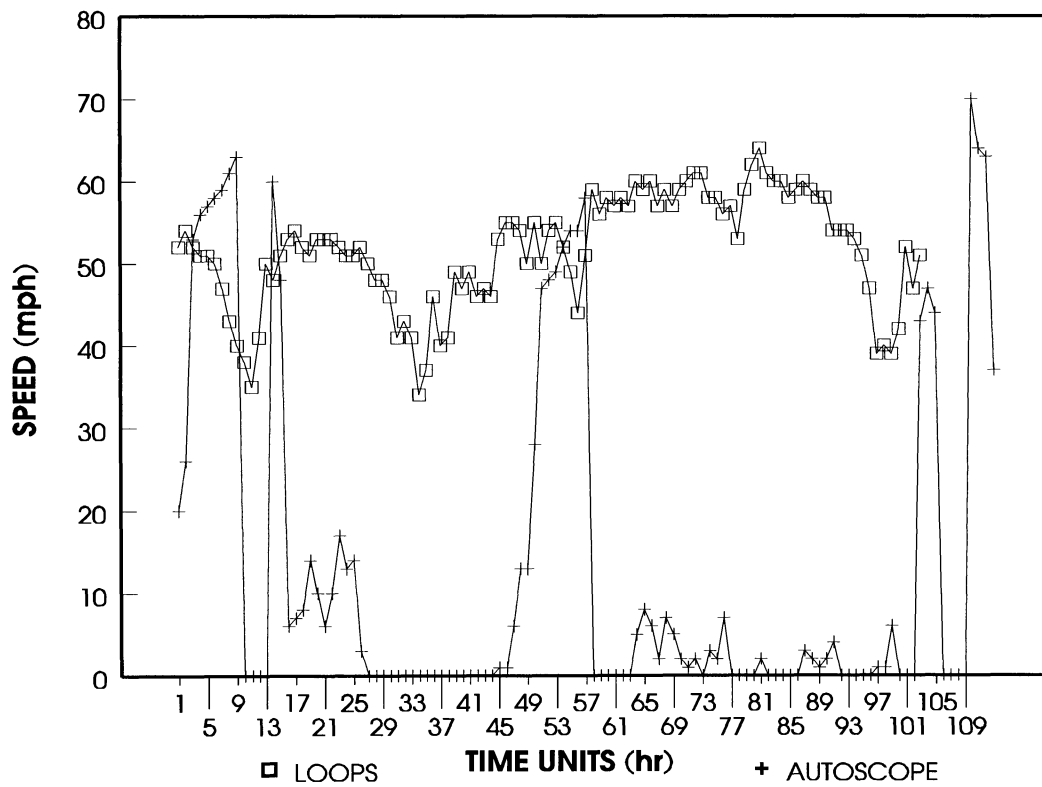
Figure 15. Volume and speed of lane 2 at WW Bridge.

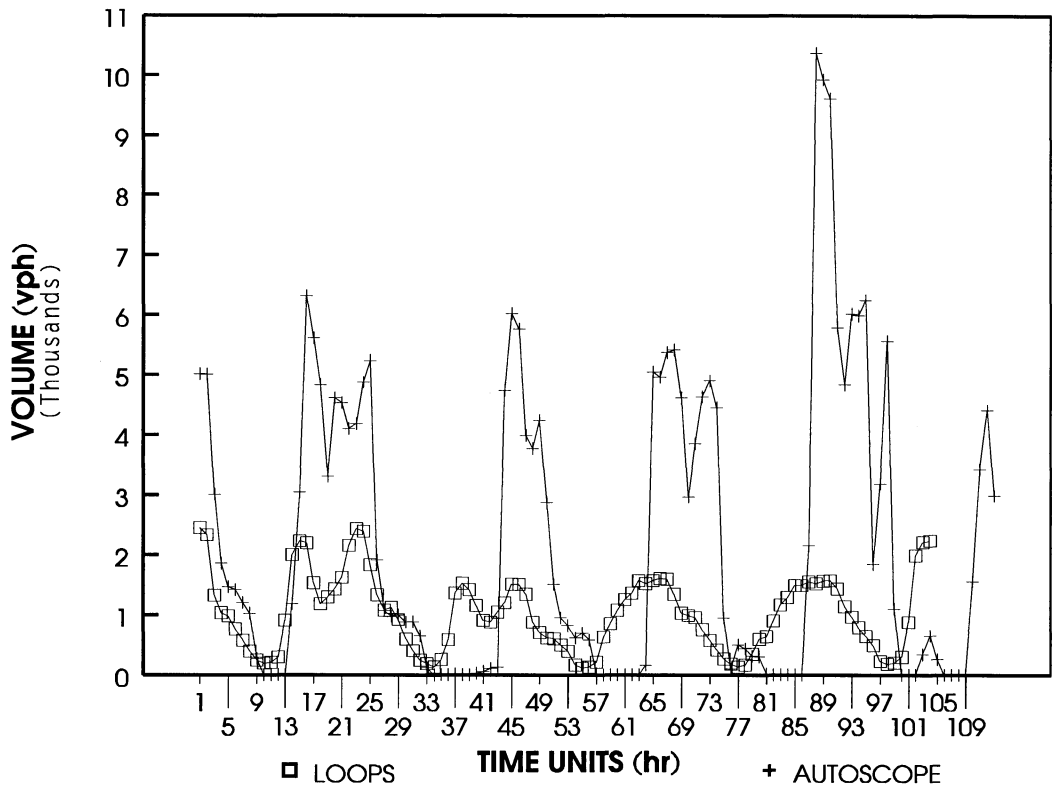
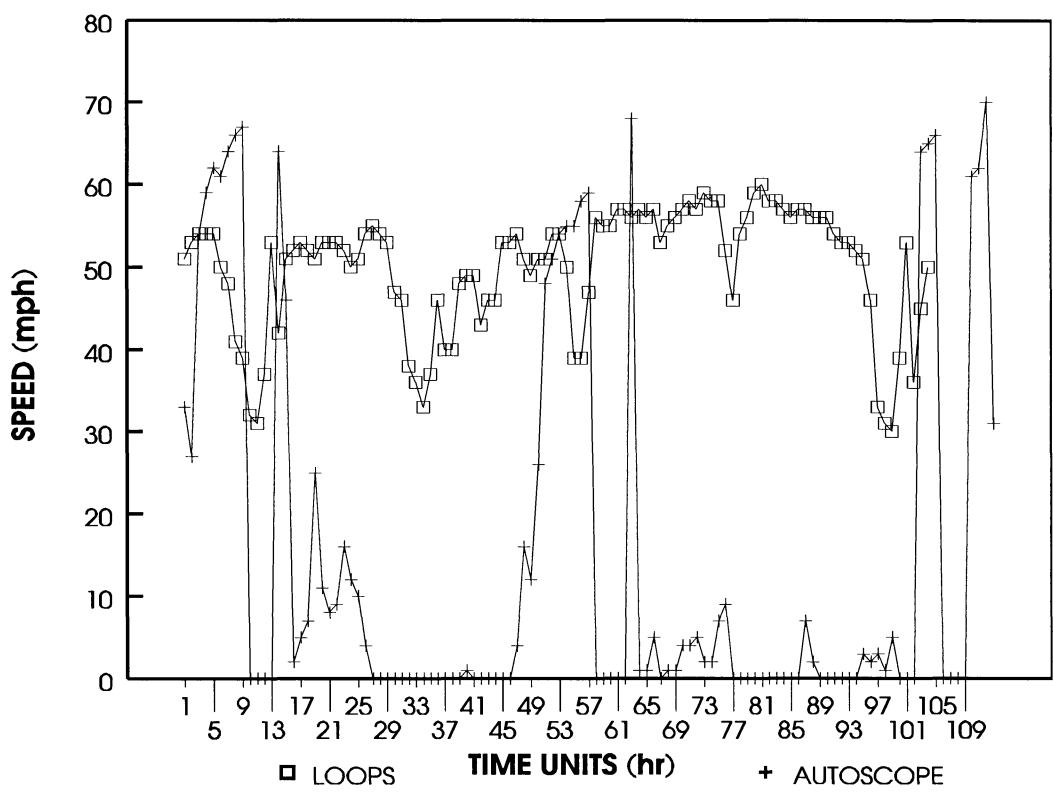
Figure 16. Volume and speed of lane 3 at WW Bridge.
