FINAL REPORT

EVALUATION OF A VIDEO IMAGE DETECTION SYSTEM

1. Report No. FHWA/VA-94-R22		2. Government Accession No.		3. Recipient's Catalog No.	
4. Title and Subtitle Evaluation of a Video Image Detection System				5. Report Date May 1994

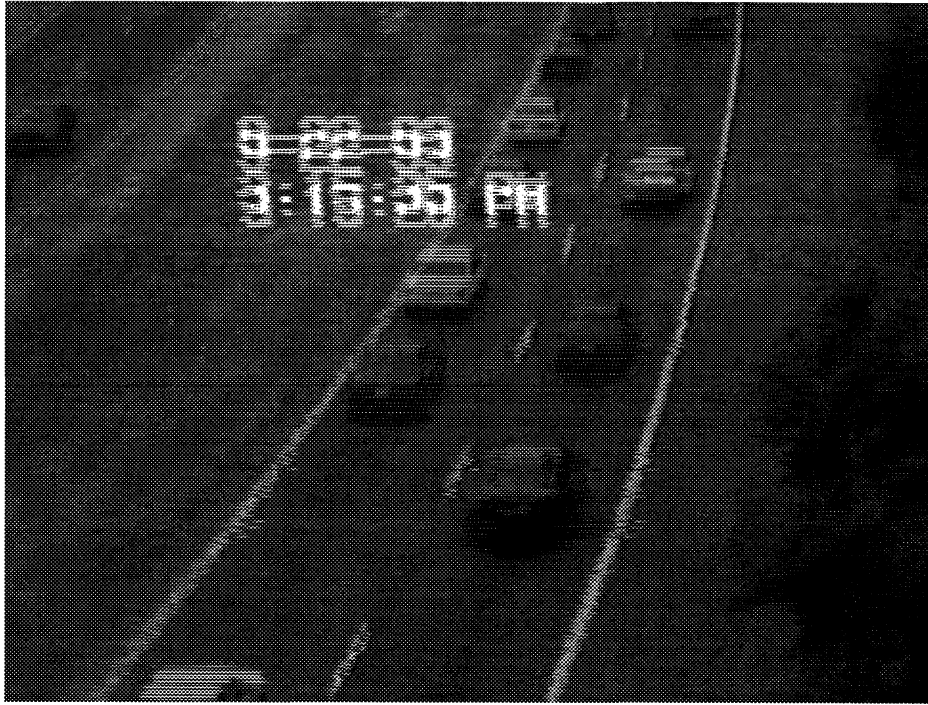
Figure 17. I-295 near the WW Bridge with the camera position directly over the lanes.

A section of I-295 near the WW Bridge was selected because the camera position was such that it appeared that the camera was directly over the two northbound lanes, which is the ideal camera position (see Figure 17). Because there were no loop detectors near the study section, the Autoscope volume data were analyzed by manually counting the traffic from a videotape of the site. To minimize the amount of effort for this labor intensive task, it was decided that at least 500 vehicles across each detector would be examined. This volume level was satisfied by analyzing about 15 minutes of the videotape. The Autoscope and manual volume counts and the percentage of difference are shown in Table 5 for each of the four detectors. The percentage of difference, which ranged from 2 to 7 percent (4 percent for all detectors), is much smaller than the differences obtained at sites 1 and 2. It was also observed that the standard deviation of the Autoscope speed was much smaller than at the other sites. However,
