Management Considerations
for Cultural Resources in Virginia
Department of Transportation Rights of Way

Report No. VTRC 07-R19	Report Date April 2007	No. Pages 57	Type Report: Final Period Covered: May 2004 to December 2006	Project No.: 73233 Contract No.
Title: Management Considerations for Cultural Resources in Virginia Department of Transportation Rights of Way				Key Words: Cultural resources
Authors: Ann B. Miller				
Performing Organization Name and Address: Virginia Transportation Research Council 530 Edgemont Road Charlottesville, VA 22903				
Sponsoring Agencies' Name and Address Virginia Department of Transportation 1401 E. Broad Street Richmond, VA 23219				
Supplementary Notes				
<p>Abstract</p> <p>At present, there are no clear guidelines for identifying and managing the wide variety of cultural resources within the Virginia Department of Transportation (VDOT) highway rights of way. These resources include such elements as archaeological sites; military earthworks; early road beds; buildings; structures; and objects as diverse as 19th century turnpike milestones, Civil War monuments, stone boundary markers, and early waysides.</p> <p>This project identified the types

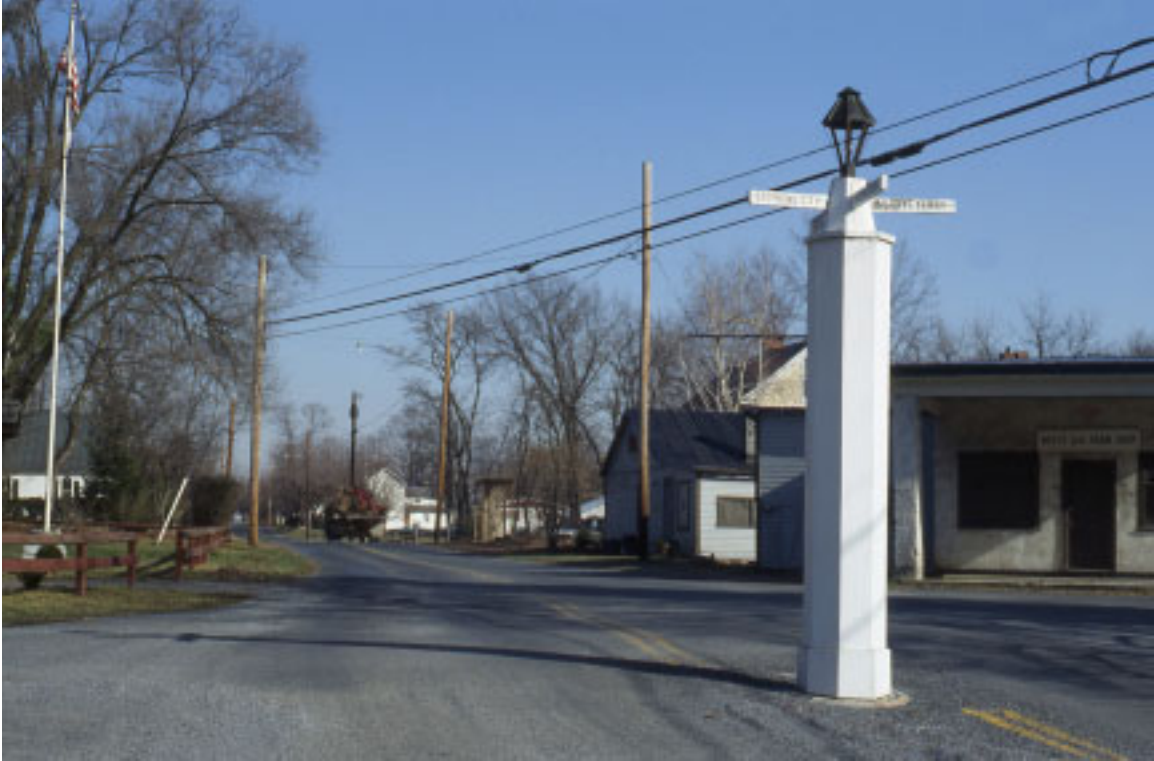
Representative Examples. The best-known resource of this type is the “White Post” at the crossroads in the village of the same name in Clarke County (Figure 1). The original post was erected during the mid-18th century and provided directions to locations within Lord

Figure 1. “White Post” at White Post, Clarke County (a 20th century recreation of the 18th century original)

Fairfax’s landholdings (the Northern Neck Proprietary). It has been replaced a number of times since, with the design of each post apparently based on its predecessor. The latest post was erected after a 1998 vehicle impact destroyed the previous post. The octagonal post stands approximately 12 feet tall and has four signboards, pointing the ways to Berry’s Ferry, Stephens City, Battletown, and Greenway Court (Lord Fairfax’s local residence).

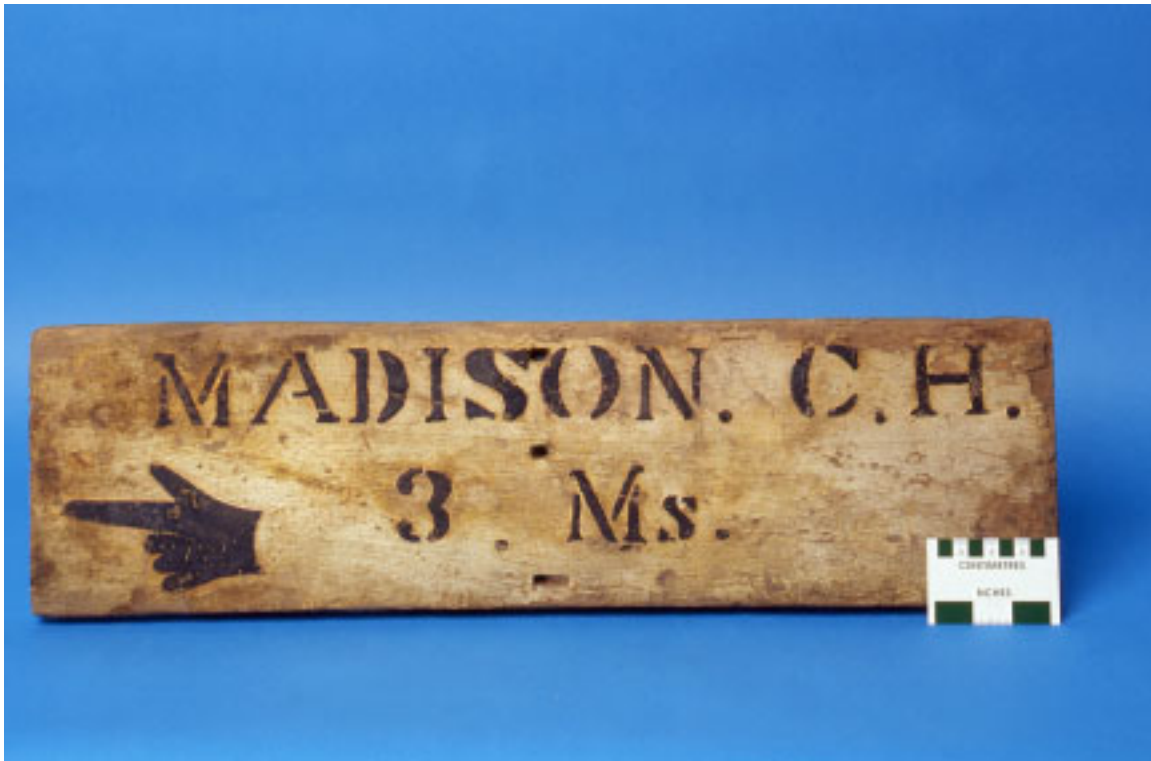
Only one set of pre-20th century wooden signboards from an early “post of directions” is known to survive in Virginia. The surfaces of the signboards are whittled or routed so that the letters stand raised approximately 1/16 inch. Directions are shown by stylized hands with pointing index fingers. The dimensions of the larger board (inscribed “Era Mills. 1 M[ile]s. / Criglersville. 6. M[ile]s.”) are 50 1/8 inches long by 7 15/16 inches wide by 1 1/4 inches deep. The smaller board (inscribed “Madison. C. H. 3. M[ile]s.”) is 26 15/16 inches long by 7 11/16 inches wide by 1 1/4 inches deep (Figure 2). From mileage and directions on signboards, these signs apparently stood at or close to the intersection of present Routes 638 and 603, west of Route 29 in Madison County. The boards can be dated to the last half of the 19th century, as Era Mills was set up in the mid-19th century and the name was changed to Zeus Mills in 1904. These signboards were discovered in a nearby barn in the 1990s; they apparently survived only because after they were removed from their posts (probably after the Zeus Mills name change) they were salvaged; the boards were reused inside a barn on a nearby farm, where they were kept under shelter. They are now in the property owner’s private collection.

Figure 2. 19th Century Signboard from Madison County

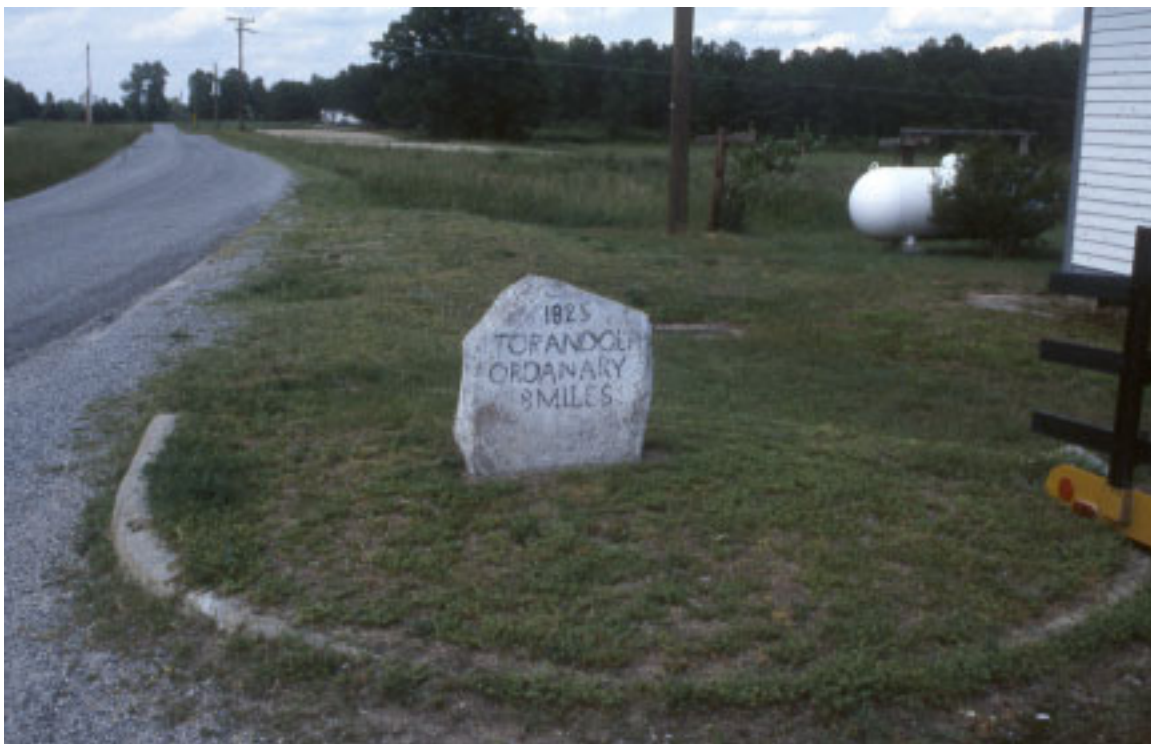
Figure 3. Road Stone at Valentines, Brunswick County, Dated 1825

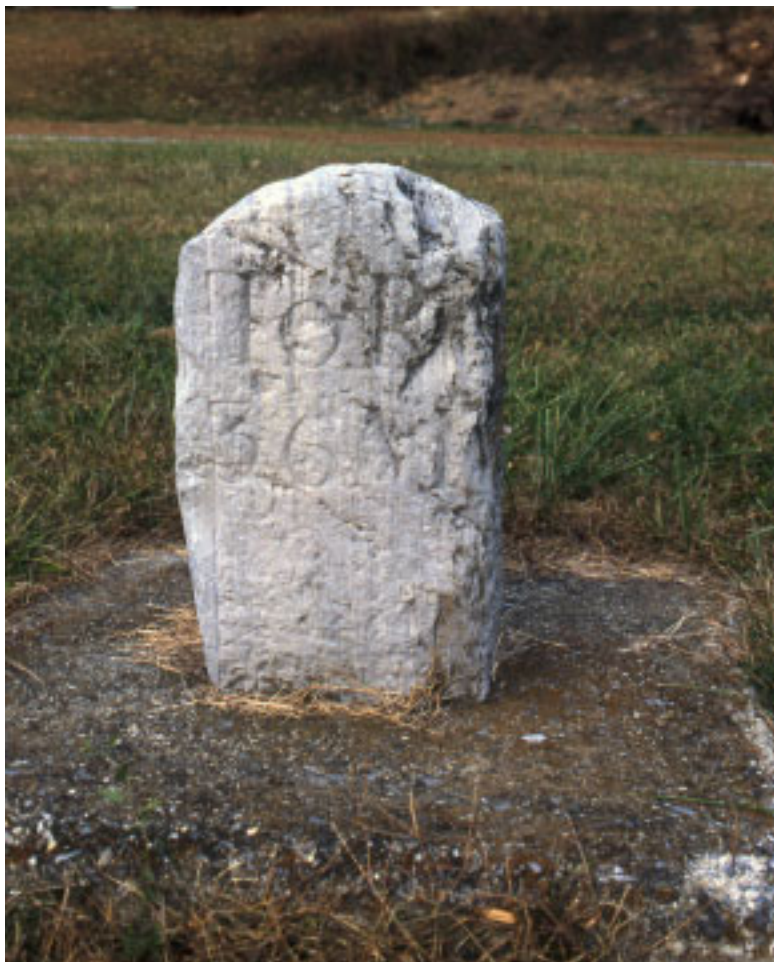
The Northwest Turnpike milestones, all of similar design, are rectangular limestone stones. The ranges of the above-ground dimensions are approximately 16 to 18 inches high, approximately 10 to 15 inches wide, and approximately 6 to 8 inches deep. Milestones 38, 36, 35, 33, and 31 survive, indicating the distances to Romney (now in West Virginia). Carved on each stone is the inscription “TO R” and the mileage, i.e., for the first stone “38 M,” with subsequent stones marked “36 M,” “35 M,” etc. The inscription indicates “To Romney 38 [or 36, etc.] miles.” Each of these milestones was reset in a concrete base during the improvements to Route 50 in the mid-20th century (Figure 4). Where construction of a new alignment or other changes prevented the old milestone from remaining in its original location, it was reset as close as possible to the original location and in the same relationship as it originally had to the highway right of way.

Figure 4. Milestone 36 on Northwest Turnpike, Frederick County, Erected in 1830s

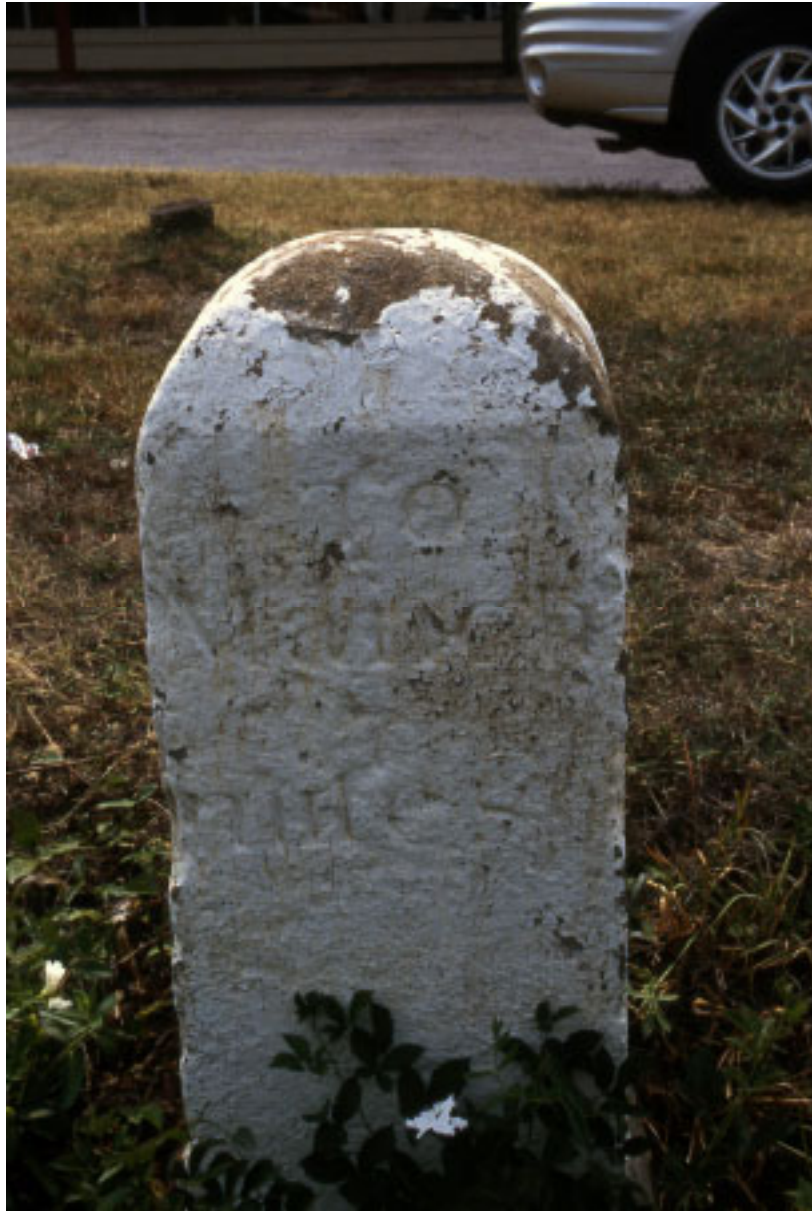
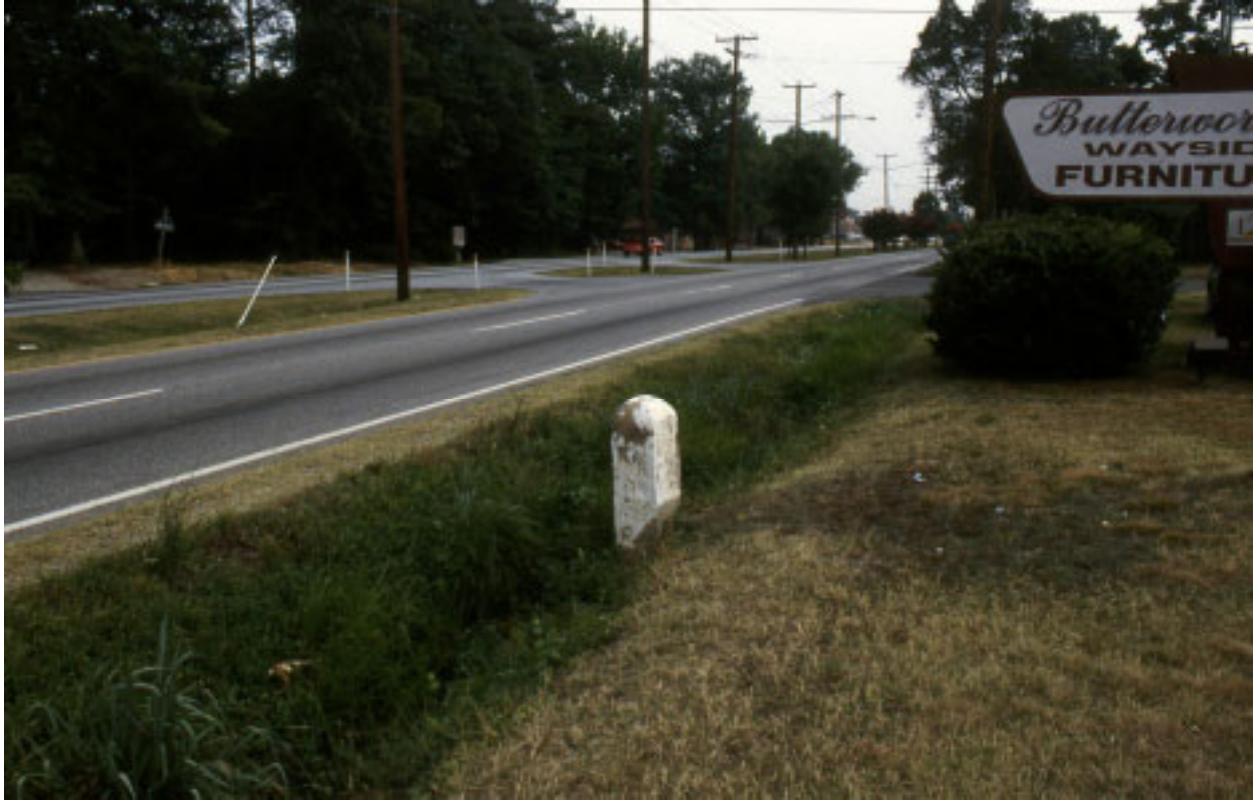
The Manchester-Petersburg Turnpike milestones, also all of similar design, are rectangular stones with rounded tops. Whitewash or white paint thickly applied to these stones prevents precise identification of the type of stone used, but all are likely of local granite. The ranges of the above-ground dimensions are approximately 32 to 33 inches high (although one is 26 inches high), approximately 15 to 16 inches wide, and approximately 8 to 11 inches deep. Milestones 1, 6, 7, and 9 survive, indicating the distances to Manchester. Carved on each stone is the inscription “TO MANCH” and the mileage, i.e., for the first stone “1 MILE,” with subsequent stones marked “6 MILES,” “7 MILES,” and “8 MILES” (Figures 5 and 6).

Figure 5. Milestone 7 on Manchester-Petersburg Turnpike, Chesterfield County, Erected in 1820s

Figure 6. Milestone 7 on Manchester-Petersburg Turnpike, Chesterfield County, Erected in 1820s; Showing Location in Right of Way

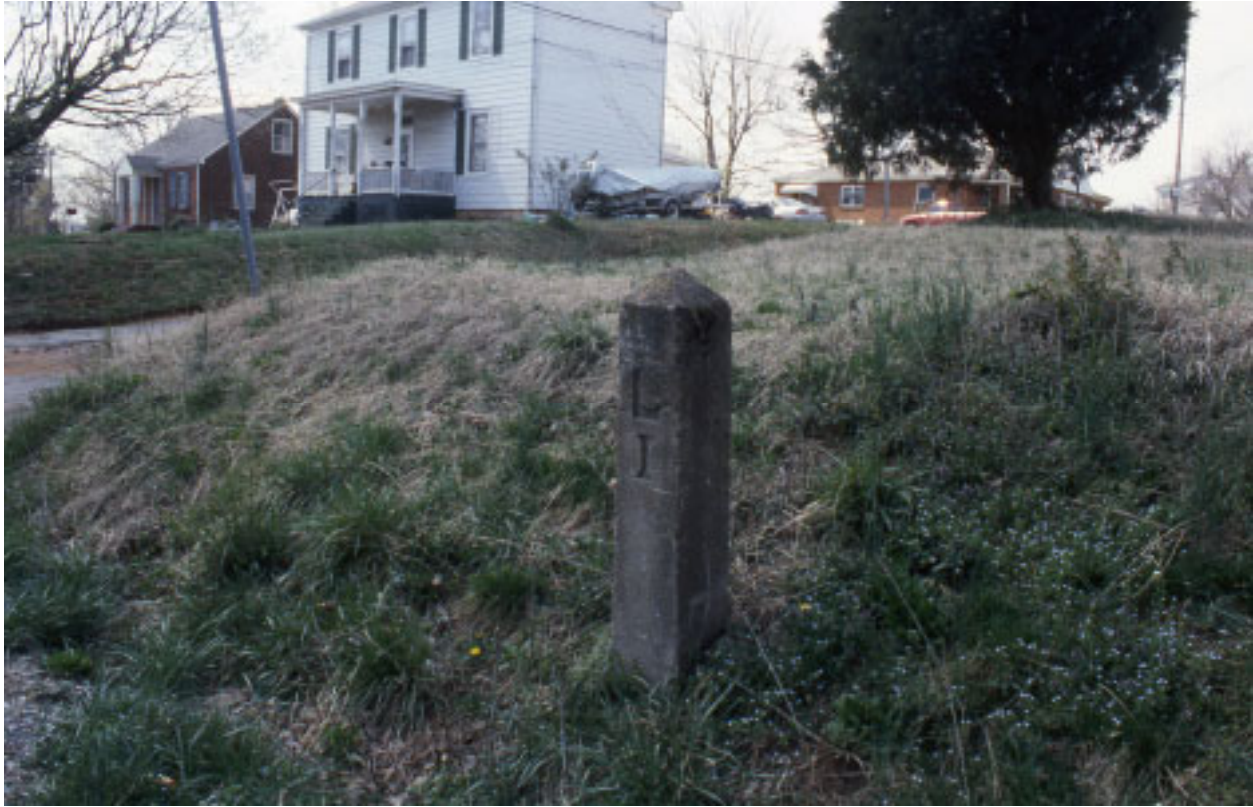
Representative Examples. The only two such markers currently known to survive date from ca. 1910 and mark the distances between Elon and Lynchburg. These cast concrete markers each stood approximately 50 inches above the ground and were 8½ inches wide and 8½ inches deep. Inscriptions noting the distance are molded into the concrete. Popularly designated as “L1” and “L5” from their inscriptions (i.e., abbreviations indicating 1 mile to Lynchburg and 5 miles to Lynchburg), these are located in Amherst County just north of Lynchburg (Figure 7). Both of these objects were erected by Amherst County as part of county road projects in the period when county roads were under county control, prior to the formation of the secondary system in 1832. Although made of cast concrete, these early markers are similar in shape and appearance to older stone markers; the form of the inscriptions is similar to that of the hand-cut letters and numbers on many 19th century road stones. The L1 marker is still in its original location; the L5 marker, which stood on an abandoned right of way, was moved to the county museum grounds to prevent its destruction.

Figure 7. “L1” (1 Mile to Lynchburg) Concrete Mile Marker, Erected ca. 1910 by Amherst County, in Madison Heights

The concrete of such resources may be fragile because of its composition, insufficient rebar, the action of weather, the application of substances that are reactive with the concrete, and/or previous damage. Since early concrete structures of this type can be damaged, broken, or eroded by mechanical impacts, maintenance operations should be done with care around any resource of this type to avoid damage to the object. Avoiding impacts to such sites can often be successfully done in maintenance work since many maintenance projects are not ground-disturbing but instead involve work such as ditch clearing, mowing, etc. In an area with known resources of this sort, impacts can usually be avoided by using a light touch with lawnmowers, weed whackers, larger mowers, etc. Any materials applied near such a resource should not react with concrete. The placement of flagging tape or erosion fence around a vulnerable site or resource creates an easily erected and easily noticeable boundary for crews or contractors.

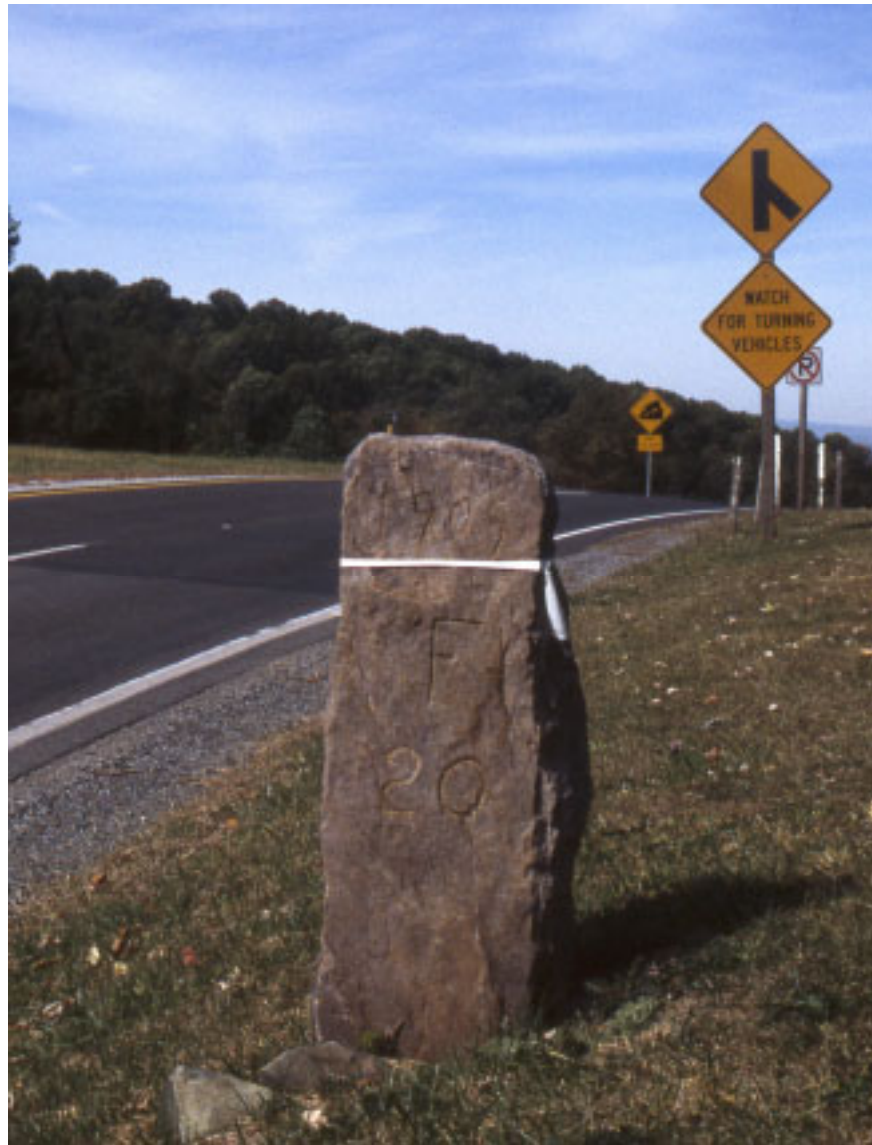
Representative Examples. An excellent example of an older county line marker can be seen on the northeast side of Route 50/17 near the intersection with Route 601, approximately 1 mile west of the village of Paris in Fauquier County. This is an irregular stone; its above-ground dimensions are 38 inches high, 13 to 19 inches wide, and approximately 8 inches deep. Carved on the stone is the inscription “1909 / F / 20” (Figure 8). Sometimes mistaken for a road stone,

Figure 8. Stone Boundary Marker for Fauquier County Line, Erected ca. 1909

this object is located at the intersection of Fauquier, Clarke, and Loudoun counties; it was set ca.1909 to replace the large poplar tree that had marked this point from the late 18th century until the tree fell in 1907. The Fauquier Heritage Society in Marshall, Virginia, has a photograph of the poplar; Daniel E. deButts, volunteer at the Fauquier Heritage Society, stated that his grandfather set the stone to replace the fallen poplar; apparently there was no official or monetary participation from the county for the erection of the stone marker (D.E. deButts, personal communication, May 30, 2002). The poplar is also noted in *Landmarks of Old Prince William* (Harrison, 1987).

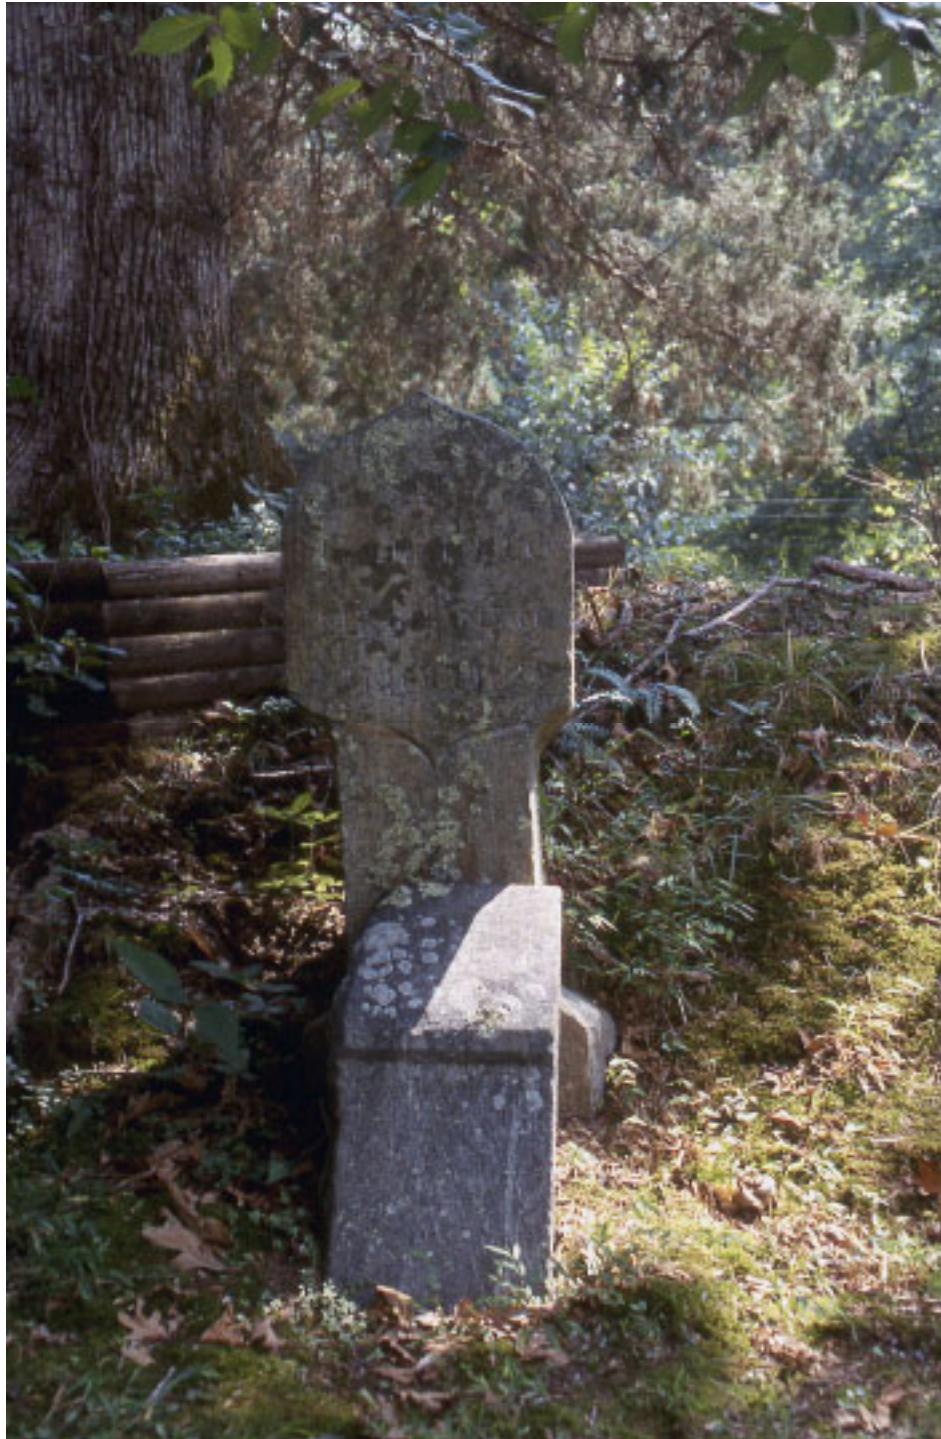
Representative Examples. The oldest identified surviving memorial stone in Virginia is the S. F. Stone adjoining the Belmead estate on Route 684 in northwestern Powhatan County. Within the right of way and in its original location, this monument consists of carved stones (an

upright and a support stone). Its above-ground dimensions are approximately 46¾ inches high, approximately 18¼ inches wide, and approximately 15 inches deep. Carved on the stone is the inscription “S:F/NOV : 14 1840/MEMENTO/MORI” (Figure 9). According to local tradition, this marks the site of a riding or carriage accident in which a member (or acquaintance, in some

Figure 9. S. F. Stone, an 1840 Roadside Memorial Marker at Belmead Plantation, Route 684, Powhatan County

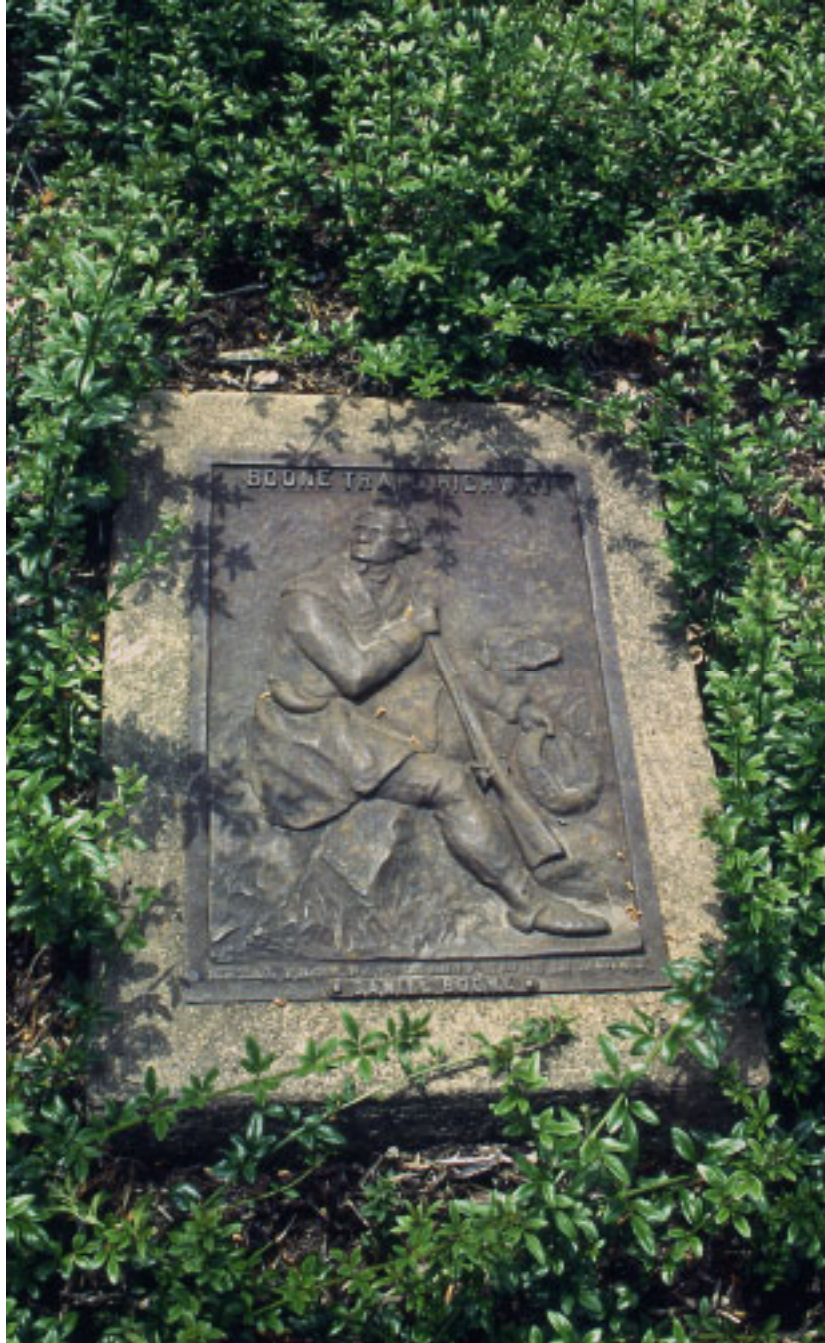
Representative Examples. Perhaps the largest single group of markers of this sort comprised the markers memorializing Daniel Boone erected during the early 20th century by North Carolina entrepreneur Joseph Hampton Rich. Rich founded the Boone Trail Highway and Memorial Foundation Association, which was chartered in 1913 by the state of North Carolina. Rich commissioned metal tablets based on the 1861 Alonzo Chappel painting of Daniel Boone (showing Boone seated with his dog and gun and gazing westward). Rich quickly moved beyond the historical areas associated with Boone, and between 1913 and 1938, he erected approximately 358 of these plaques nationwide, in areas ranging from Virginia Beach to San Francisco, California. The plaques were mounted in a variety of bases, ranging from low plinths, locations in the walls of buildings, free-standing stone slabs or concrete bases, to (frequently) mortared stone masonry bases often in the shape of a giant arrowhead. More than 130 plaques, some still in place in their original bases, have been located nationwide to date, including 10 in Virginia (Figure 10).

Figure 10. Boone Trail Highway and Memorial Association Marker on University Avenue on the Grounds of the University of Virginia, Charlottesville

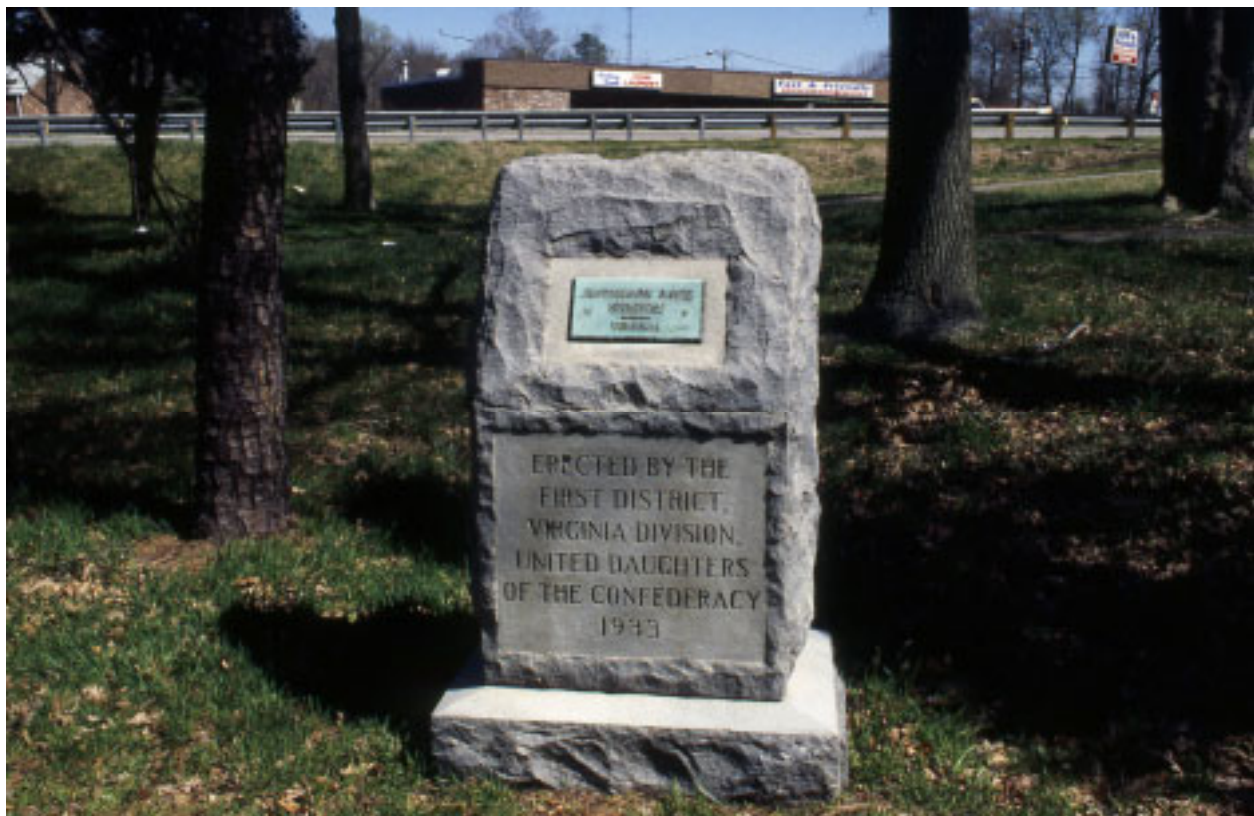
Figure 11. Jefferson Davis Highway Marker, Erected in 1933 at Falling Creek Wayside, Chesterfield County

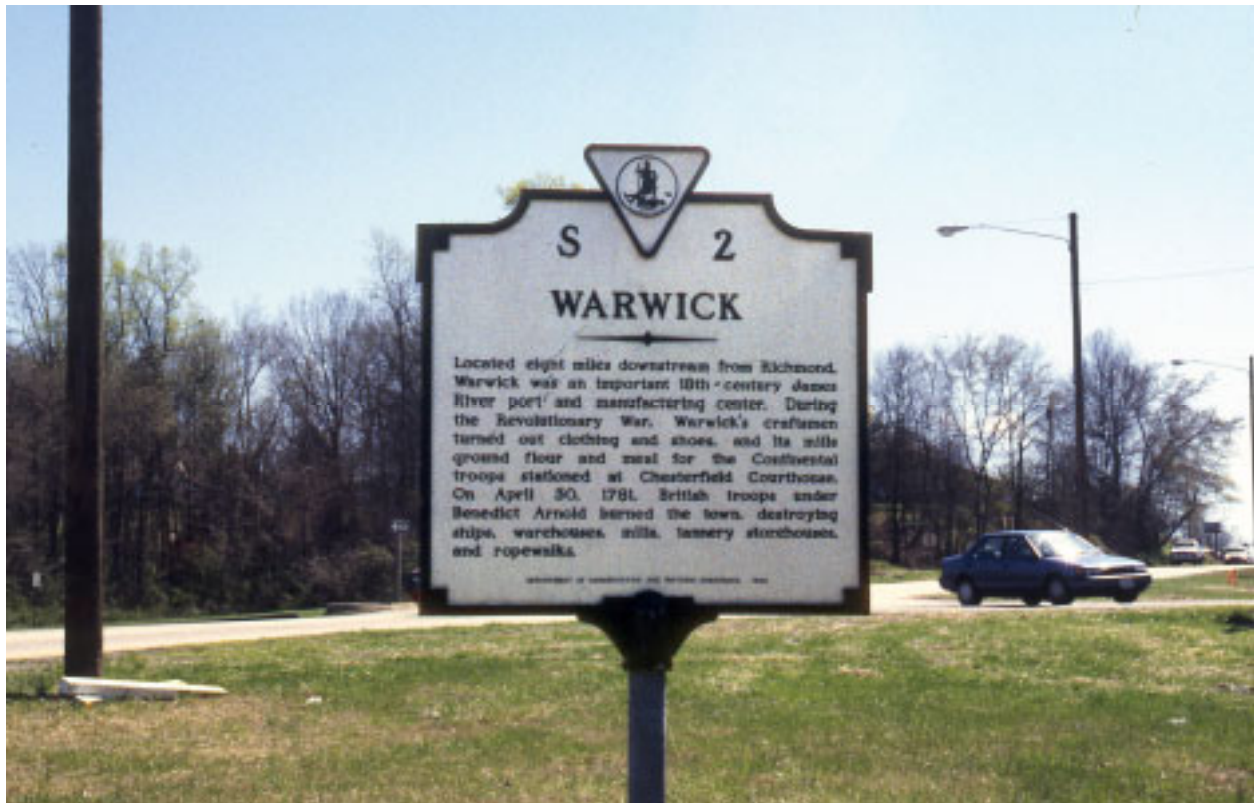
Description. Virginia's historical highway marker program was established in 1927 and is one of the oldest in the United States. All Virginia markers have the same distinctive design: a metal plaque with black raised lettering on a light background, mounted on a metal pole. These markers commemorate people, places, and events of regional, statewide, or national importance (Figure 12). Currently, the program is administered by the DHR. New or replacement markers cost \$1,350; the cost of a marker is no longer covered by state funds and must be paid for by

Figure 12. Typical Virginia Historical Highway Marker
