Best Practices for Historic Masonry Repair and Rehabilitation

Final Report VTRC 23-R10

Virginia Transportation Research Council
(A partnership of the Virginia Department of Transportation
and the University of Virginia since 1948)

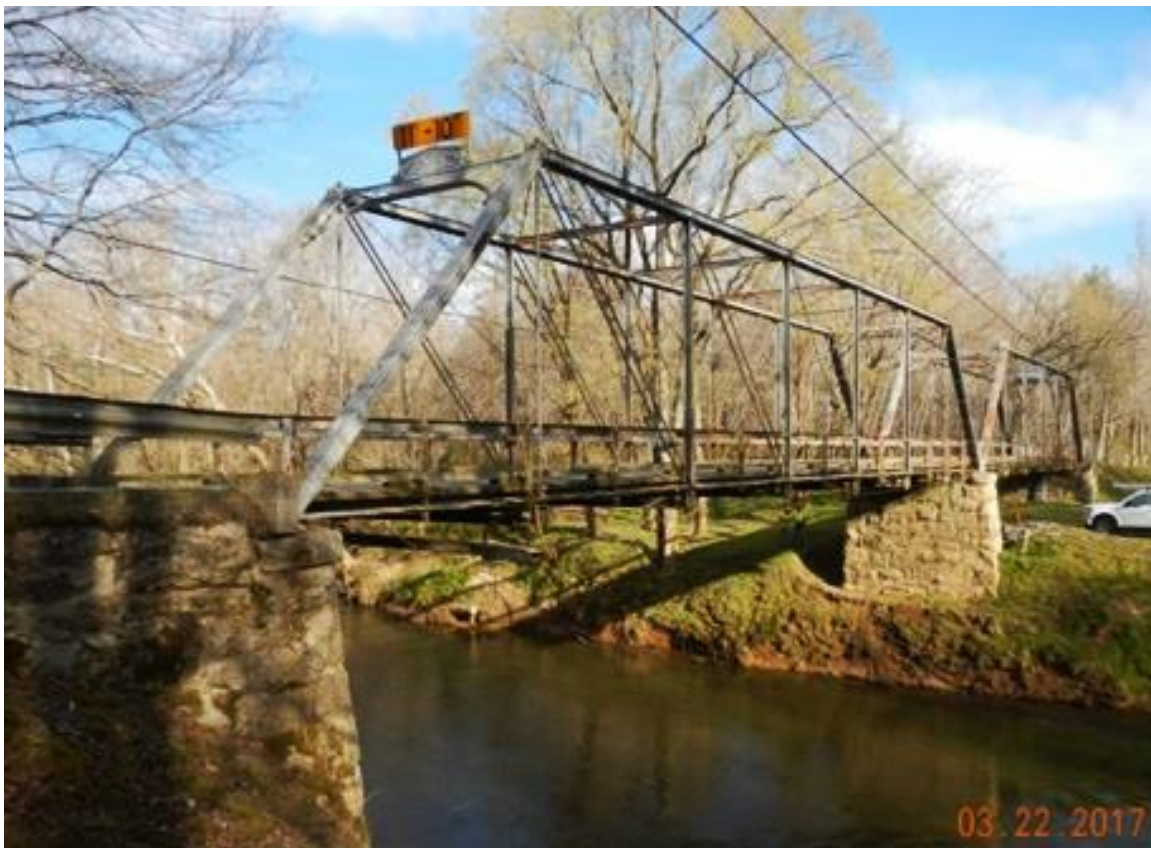
Figure 1. Stone Masonry Piers and Abutments Supporting an 1884 Truss Bridge (Brunswick County Structure No. 6104)

Typically, the earliest examples of stone abutments and piers supported wooden bridge elements (such as the floor beams and deck, and in some cases, wooden trusses). By the mid- to later 19th century, wooden trusses were being succeeded by combination (wood and metal) trusses and metal trusses. Stone masonry continued to be used for abutments and piers on truss bridges through the end of the 19th century and into the very early 20th century. In Virginia, examples are not uncommon, particularly on 19th century and early 20th century truss bridges and small beam bridges. Examples of stone masonry piers and abutments on two of Virginia's historic truss bridges (Brunswick County Structure No. 6104 and Alleghany County Structure No. 9007) are shown in Figures 1 and 2.

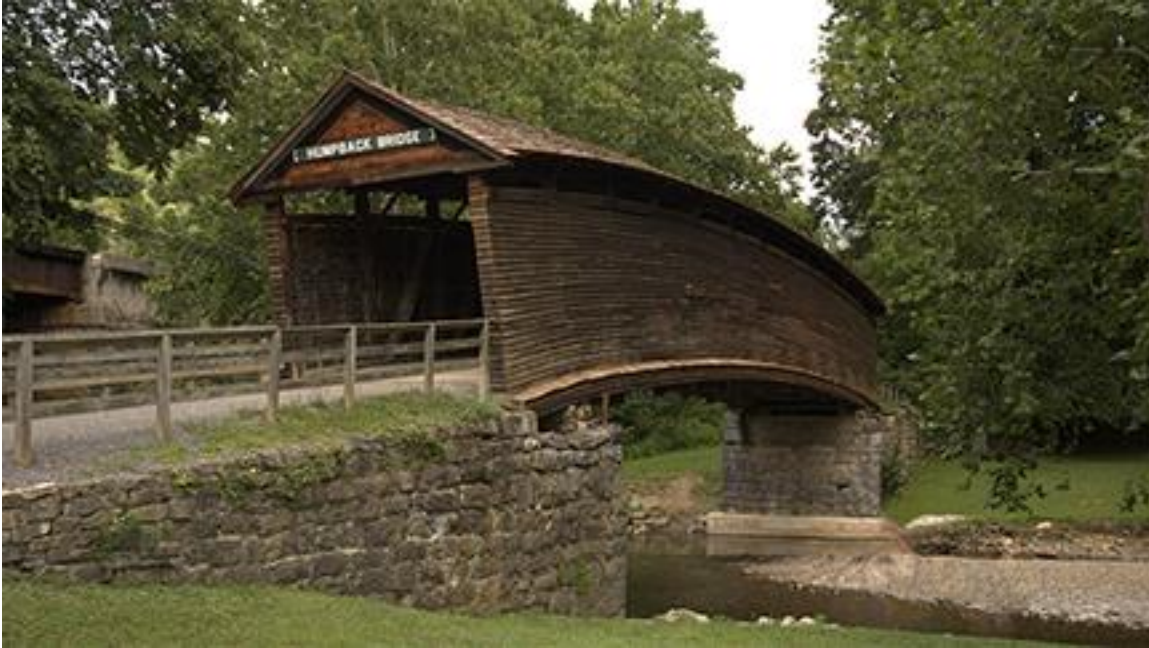
Figure 2. Stone Masonry Abutments and Stone Masonry Approaches on Humpback Bridge, 1857 (Alleghany County Structure No. 9007)

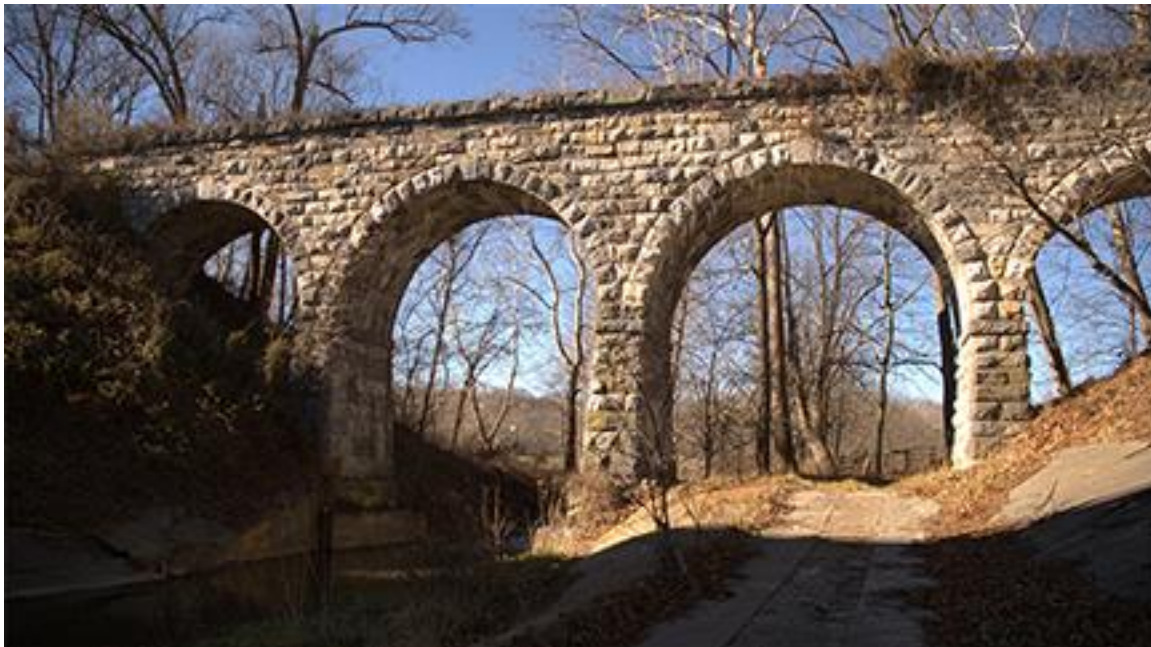
Figure 3. Stone Masonry Arch, Built as a Railroad Bridge, 1874 (Augusta County Structure No. 6997)

Six historic Virginia bridges in the management plan are of stone masonry arch construction: these variously were constructed by turnpike companies (the Southwest Turnpike Company bridge in Wythe County, the Falling Creek bridge in Chesterfield County, Loudoun County Structure No. 1025, and Loudoun County Structure No. 6088); canal companies (Nelson County Structure No. 6070); and railroads (the Valley Railroad bridge, Augusta County Structure No. 6997). All of the original builders were organizations that could marshal the funds, the engineering talent, the additional skilled craftsmen, and the materials needed to produce stone arch bridges. Three of these stone masonry arch bridges, i.e., Augusta County Structure No. 6997, Nelson County Structure No. 6070, and Loudoun County Structure No. 1025, are shown in Figures 3, 4, and 5, respectively.

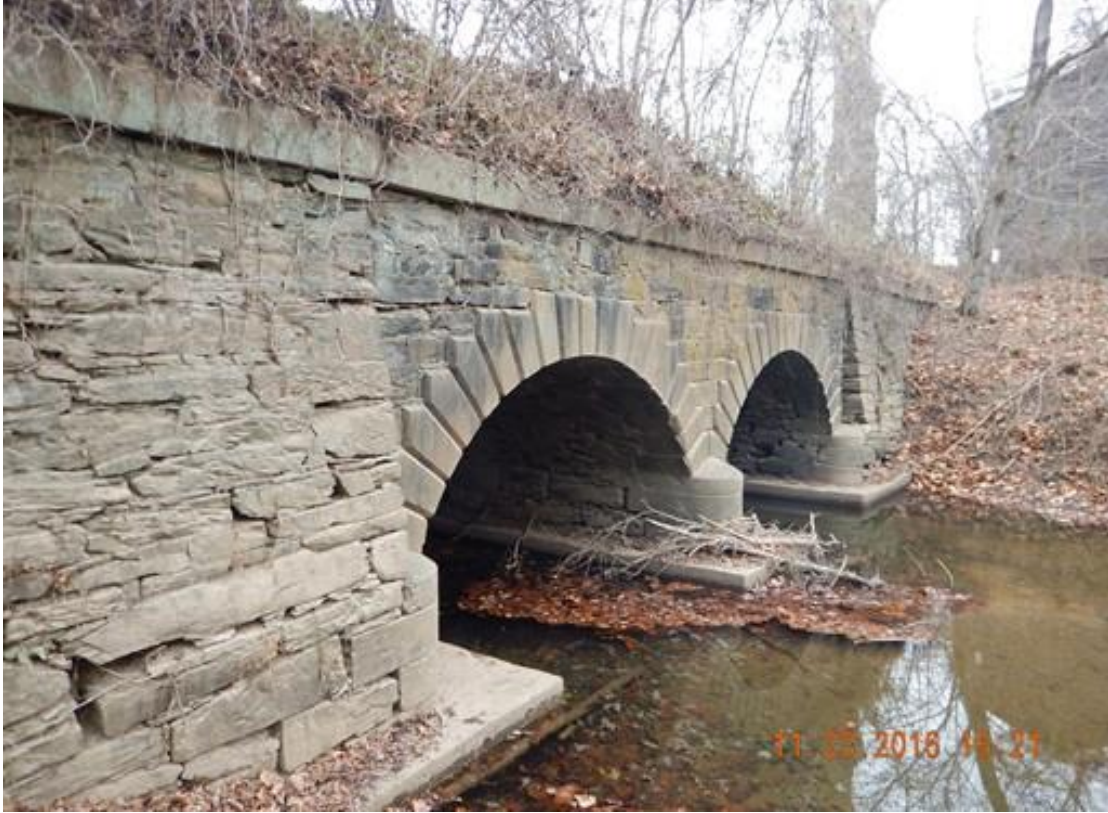
Figure 4. Stone Masonry Arch, Originally Built as a Canal Viaduct, 1835 (Nelson County Structure No. 6070). Note the particularly fine finishing of the voussoirs.

At the exterior of the arch ring, and forming the face of the arch at that point, are the wedge-shaped voussoirs that define the curve of the arch and rise to a central keystone. Treatment of the voussoirs can range from utilitarian (such as stone finished in the same manner as the rest of the masonry, as seen on the ca. 1850 Southwest Turnpike bridge in Wythe County) to decorative (such as the voussoirs made from a stone of contrasting color to that of the rest of the bridge on the old turnpike bridge carrying Rt. 50 at Aldie [Loudoun County Structure No. 1025] and the notable smooth, beautifully shaped voussoirs on the former James River and Kanawha Canal viaduct in Nelson County [Nelson County Structure No. 6070]).

Some older stone masonry arch bridges were repaired or enlarged with concrete in the 20th century. The Nelson County structure noted above exhibits one such enlargement: a concrete arched extension.

A notable example of issues caused by vegetation was seen in the late 1990s on the former James River and Kanawha Canal viaduct in Nelson County (Nelson County Structure No. 6070). Several large trees growing near and on the structure were impacting the stonework; these trees had to be removed before further damage was done. The large size of the trees necessitated greater effort for removal of the trees and repair of the structure than would have been necessary if the trees had been removed when small.

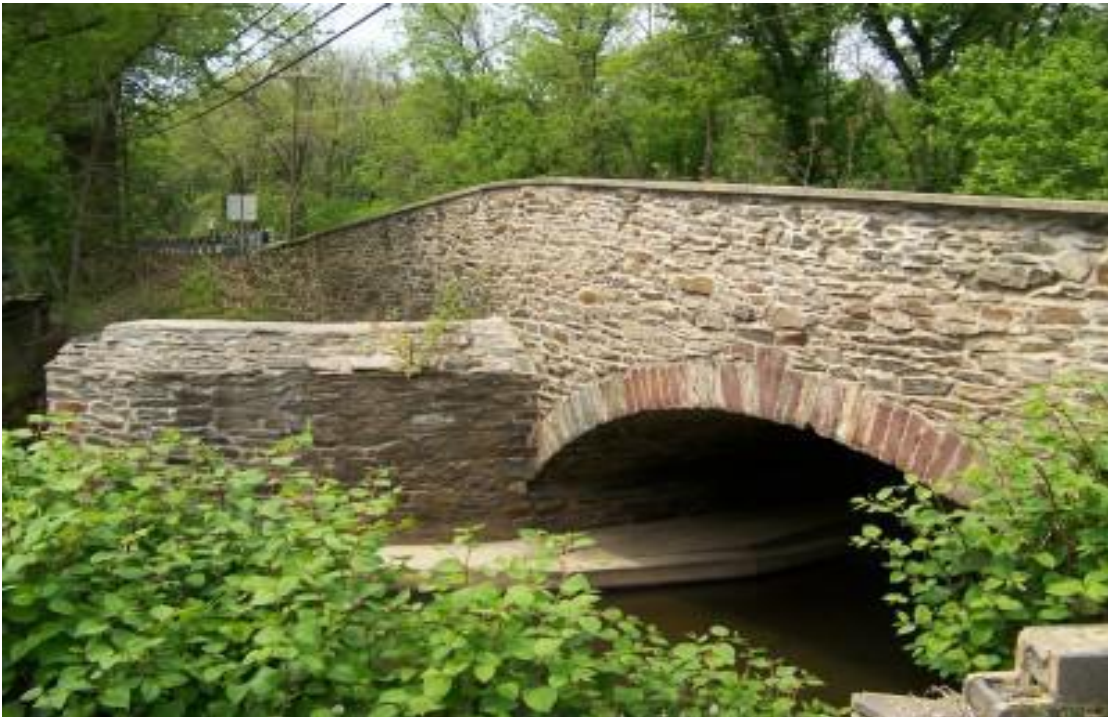
Figure 5. Stone Masonry Arch, Built as a Turnpike Bridge in the First Quarter of the 19th Century (Loudoun County Structure No. 1025). A contrasting color of stone was used in the voussoirs for decorative effect. Note the relatively flat arch that is seen in many stone masonry bridges of this era.

A grouted anchor process was used in 2001 on Loudoun County Structure No. 1025 (the Little River Turnpike bridge). An inspection had revealed that a portion of the bridge's wing wall and buttress required reconstruction due to severe deterioration of the mortar between the stones. Accordingly, portions of the wing wall and buttress were reconstructed, and the proprietary (Cintec) grouted anchor system was used to repair and strengthen the bridge. The system has worked well.
