Repairs With Self-Consolidating Concrete and Galvanic Anodes to Extend Bridge Life

H. CELIK OZYILDIRIM, Ph.D., P.E.
Principal Research Scientist

STEPHEN R. SHARP, Ph.D., P.E.
Senior Research Scientist

Final Report VTRC 18-R9

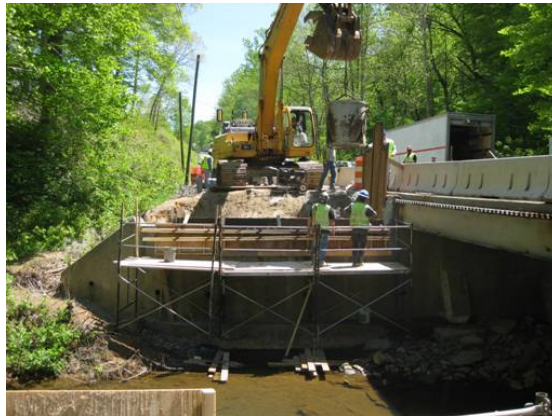
A bucket attached to a track hoe was used to place the concrete, as shown in Figure 1. Once placed, the backwall was finished and then covered with plastic for curing, as shown in Figure 2.

Figure 1. Bucket Being Used to Place Concrete Into Backwall for Route 699 Bridge

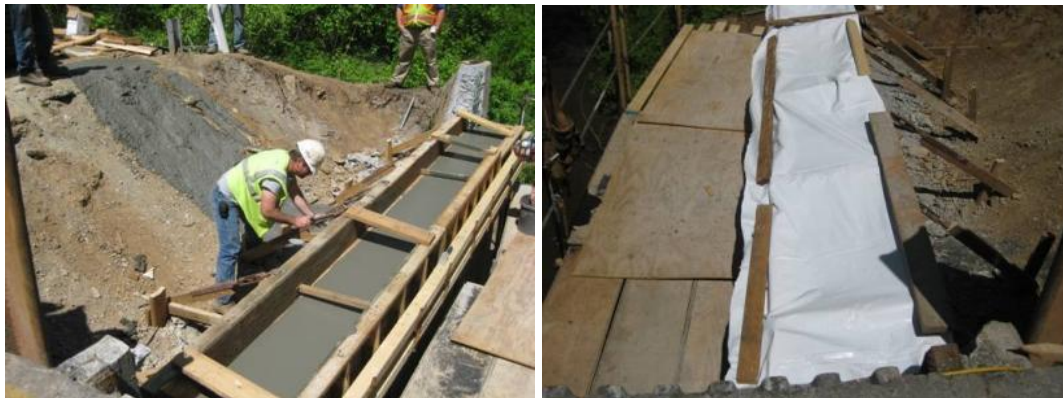
Figure 2. Concrete Finishing Before Curing (left) and Plastic Covering (right) for Route 699 Bridge

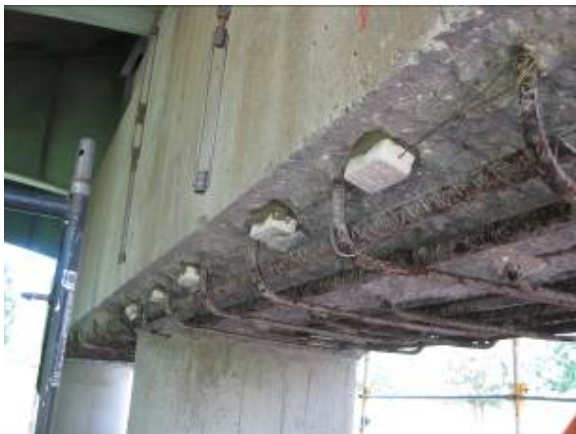
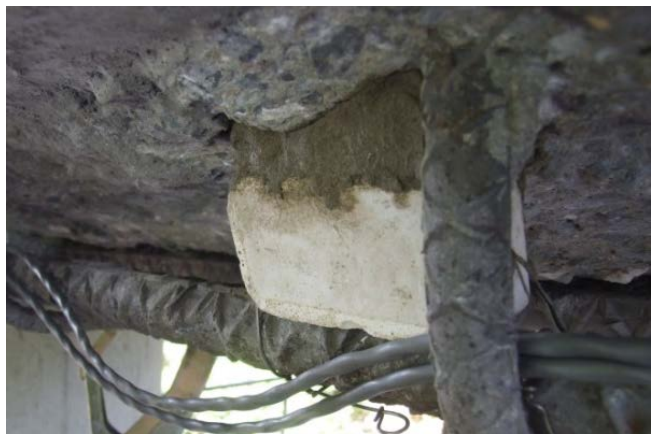
Figure 4. Exposed Steel and Anodes With Embedment Mortar for Route 712 Bridge

In the repair area, the north side did not contain any anodes, the middle section had anodes with embedment mortar, and the south side had anodes without the mortar. The embedment mortar had high alkalinity, enabling an electrical circuit. The repair was performed in two phases on two separate days. The corroded steel was exposed, and about 1.5 in was cleared behind the reinforcement; 1.25-in-thick anodes were placed behind or next to the reinforcement along the perimeter against the existing concrete. A minimum clearance of 1 in was planned around the anodes or the steel to ensure the flow of the SCC except when embedment mortar was used. Embedment mortar filled the area behind the anode. The placement of anodes required that a deeper section be removed to allow the insertion of the anode with a minimum 1-in concrete cover.

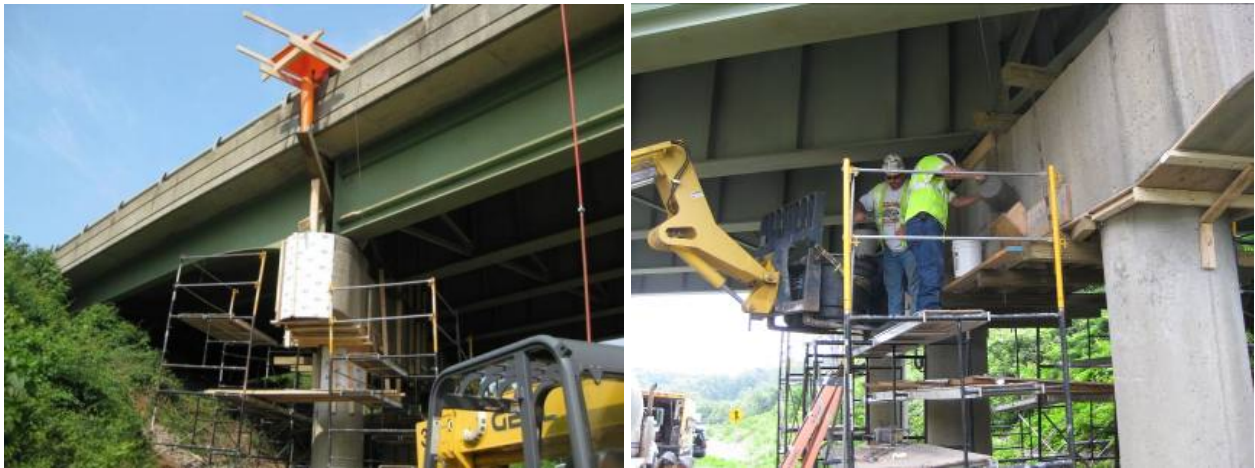
For the repair sections, plywood forms were used on flat surfaces and tubular form material was used on the round surfaces. A funnel shown in Figure 5 held at bridge level was used to place the concrete, which was carried to the repair sites by gravity with the use of a flexible tube. At some intermediate points in the forms on the pier cap, buckets were used to place the SCC, as shown in Figure 5.

Figure 5. Funnel Being Used to Gain Pressure From Height Difference During Placement (*left*) and Manual Placement Method Using Container and Bucket (*right*) for Route 712 Bridge

During the first portion of SCC placement, the concrete traveled about 20 ft and was deposited from the top with a high head, as shown in Figure 5. On one side of the cap, the repair area covered the entire face, whereas only the lower part of the cap face needed repair on the other side. At the ends, there were ports to enable expulsion of air and access to the repair area. Holes were drilled in multiple areas across the forms to expel air and to allow the flow of SCC to be monitored. During placement on the side that had a repair area extending the entire height, the form began to bulge. Therefore, the placement was stopped and the area was shored and strengthened. The time spent on strengthening the forms, about 15 min, caused stiffening of the SCC so that when placement resumed, the concrete did not flow easily and did not reach the ends. The contractor placed the stiffening concrete manually through the ports at the ends and used vibrators to ensure proper consolidation.

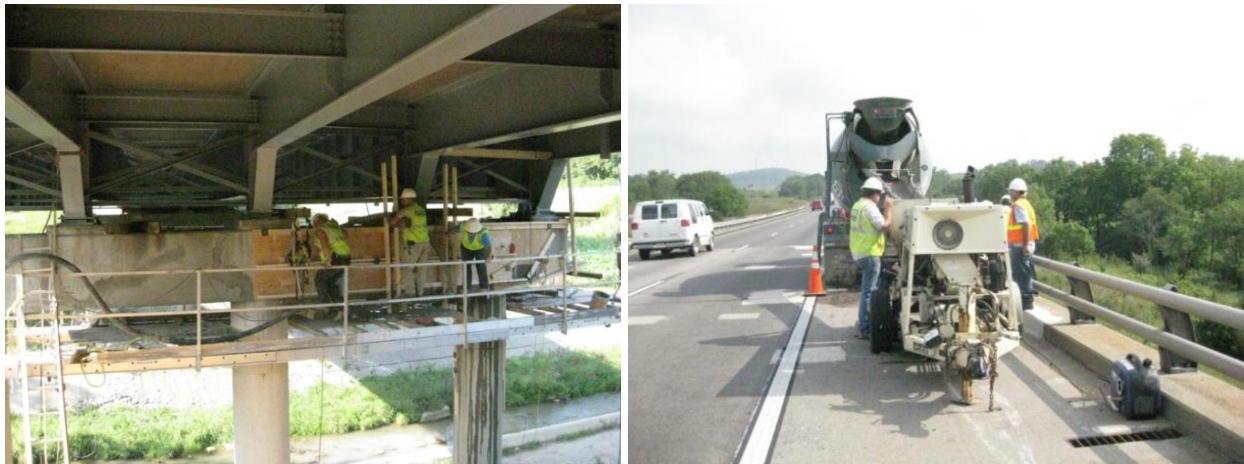
The repaired pier during placement is shown in Figure 6. The SCC was placed using a small pump located on the bridge, also shown in Figure 6. Pumping allowed the SCC to flow fast, and the pump pressure enabled easy placement.

Figure 6. Deteriorated Pier of I-81 Bridge During Placement (left) and Small Pump on Deck (right)

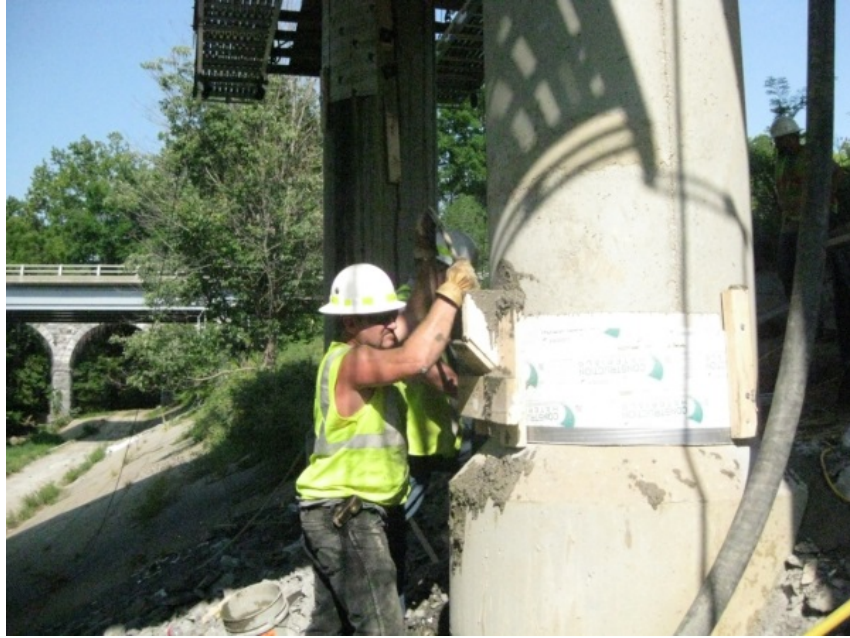
Because of the extended placement time, the column repairs, which were done after the pier cap repairs, required internal vibration to consolidate the concrete because it was losing workability. This process is shown in Figure 7.

Figure 7. Column Being Consolidated With Internal Vibrator for I-81 Bridge

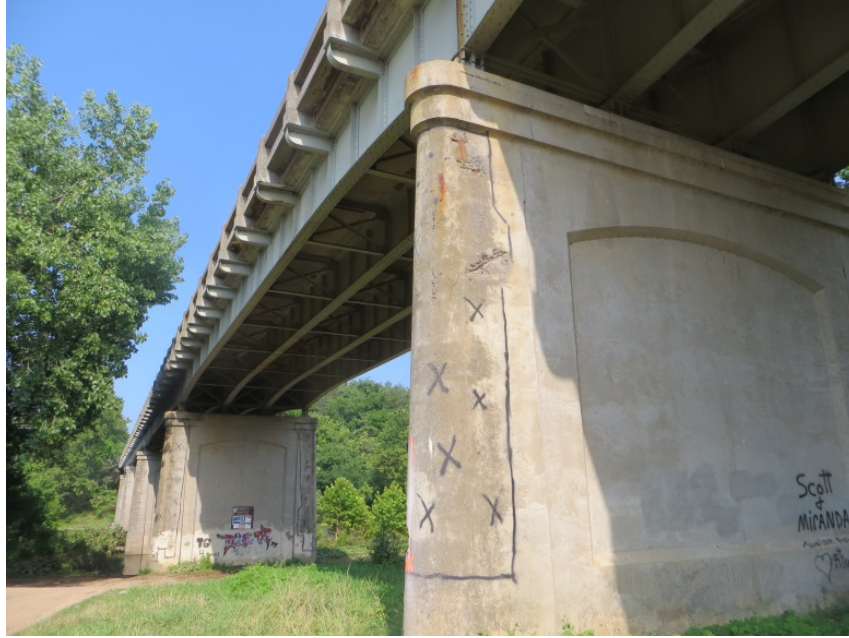
SCC was used to repair three piers of the bridge, as shown in Figure 8. The bridge has six piers, three of which are in the river. The piers on land were repaired with SCC, with anodes placed in selected repair areas.

Figure 8. Route 340 Bridge

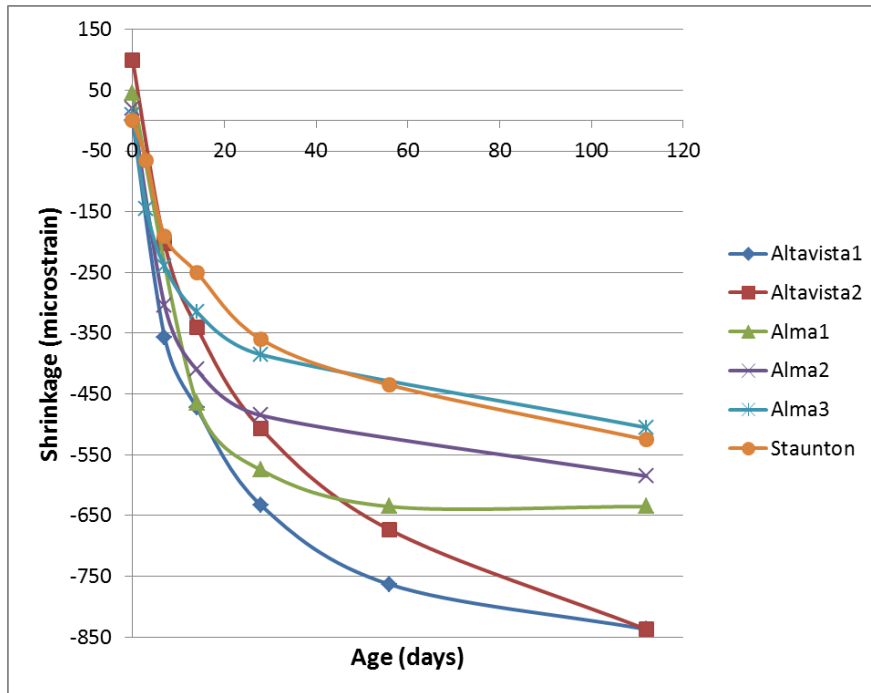
The average compressive strengths of concretes ranged from 4,090 to 5,430 psi, as shown in Table 6. They were satisfactory but lower than for the Route 699 Bridge. This indicates the high variability in properties in SCC attributable mainly to its sensitivity to water content. The high water content in the samples from the Route 712 Bridge is also reflected in the high shrinkage values obtained for these concretes, as shown as Altavista 1 and 2 in Figure 13.

Figure 13. Shrinkage Data for Route 712 (Altavista), Route 340 (Alma), and I-81 (Staunton) Bridges

The results for the Route 340 Bridge show that the concretes, in general, had the high workability needed for placement in narrow areas and locations with heavy reinforcement and that they were stable with a visual stability index of 1 or less. There was high variability in air content, density, strength, and permeability. However, the 28-day compressive strengths were much higher than 3,000 psi, ranging from 4,560 to 7,010 psi with an average of 5,726 psi and a standard deviation of 766 psi, and the coefficient of variation was 13%. The permeability values were low or very low except for the last batch tested, which had a permeability in the moderate range. However, all values were less than the 3500 coulomb requirements for VDOT Class A3 concrete. This last batch also had the lowest density and compressive strength. The shrinkage values were also variable, as shown in Figure 13, based on three batches of concrete tested.

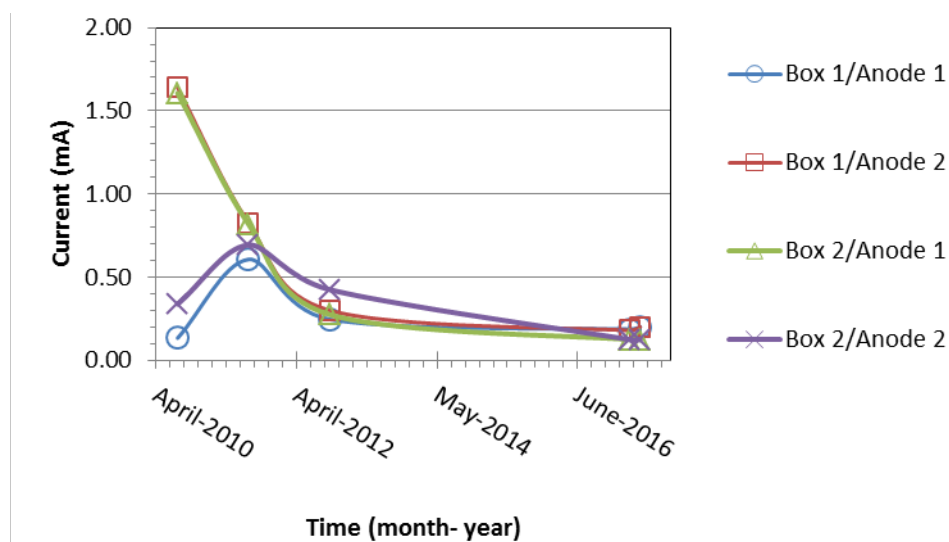
Measurements of current over time were gathered from four specially modified anodes. Initially, these anodes had differing current outputs, as shown in Figure 15. About one-third more charge was passed by the anodes that started at the higher current; however, after approximately 3 years, the current outputs of all anodes decreased to an equivalent level.

There are efforts by the manufacturers to increase the amount of zinc in the anodes to extend the time of protection with galvanic anodes. However, it is important to recognize that the galvanic cathodic protection (CP) systems will have a limited driving voltage and protection area as compared to an impressed current CP system. This is because the potential difference for galvanic CP systems is fixed by the voltage difference between the anode material selected for the galvanic systems and the steel that is being protected. Further, galvanic anodes can lose efficiency over time, so additional zinc may not provide for a much longer life. A properly designed impressed CP system, however, can be adjusted to provide sufficient protection of the steel. Therefore, the CP options for repair might be either to increase the number of galvanic anodes that are distributed in the old and new concrete or to select a CP system that has a greater driving voltage. Therefore, proper CP design is important, and the limited driving voltage of the galvanic system must be considered when the repair is made.

Figure 15. Current Measured at Four Anode Locations on Route 712 Bridge Over Time

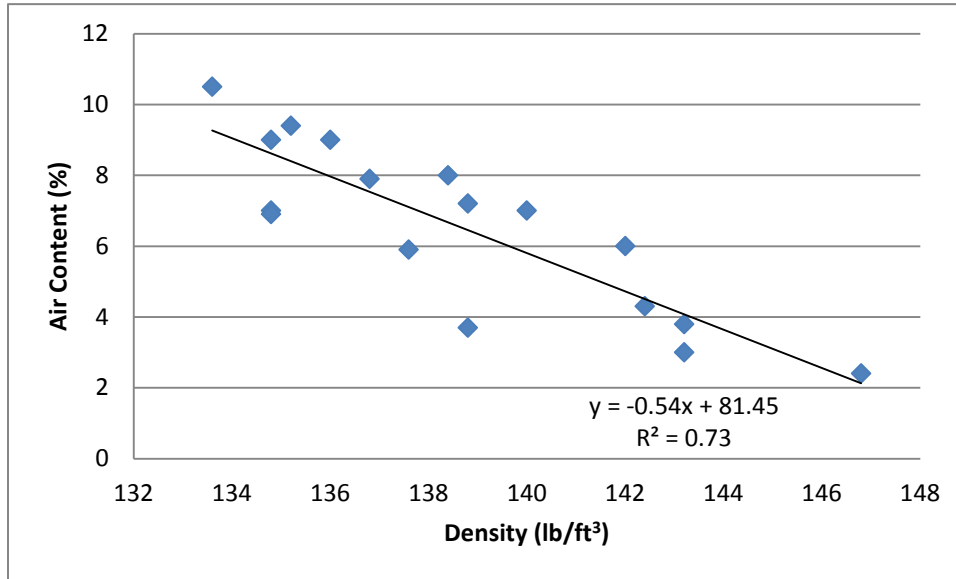
Even though the results of SCC testing showed that the product was highly variable, concretes used in the structure are air entrained and have the strength and permeability values to provide the expected service life. The relationship between air content and density for all projects is shown in Figure 20. There is a good correlation, and as expected, air content increases with a reduction in density.

Figure 20. Density vs. Air Content for the SCC Mixtures
