Durability and Inspection of Hybrid Composite Beams

Final Report VTRC 20-R7

FINAL REPORT

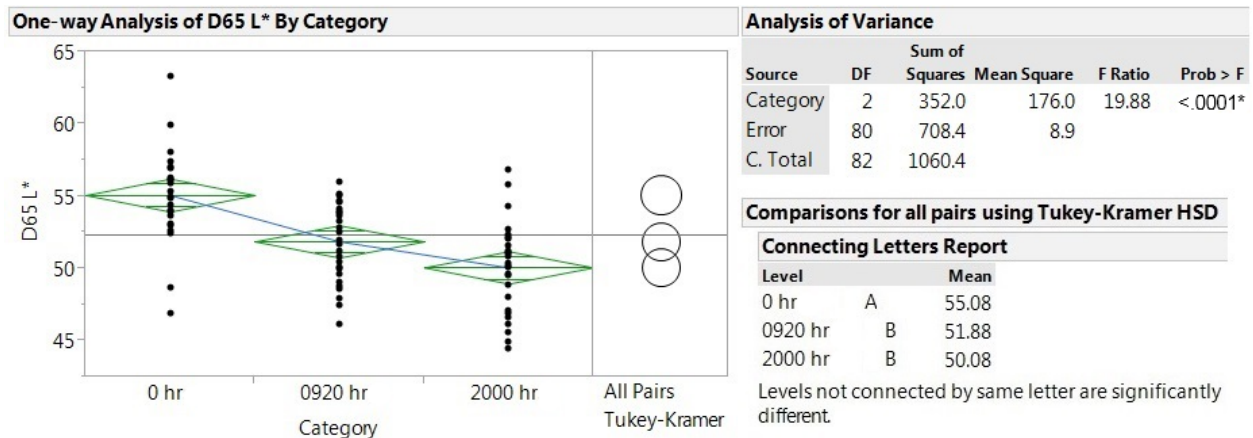
Figure 15. Statistical Means Comparison for D65 L* (Lightness) Values of Laboratory Specimens

Figure 15 shows the results for the L^* (lightness) parameter. The plot shows the decreasing L^* values with increasing duration of UV radiation exposure, almost in a linear fashion. The connecting letters report on the right side of the one-way analysis plot shows the results from the Tukey-Kramer test. The groups that are assigned the same letter are not significantly different, whereas the groups assigned different letters are significantly different. In this case, Figure 15 shows a big drop in lightness at 920 hr from 0 hr, but the drop was not statistically significant.

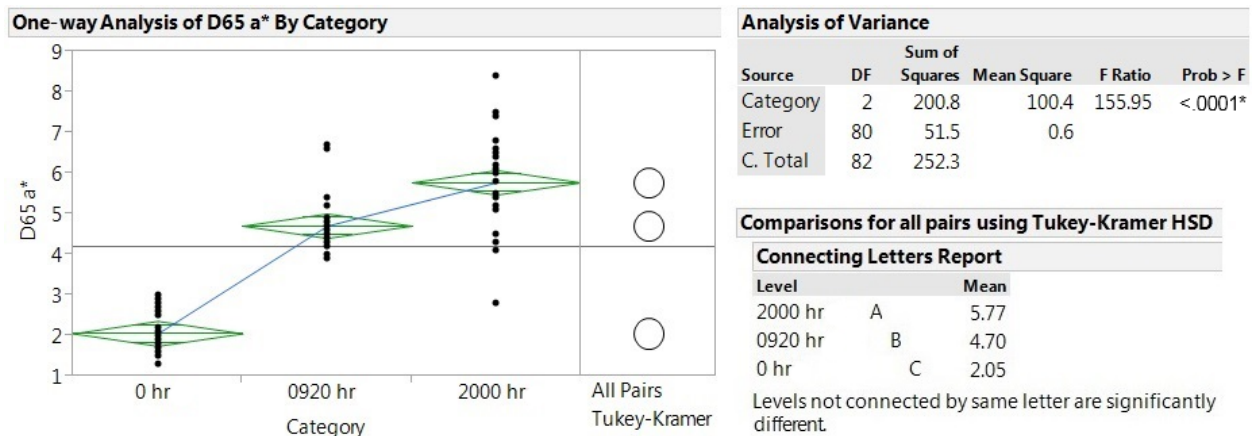
Figure 16. Statistical Means Comparison for D65 a* (Green-Red) Values of Laboratory Specimens

Figure 16 shows the results for the a* (green-red) parameter. The plot shows increasing a* values with the increase in UV exposure, which is interpreted as an increase in the red component of the color. The connecting letters report from the Tukey-Kramer test shows that the increase in a* or red color was statistically significant with increasing UV exposure durations.

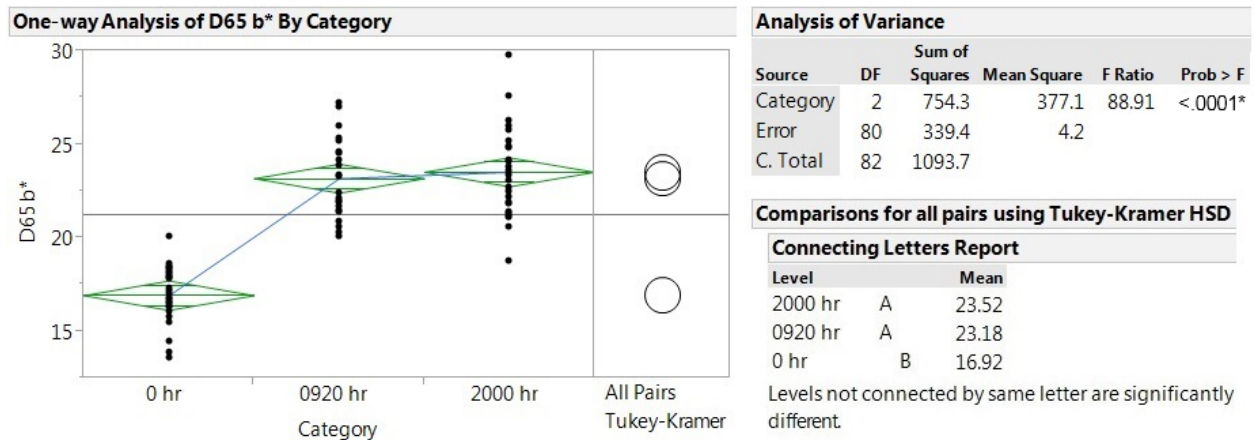
Figure 17. Statistical Means Comparison for D65 b* (Blue-Yellow) Values of Laboratory Specimens

Figure 17 shows the results for the b* (blue-yellow) parameter. The plot shows increasing b* values with the increase in UV exposure up to 920 hr, which is interpreted as an increase in the yellow component of the color. No significant change was detected at 2,000 hr. The connecting letters report from the Tukey-Kramer test shows that the increase in +b* or yellow color was statistically significant at 920 hr from 0 hr but was not significant beyond that.

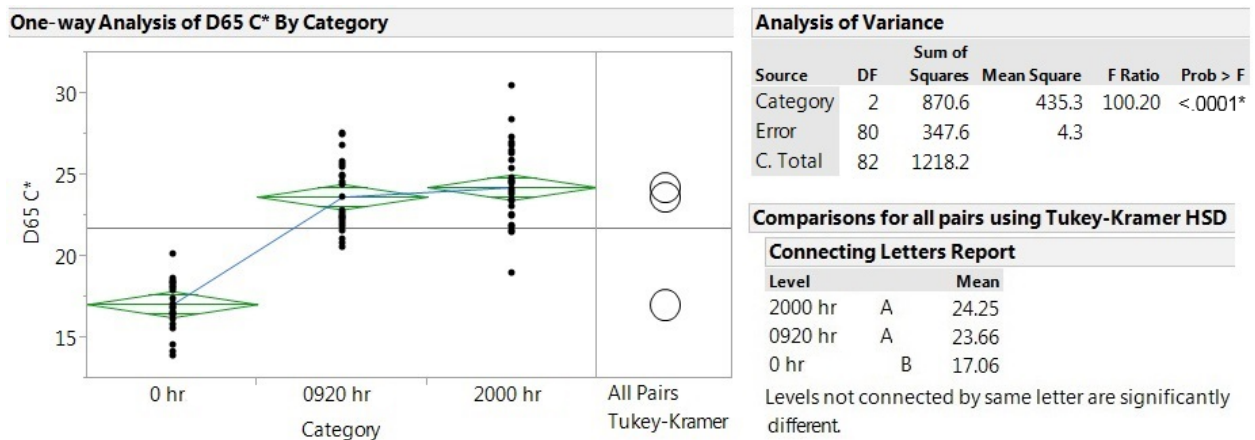
Figure 18. Statistical Means Comparison for D65 C* (Chroma) Values of Laboratory Specimens

Figure 18 shows the results for the C* (Chroma) parameter. The plot shows increasing C* values with the increase in UV exposure up to 920 hr, which is interpreted as an increase in the saturation or purity of the color. No significant change was found at 2,000 hr. The connecting letters report from the Tukey-Kramer test shows that the increase in C* was statistically significant at 920 hr from 0 hr but was not significant beyond that.

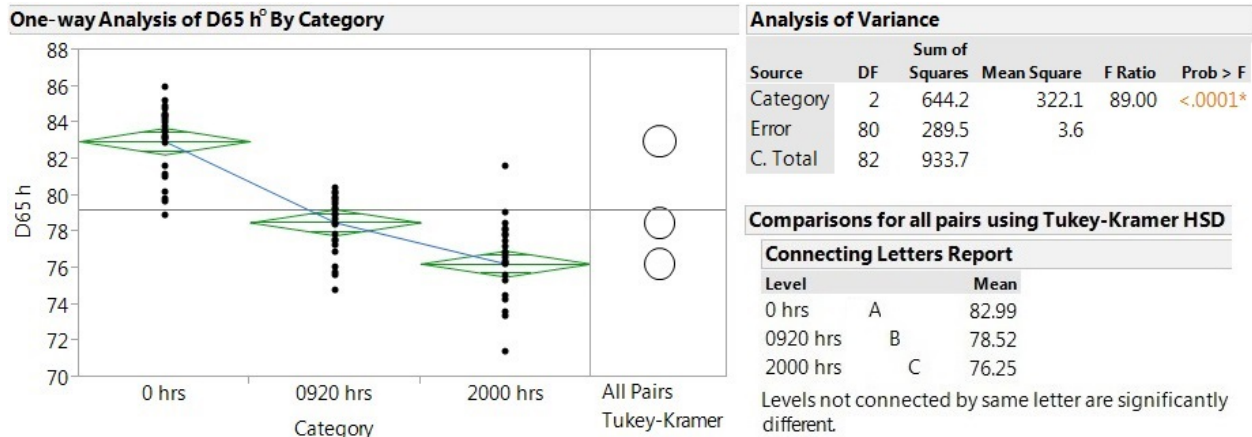
Figure 19. Statistical Means Comparison for D65 h° (Hue Angle) Values of Laboratory Specimens

Figure 19 shows the results for the h° (hue) parameter. The plot shows the decreasing h° values with increasing duration of UV radiation exposure, almost in a linear fashion. This can be interpreted as the change in hue from near-yellow to brown as UV exposure increased. The connecting letters report from the Tukey-Kramer test shows that the increase in h° was statistically significant with increasing UV exposure duration.

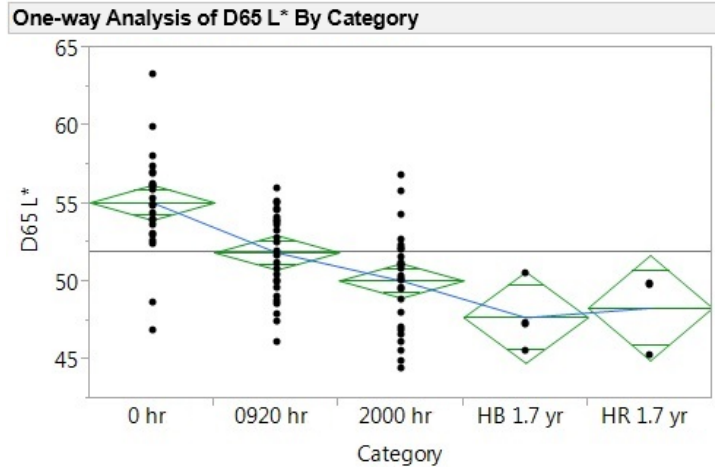
Figure 20. Statistical Means Comparison for D65 L* Values of Laboratory and Field Specimens

Figures 20 through 24 show the results of the statistical analysis of L*, a*, b*, C*, and h°, respectively, from both laboratory and field exposure specimens. The L* values for the field specimens were significantly lower (darker) than that for the specimens exposed for 2,000 hr from the connecting letters report of the Tukey-Kramer analysis. This might appear as if the field specimens degraded more than the laboratory specimens with 2,000 hr of UV exposure. However, the color parameters cannot be evaluated individually. In addition, it should be noted that the laboratory accelerated exposure cycle involves condensation for 4 hr after the UV cycle, which will clean the surface of the specimens regularly. The field exposure specimens were exposed to sporadic precipitation and exposure to dust and other impurities, likely resulting in darker specimens. This can be concluded only by considering the other color-related parameters.

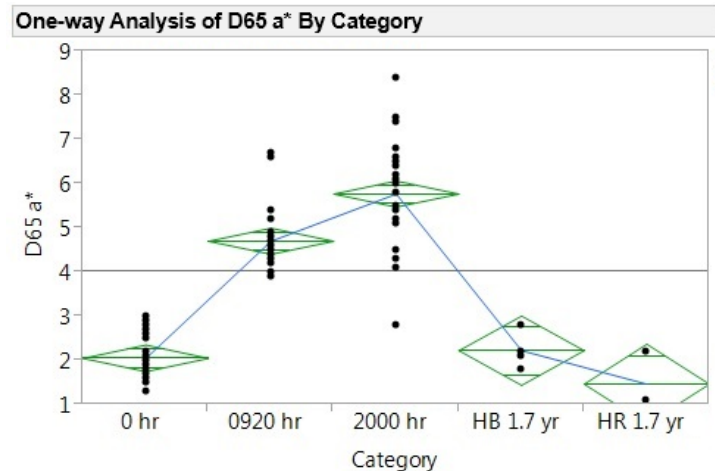
Figure 21. Statistical Means Comparison for D65 a* Values of Laboratory and Field Specimens

Figure 21 shows that the field specimens were lower on the a*, or red, scale and belong in the same level as the specimens that were never exposed and were significantly different from the exposed specimens. In addition, Figure 22 shows that the field specimens were lower on the b*, or yellow, scale and the same level as the specimens that were never exposed and were significantly different from the exposed specimens. Similarly, as shown in Figure 23, the field specimens were noted to have low Chroma values, significantly lower than the laboratory specimens exposed to UV radiation. Likewise, the hue angle was significantly lower than the exposed laboratory specimens.

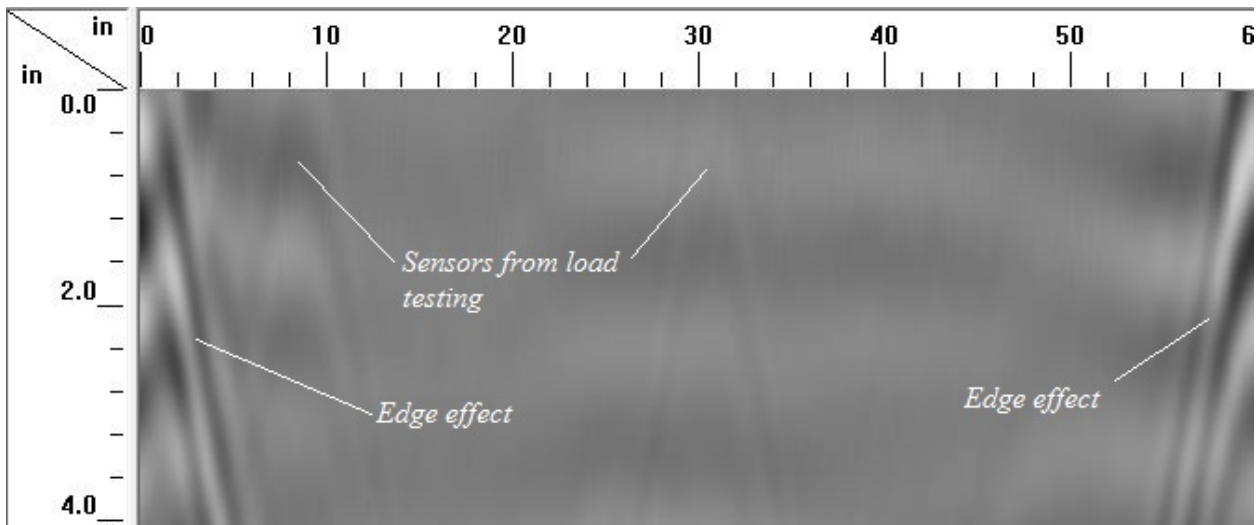
Figure 25. Ground Penetrating Radar Scan of Bottom Flange With No Moisture

Figure 25 shows a GPR scan in the longitudinal direction of the HCB in the middle. The x-axis shows the longitudinal spatial length of the scan, and the y-axis shows the depth. Then, moisture was applied using a brush on the same section for a 12-in length from the edge. Figure 26 shows the GPR scan with the 12-in-long moisture signature clearly. It can be noted that the edge effect in the form of hyperbolas appears more prominent than the presence of water.

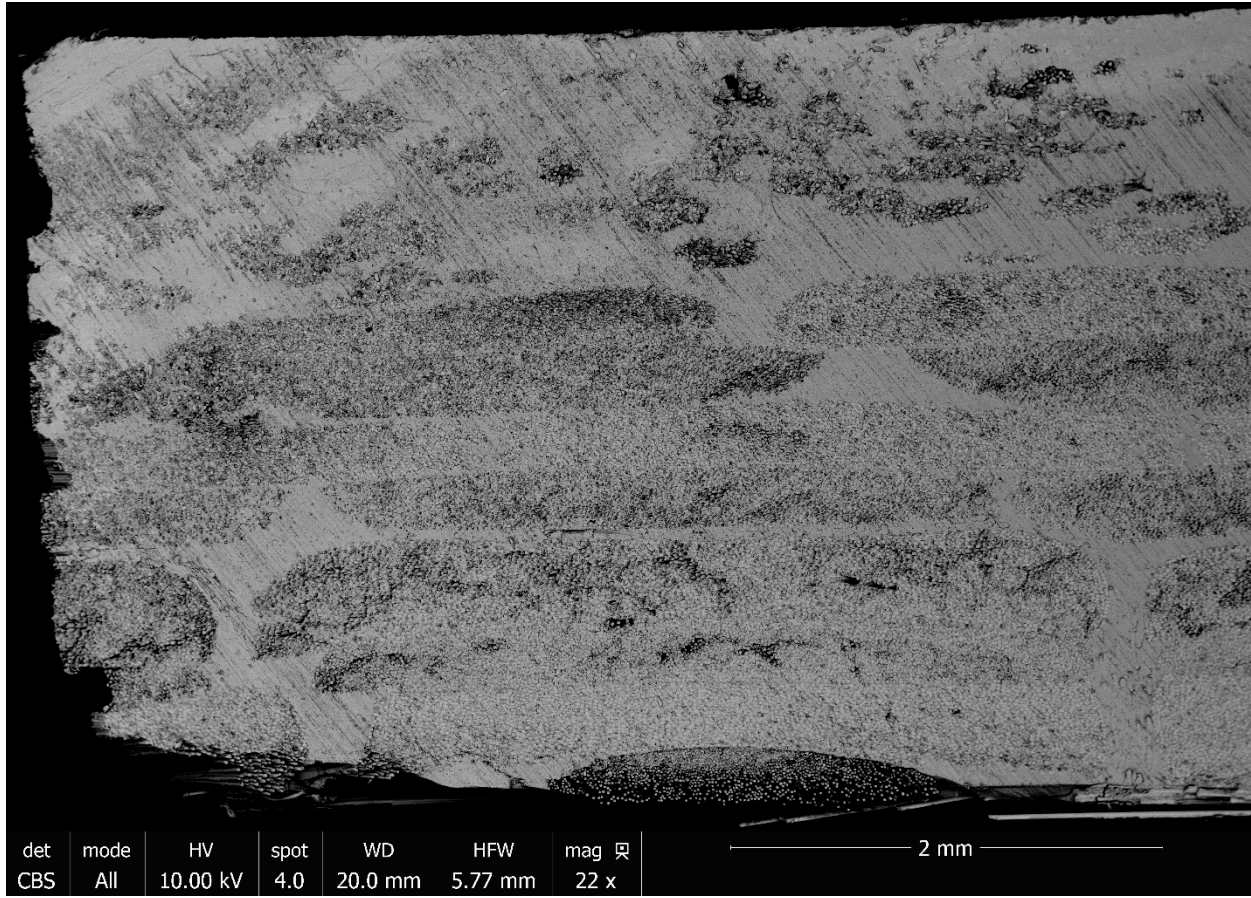
Figure 40. Scanning Electron Microscope Image of Highly Polished Fiber-Reinforced Polymer Sample

A magnified portion of Figure 40 is shown in Figure 41. The fiber layers can be easily identified; however, as stated before, the fiber orientations appear vague. In the same image, the bottom surface of the sample shows some rough edges that were not polished well. It was ironically more useful in identifying the fiber strands and orientation. The rough clump of fibers runs perpendicular to the plane of the image, as indicated by the circular cross section of the individual fiber strands. It was found that unpolished specimens also provided less reliable visualization of the resin.

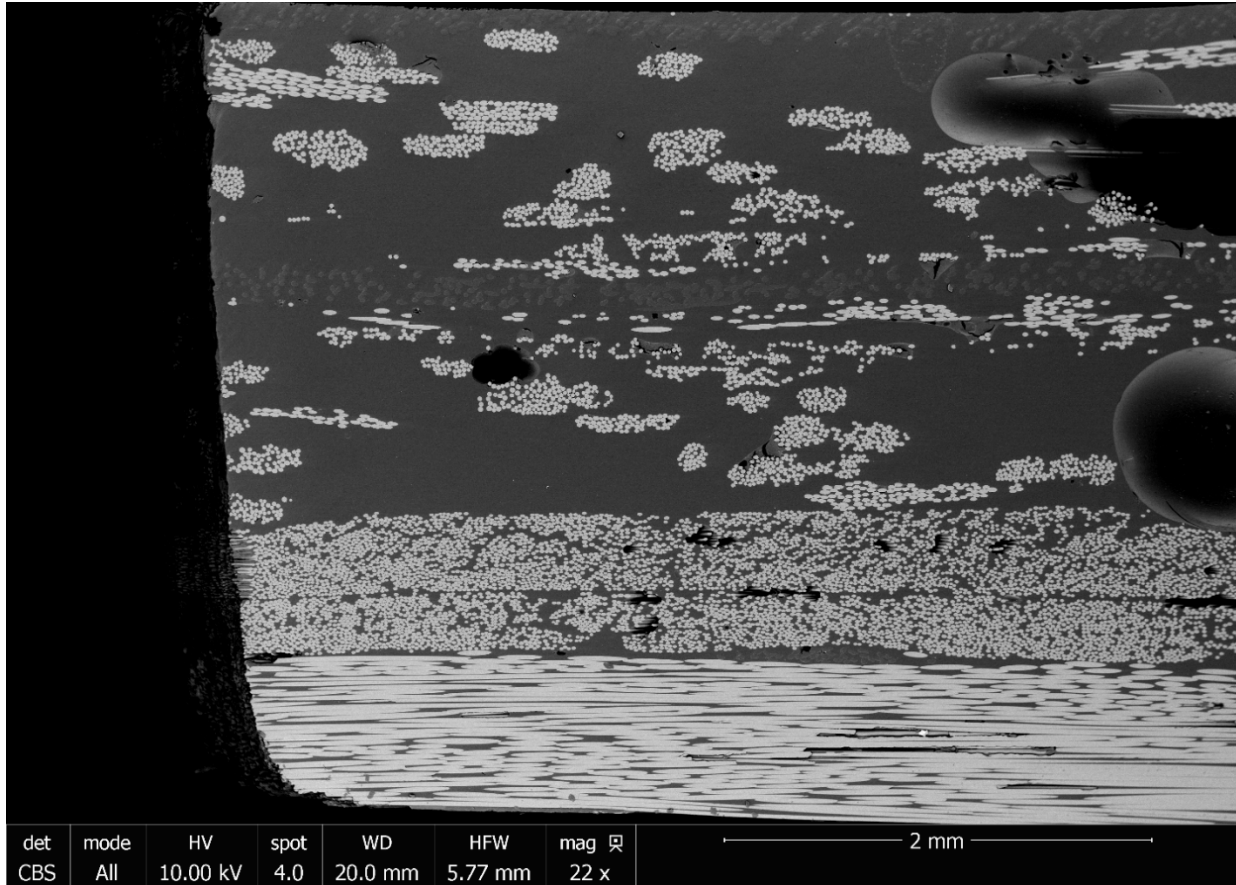
Figure 42. Scanning Electron Microscope Imaging of Mildly Polished Sample

Therefore, further specimens were polished mildly, to remove dirt and foreign material, before SEM imaging was performed, as shown in Figure 42. However, the outer layer of FRP (top two-thirds thickness of Figure 42) showed irregular and scarce fiber content without a particular orientation. It is possible that there were fiber mats in this layer, but was not visible on the surface.

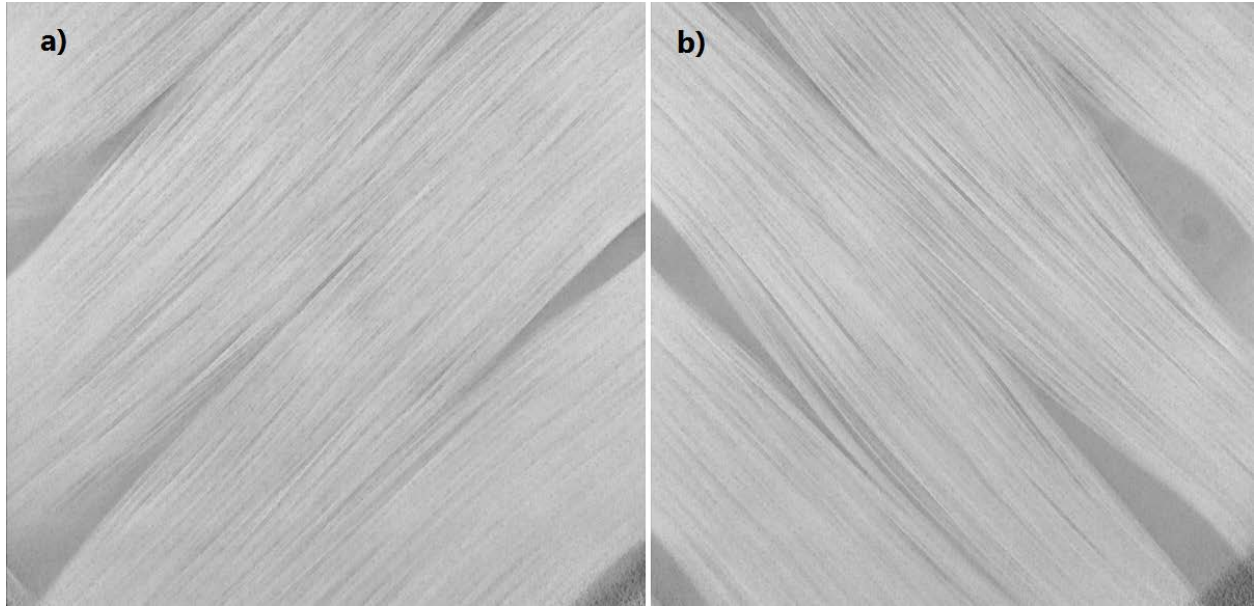
Figure 43. X-ray Computed Tomography Imaging of Fiber Mats: (a) at 45 degree angle; (b) at 135 degree angle

Figure 43 shows images of the longitudinal sections with distinct visualization of the fiber mat orientations. The resolution was more than adequate, displaying particles as small as fiber strands. The outer layer of the FRP sample was scanned to check for actual fiber content, as shown in Figure 44. There were random fiber clumps present in the outer resin layer, but there were no fiber mats. These could have been residues from the fiber mats. Thus, their influence on the tensile strength is miniscule.

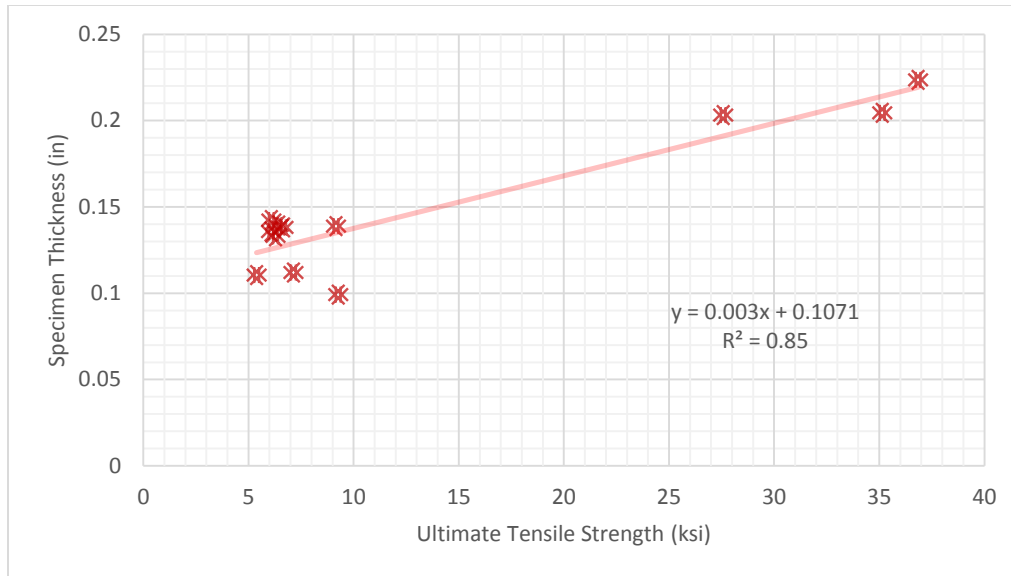
Figure 46. Relationship Between Specimen Thickness and Ultimate Tensile Strength

On average, the thickness of the LO# specimen was 65% greater than that of the rest of the specimens; however, their average tensile strength was about 374% greater. By evaluating the SEM images of the cross sections, it was found that most of the tensile fiber content started at about 0.09 in (2.25 mm) from the outside surface of the FRP specimens. This indicates for the sake of the inspection that if scraping damage is limited to the outer 2 mm or so, the strength of the material will not decrease significantly. However, this finding might apply only to this case, since FRP construction may not be precise enough to have the exact cross section in every beam.

In addition, it was established earlier that the FRP shell acts as an important load-bearing member; thus, the fiber content in the shell, being the principal tensile load-carrying material, must be preserved for structural integrity and expected load-carrying performance. Thus, any fiber exposure must be sealed because of resin degradation as soon as possible for durability.
