Documentation and Evaluation of ASTM A709 Grade 50CR Steel Bridges on Virginia's Eastern Shore

Final Report VTRC 24-R2

Virginia Transportation Research Council
(A partnership of the Virginia Department of Transportation
and the University of Virginia since 1948)

November 2023
VTRC 24-R2

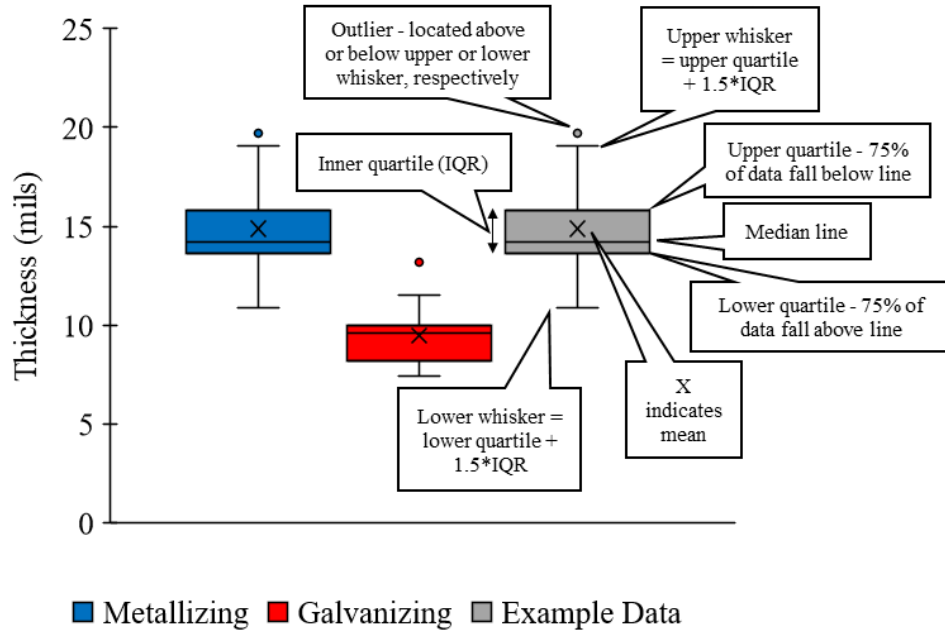
Figure 14. Box and Whisker Plot of Galvanizing and Metallizing/Sealing Thickness Measurements From Nonstructural Beams on the 2022 Holdens Creek Bridge

As shown in the plot, the metallizing/sealing thickness measurements had an approximate mean value of 15 mils and a median value of 14 mils; the lower and upper quartile values ranged from 13.5 to 16 mils. Based on these results, most of the thickness values were relatively consistent, even though the minimum and maximum values ranged from approximately 11 to 21 mils. As discussed previously, the average specified metallizing thickness was 8 to 12 mils, so the additional thickness on the nonstructural beam could be due to the seal coat applied after the metallization process. Also shown in Figure 14 is the galvanizing thickness of the nonstructural beam. The galvanizing thickness measurements had an approximate mean and median value of 9.7 mils, and the upper and lower quartile values ranged from 8 to 10 mils, indicating relatively consistent values.

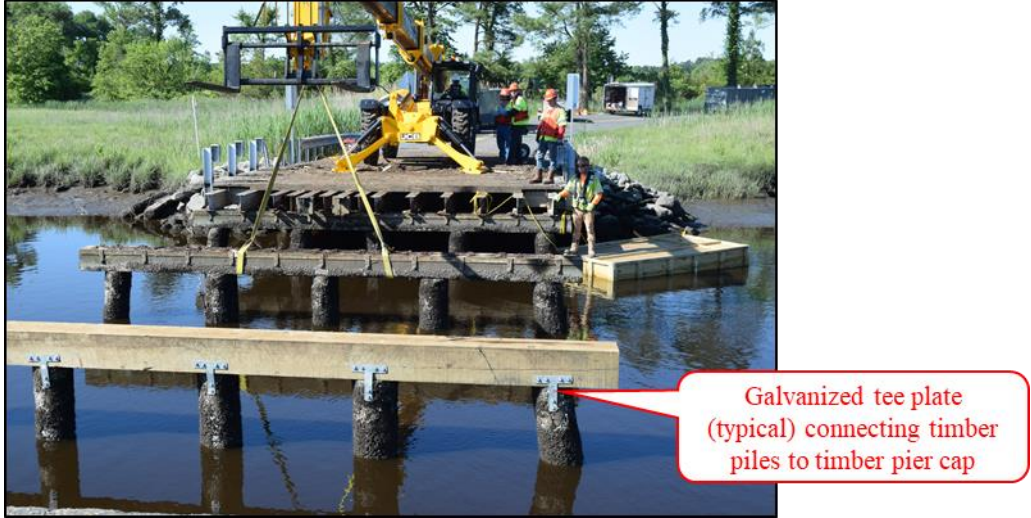
Figure 15. Photograph Showing Galvanized Tee Plates Connecting Timber Piles to Timber Pier Cap

The thickness of the galvanizing was also measured on secondary elements, such as the diaphragms, deck stringers, and tee plate connectors between the timber piers and pier caps. These elements were shown in the bridge cross section in Figure 7. Figure 15 shows a photograph of one of these tee plate connectors after installation. Fifteen galvanizing thickness measurements were taken on the deck stringers, 12 measurements were taken on the diaphragms, and 12 measurements were taken on the tee plates. These measurements were recorded from random locations on each galvanized secondary element type. The measurements are shown in a box and whisker plot in Figure 16.

As seen in the plot, the galvanizing thickness on the deck stringers and diaphragms appeared to be similar, with mean values of approximately 10.4 mils and 9.3 mils, respectively. The tee plates, however, had much thinner galvanizing on them, with a mean value of approximately 2.1 mils. With such a thin layer of initial galvanizing, the tee plates should be a focus for monitoring over time, especially since they are located at a lower elevation than the bridge girders and will therefore be submerged in the brackish water more frequently.

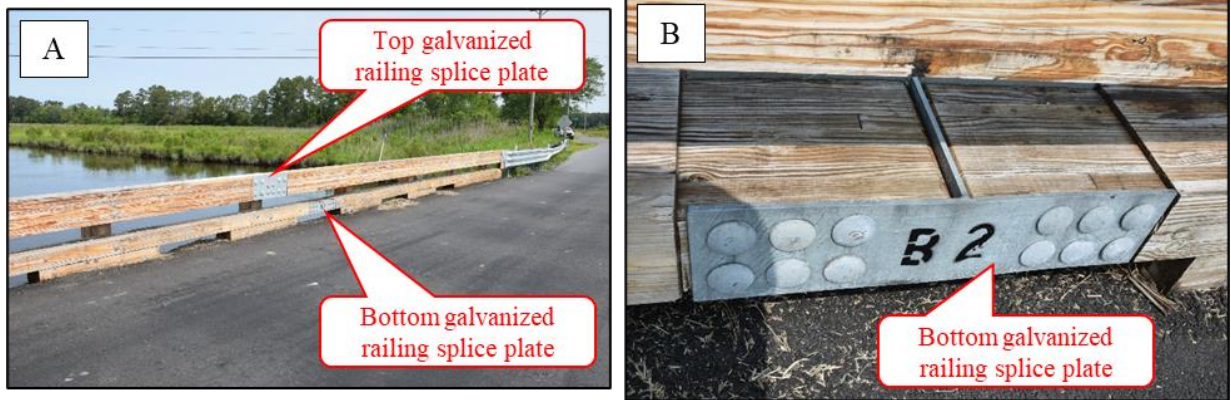
Figure 18. Photographs of Galvanized Splice Plates for Glulam Railing on the 2022 Holdens Creek Bridge: (A) overall view; (B) close-up of bottom splice plate.

The guardrail system on the approach roadways to the north and south of the bridge and the railing system on the bridge also provided opportunities to monitor corrosion performance over time. Near the middle of the bridge, the glulam railing system on both sides of the bridge was spliced together using galvanized steel plates. These galvanized steel splice plates are shown in Figure 18. These splice plates were present on both the water side and the traffic side of both the east and west railings. Thickness measurements on the galvanizing of all these splice plates were recorded. Overall, the top splice plates had a galvanizing thickness of 4 to 6 mils, and the thickness of the galvanizing on the bottom splice plates ranged from 7 to 9 mils.

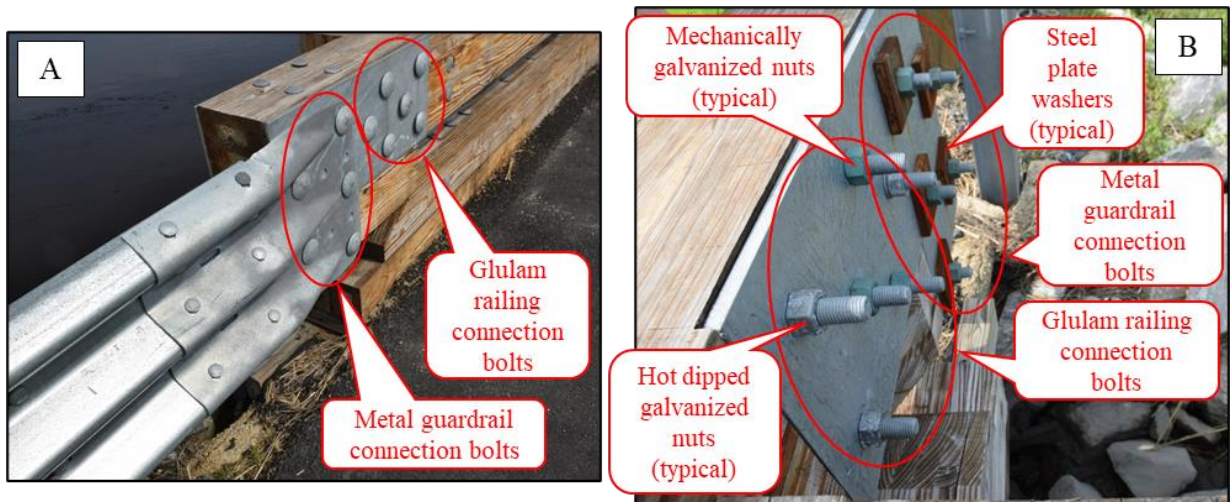
Figure 19. Photographs of Metal Guardrail to Glulam Railing Guardrail Connection on Southwest Corner of Bridge Showing Connection: (A) traffic side; (B) water side.

The connections from the metal guardrail on the roadway to the glulam railing on the bridge also offered an opportunity to monitor corrosion performance over time with different types of corrosion protection systems. Figure 19 shows photographs of this connection at the southwest corner of the bridge. It can be seen that the metal guardrail connection bolts have steel plate washers, which are not galvanized, between the nuts and galvanized splice plate. It is expected that these steel plate washers are likely made of ASTM A36 steel. Because these steel plate washers were not galvanized and were made from typical carbon steel, they are expected to have much less corrosion resistance than the rest of the surrounding hardware. As for the glulam railing connection bolts, the nuts were galvanized with two different methods: the gray/silver nuts were hot dipped galvanized, and the green nuts were mechanically galvanized. This difference was noted so that any difference in corrosion performance between the two different galvanization methods can be monitored in the future.

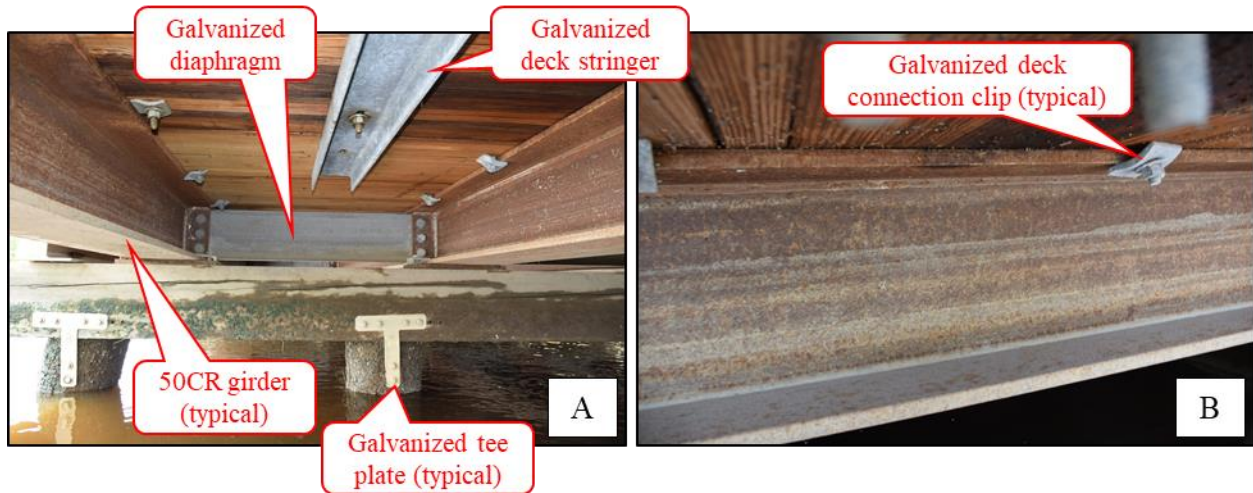
Figure 20. Photographs of Underneath Side of the 2022 Holdens Creek Bridge: (A) general view; (B) close-up of 50CR steel girder.

Figure 20 shows photographs of the underneath side of the bridge. Figure 20a presents a general view showing the 50CR steel girders; a galvanized diaphragm with galvanized fastener connections; a galvanized deck stringer; and the substructure, including a galvanized tee plate connecting the timber piles to a timber pile cap. Figure 20b shows a close-up of one of the 50CR steel girders with a galvanized deck connection clip. Overall, the 50CR steel girders showed the rustic patina that was expected. Water lines were also present on the girders where the water from Holdens Creek below had partially submerged the girders for periods of time. There did not appear to be any zinc product migrating from the galvanized deck connection clips to the 50CR steel girders at this time.

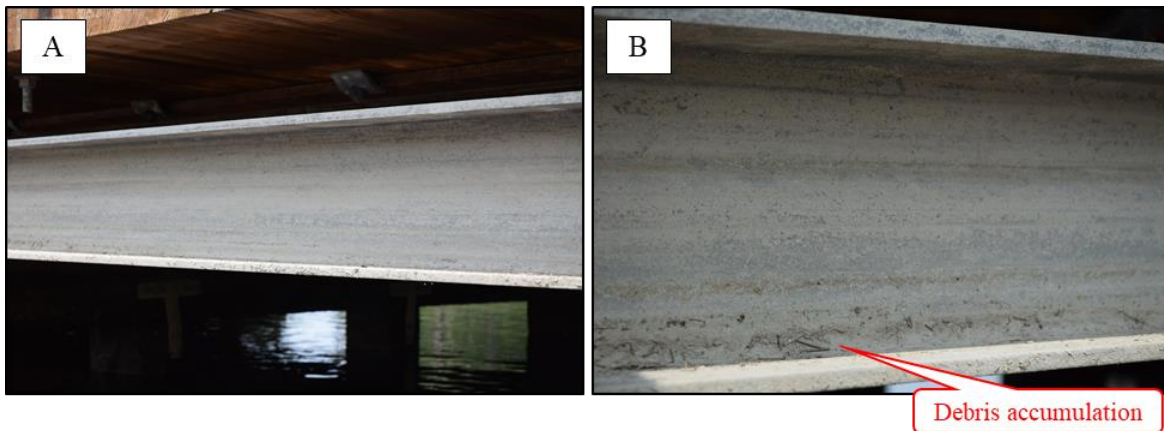
Figure 23. Photographs of Metallized/Sealed Nonstructural Beam on Atlantic Ocean Side of the 2022 Holdens Creek Bridge: (A) general view of beam; (B) close-up of beam.

Figure 23 shows photographs of the nonstructural metallized/sealed beam on the Atlantic Ocean side of the 2022 Holdens Creek Bridge. In contrast to the galvanized nonstructural beam, there was no debris accumulation on top of the nonstructural metallized/sealed beam. However, there was more debris accumulation on the ocean side of the bottom flange. These differing levels of debris accumulation are likely due to differences in the ebb and flow of the tide in Holdens Creek. Since debris accumulation can lead to increased corrosion, it will be interesting to watch how it affects both the nonstructural galvanized and metallized/sealed beams.

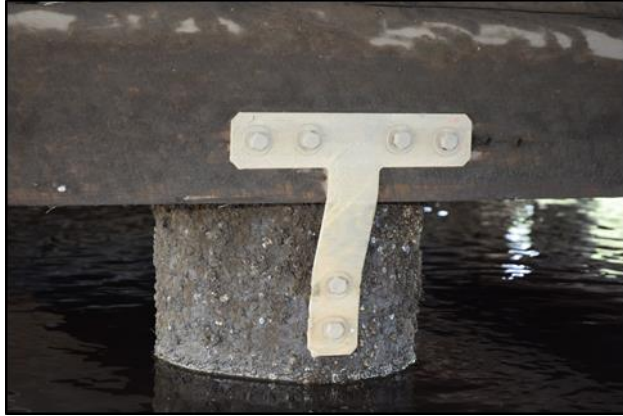
Figure 24. Photograph of Galvanized Tee Plate Connection Between Piles and Pile Cap on the 2022 Holds Creek Bridge

Figure 24 shows a photograph of one of the galvanized tee plate connections on the substructure. The tee plate connection in this photograph was bent both longitudinal and transverse to the bridge. Since these tee plates were not bent when originally installed (see Figure 15), this is likely to have been caused by movement of the bridge due to traffic and flooding forces.

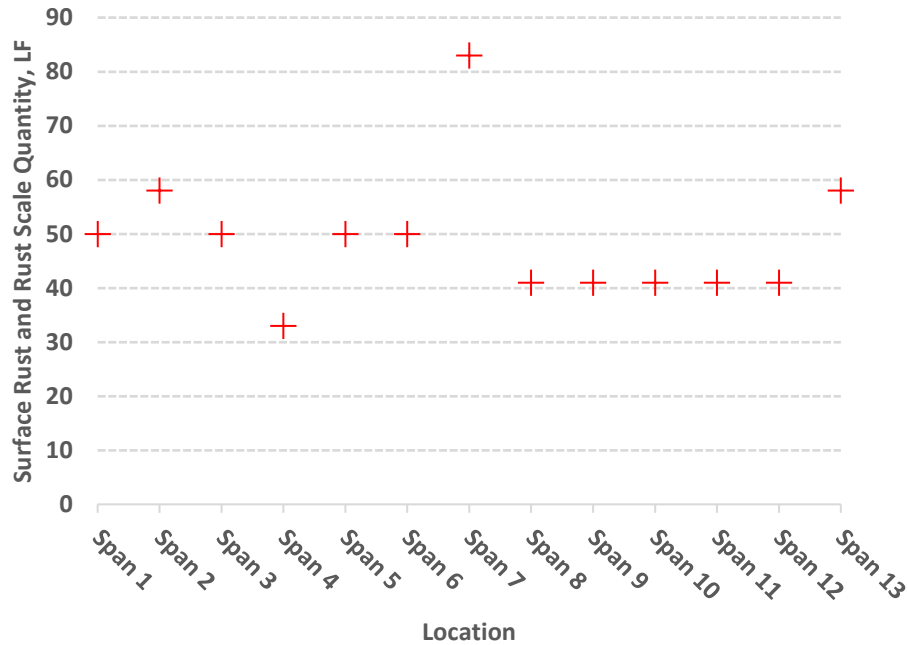
Figure 25. Lineal Feet of Surface Rust and Rust Scale on Beams Within Each Span of the Onancock Bridge

In 2017, the VDOT inspection report indicated that reflective cracking of the wearing surface on top of the deck with crack widths of up to $\frac{1}{2}$ in was observed between all decking timbers. The coating on the beams supporting the timbers was considered “Poor,” so when rain or snow was present, the coating no longer protected the steel and moisture could readily reach the steel. The degree of rusting along these beams is shown in Figure 25. Photographs taken during the 2017 inspection of these beams are provided in Figure 26.

The 2017 inspection report indicated that surface rust and rust scale with section loss were evident along the top flange of all beams, with the section loss primarily at deck clip locations. Surface rust and rust scale were noted in the bottom flanges and webs of all beams, with measurable section loss up to $\frac{1}{16}$ in also being observed in the bottom flanges. The inspection report also noted rust perforation in the webs and up to $\frac{1}{8}$ in of section loss in the bottom flanges of multiple beams, shown in Figure 27.

The 2017 inspection report recommended that multiple deficient beams receive special attention and be made a priority over routine and preventative maintenance work. It also recommended that a contract be scheduled to clean and paint all structural steel, 6,576 ft², which included the steel beams and steel caps.

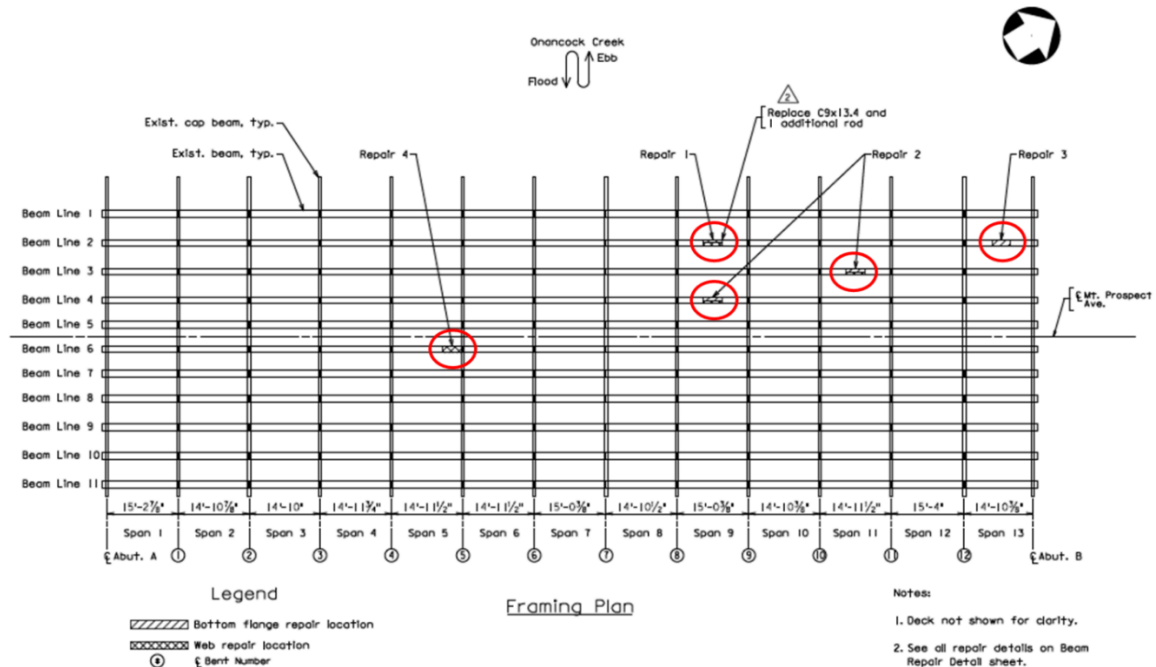
Figure 28. Framing Plan of the Onancock Bridge Showing Bolted Repair Locations. The locations of the five bolted repairs are indicated by red circles.

Based on the repair plan scope of work, five bolted repairs were required at the Onancock Bridge. Figure 28 shows a framing plan of the Onancock Bridge with the locations of the five bolted repairs indicated by red circles. Among the five locations, there were four different repair types. This is noted by Repair Type 2 being indicated in two locations on the framing plan. The repair types differed by steel type; fastener assembly type; geometry; and whether the repair included a bottom flange splice, web splice, or both.

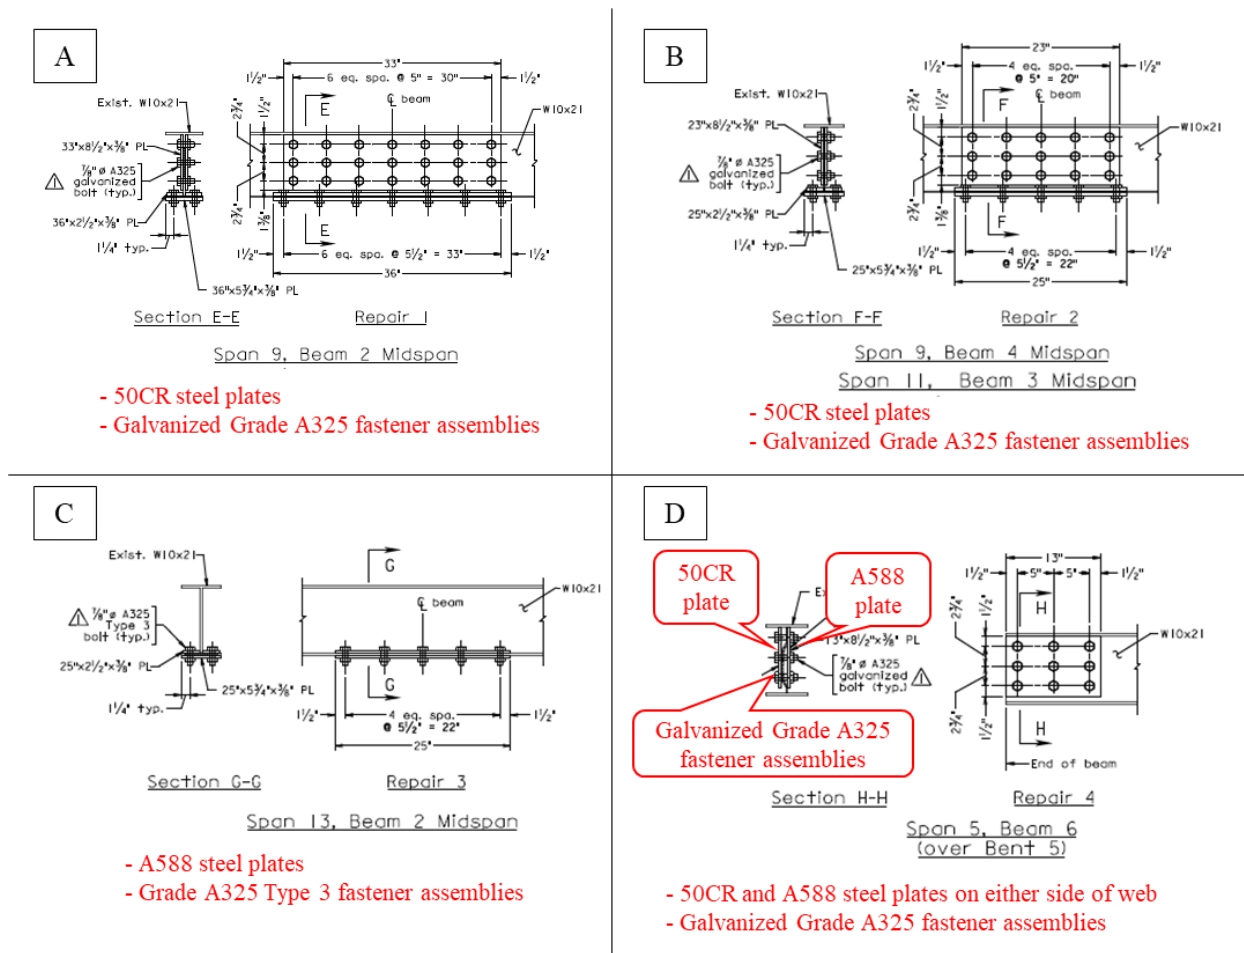
Figure 29. Bolted Repair Details for the Onancock Bridge Indicating Type of Steel Plates and Fastener Assemblies Used: (A) Repair Type 1; (B) Repair Type 2; (C) Repair Type 3; (D) Repair Type 4.

Figure 29 shows the details of each repair type. As indicated in the figure, Repair Types 1 and 2 both consisted of 50CR steel repair plates combined with galvanized ASTM F3125, Grade A325 (A325), fastener assemblies. For these repairs, repair plates were installed on the web and bottom flange at each specified location. The repair types differed only by the length of the steel plates required. Galvanized fastener assemblies were selected with these repair types to follow the cost-saving design alterations used for the 2022 Holdens Creek Bridge, discussed previously. Repair Type 3 consisted of weathering steel repair plates and fastener assemblies, i.e., A588 steel plates and A325, Type 3, fastener assemblies. For this repair, plates were added to the bottom flange of the beam. Weathering steel plates and fastener assemblies were selected for this type of repair to serve as the control and to provide a comparison to the 50CR steel plate with galvanized fastener assemblies in Repair Types 1 and 2. Repair Type 4 was somewhat of a combination of Repair Types 1 and 2 and Repair Type 3. Repair Type 4 contained one 50CR steel plate on one side of the beam web, one A588 steel repair plate on the opposite side of the beam web, and galvanized A325 fastener assemblies connecting the repair plates to the existing beam. This combination of steel plates and fastener assemblies was selected to determine the difference in corrosion performance when 50CR steel and A588 steel are connected via galvanized fastener assemblies. The bolted repairs were installed on the Onancock Bridge in February 2018.

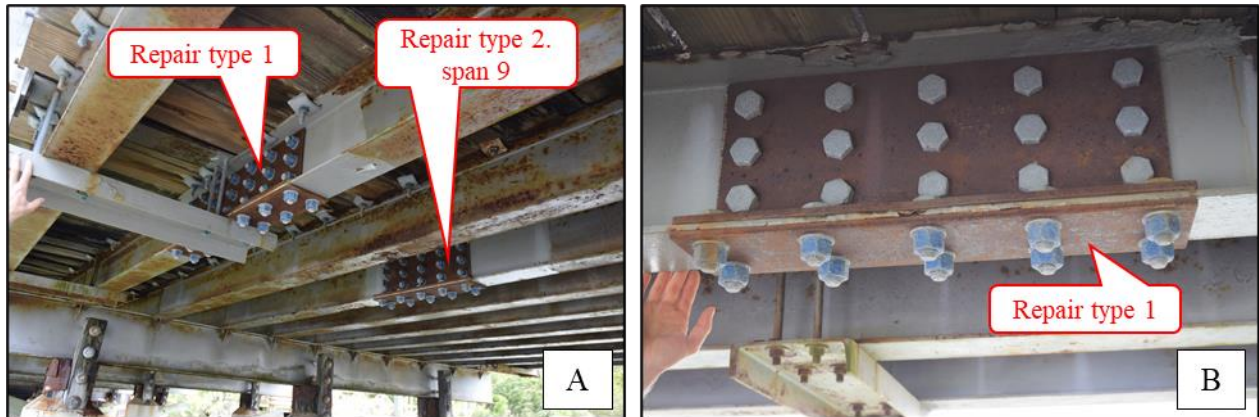
Figure 30. Photographs of Bolted Repair Types 1 and 2 Made of 50CR Steel and Galvanized Fastener Assemblies on the Onancock Bridge: (A) general view of both repairs; (B) close-up of Repair Type 1.

Since the Repair Type 1 and both Repair Type 2 repairs consisted of 50CR steel plates with galvanized fasteners and had similar conditions in the field, they are discussed together. Figure 30 shows photographs of Repair Types 1 and 2 from Span 9. Overall, these repairs appeared to be in good condition, and the 50CR steel plates appeared to have a consistent rustic patina. The thickness of the 50CR steel plates was measured with a UT thickness gauge and was consistently 0.40 in. As noted in the design drawings for these repairs, all repair plates had a nominal thickness of 3/8 in.
