Forensic Investigation of Two Voided Slab Bridges in the Virginia Department of Transportation's Richmond District

SOUNDAR S.G. BALAKUMARAN, Ph.D., P.E.
Research Scientist
Virginia Transportation Research Council

Final Report VTRC 17-R12

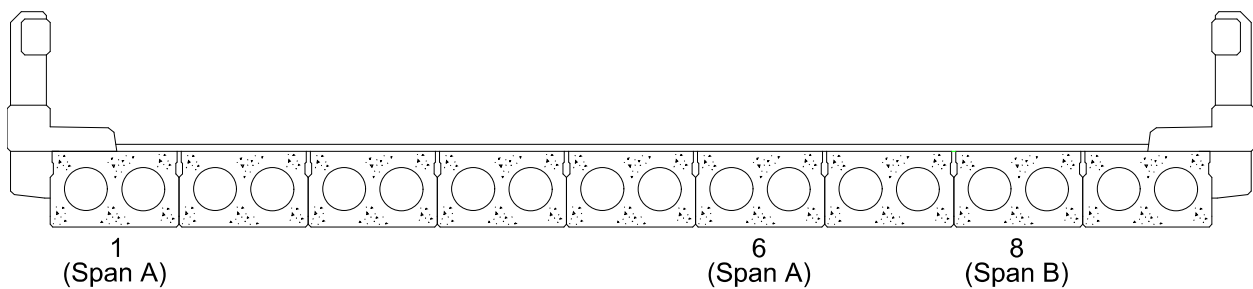
Figure 4. Beams From Qualla Road Bridge Selected for Non-Destructive Evaluation

For the Qualla Road Bridge, three beams, shown in Figure 4, were selected for NDE. One beam was an exterior beam containing large holes on the exterior face (Beam 1, Span A); these holes had exposed prestressing strand and opened into one of the preformed, cylindrical voids. A second member, Beam 6, Span A, had been reported to have excessive mid-span deflections. The third beam was adjacent to an exterior beam but showed no external damage (Beam 8, Span B). The beams were shipped from the bridge site to the temporary storage location and inverted for ease of access to the tension face of the beams.

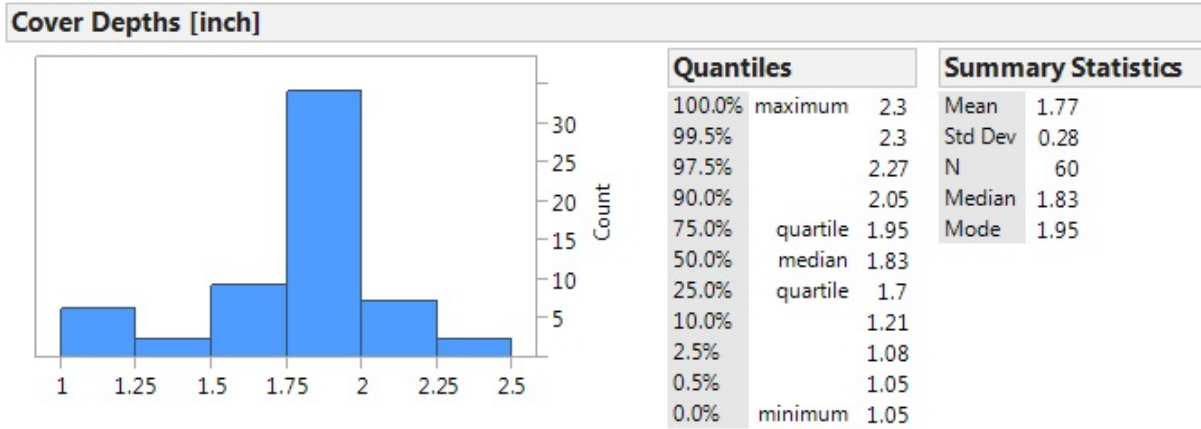
Figure 15. Histogram of Cover Depths Measured From Dismantled Beams of Qualla Road Bridge

Cover depths were measured using a magnetic pachometer. For those cases where the pachometer had difficulty locating strands because of overcrowding, GPR proved to be a quick alternative. Figure 15 shows the distribution of all of the concrete cover depths measured to the surface of the reinforcement. Most of the values are concentrated between 1.75 and 2 in, with nearly 75% of all measurements being less than 2 in. The plans specified a concrete cover depth of 2 in to the center of the 3/8-in-diameter strands, which equals 1.81 in of clear cover. Figure 15 indicates that about 50% of the cover depths did not meet the thickness specifications.

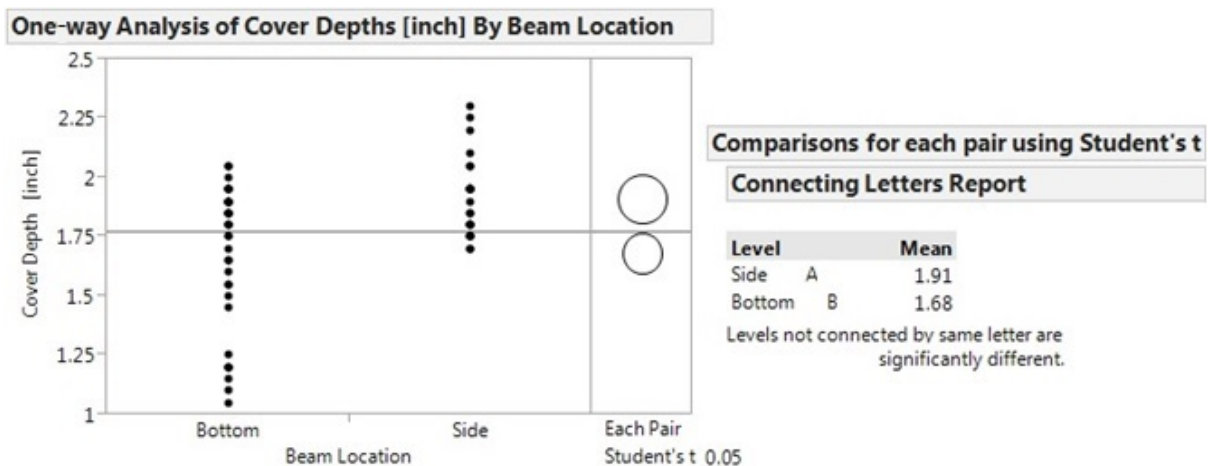
Figure 16. Comparison of Cover Depths for Beam Sides and Bottom of Qualla Road Bridge

Figure 16 presents the comparison between the concrete cover over the strands on the sides of the beams to cover at the bottom of the beams. Apparently, the concrete cover thicknesses for the sides were significantly higher compared to those of the bottoms; thus, the expected likelihood of corrosion in the bottom of the slabs was greater.

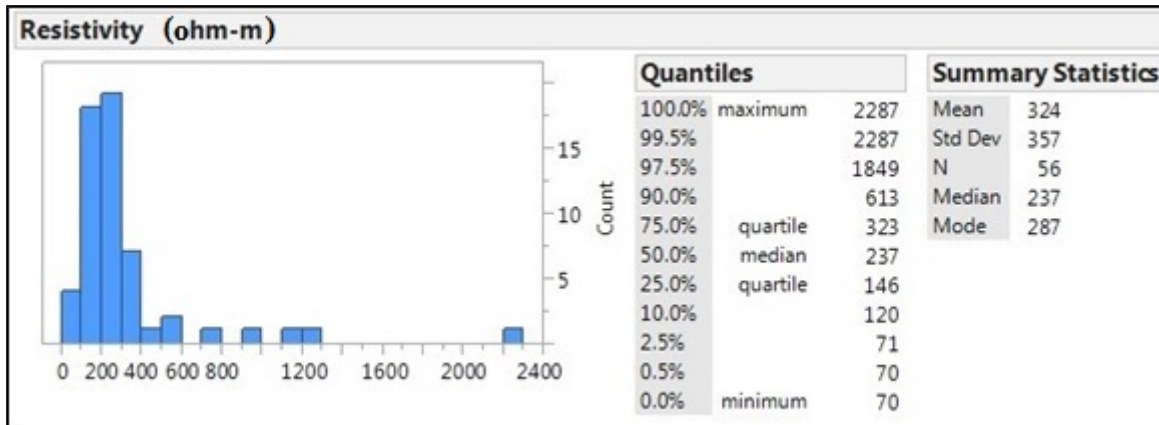
Figure 17. Histogram of Resistivity Measured From Dismantled Beams of Qualla Road Bridge

From Figure 17, more than 75% of the concrete resistivity measurements were below 400 ohm-m, meaning that the concrete was expected to support high rates of corrosion (Balakumaran, 2012). This result indicates that the quality of the concrete, which reflects the permeability, void structure, void size distribution, and moisture saturation of the concrete, was poor enough such that rates of corrosion activity could be high. To reiterate, low resistivity values mean only that corrosion, should it occur, could proceed at higher rates in the concrete but does not indicate whether corrosion is actively occurring.

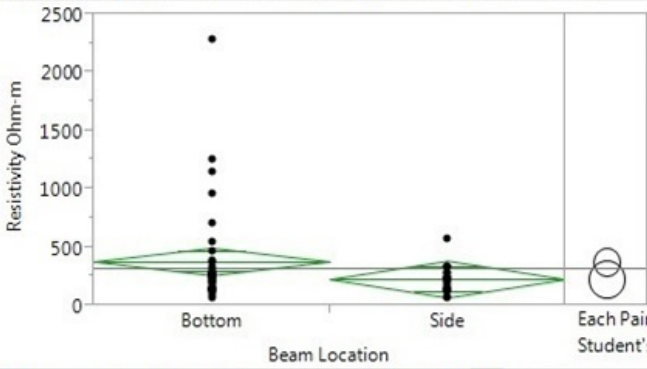
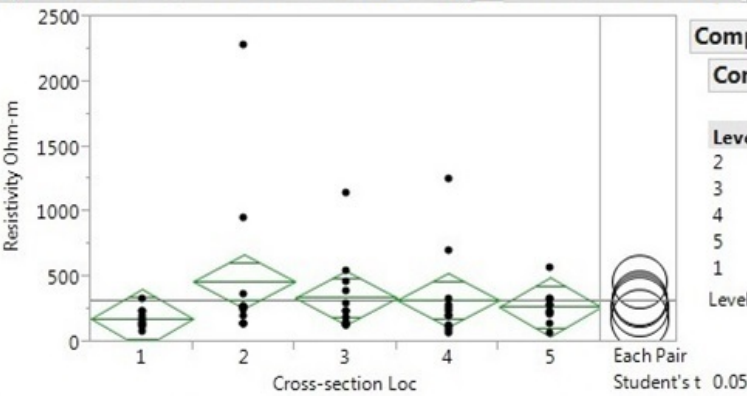
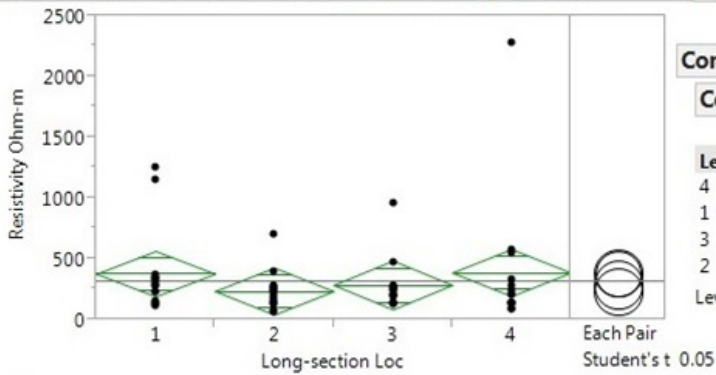
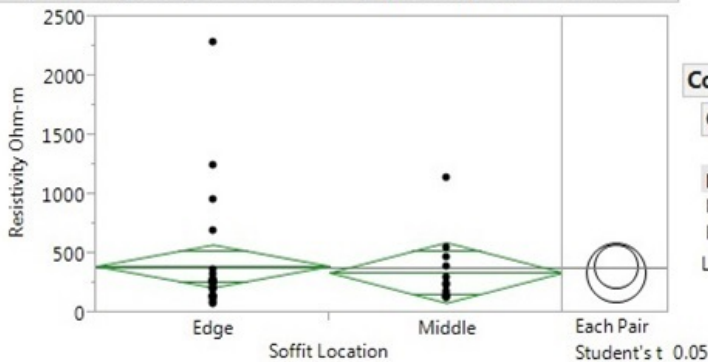
Figure 18. Resistivity Values Compared Based on Test Location Groups of Qualla Road Bridge

Figure 18 clearly shows that the resistivity values are not statistically different at any particular location on the beams. Thus, the concrete resistivity is fairly uniform among all of the beams. This suggests uniform concrete placement and compaction among the beams.

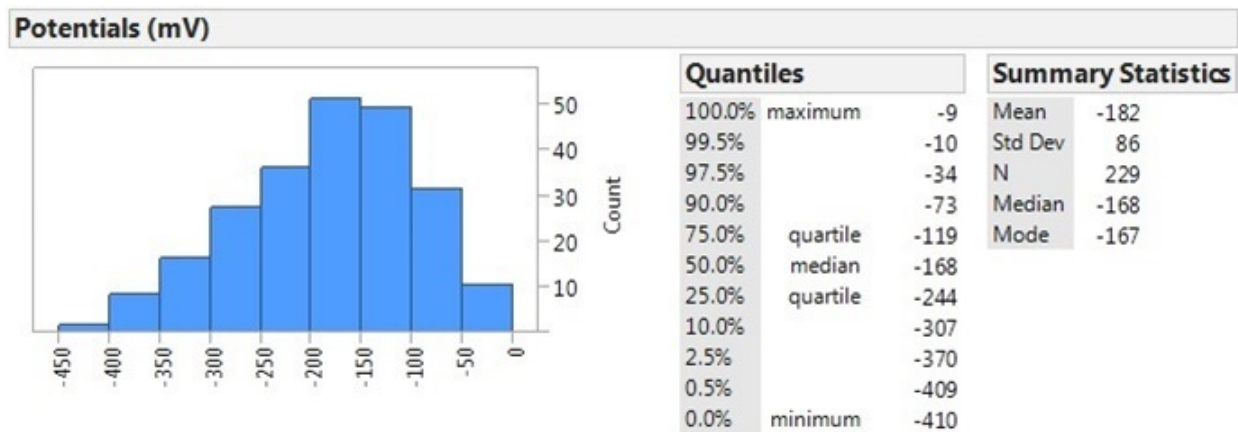
Figure 19. Histogram of Potentials Measured From Dismantled Beams of Qualla Road Bridge

Figure 19 shows the distribution of potentials from all three beams. About 90% of the values were less negative than -350 mV CSE. ASTM C876 (ASTM, 2009) states: “If potentials over an area are more negative than -0.35 V CSE, there is a greater than 90% probability that reinforcing steel corrosion is occurring in that area at the time of measurement.” However, values that are more positive than -350 mV do not necessarily imply that the steel reinforcement is free of corrosion byproducts.

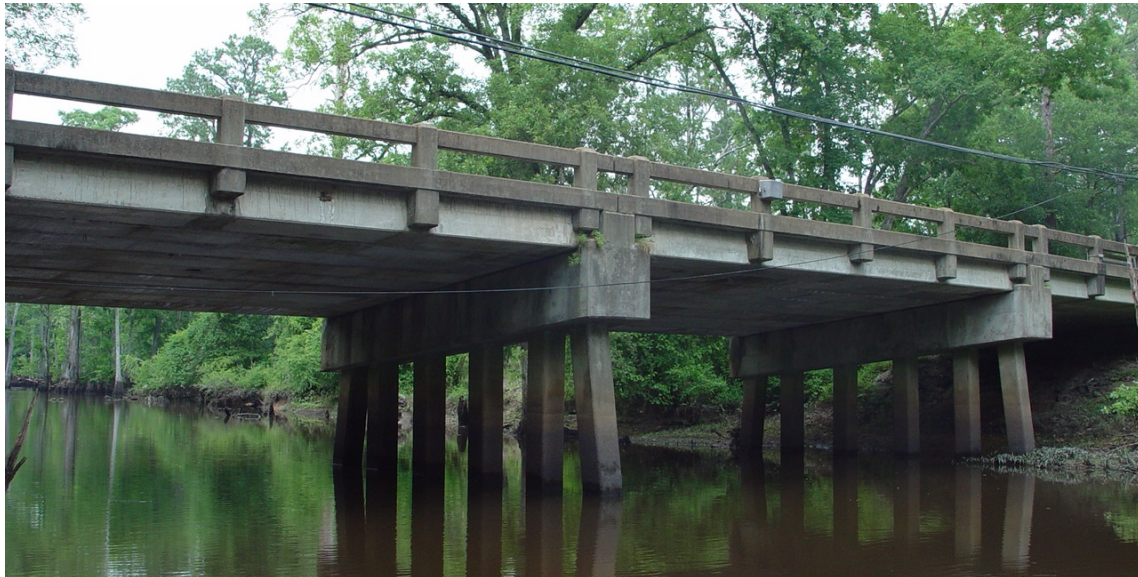
Figure 23. Side View of Adkins Road Bridge

Figure 23 shows a side view of the Adkins Road Bridge over the Chickahominy River. Water runoff drains on the bridge cross slope to the lower parapet of the superelevated deck, which is on the upstream side of the river. Like the Qualla Road Bridge, this structure had scuppers, a number of which were filled with dirt and plants, as shown in Figure 24. This also shows the large concrete patches found in the asphalt wearing surface. These patches were primarily in the lane of higher elevation, which was the downstream side of the bridge. These patches indicated severe damage in the asphalt overlays in the past. This contradicts conventional thinking, where the snow would have likely been pushed to the lower elevation and consequently would have been where the water would have ponded. Thus, one might expect that the lower elevation would have had more damage on the top of the beams. However, the vegetation and organic matter on the higher elevation may have been holding water long enough for the water to stagnate and diffuse below the asphalt wearing surface.

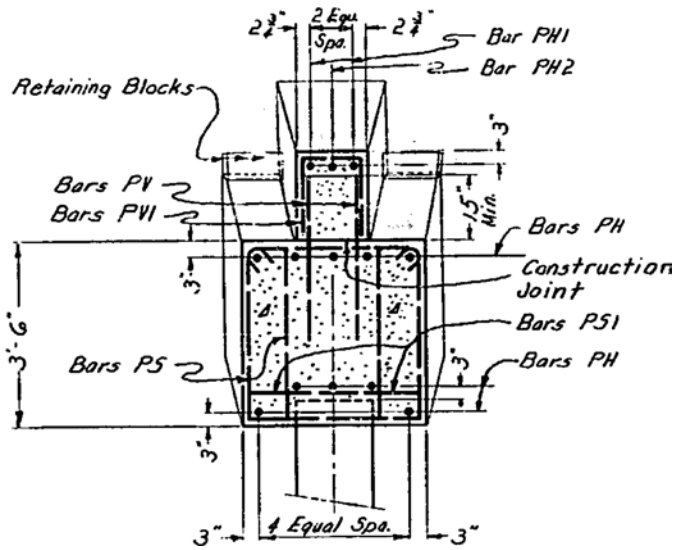
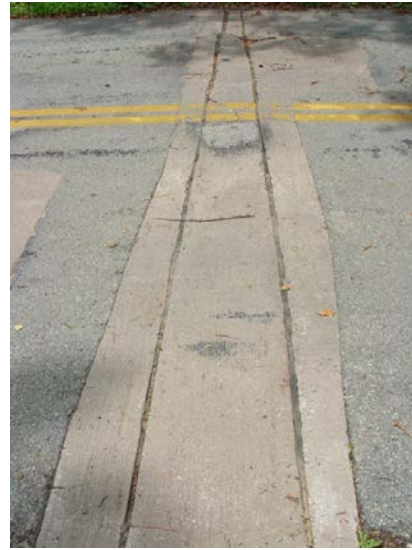
Figure 25. Adkins Road Bridge: (a) Cross Section, and (b) Photograph of Wedge-Shaped Bent Cap / Beam Seat Designed to Accommodate Straight Beams Supporting a Curved Road

The structure was on a curve; therefore, in order to accommodate the straight voided slabs, the bent caps had a slight wedge shape in the plan, where the upstream end of the cap was slightly wider than the downstream end, as shown in Figure 25(a). The joints on both sides of each cap were filled with a pourable sealant, as shown in Figure 25(b). All of the joints were cracked, allowing water runoff from the roadway to reach the ends of the beams below. The asphalt wearing surface was cracked along a number of the longitudinal joints between the adjacent slabs. Roadway runoff had leaked through these joints and wicked across the bottom of the beams.

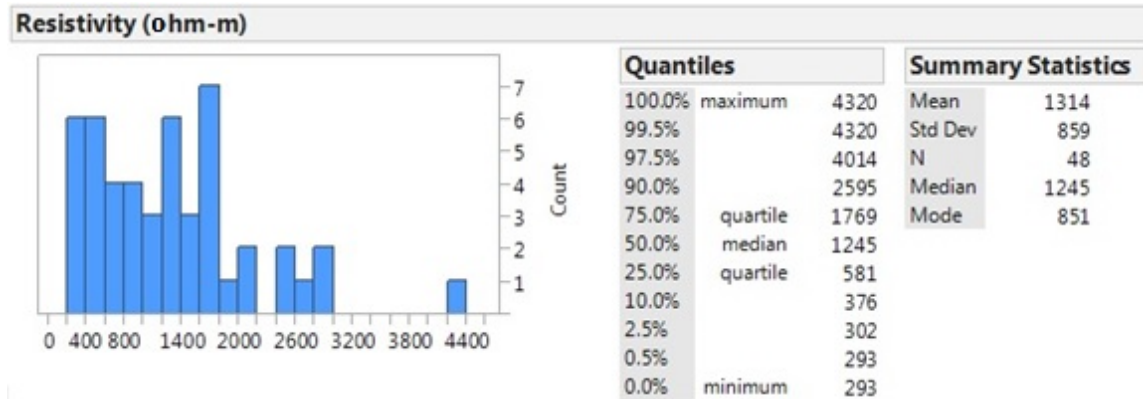
Figure 27. Histogram of Resistivity Values From Adkins Road Bridge

Figure 27 presents the histogram of the resistivity values obtained from the beam soffits. The values appear to be mostly greater than 400 ohm-m, which would ordinarily indicate concrete that can support low-to-medium corrosion rates. However, the bottom surface was very dry during testing. Ideally, the concrete surfaces would be wetted prior to resistivity measurements being made because resistivity depends on the moisture content of concrete. Unfortunately, in the case of the Adkins Road Bridge, pre-wetting was not practical because the concrete surfaces were upside down. Therefore, the resistivity values for the bottom of the beams may not have represented the condition of the concrete when moist or saturated. The uncertainty in the results highlights the fact that the in situ NDE of superstructure soffits has a set of challenges that need to be addressed in order for the test results to be reliable.

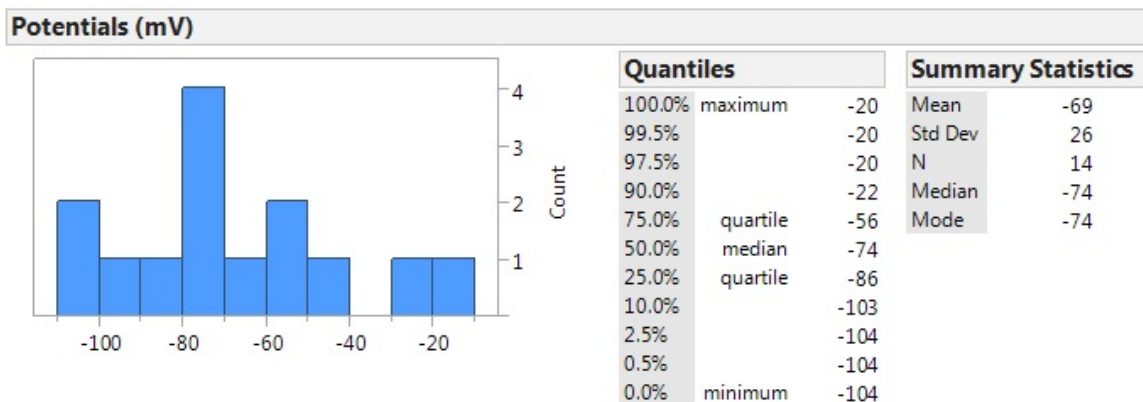
Figure 28. Histogram of Potentials From Adkins Road Bridge

Figure 28 shows the histogram of the potentials obtained from the beam soffits. As with the resistivity measurements, the values given may not be truly representative of the corrosion activity in the reinforcement because of the extremely dry surface of the bottom of the beams.

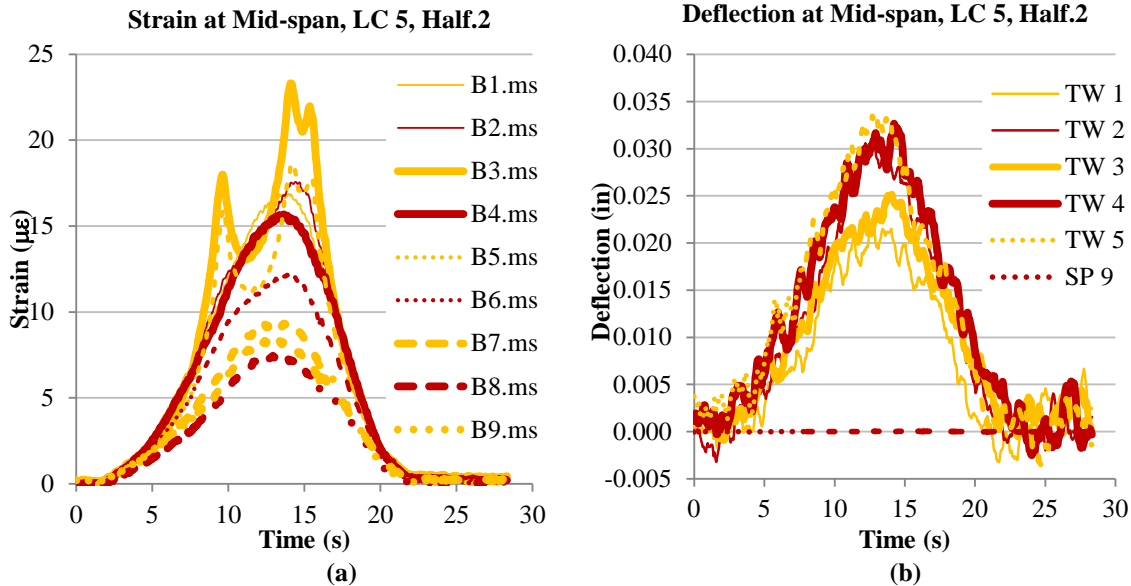
Figure 30. Adkins Road Bridge: Typical Plots for (a) Mid-span Strain and (b) Deflections During a Live Load Test. LC 5 = Load Case 5.

The third item is that the string potentiometer in Figure 30(b), *SP 9*, behaved as if there was no deflection in Beam 9. Even when the full truck was the closest to Beam 9 in LC 1, the wire potentiometer registered very small deflections (about 0.007 in), as shown in Figure 31(a). As a comparison, the condition when the full truck was closest to Beam 1 in LC 3 in Figure 31(b) may be considered. This loading scenario is symmetric to Beam 9 in LC 1. For LC 3, the data from the deflectometer, *TW 1*, indicated that Beam 1 was one of two beams that had the largest deflection being recorded and had a maximum deflection that was about 6 times the maximum deflection recorded in Beam 9 during LC 1. Thus, according to Figure 31, Beam 9 was dramatically more rigid than its companion exterior girder under similar loading conditions. However, the same extension wire anchoring the deflection measurement reference point to the riverbed was used in device *SP 9* as was used for the other five deflection measurements. Therefore, the more likely scenario is that there was an error in the equipment installation, where the slight spring force in the potentiometer could not resist either the weight of or the spring force in the extension wire. Thus, as Beam 9 deflected downward, the extension wire may have recoiled somewhat as the distance from the end of the potentiometer wire to the ground surface decreased in length instead of, at least in part, the potentiometer retracting by the amount of deflection. Because of the lack of confidence in the measurements taken with the device *SP 9*, the deflection in Beam 9 is disregarded in any further discussions.

The fifth and final item regarding Figure 30 is that unlike the strain results, the deflection was not always the largest in the beam directly under the passenger-side wheel line. The deflection in Beam 3, *TW 3* in Figure 30(b), is less than in three of the other beams instrumented for deflection, whereas the same beam had the largest recorded strain. Much of the discrepancy can be explained by the 0.005-in accuracy of the deflectometers, where the difference between the deflection in Beam 3 in LC 5 and the largest measured deflection was about 0.007 in when loaded with the half truck. Of course, no comment can be made regarding the deflection in LC 1 and LC 2 because of the fact that there were no functioning deflection devices underneath the beams on the downstream half of the bridge.

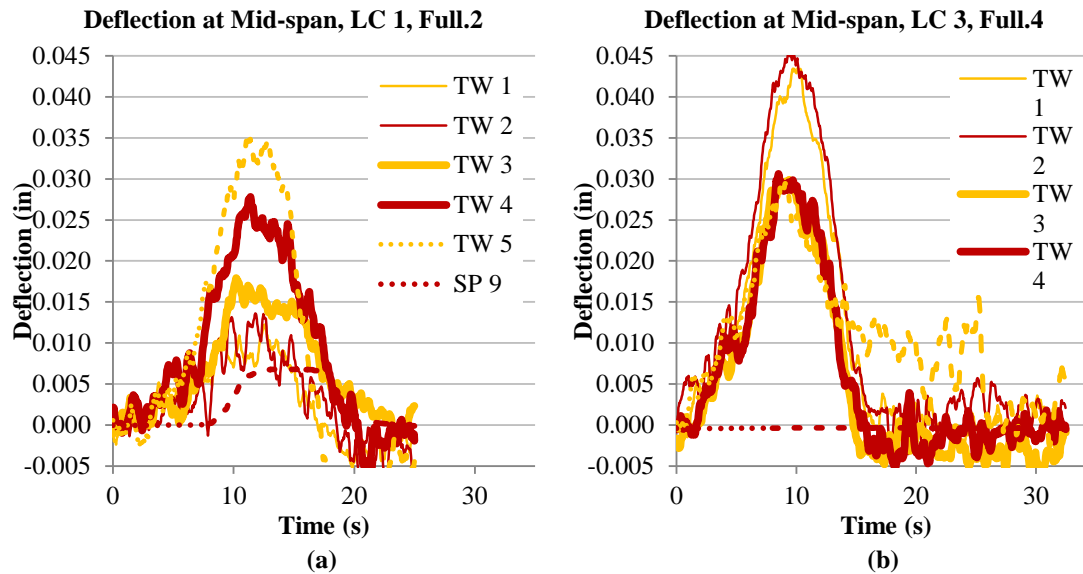
Figure 31. Adkins Road Bridge: Comparison of Typical Deflection Data for Two Symmetrical Load Cases: (a) LC 1, and (b) LC 3

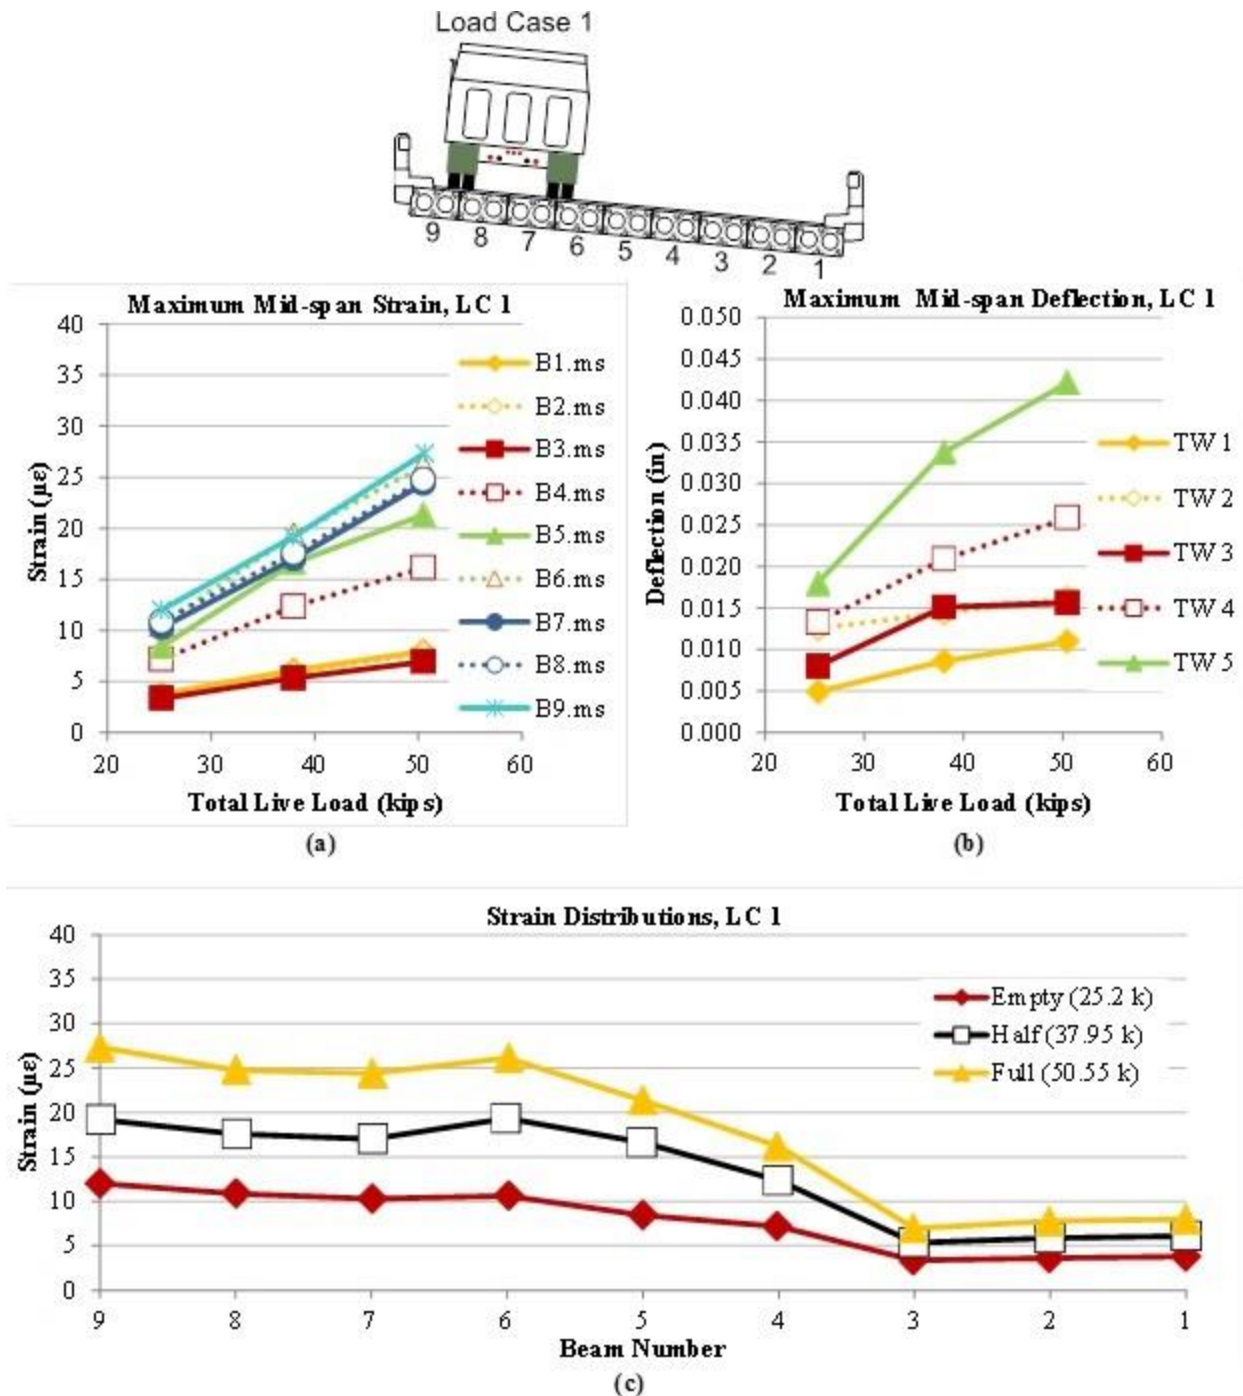
Figure 32. Adkins Road Bridge: Average (a) Maximum Strain and (b) Maximum Deflection for Each Beam, and (c) Strain Distributions at Mid-span for All Beams at Time of Maximum Strain for Load Case 1 (LC 1). Empty = empty truck; Half = half-full truck; Full = full truck.

The calculated compressive force in Beam 1 was consistent with the strain versus load graphs in Figures 32 through 37, where the strains measured at mid-span increased fairly linearly up to the weight of the full truck. These linear results show that the structure remained within its linear elastic limit up to 25 tons during the load test, which was about 18 tons less than the inventory rating for a single-unit vehicle on this particular bridge, as listed in the 2011 inspection report.

Regarding the load distribution graphs shown in Figures 32 through 37, if the load were evenly spread out across all the beams in a bridge, the amount of strain in each beam would be identical. However, if the weight of a truck is borne solely by the beams directly underneath the truck's wheels, then a more localized distribution of the load would be indicated by a sizable change in the strain in those beams relative to the other members. Although all of the LCs during this test had distribution results that were somewhere between these two outcomes, LCs 1 and 2 were closer to the former scenario, where Beams 5 through 9 had a relatively similar amount of strain (at the time of maximum strain) when the truck was located on the elevated half of the bridge.

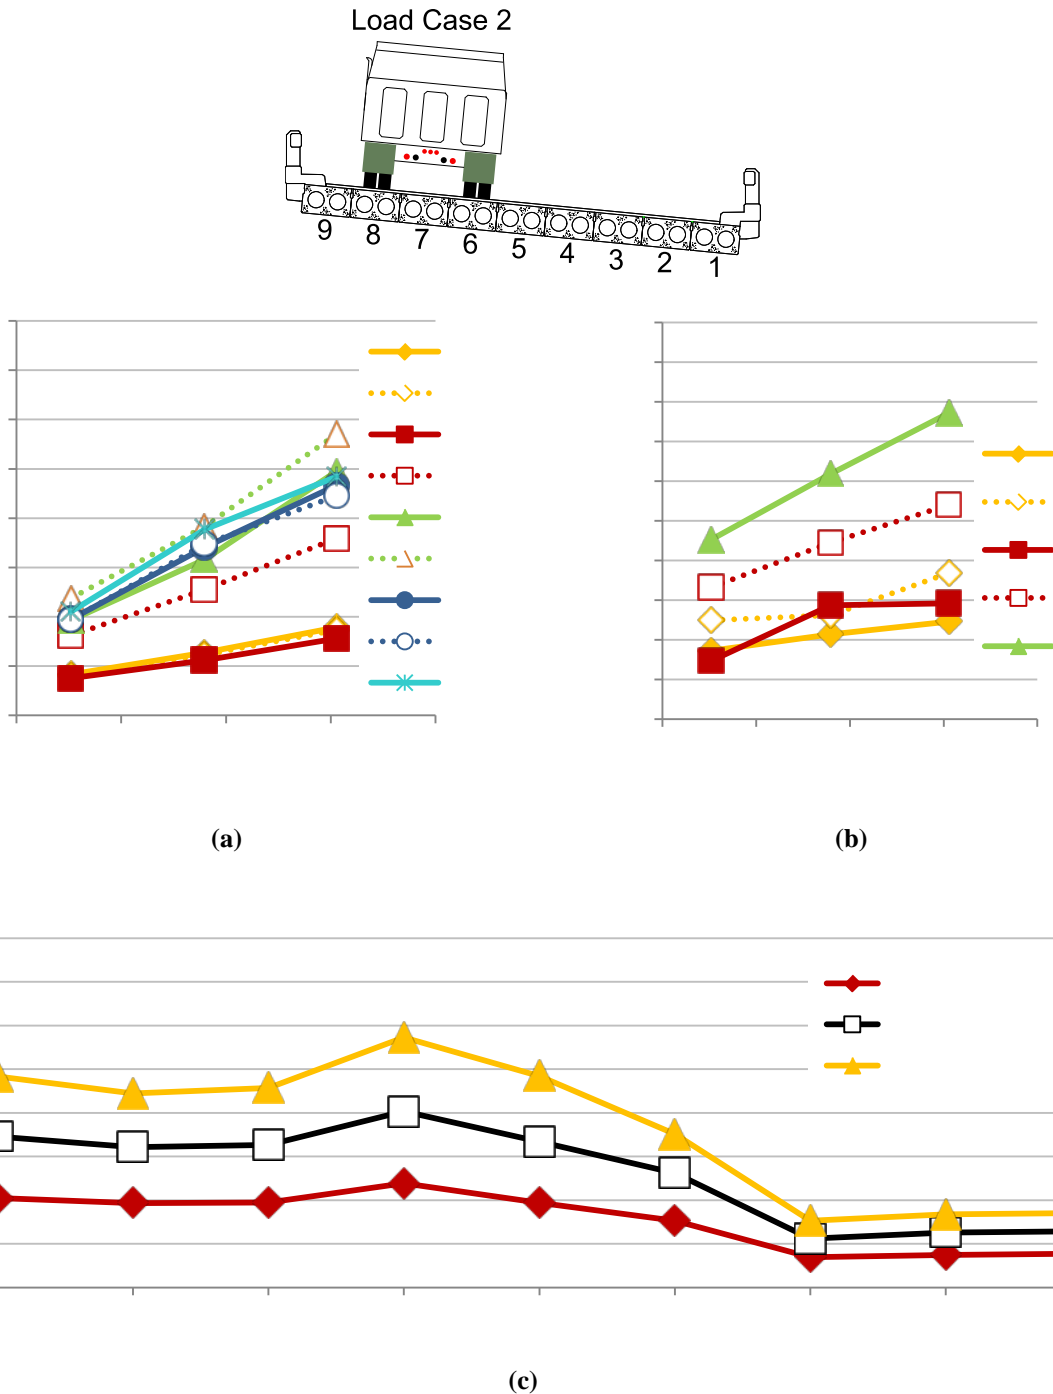
Figure 33. Adkins Road Bridge: Average (a) Maximum Strain and (b) Maximum Deflection for Each Beam, and (c) Strain Distributions at Mid-span for All Beams at Time of Maximum Strain for Load Case 2 (LC 2). Empty = empty truck; Half = half-full truck; Full = full truck.

The exceptions to this linearity in load-strain behavior were Beam 5 in LC 2, shown in Figure 33(a); Beam 3 in LC 6 and, to a lesser extent, Beam 6 in LC 2, shown in Figure 33(a); and Beam 2 in LC 4, shown in Figure 35(a). In these cases, the rate of increase in strain between the half truck and the full truck was greater than the increase going from the empty truck to the half truck, on a strain per unit load basis. Interestingly, the instances with Beam 5 and Beam 3 occurred with a wheel line adjacent to the beam in question, as opposed to being directly on top of Beam 6 and Beam 2. These increases could indicate that the beams were getting closer to their elastic limits. However, the deviation from the linear strain increase for Beam 5 and Beam 3 was only about 5 $\mu\epsilon$, which is negligible. Further, the relatively small rate of change suggests that there was still some room to increase the load if desired, as suggested by the relatively low ratio of the experimental-to-design stress.

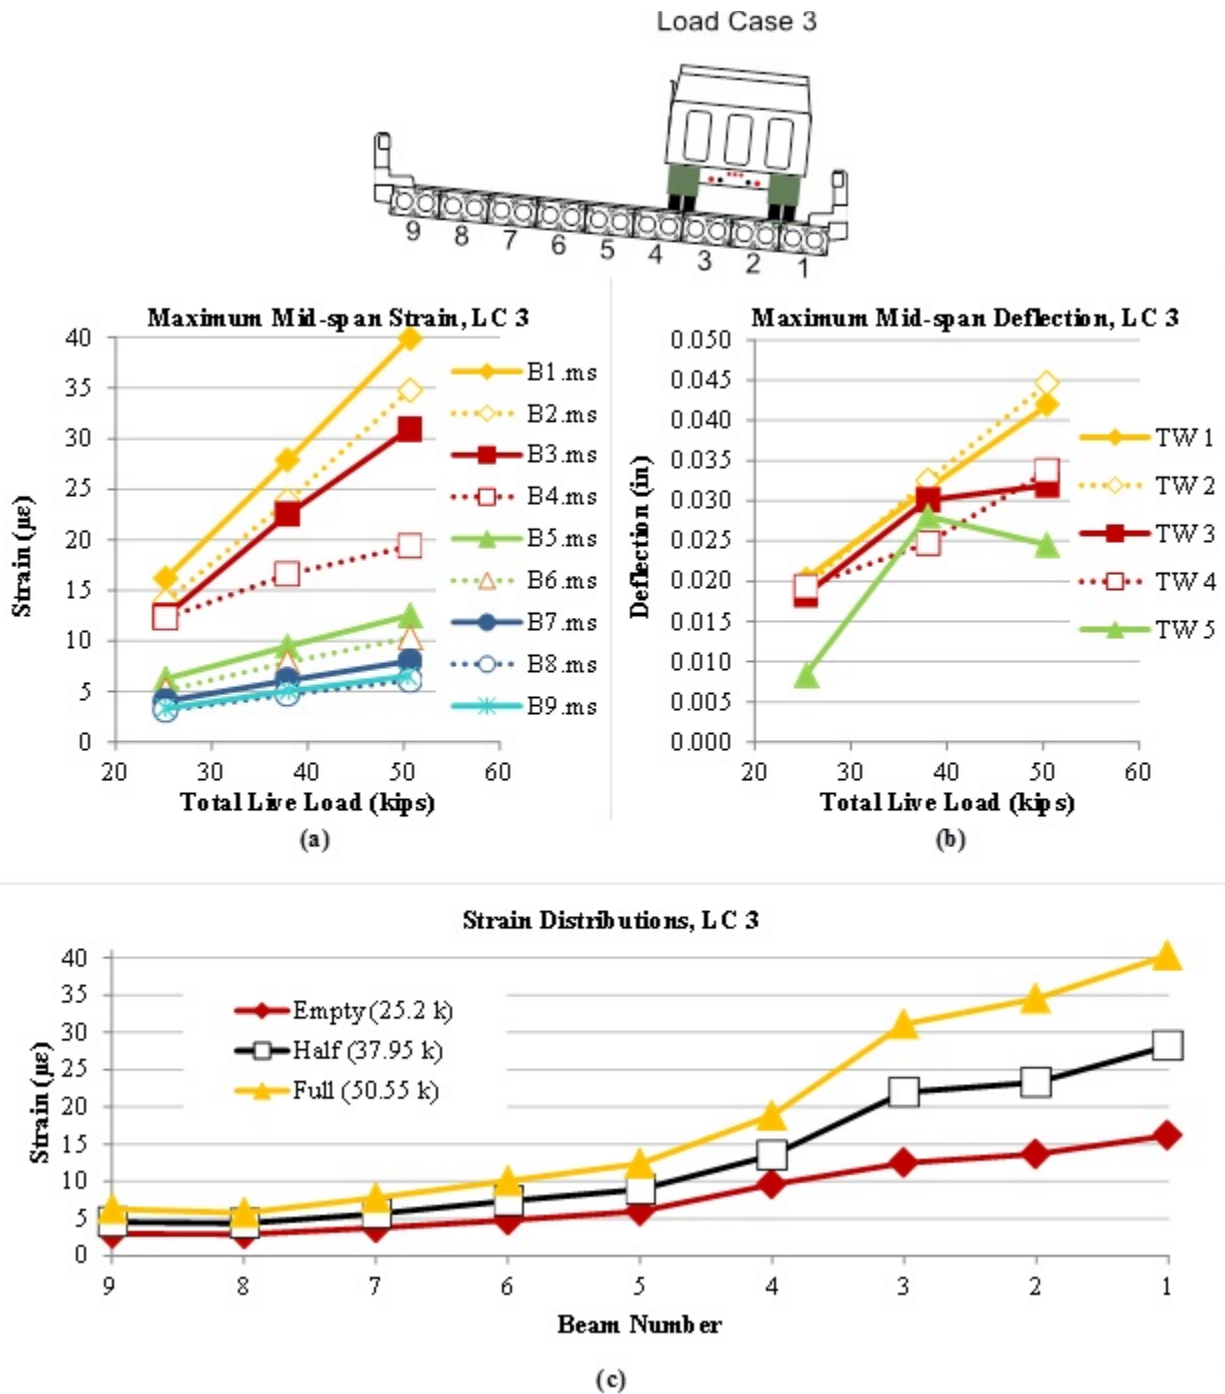
Figure 34. Adkins Road Bridge: Average (a) Maximum Strain and (b) Maximum Deflection for Each Beam, and (c) Strain Distributions at Mid-span for All Beams at Time of Maximum Strain for Load Case 3 (LC 3). Empty = empty truck; Half = half-full truck; Full = full truck.

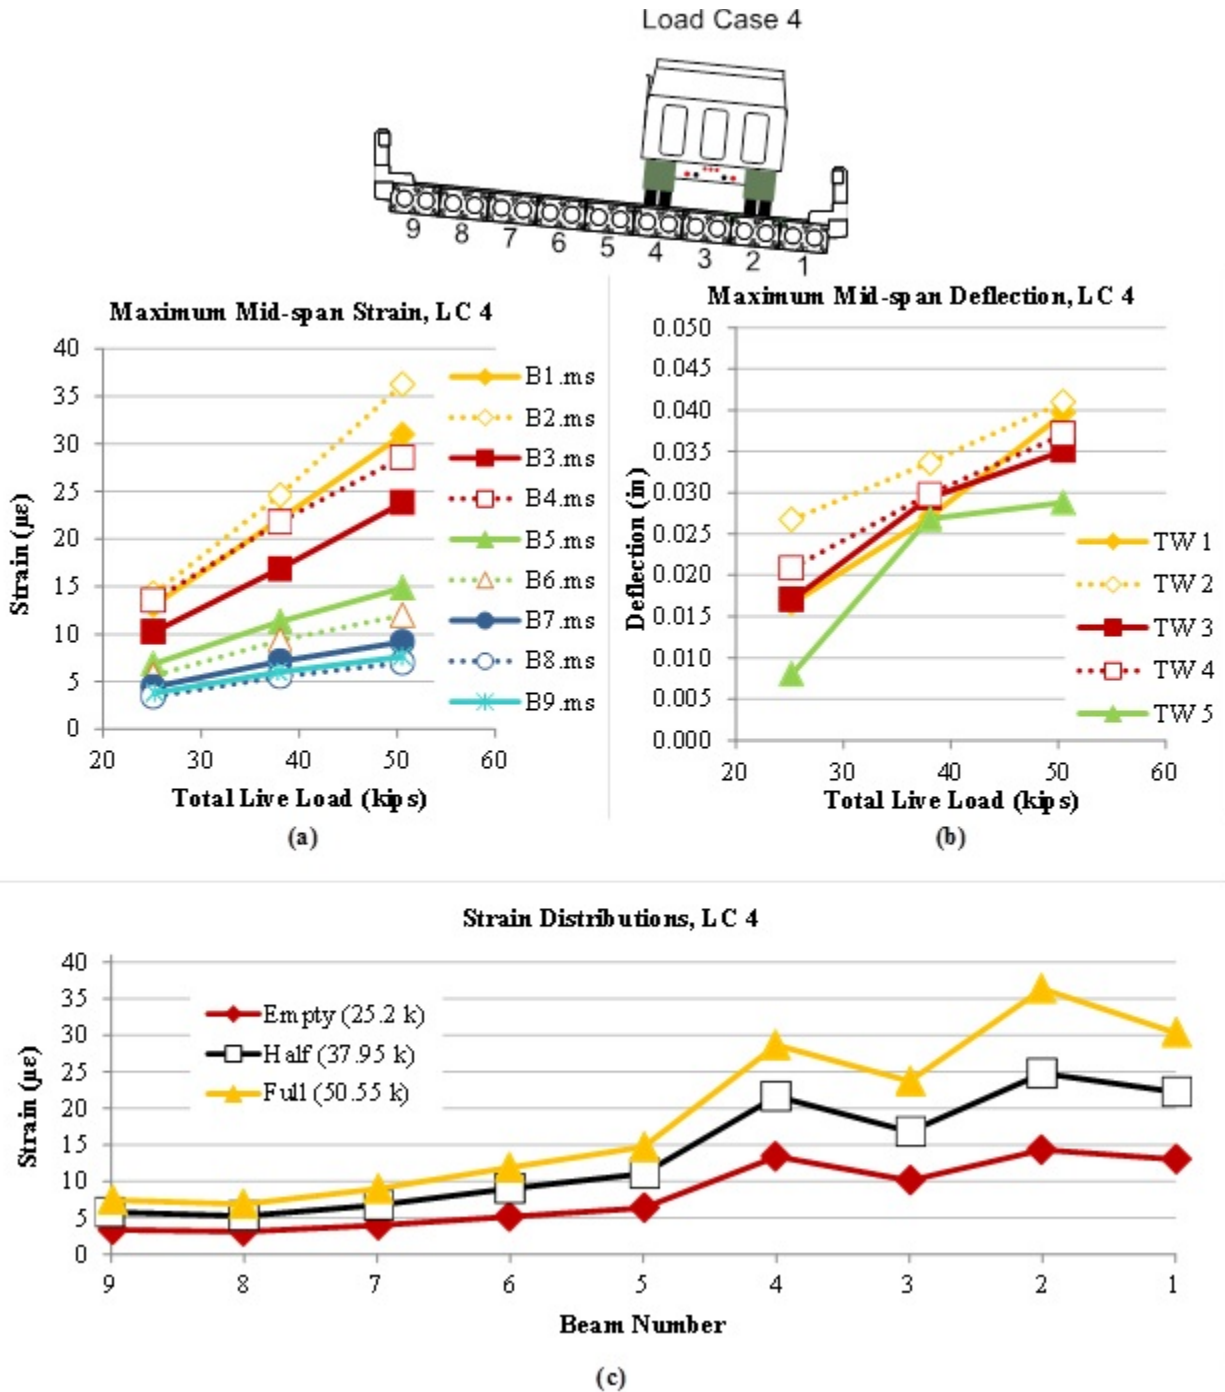
Figure 35. Adkins Road Bridge: Average (a) Maximum Strain and (b) Maximum Deflection for Each Beam, and (c) Strain Distributions at Mid-span for All Beams at Time of Maximum Strain for Load Case 4 (LC 4). Empty = empty truck; Half = half-full truck; Full = full truck.

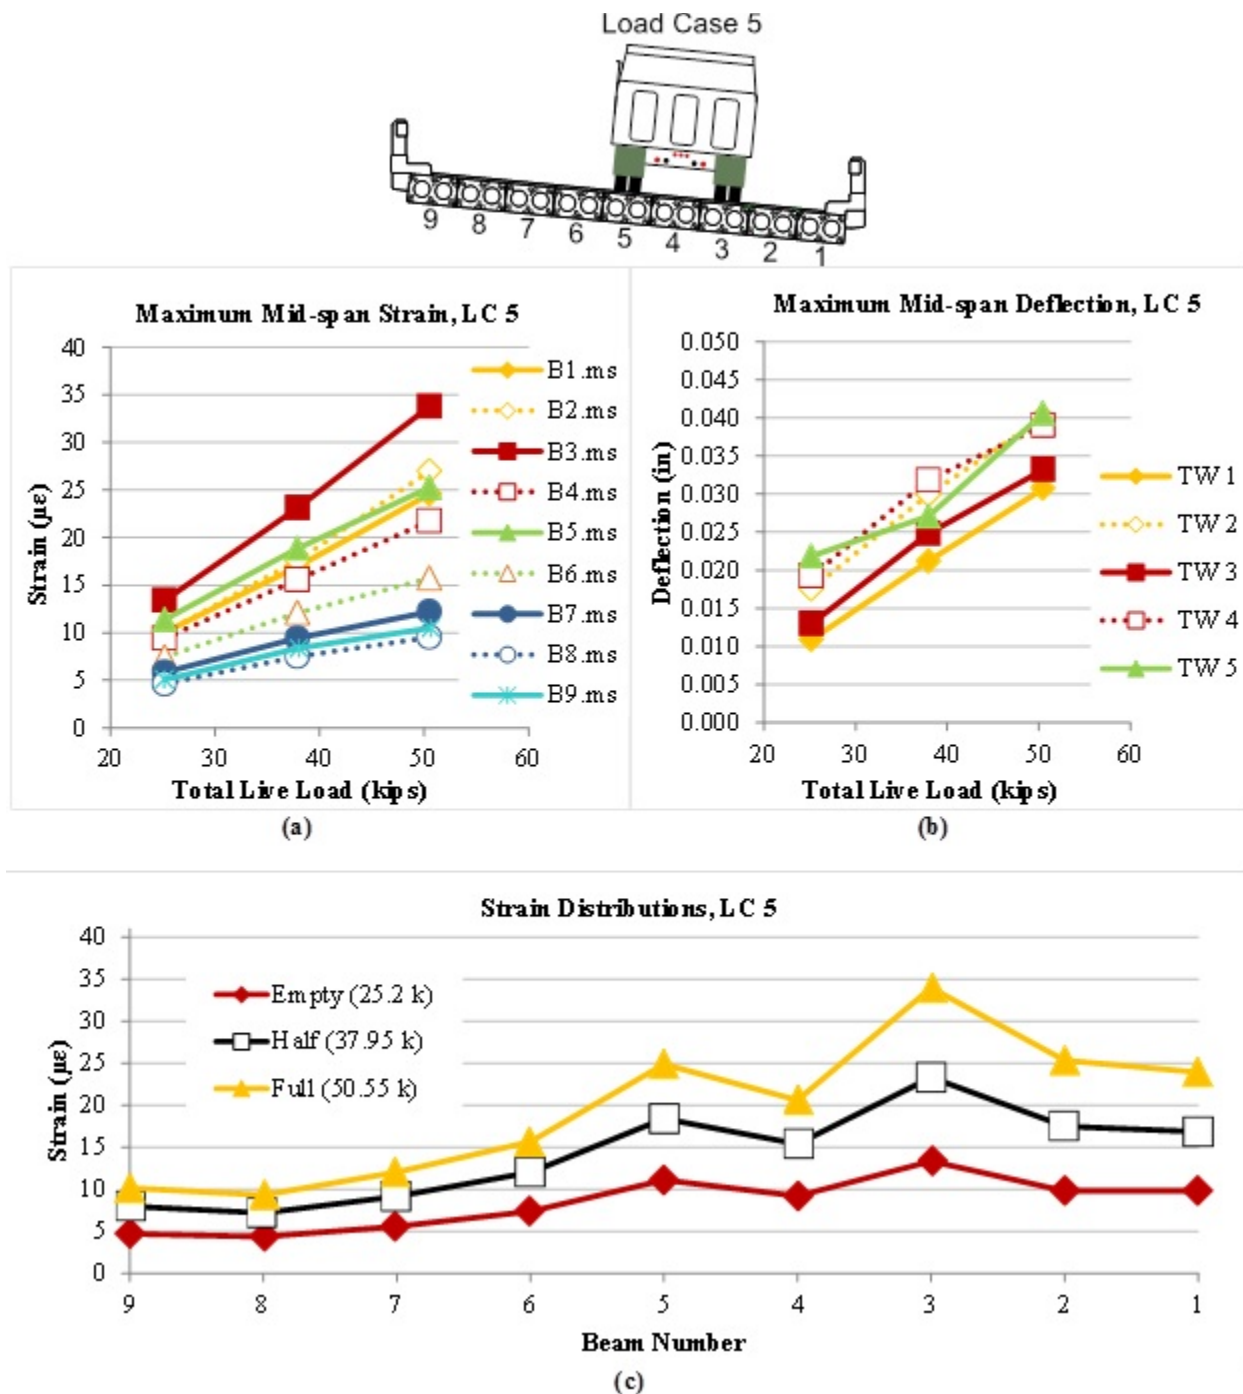
Figure 36. Adkins Road Bridge: Average (a) Maximum Strain and (b) Maximum Deflection for Each Beam, and (c) Strain Distributions at Mid-span for All Beams at Time of Maximum Strain for Load Case 5 (LC 5). Empty = empty truck; Half = half-full truck; Full = full truck.

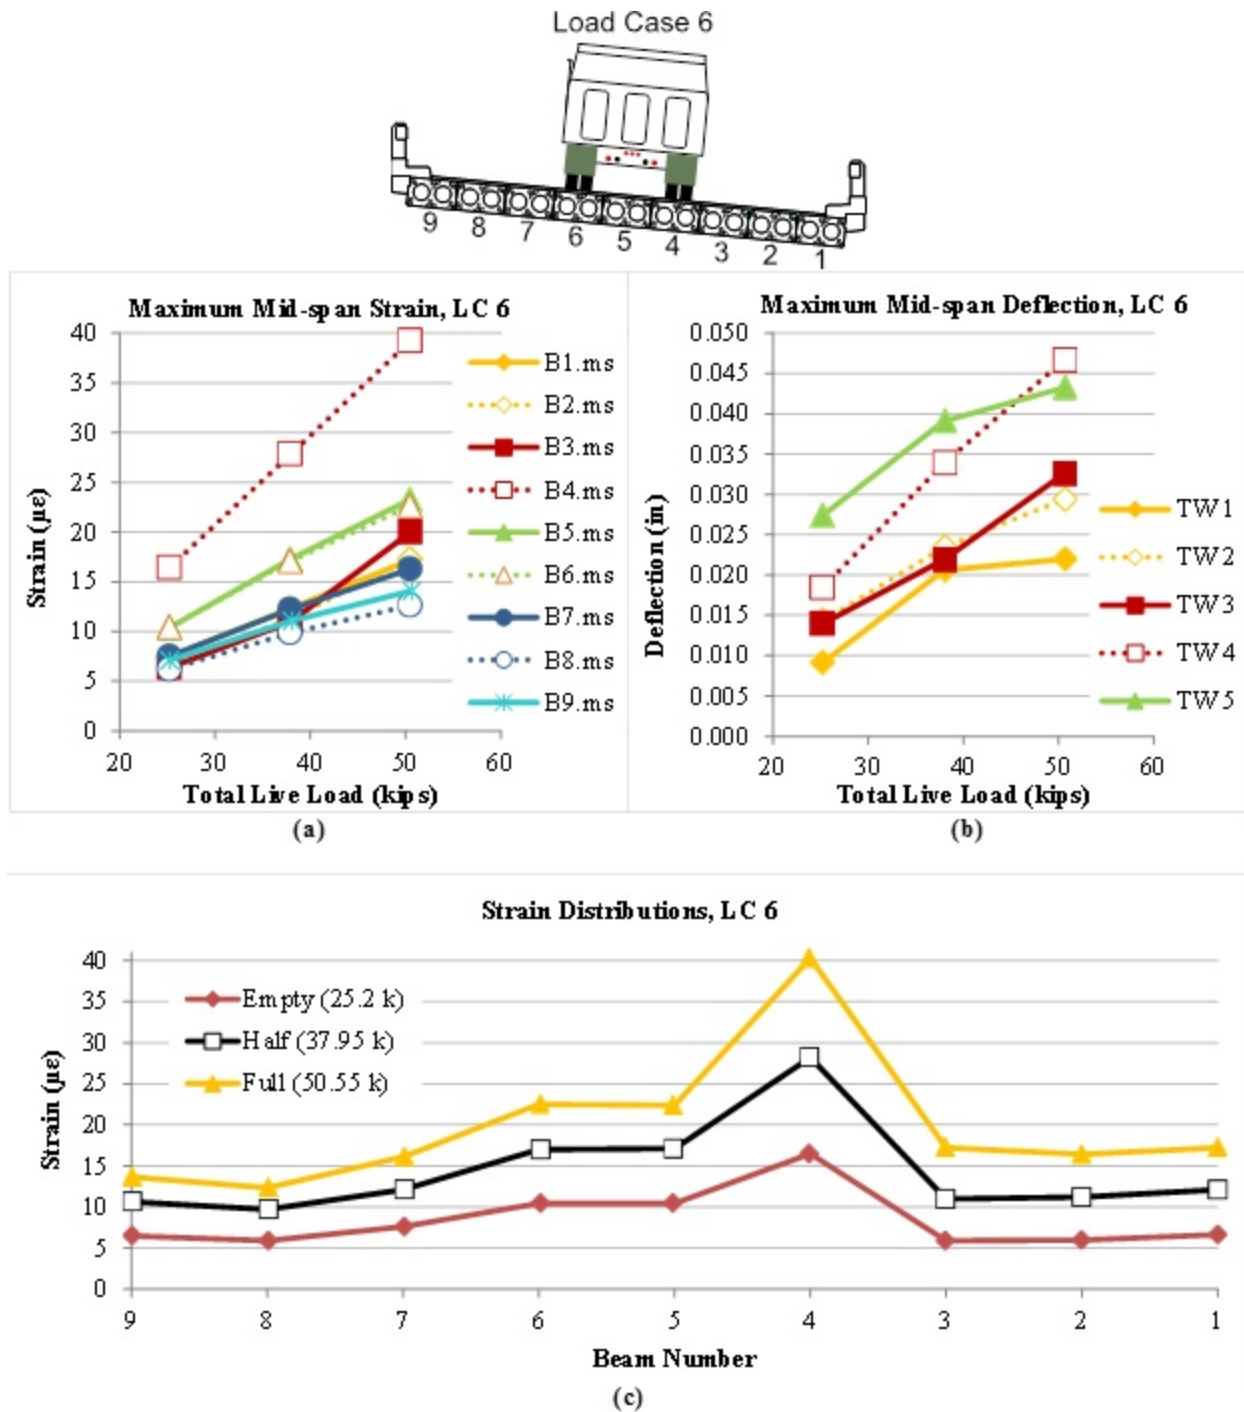
Figure 37. Adkins Road Bridge: Average (a) Maximum Strain and (b) Maximum Deflection for Each Beam, and (c) Strain Distributions at Mid-span for All Beams at Time of Maximum Strain for Load Case 6 (LC 6). Empty = empty truck; Half = half-full truck; Full = full truck.

On the other hand, the remaining LCs do show a little bit of a spike in the load distribution graphs. This spike was most evident in LC 6, when one of the wheel paths of the load truck was directly over Beam 4. Given that similar, albeit less prominent, changes in strain levels occurred in LCs 3 through 5, where a wheel path was over or adjacent to Beam 4, the data indicate that the longitudinal joints on either side of Beam 4 were no longer intact. Although the researchers observed that there was virtually no efflorescence at these two joints, the damage to the joints may have been relatively recent such that mineral buildup did not have sufficient time to develop. Regardless, there was at least some degree of load distribution occurring in each of the six LCs, as indicated by the amount of strain in all of the beams, with the exception of those members farthest away from the load truck.

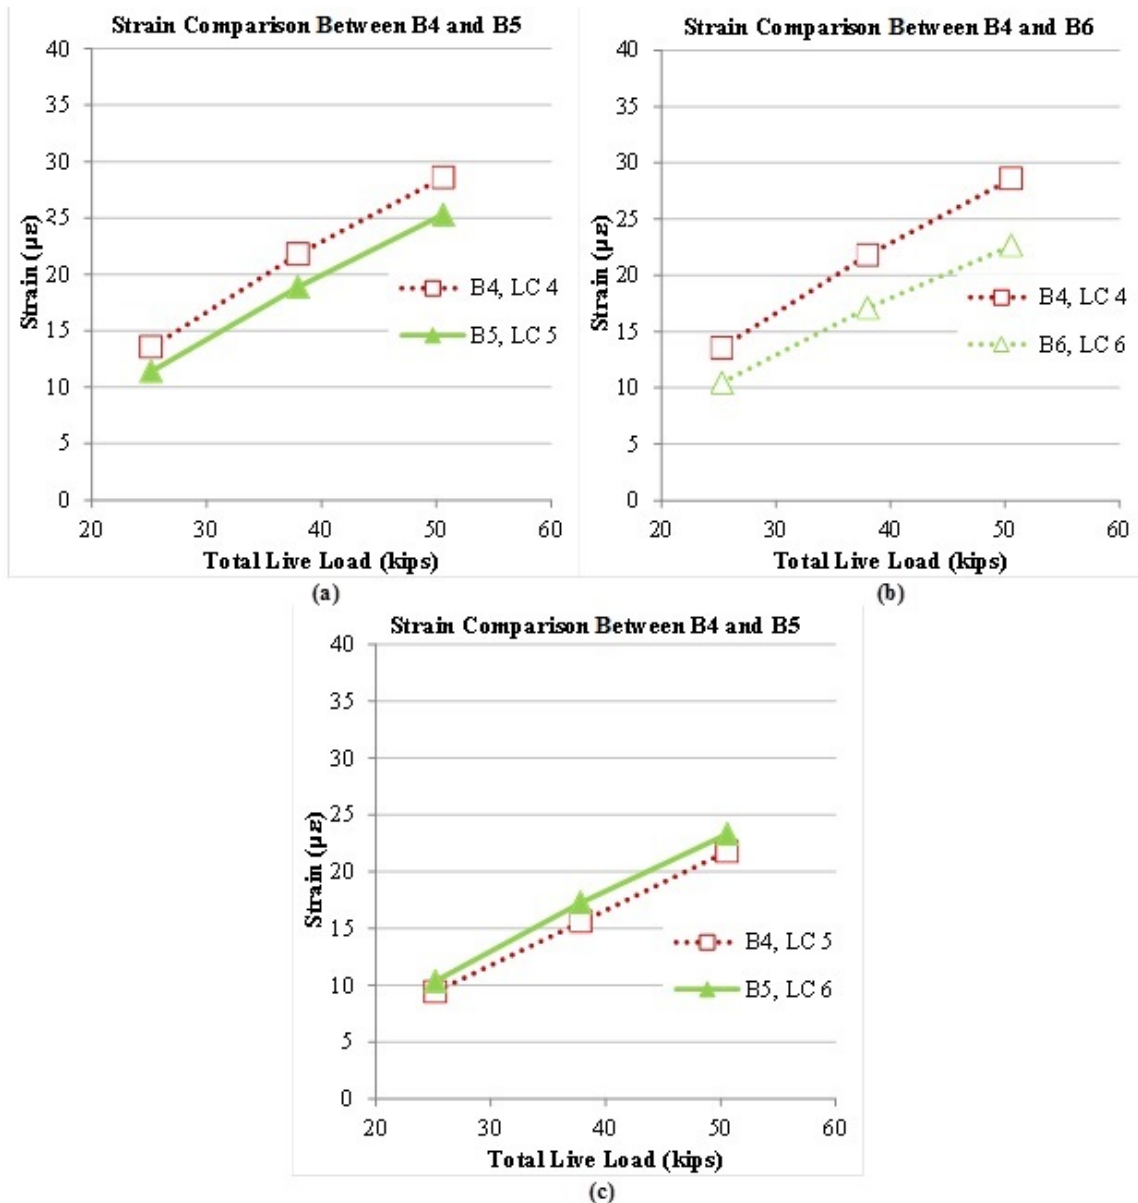
Another way to view the strain results for Figures 32 through 37 is to compare beams that had similar loading conditions, albeit in different LCs. The plots in Figure 38, which compare the average maximum strains for Beam 4 to those of Beams 5 and 6 under select LCs in Subplots (a), (b), and (c), respectively, may be taken as examples. The difference between Subplots (a) and (c) is that Subplot (a) shows data when a wheel line was directly on the centerline of the indicated beam whereas Subplot (c) has the two wheel lines straddling the beam. In each comparison, the measured strains were virtually identical, where the largest difference was about $5 \mu\epsilon$ when the left wheel line was on top of Beam 4 versus Beam 6, again indicating that the broken strands in Beam 4 did not have a large impact on the strength of the beam.

Figure 38. Adkins Road Bridge: Given Similar Loading Conditions, Comparison of Strain in Beam 4 to Strain in (a) Beam 5 With Both Beams Directly Loaded, (b) Beam 6, and (c) Beam 5 With Each Beam Straddled by Wheel Loads. B = beam; LC = load case.
