Forensic Investigation of Two Voided Slab Bridges in the Virginia Department of Transportation's Richmond District

SOUNDAR S.G. BALAKUMARAN, Ph.D., P.E.
Research Scientist
Virginia Transportation Research Council

Final Report VTRC 17-R12

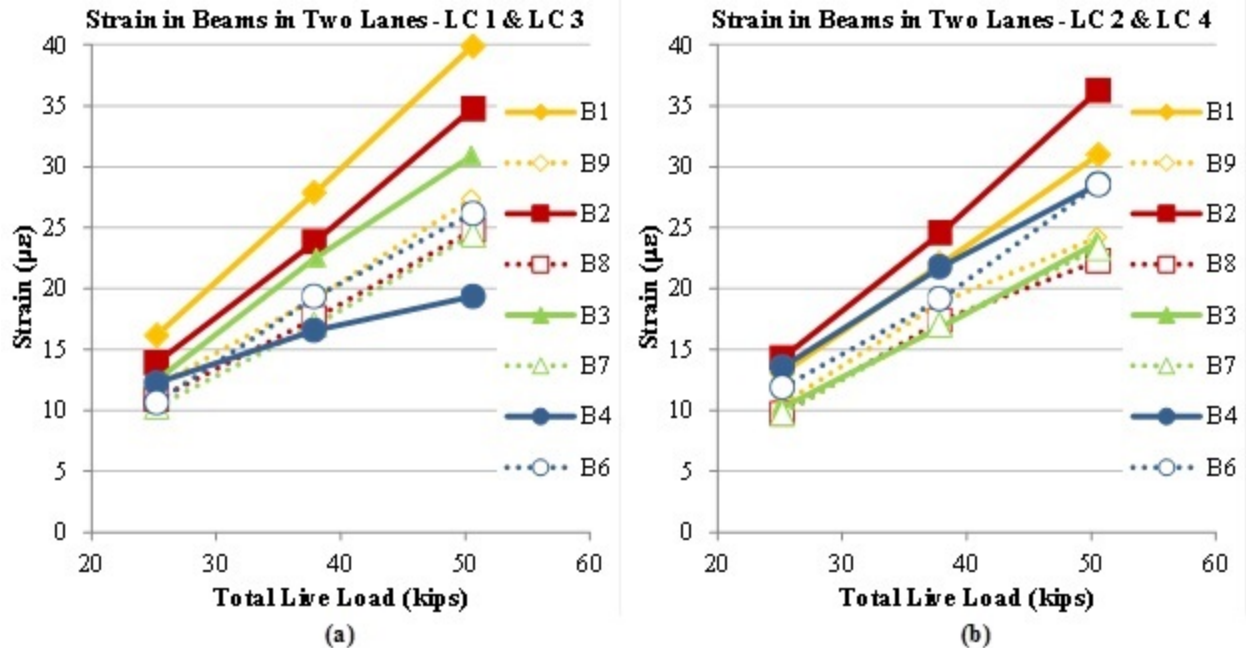
For another comparison, the graphs in Figure 39 may be considered, which pair the results for a beam in the southbound lane with the average maximum strain recorded for a beam in the northbound lane that was symmetric to the bridge centerline and subjected to a similar load pattern as shown in Figure 39(a), LCs 3 and 1, respectively, and Figure 39(b), LCs 4 and 2, respectively. The beams in Figure 39 are paired together in the figure legend according to their symmetric location; plots for the beams in the southbound lane are solid lines, whereas plots for the beams in the northbound lane are dotted lines. In other words, Beam 1 (solid line) is paired with Beam 9 (dotted line), Beam 2 (solid line) is paired with Beam 8 (dotted line), etc. Figure 40 is more of a reconfiguration of the results for LC 6 in Figure 37(a), but again beams that were symmetric to the bridge centerline are coupled together. For the most part, all three scenarios in Figures 38 through 40 demonstrate that the peak strains in the beams in the southbound lane were generally slightly greater than those in the northbound lane. The southbound lane is the lane on the lower end of the superelevation. Thus, the southbound lane was likely the side of the bridge where snow would pile up during snow removal and certainly the side subjected to more chloride during snow melts and rain runoff. Thus, the beams in the southbound lane could conceivably have had a greater degree of deterioration and, thus, this could have been the reason that lane exhibited larger strains during the load test.

Figure 39. Adkins Road Bridge: Comparison of Strains in Beams Symmetric to Bridge Centerline for (a) Load Cases 1 and 3 (LC 1 and LC 3), and (b) Load Cases 2 and 4 (LC 2 and LC 4). B = beam; LC = load case.

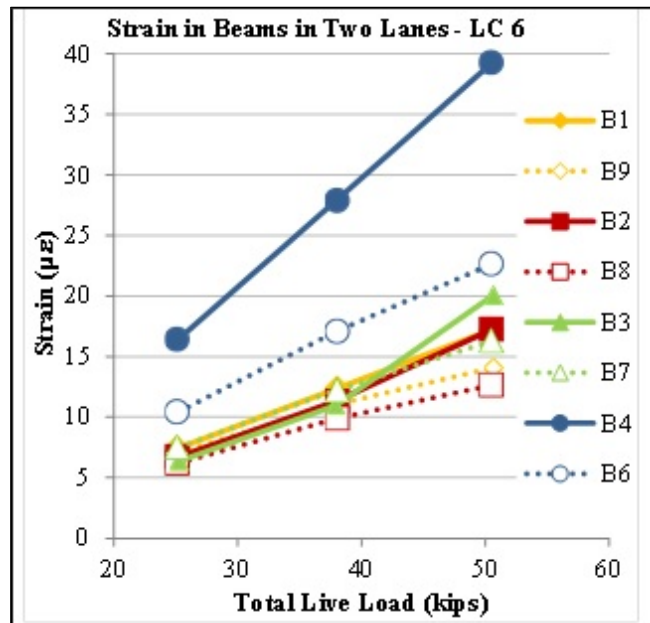
Figure 40. Adkins Road Bridge: Comparison of Strains in Beams Symmetric to Bridge Centerline for Load Case 6 (LC 6). B = beam.

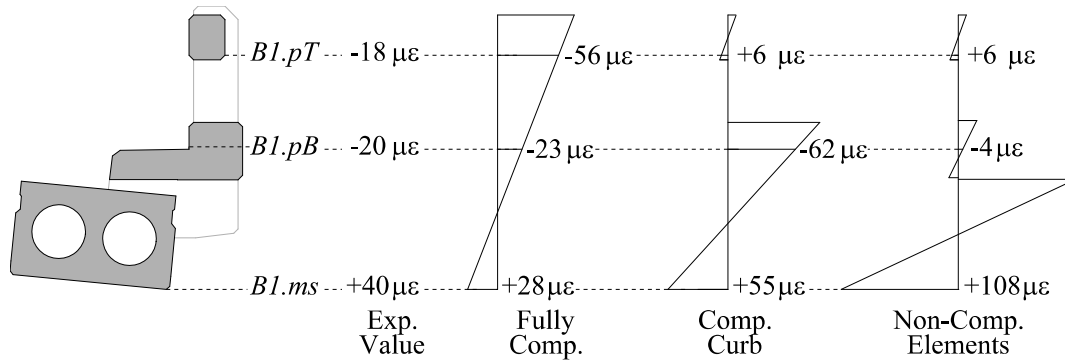
Figure 44. Adkins Road Bridge: Comparison of Experimentally Measured Strains Versus Calculated Values Assuming Various Degrees of Composite Action. Exp. = experimental; Comp. = composite.

In calculating the theoretical strains for the given levels of composition, the compressive strength of the concrete in the beam was assumed to be 4 ksi and the strength of the curb and railing was assumed to be 2.5 ksi. The section properties of the curb and railing were transformed to that of the beam using calculated values for the modulus of elasticity in accordance with Equation 1. Varying the assumed compressive strength, and hence the elastic modulus, did not have a major impact on the calculated strain values given in Figure 44. The moment applied to the composite portion of the structure was assumed using the weight of the

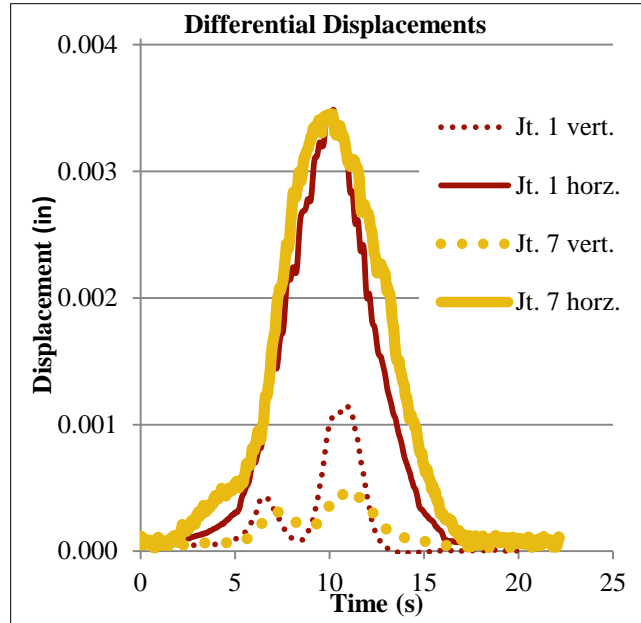
Figure 45 shows a comparison in the typical behavior of two longitudinal joints at the mid-span of Span 3, where Joint 1 was considered to be a representative joint in poor condition whereas Joint 7 was similar to other joints deemed to be in relatively good condition based on visual observation of the underside of the bridge. Figure 45 reflects a full truck for two LCs, LC 4 and LC 2, for the two respective joints. These two LCs are the only comparable truck orientations where a wheel line from the load vehicle was adjacent to a longitudinal joint at which differential displacement was measured. Although the truck orientations themselves were symmetrical with respect to the centerline of the bridge, the two joints did not receive quite the same loads. The difference lies in the fact that Joint 1 was primarily loaded with the passenger side of the truck whereas the driver side of the vehicle was adjacent to Joint 7. Again, because of the nature of the weight distribution of the truck, Joint 1 experienced about 2% greater load than Joint 7.

Despite the slight differences in loading, the relative displacements at both joints were extremely small, with the largest vertical differential movement being just above 0.001 in. Interestingly, the differential horizontal displacement was greater than the vertical displacement in both joints. Even so, the recorded displacements were below the precision in the LVDTs, which was 0.005 in. Nevertheless, just as a point of comparison, the two longitudinal joints had a similar degree of horizontal movement between the two beams at the given joint. On the other hand, Joint 1 had about twice as much vertical differential movement as did Joint 7. Again, however, greater emphasis should be placed on the fact that all of the measured movements between two beams were minute.

Figure 45. Adkins Road Bridge: Comparison of Differential Displacements at Mid-span for Joints 1 and 7. Jt. = Joint; vert. = vertical; horz. = horizontal.

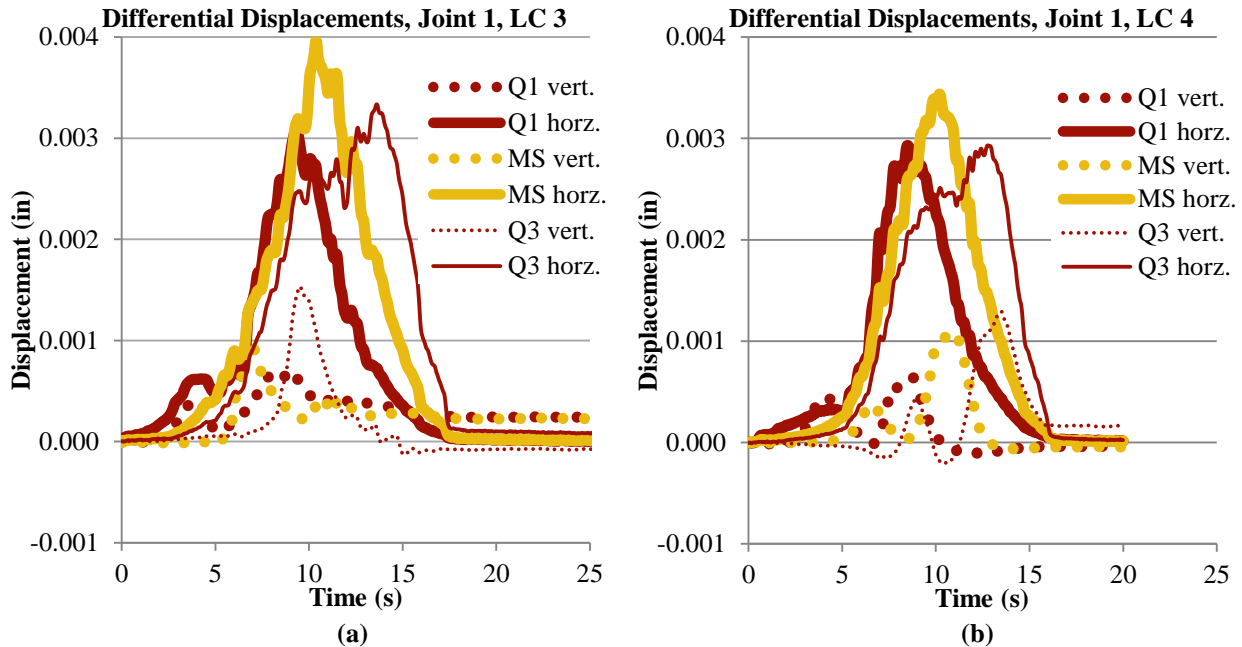
With regard solely to Joint 1, Figure 46 shows a typical comparison of the movement between Beams 1 and 2 under two load scenarios. Figure 46(a) shows the behavior when a wheel line from the load truck was positioned directly over the joint; Figure 46(b) shows the result of having a wheel line centered on a beam adjacent to the joint. The measurements in these plots are quite small; nevertheless, the vertical differential displacement was marginally greater for LC 4.

Figure 46. Adkins Road Bridge: Differential Displacements Between Beams 1 and 2 for (a) Load Case 3 (LC 3), and (b) Load Case 4 (LC 4). vert. = vertical; horz. = horizontal.

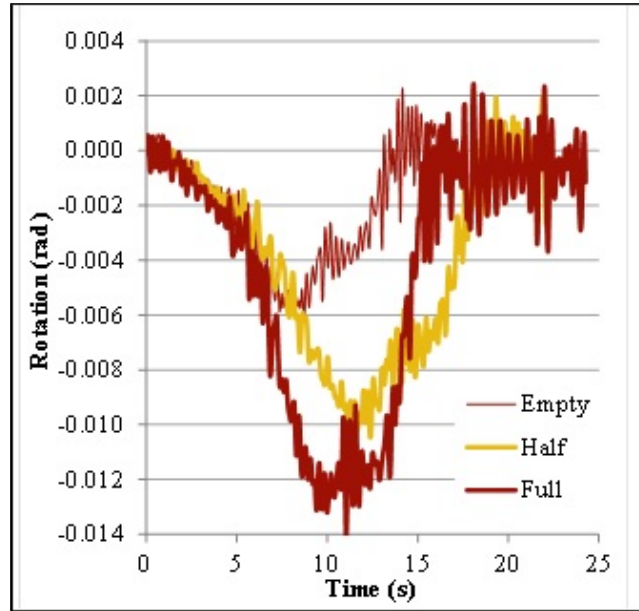
Figure 47. Adkins Road Bridge: Typical Plots Showing Rotation of Beam 4 Near Pier 3 as a Given Load Truck Crossed Span. Empty = empty truck; Half = half-full truck; Full = full truck.

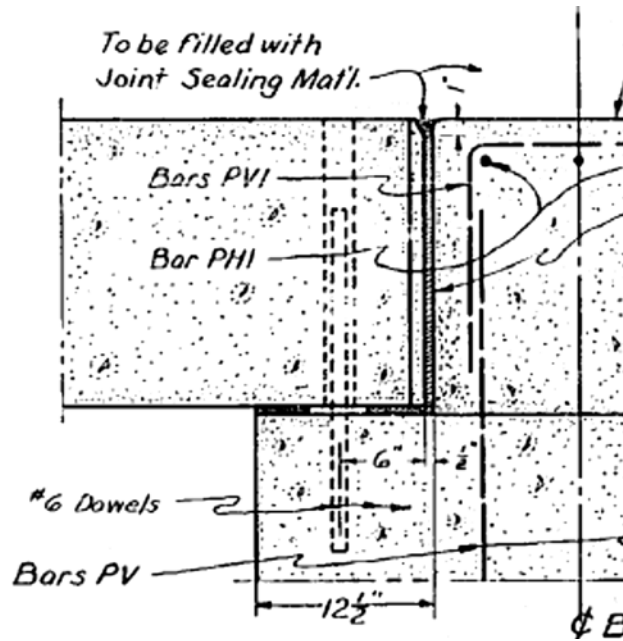
The voided slab structure in the Adkins Road Bridge was evidently restrained at the supports compared to the theoretically simply supported superstructure members. If so, this restraint could provide some explanation as to why the measured deflections in the beams were so small compared to theoretical deflections for simply supported flexural members. The cause of the restraint may partly be attributed to standard anchorage details at the time the bridge was originally built whereby each of the beams was anchored to the pier support by the use of 3/4-in dowel bars cast vertically into the pier caps and then going through the beams, as shown in Figure 48.

Figure 48. Anchorage Details Connecting Voided Slabs to Substructure of Adkins Road Bridge
