## Assessment of Soil and Wash Water Quality Beneath Salt-Spreader Racks

1. Report No. FHWA/VTRC 09-R3		2. Government Accession No.		3. Recipient's Catalog No.	
4. Title and Subtitle Assessment of Soil and Wash Water Quality Beneath Salt-Spreader Racks				5. Report Date July 2008

**FINAL REPORT**

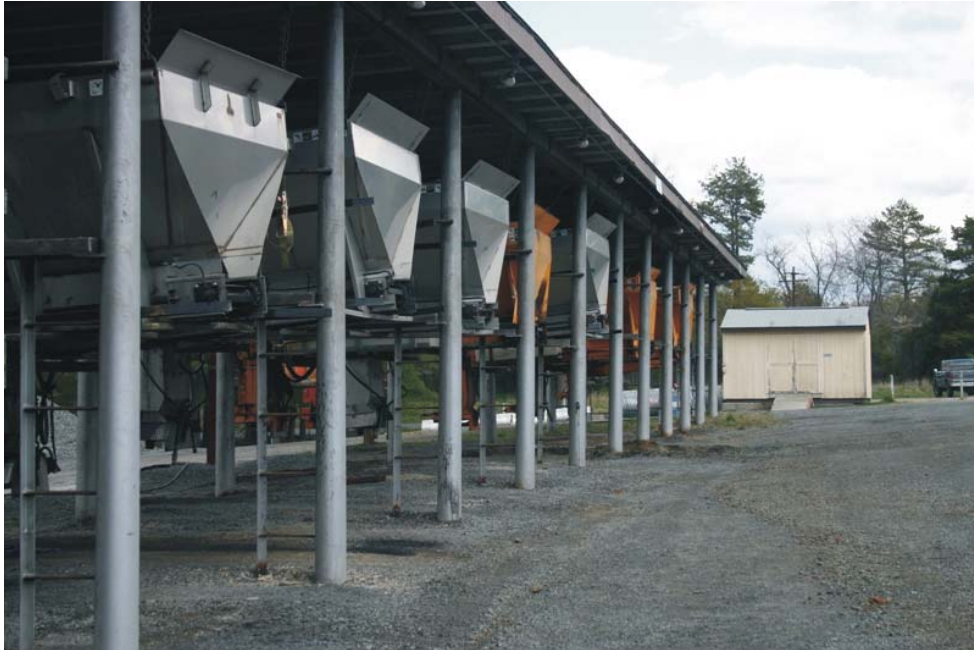
**Figure 1. Salt-Spreader Racks Typical of Those Found at VDOT Area Headquarters Maintenance Facilities**

VDOT is responsible for maintaining more than 57,000 miles of interstate, primary, and secondary roadways. VDOT's winter maintenance program is correspondingly large and hinges primarily on the use of granular NaCl for deicing. Between 2000 and 2005, VDOT applied approximately 330,000 tons of NaCl per year. This salt, along with various other anti-icing chemicals, is stored at area headquarters and dedicated chemical storage facilities, at least one of which is located in every county. In total, salt is stored at more than 300 locations throughout the state. Most of the storage facilities are composed of a building used to stockpile the chemicals, an adjacent impermeable pad that serves as a loading area for trucks, a stormwater storage pond or collection basin, and spreader racks (see Figure 1). The pad is designed to contain any chemicals that may be spilled during the loading process; the runoff from this area is directed to and stored in the nearby stormwater pond. The pond itself is designed to be impermeable to prevent infiltration of the water containing varying concentrations of anti-icing chemicals. The spreader racks are used for lubrication and storage of the spreaders used to apply salt from dump trucks.

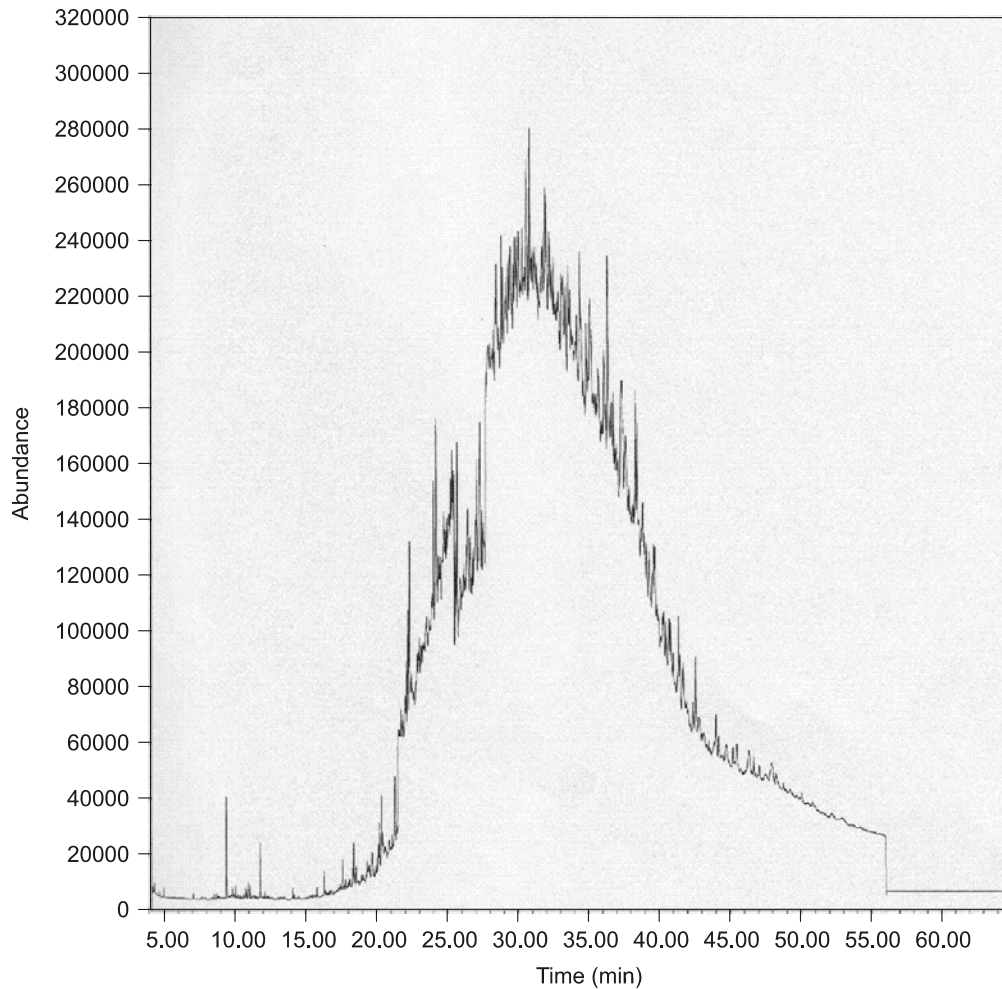
The chromatogram for Lubrikote is shown in Figure 3. Of the 37 compounds specifically identified, the prominent compounds found in the lubricant were n-C17, n-C18, dibenzothiophenes, naphthalenes, phenanthrenes, triterpanes, pyrenes, and other hydrocarbons. Figure 4 shows the chromatogram of Zep Dry Moly; it looks markedly different than the chromatogram of Lubrikote. The only organic compounds present in the Zep Dry Moly chromatogram were lightweight volatile compounds resulting from its aerosol nature.

**Figure 3. Gas Chromatogram for Lubrikote**

chromatogram of the pure lubricant and that of the soil extract are not expected to be perfect matches, as weathering and degradation cause changes in the organic constituents in the lubricant present in the soil (Wang and Fingas, 1995).

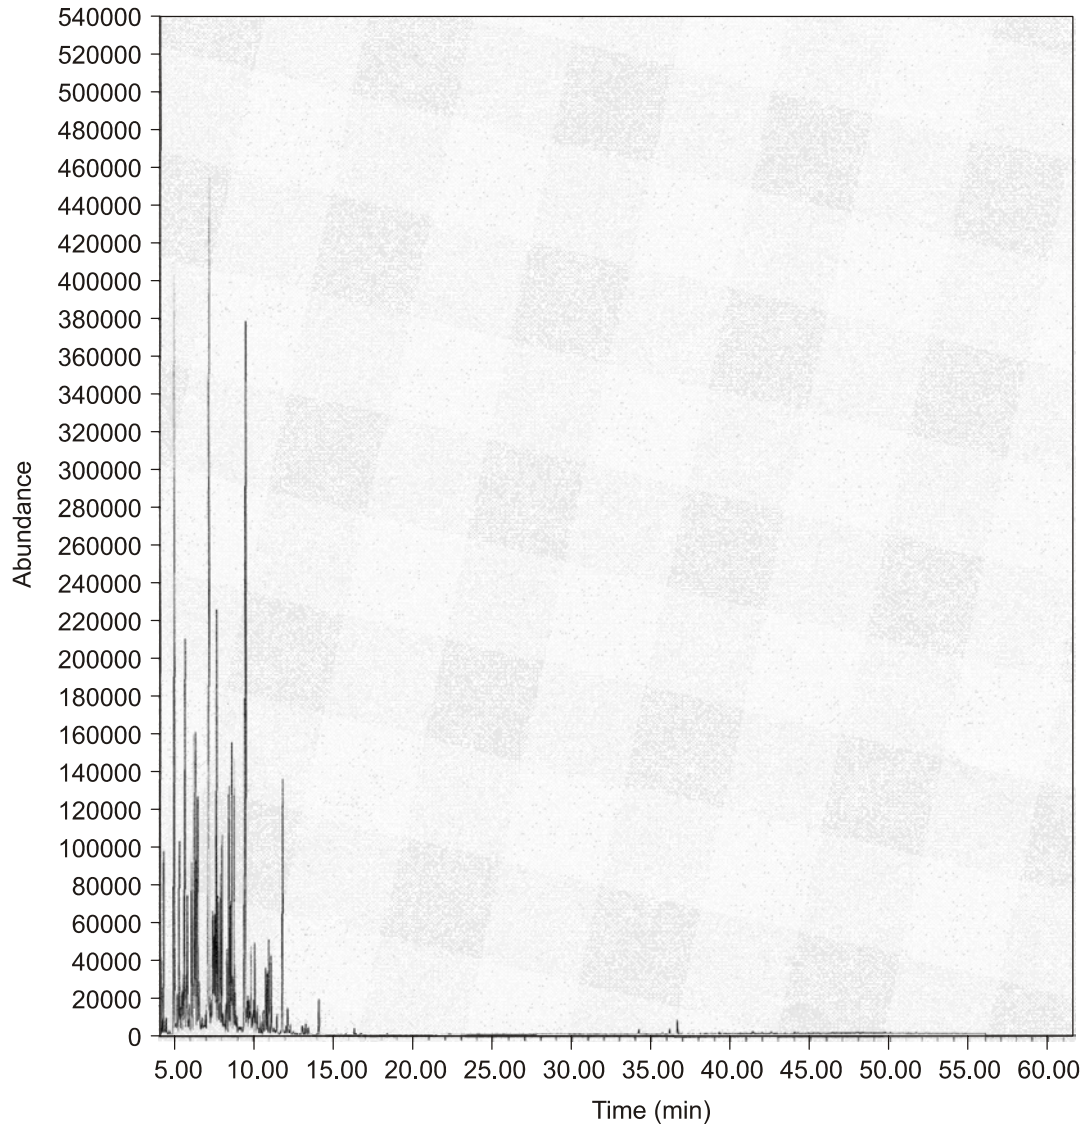
**Figure 4. Gas Chromatogram for Zep Dry Moly**

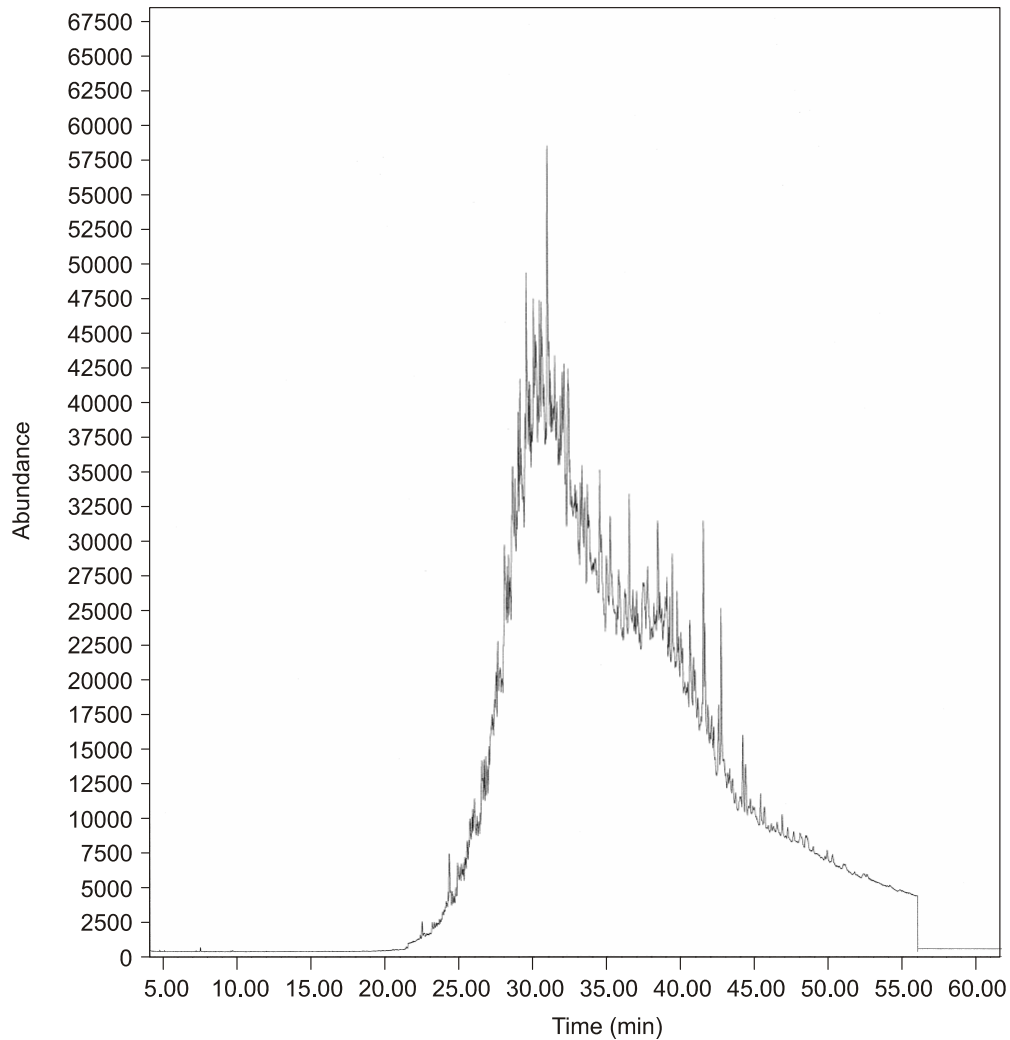
Figure 5 shows the cyclohexane extract from a soil sample collected from under the spreader racks at a VDOT location. This chromatogram for the soil extract shows the presence of dibenzothiophene, triterpanes, and pyrene, among other heavy hydrocarbons. The

**Figure 5. Gas Chromatogram of Cyclohexane Extract of Soil Sample Taken Under Spreader Rack**
