Corrugated Metal Pipe Culvert Invert Repair Using Engineered Cementitious Composite

Final Report VTRC 21-R5

FINAL REPORT
**CORRUGATED METAL PIPE CULVERT INVERT REPAIR USING ENGINEERED
CEMENTITIOUS COMPOSITE**

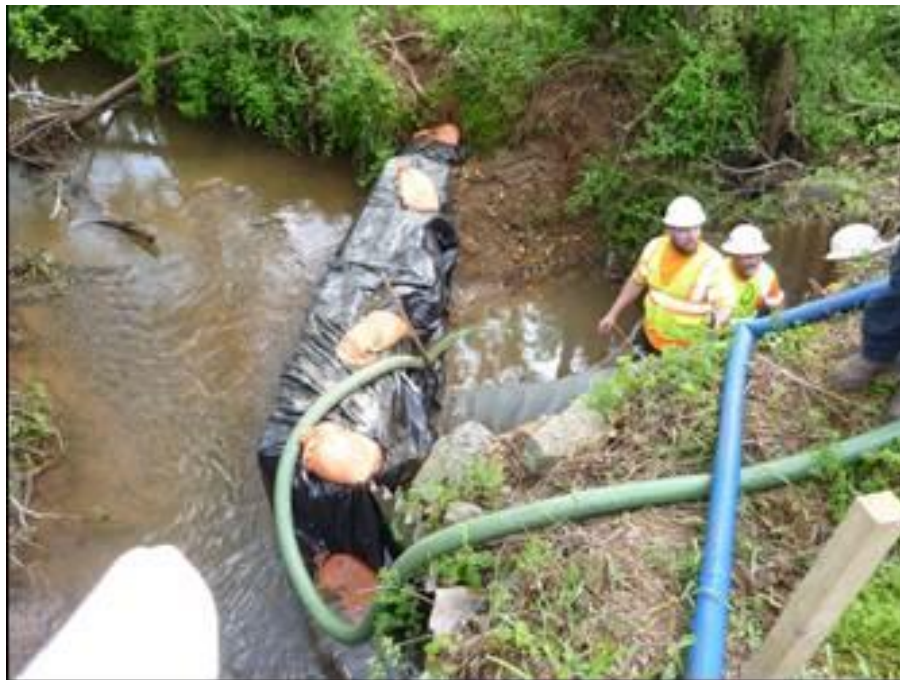
Before the repairs, the water flowing through each culvert was diverted. As shown in Figure 2, ground and surface water was prevented from entering the culvert using a pump. The inverts and sides of the pipes were cleaned by removing debris, mainly silt, with low pressure water hoses; sweeping; washing the second time; and then blowing with air before the placement of the geogrid and the application of ECC. Loose rust and extra puddles of water in the valleys of the culvert were also removed.

Figure 2. Dewatering

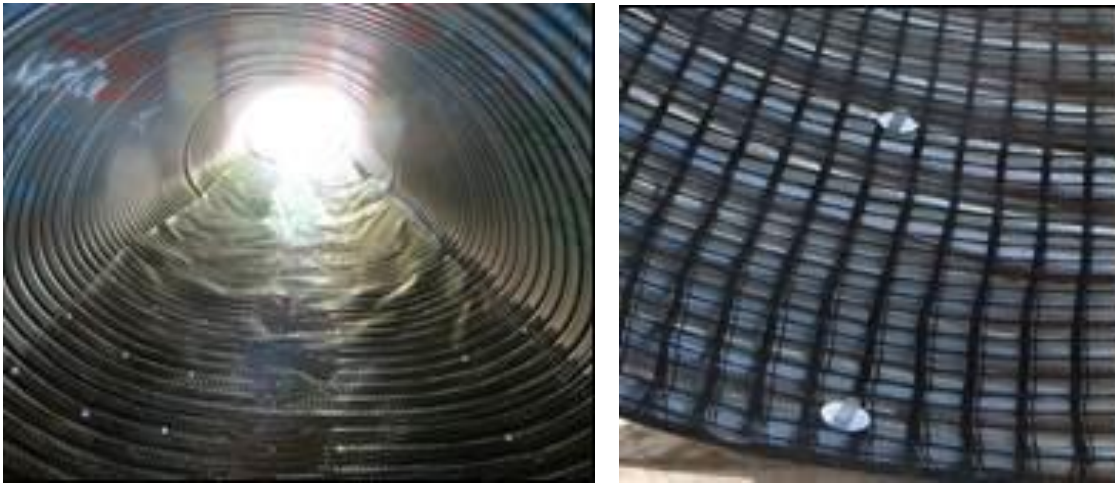
Synthetic biaxial geogrids, PVA in the first culvert and polypropylene in the rest, with a 1-in aperture size were used in the field. The geogrid was attached to the top of the corrugations with a screw at 1.5 to 2 ft spacings; the screws had spacers to ensure that a maximum 1-in thickness was maintained, as shown in Figure 3. Geogrid was used on all culverts except for a 20-ft section of Route 611, which had lost some of the corrugations and was first repaired with rapid set cement, which closed the missing and existing corrugations before the placement of ECC. Water diversion, geogrid placement, and the repair of the holes were done before the placement of the ECC and required about 2 days.

Figure 3. Geogrid Attached (Left), Screw With Spacer (Right)

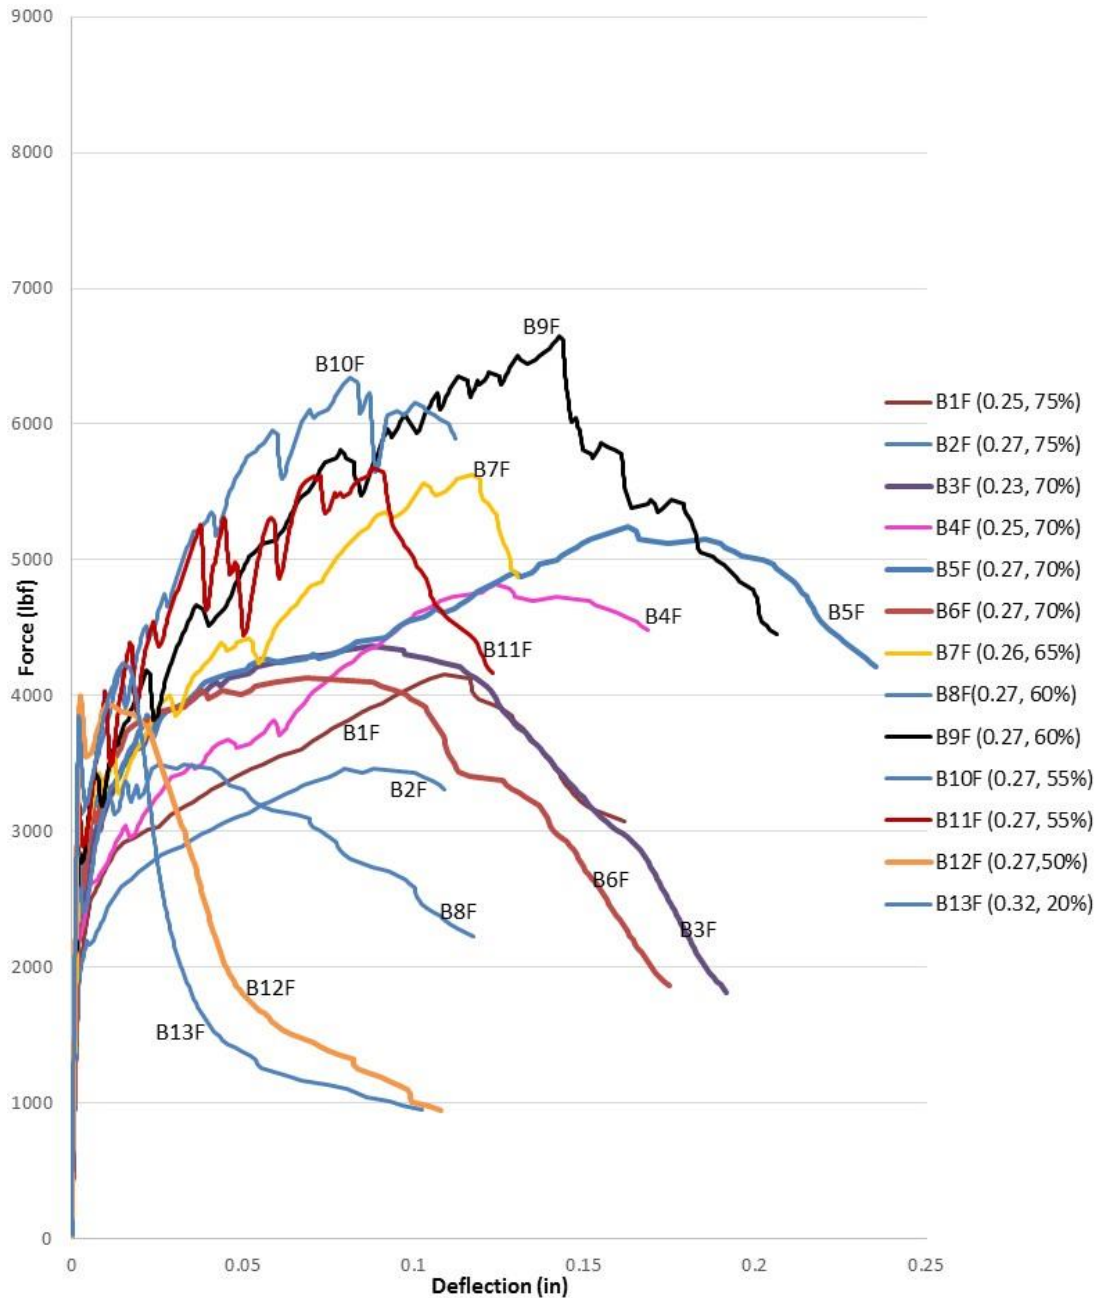
Flexural strengths for ECC mixtures with high amounts of fly ash are given in Table 10. Figure 7 displays the load versus deflection curves for these mixtures. Deflection hardening and high ductility were found even though the flexural strengths were not as high as for the typical ECC mixtures. Mixtures with typical proportions of cementitious material, 55% fly ash replacement, and higher percentages of fly ash have good ductility; at lower percentages of fly ash, ductility was lower. The variation in ductility with high percentages of fly ash is attributed to differences in fiber amount and distribution and the w/cm. Use of high amounts of fly ash is beneficial in this instance, since improved robustness (reduced variability) in ductility has been found (Yang et al., 2007).

Figure 7. Load Versus Deflection Curves for ECC Mixtures With High Amounts of Fly Ash. ECC = engineered cementitious composite; B = batch; F = high fly ash. Values in parenthesis are the water-cementitious material ratios and the percentages of fly ash.

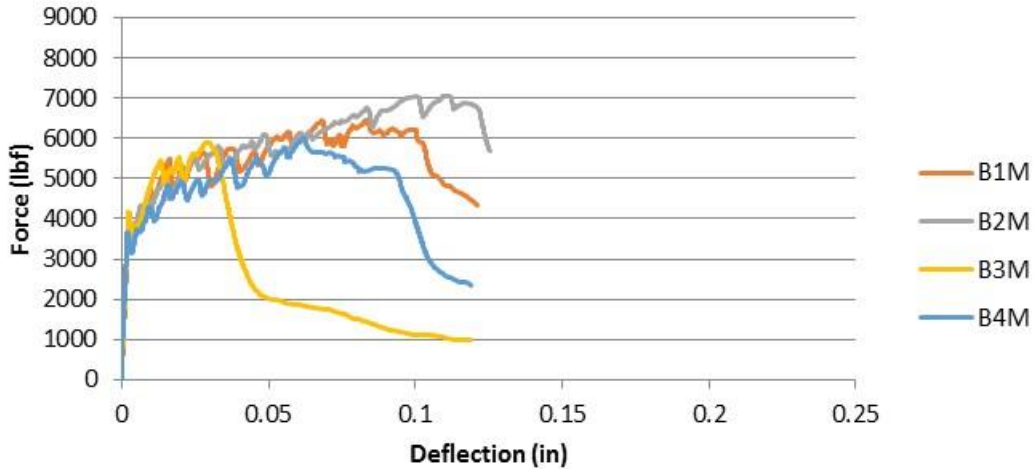
Figure 8. Load Versus Deflection Curves for ECC Mixtures With Mortar Sand. ECC = engineered cementitious composite; B = batch; M = mortar sand.

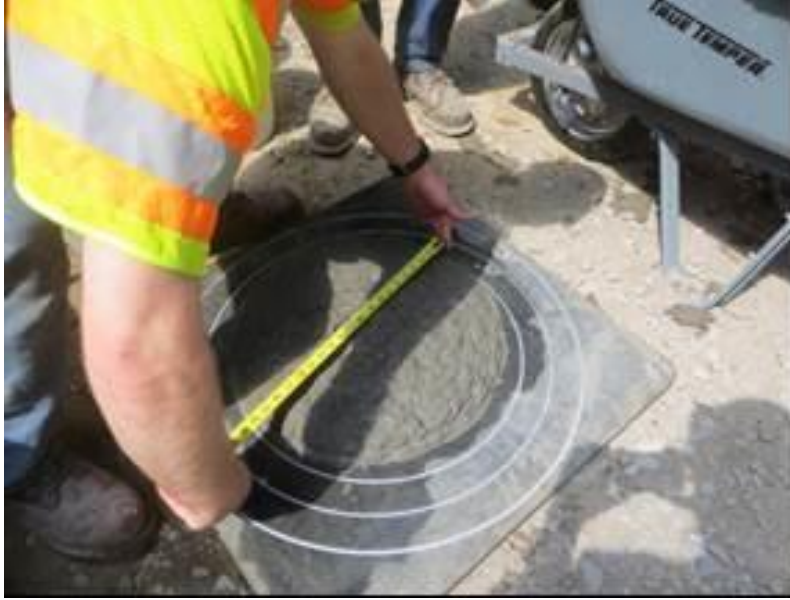
Figure 9. ECC in the Trial Batch and Mortar Mixer Batch. Batches 1 and 2 were self-consolidating, as shown by the measured slump flow. ECC = engineered cementitious composite.

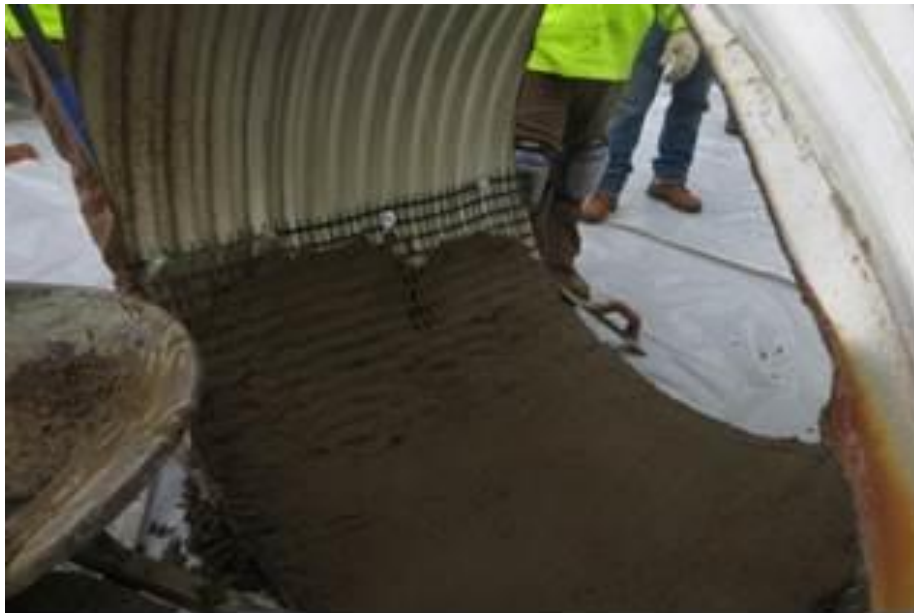
The trial batch had 1.8% PVA fibers and was retarded extensively with a retarding admixture to enable sufficient delivery and placement time. This wet mixture flowed down the sides of the culvert piece, as shown in Figure 10. The trial batch was tested for fresh concrete properties and handling characteristics.

Figure 10. ECC From Trial Batch Flowing Down Sides in Ripples. ECC = engineered cementitious composite.

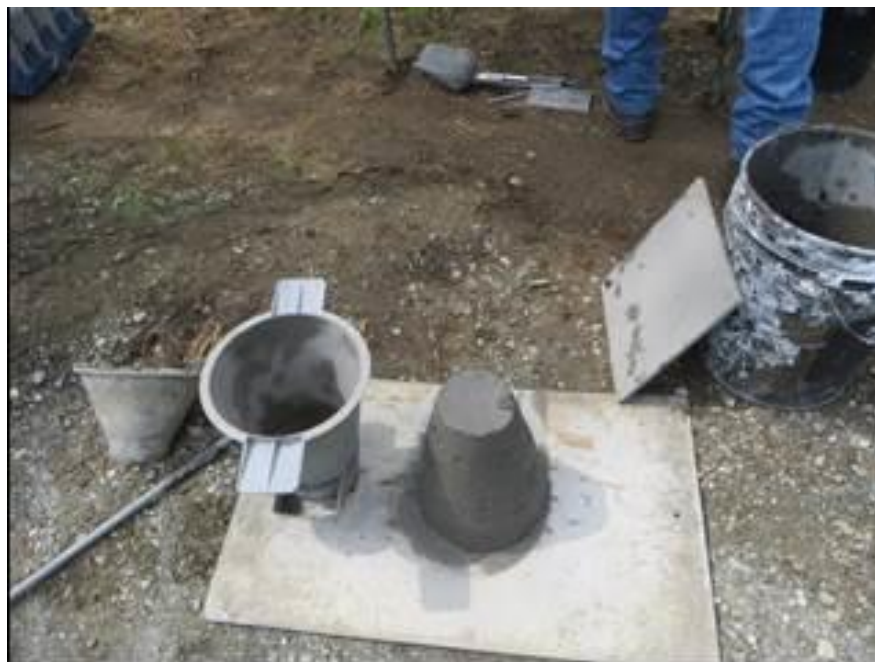
With Batch 3, by reducing the amount of admixtures and reducing the w/cm, a stiffer mixture was made, as illustrated by the slump test in Figure 11. Batch 3 with 1.5% fiber was used in one of the barrels of a 51-ft-long culvert at Route 774. The second barrel of this culvert was repaired 1 week later with Batch 4. Batch 3 was too stiff to go through the grate of the pump and had to be pushed with a shovel through the grate. For Batch 4, which was also a stiff mixture, a vibrator was placed on the grate to facilitate the flow of ECC through the grate. In Batch 4, more fibers (1.8%) were added to the mixture to improve the post-crack behavior. The stiff mixtures sprayed well and stuck to the sides without flowing down; the trailer pump had no difficulty spraying the stiff ECC, even with 1.8% PVA fibers. Pump operators preferred stiffer mixtures. Spraying was very efficient in the placement of the culverts; each barrel was repaired within 1 hour.

Figure 11. Slump Test for Stiff Batch 3
